# Inspection Report

| Project Name: | Unicorn House |
| Job Purpose: | Sample condition survey |

**Street:** Unicorn House, Cheetham Street  
**Town or City:** Middleton  
**Post Code:** M24 4DG

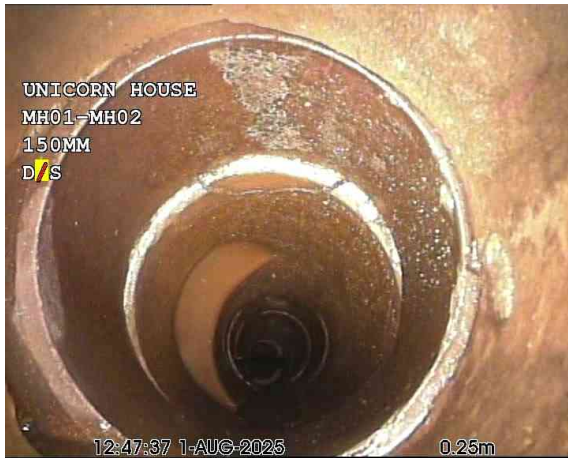
| Scale: | 1:50 | Position [m] | Code | Observation | MPEG | Photo | Grade |
|---|---|---|---|---|---|---|---|
| | | 0.25 | JDL | Joint displaced, large | 00:00:03 | MH01_cff5<br>de7b-2c5e<br>-4cca-b2d | 1 / 4 |

MH01\_cff5de7b-2c5e-4cca-b2d3-9116e3428715\_20250807\_1  
 10739\_530.jpg, 00:00:03, 0.25 m  
 Joint displaced, large

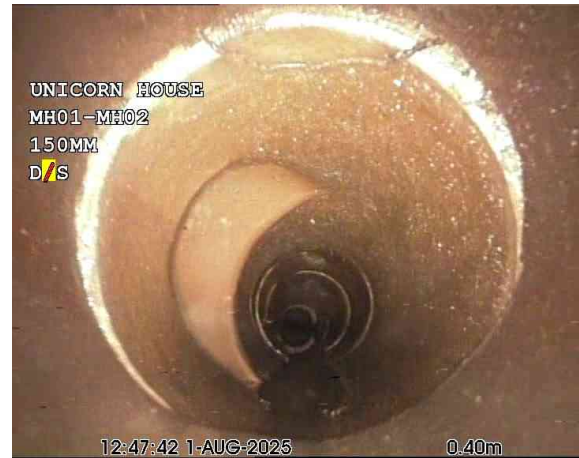
| Scale: | 1:50 | Position [m] | Code | Observation | MPEG | Photo | Grade |
|---|---|---|---|---|---|---|---|
| | | 0.40 | FCJ | Fracture, circumferential at joint from 11 o'clock to 1 o'clock | 00:00:07 | MH01_ded<br>3a96f-066<br>d-420b-a1 | 3 / 2 |

MH01\_ded3a96f-066d-420b-a1dc-014538a649b7\_20250807\_  
 110825\_143.jpg, 00:00:07, 0.40 m  
 Fracture, circumferential at joint from 11 o'clock to 1 o'clock

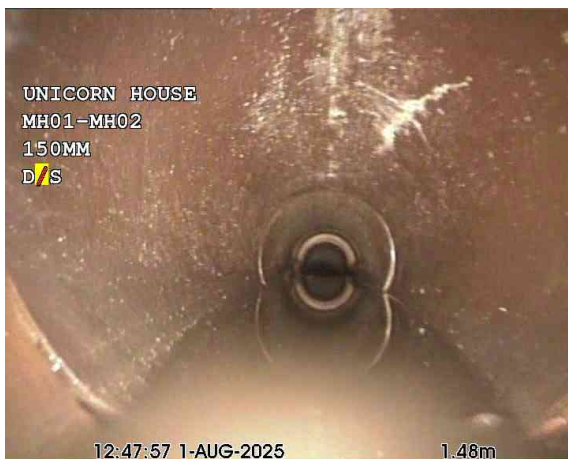
MH01\_4f80a8fa-e08b-4d76-933b-8cce79fe3443\_20250807\_1  
 10951\_577.jpg, 00:00:22, 1.48 m  
 Water level, 20% of the vertical dimension

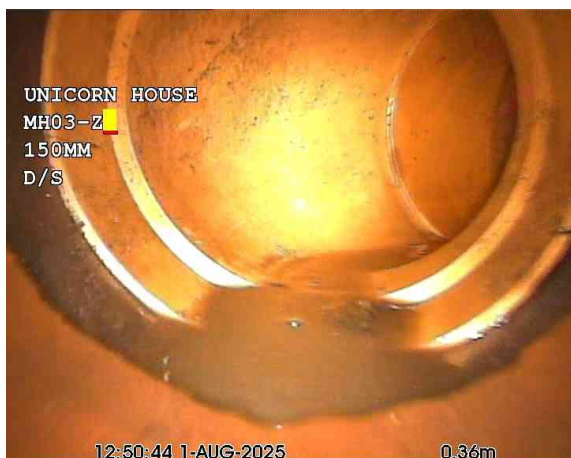
| Scale: | 1:50 | Position [m] | Code | Observation | MPEG | Photo | Grade |
|---|---|---|---|---|---|---|---|
| | | 0.36 | OJL | Open joint, large | 00:00:05 | MH03_f2a<br>53a16-d30<br>7-4303-af9 | 1 |

MH03\_f2a53a16-d307-4303-af9e-4bc18c37c83c\_20250807\_11851\_115.jpg, 00:00:05, 0.36 m  
Open joint, large

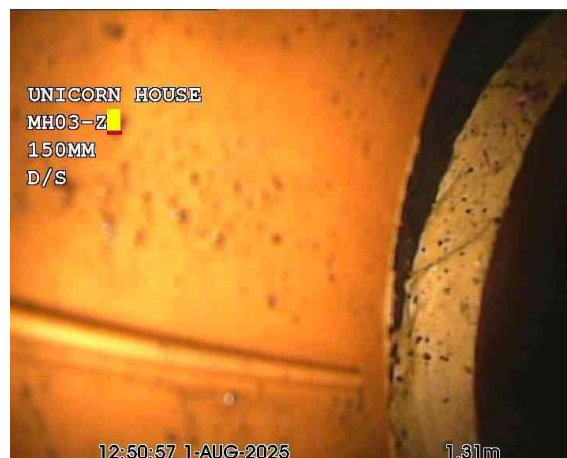
| Scale: | 1:50 | Position [m] | Code | Observation | MPEG | Photo | Grade |
|---|---|---|---|---|---|---|---|
| | | 1.31 | JDL | Joint displaced, large | 00:00:18 | MH03_489<br>e6729-736<br>f-450f-933 | 1 / 4 |

MH03\_489e6729-736f-450f-9333-f8854997553f\_20250807\_112126\_776.jpg, 00:00:18, 1.31 m  
Joint displaced, large

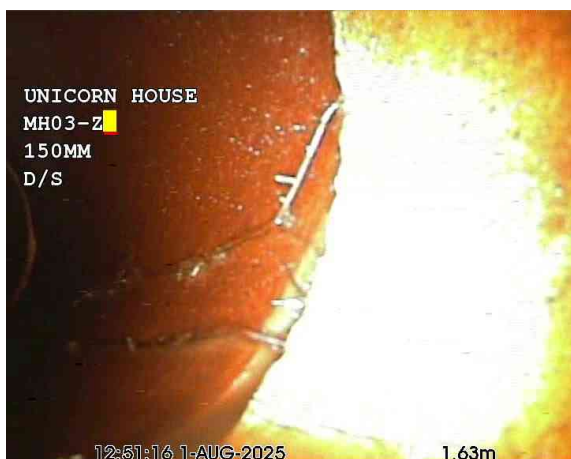
| Scale: | 1:50 | Position [m] | Code | Observation | MPEG | Photo | Grade |
|---|---|---|---|---|---|---|---|
| | | 1.63 | RFJ | Roots, fine at joint | 00:00:37 | MH03_b0d<br>99bc4-a16<br>b-4ce5-9e | 2 |

MH03\_b0d99bc4-a16b-4ce5-9ed5-45eabae749cb\_20250807\_112326\_449.jpg, 00:00:37, 1.63 m  
Roots, fine at joint

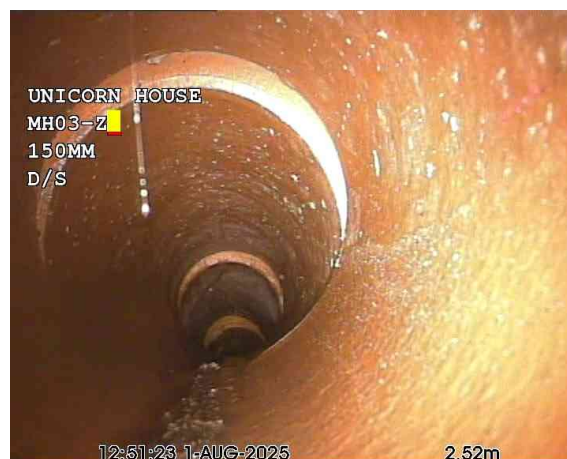
| Scale: | 1:50 | Position [m] | Code | Observation | MPEG | Photo | Grade |
|---|---|---|---|---|---|---|---|
| | | 2.52 | JDL | Joint displaced, large | 00:00:44 | MH03_061<br>212bb-9fd<br>e-4c68-a5 | 1 / 4 |

MH03\_061212bb-9fde-4c68-a538-d0ce1ad9c9d0\_20250807\_112406\_584.jpg, 00:00:44, 2.52 m  
Joint displaced, large

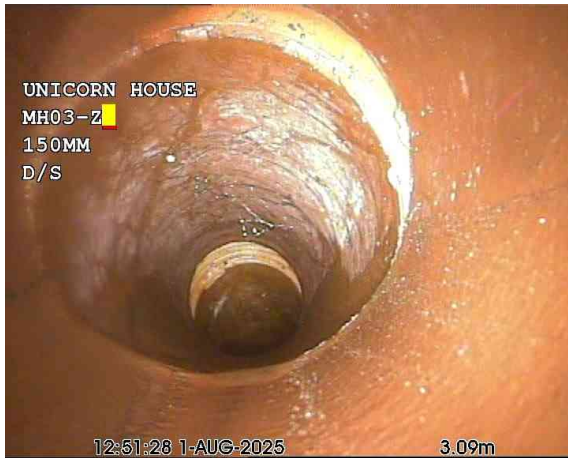
| Scale: | 1:50 | Position [m] | Code | Observation | MPEG | Photo | Grade |
|---|---|---|---|---|---|---|---|
| | | 3.09 | JDL | Joint displaced, large | 00:00:49 | MH03_99c<br>7ba3a-1cd<br>e-4992-a4 | 1 / 4 |

MH03\_99c7ba3a-1cde-4992-a401-345e34a2d39e\_20250807\_112431\_008.jpg, 00:00:49, 3.09 m  
Joint displaced, large

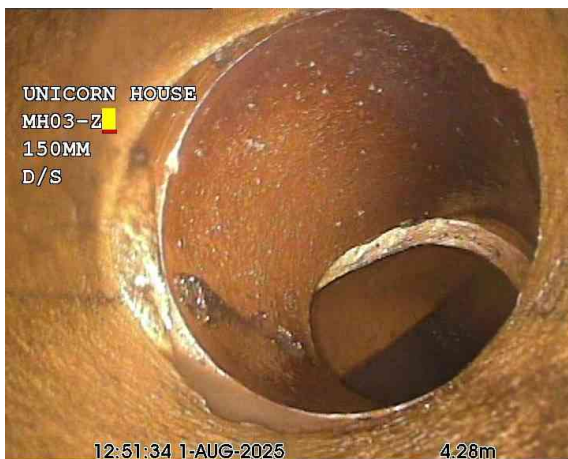
| Scale: | 1:50 | Position [m] | Code | Observation | MPEG | Photo | Grade |
|---|---|---|---|---|---|---|---|
| | | 4.28 | JDL | Joint displaced, large | 00:00:55 | MH03_901<br>3f87e-202<br>b-407b-af1 | 1 / 4 |

MH03\_9013f87e-202b-407b-af11-55057019b937\_20250807\_112601\_879.jpg, 00:00:55, 4.28 m  
Joint displaced, large

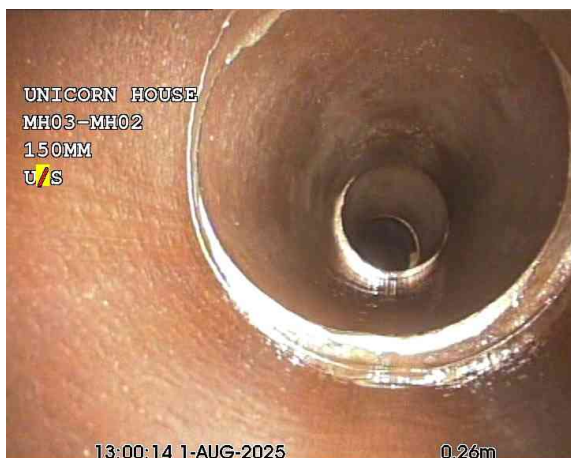
| Scale: | 1:54 | Position [m] | Code | Observation | MPEG | Photo | Grade |
|---|---|---|---|---|---|---|---|
| | | 0.26 | CCJ | Crack, circumferential at joint from 7 o'clock to 12 o'clock | 00:00:03 | MH02_32e4e53f-4387-4807-a5f | 2 / 2 |

MH02\_32e4e53f-4387-4807-a5fe-92f3601dc9b6\_20250807\_1  
13249\_977.jpg, 00:00:03, 0.26 m  
Crack, circumferential at joint from 7 o'clock to 12 o'clock

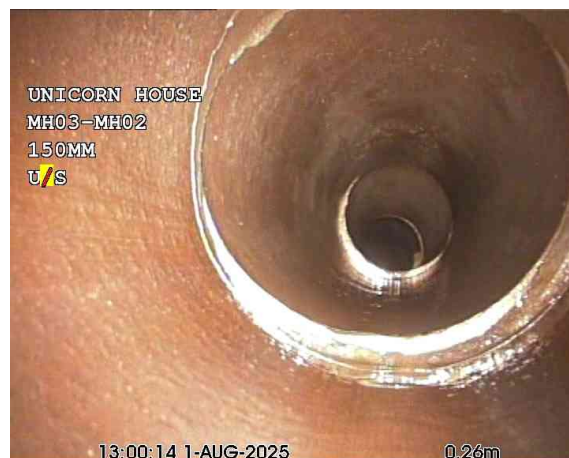
| Scale: | 1:54 | Position [m] | Code | Observation | MPEG | Photo | Grade |
|---|---|---|---|---|---|---|---|
| | | 0.26 | JDL | Joint displaced, large | 00:00:03 | MH02_2d4e8cce-47b7-4ff8-b2a | 1 / 4 |

MH02\_2d4e8cce-47b7-4ff8-b2a4-15a5cfe6edd2\_20250807\_1  
13308\_374.jpg, 00:00:03, 0.26 m  
Joint displaced, large

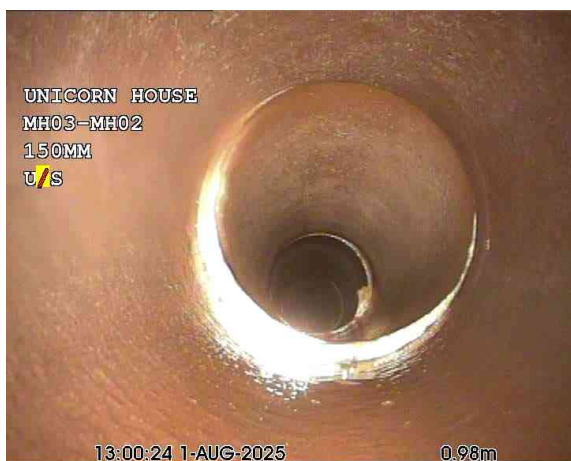
| Scale: | 1:54 | Position [m] | Code | Observation | MPEG | Photo | Grade |
|---|---|---|---|---|---|---|---|
| | | 0.98 | JDL | Joint displaced, large | 00:00:13 | MH02_21c46e36-d9c8-4333-9d | 1 / 4 |

MH02\_21c46e36-d9c8-4333-9de4-e9820aa89ad9\_20250807\_  
113448\_887.jpg, 00:00:13, 0.98 m  
Joint displaced, large

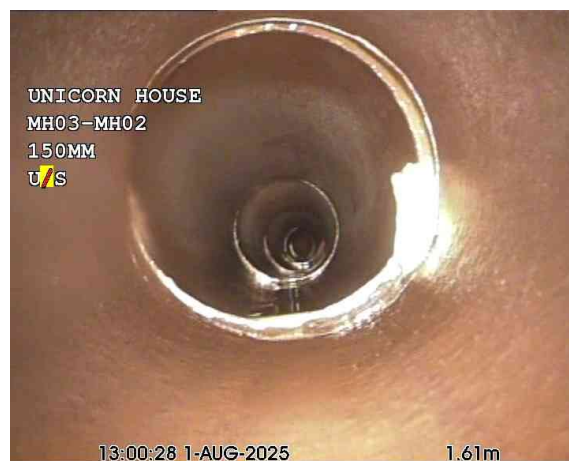
| Scale: | 1:54 | Position [m] | Code | Observation | MPEG | Photo | Grade |
|---|---|---|---|---|---|---|---|
| | | 1.61 | CCJ | Crack, circumferential at joint from 12 o'clock to 12 o'clock | 00:00:17 | MH02_e4946c1f-7ccc-4114-b3a | 2 / 2 |

MH02\_e4946c1f-7ccc-4114-b3ae-aeb7eb081feb\_20250807\_1  
13520\_417.jpg, 00:00:17, 1.61 m  
Crack, circumferential at joint from 12 o'clock to 12 o'clock

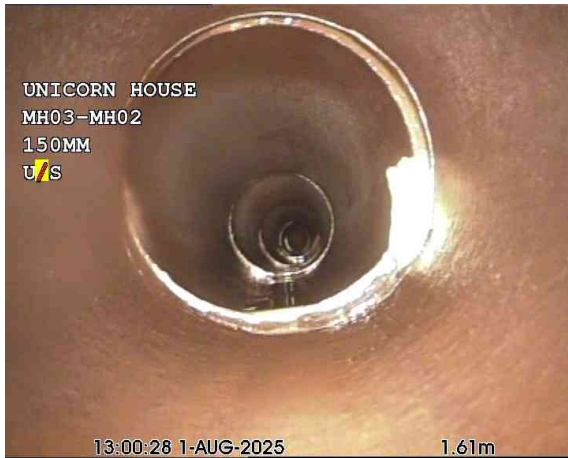
| Scale: | 1:54 | Position [m] | Code | Observation | MPEG | Photo | Grade |
|---|---|---|---|---|---|---|---|
| | | 1.61 | JDM | Joint displaced, medium | 00:00:17 | MH02_be9043b9-fd8c-464c-96f | 1 / 3 |

MH02\_be9043b9-fd8c-464c-96f4-ea3db8010cdd\_20250807\_1  
13543\_314.jpg, 00:00:17, 1.61 m  
Joint displaced, medium

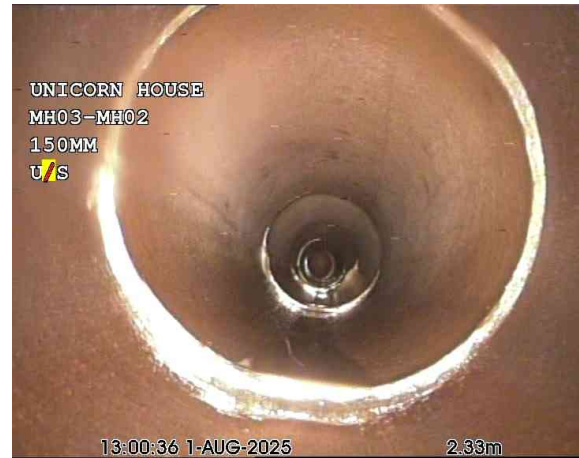
| Scale: | 1:54 | Position [m] | Code | Observation | MPEG | Photo | Grade |
|---|---|---|---|---|---|---|---|
| | | 2.33 | JDM | Joint displaced, medium | 00:00:25 | MH02_3dffbe7e-d021-4f27-a150 | 1 / 3 |

MH02\_3dffb7e-d021-4f27-a150-a183a49be435\_20250807\_1  
13609\_855.jpg, 00:00:25, 2.33 m  
Joint displaced, medium

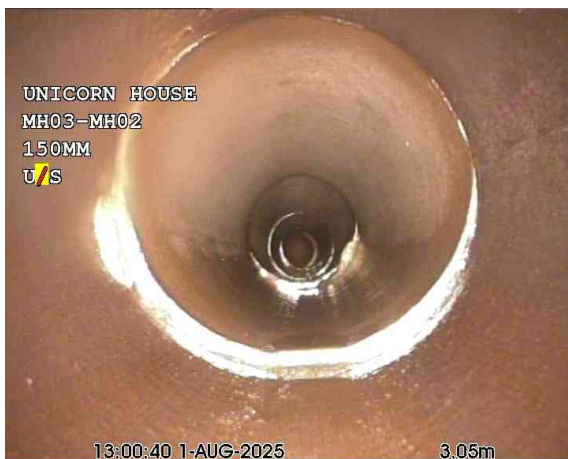
| Scale: | 1:54 | Position [m] | Code | Observation | MPEG | Photo | Grade |
|---|---|---|---|---|---|---|---|
| | | 3.05 | JDM | Joint displaced, medium | 00:00:29 | MH02_37f21446-291f-4885-ae0 | 1 / 3 |

MH02\_37f21446-291f-4885-ae03-5c3d8d025695\_20250807\_  
114105\_401.jpg, 00:00:29, 3.05 m  
Joint displaced, medium

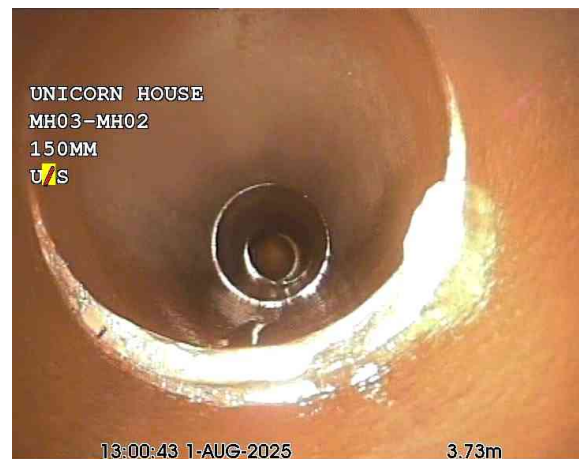
| Scale: | 1:54 | Position [m] | Code | Observation | MPEG | Photo | Grade |
|---|---|---|---|---|---|---|---|
| | | 3.73 | JDL | Joint displaced, large | 00:00:32 | MH02_710311a1-3a8d-4aa4-b3 | 1 / 4 |

MH02\_710311a1-3a8d-4aa4-b37d-ec0441cb5ca6\_20250807\_  
114201\_976.jpg, 00:00:32, 3.73 m  
Joint displaced, large

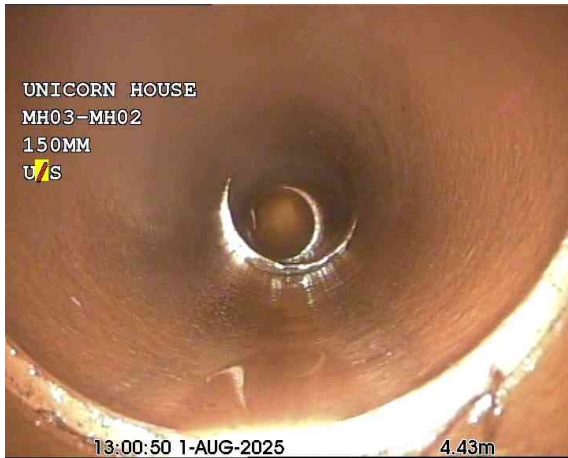
| Scale: | 1:54 | Position [m] | Code | Observation | MPEG | Photo | Grade |
|---|---|---|---|---|---|---|---|
| | | 4.43 | JDM | Joint displaced, medium | 00:00:39 | MH02_39153886-8e83-4fbf-90d | 1 / 3 |

MH02\_39153886-8e83-4fbf-90d9-0be98e1cdabc\_20250807\_114237\_158.jpg, 00:00:39, 4.43 m  
Joint displaced, medium

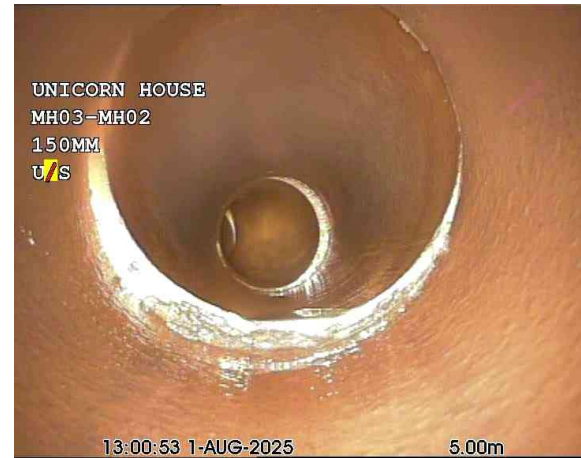
| Scale: | 1:54 | Position [m] | Code | Observation | MPEG | Photo | Grade |
|---|---|---|---|---|---|---|---|
| | | 5.00 | JDL | Joint displaced, large | 00:00:42 | MH02_02d35aeb-b62b-454f-810 | 1 / 4 |

MH02\_02d35aeb-b62b-454f-8103-db89c9ffc77f\_20250807\_114302\_695.jpg, 00:00:42, 5.00 m  
Joint displaced, large

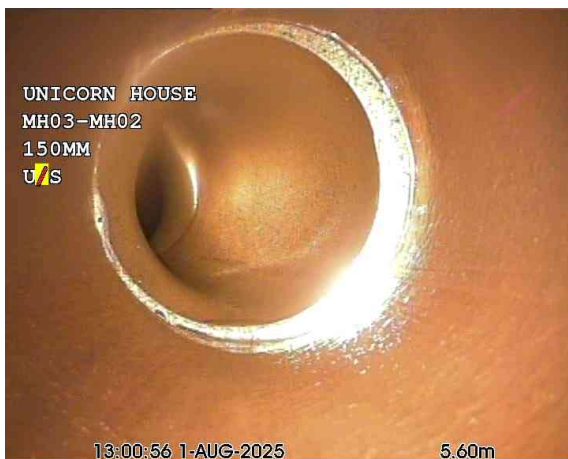
| Scale: | 1:54 | Position [m] | Code | Observation | MPEG | Photo | Grade |
|---|---|---|---|---|---|---|---|
| | | 5.60 | CCJ | Crack, circumferential at joint from 12 o'clock to 4 o'clock | 00:00:45 | MH02_d4f3ed90-e2f9-4c69-b5 | 2 / 2 |

MH02\_d4f3ed90-e2f9-4c69-b5e9-5f741d978d20\_20250807\_114343\_601.jpg, 00:00:45, 5.60 m  
Crack, circumferential at joint from 12 o'clock to 4 o'clock

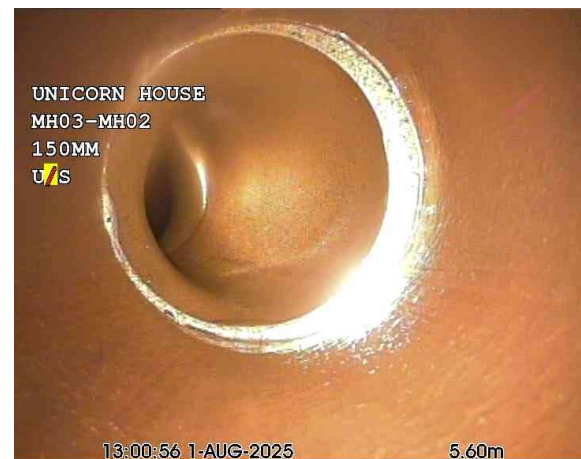
| Scale: | 1:54 | Position [m] | Code | Observation | MPEG | Photo | Grade |
|---|---|---|---|---|---|---|---|
| | | 5.60 | JDL | Joint displaced, large | 00:00:45 | MH02_ff6dbb1e-2ff2-4a06-81ee | 1 / 4 |

MH02\_ff6dbb1e-2ff2-4a06-81ee-831824fb6ac6\_20250807\_114402\_353.jpg, 00:00:45, 5.60 m  
Joint displaced, large

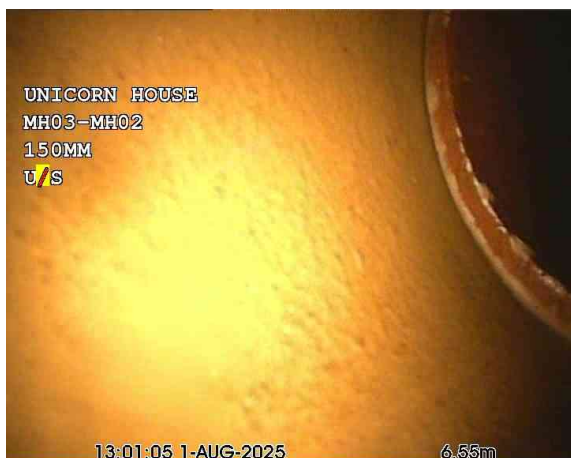
| | | 6.55 | JDM | Joint displaced, medium | 00:00:53 | MH02_e23<br>e6b2b-f85<br>8-4ab7-a2 | 1 / 3 | | |

MH02\_e23e6b2b-f858-4ab7-a288-551ee2282e7b\_20250807\_114632\_938.jpg, 00:00:53, 6.55 m  
Joint displaced, medium

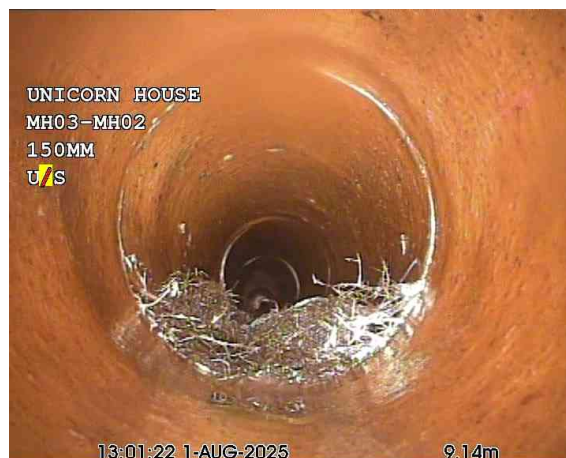
| | | 9.14 | RMJ | Roots, mass at joint, 25% cross-sectional area loss | 00:01:11 | MH02_3b1<br>89b87-b52<br>0-4c78-9e | 5 | | |

MH02\_3b189b87-b520-4c78-9e2c-15982ae097fb\_20250807\_114756\_998.jpg, 00:01:11, 9.14 m  
Roots, mass at joint, 25% cross-sectional area loss

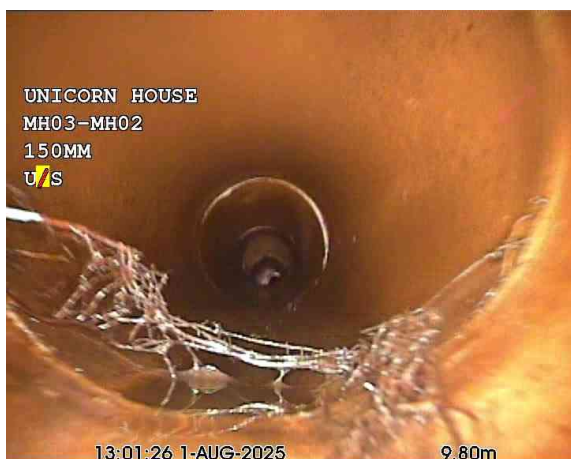
| | | 9.80 | RFJ | Roots, fine at joint | 00:01:15 | MH02_c4e<br>f7829-8de<br>c-489c-a4 | 2 | | |

MH02\_c4ef7829-8dec-489c-a4ef-74ee69762ce8\_20250807\_114844\_710.jpg, 00:01:15, 9.80 m  
Roots, fine at joint

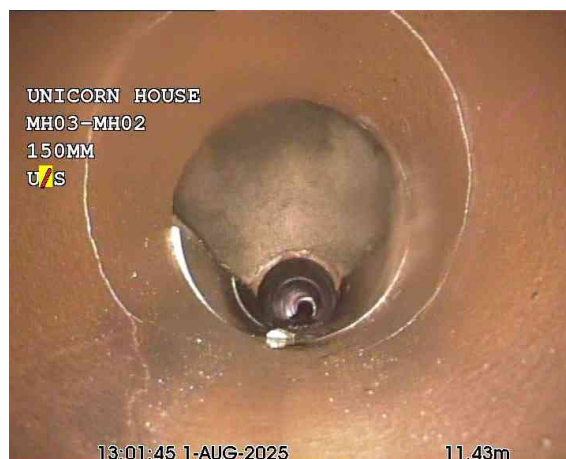
| | | 11.43 | CC | Crack, circumferential from 12 o'clock to 12 o'clock | 00:01:33 | MH02_d53<br>0ed01-3a1<br>6-47c3-bc | 2 / 2 | | |

MH02\_d530ed01-3a16-47c3-bc8c-5994f64a15b9\_20250807\_114925\_957.jpg, 00:01:33, 11.43 m  
Crack, circumferential from 12 o'clock to 12 o'clock

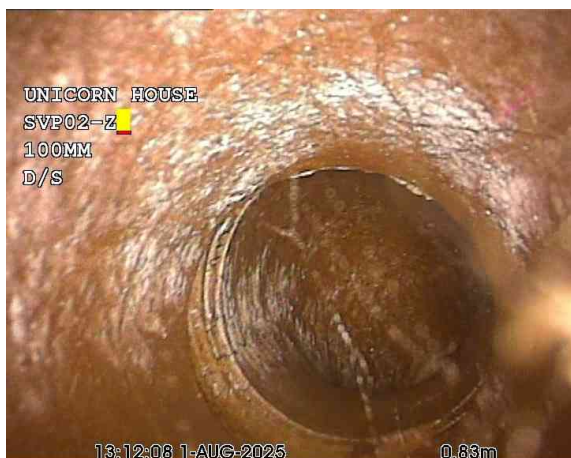
SVP02\_044f1aeb-06de-45e9-8970-eb6db91e4d5\_20250807\_121000\_519.jpg, 00:00:06, 0.83 m  
Joint displaced, large

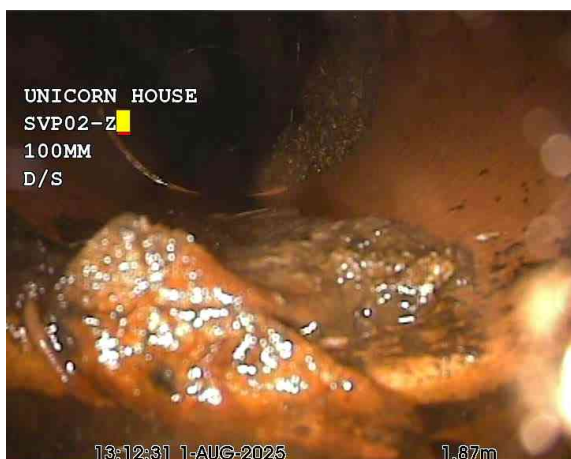
SVP02\_f2d4391c-341d-4e74-bd4c-c5b495f712c8\_20250807\_121329\_803.jpg, 00:00:29, 1.87 m  
Settled deposits, coarse at joint, 10% cross-sectional area loss

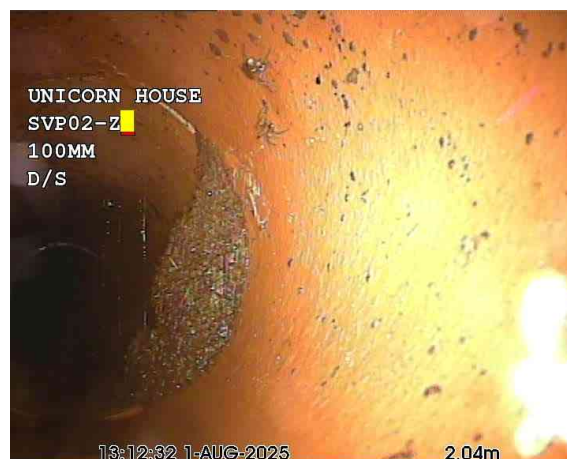
SVP02\_14d57409-9fa7-4674-b56e-b180c7f38037\_20250807\_121408\_857.jpg, 00:00:30, 2.04 m  
Roots, mass at joint, 20% cross-sectional area loss

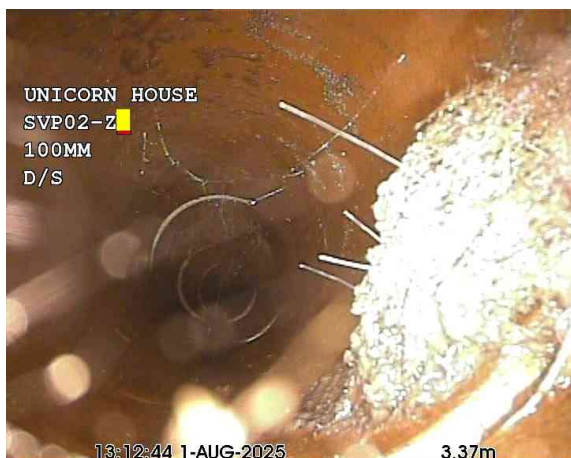
SVP02\_79927a30-6b8b-4714-80bc-3506aa2776d1\_20250807\_121527\_902.jpg, 00:00:42, 3.37 m  
Roots, mass at joint, 10% cross-sectional area loss

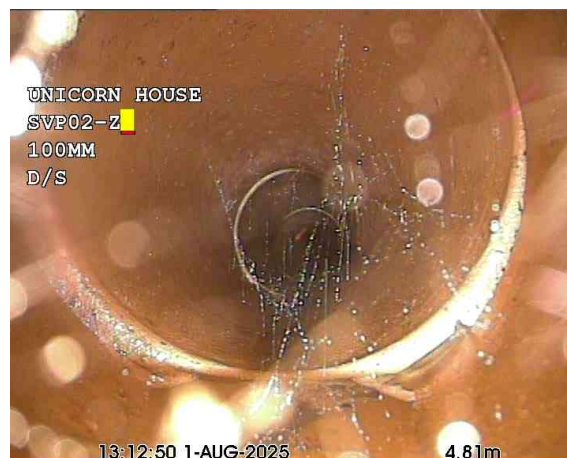
SVP02\_09e43bbf-a4f6-45a7-a404-286cb7689d18\_20250807\_121559\_550.jpg, 00:00:48, 4.81 m  
Joint displaced, medium

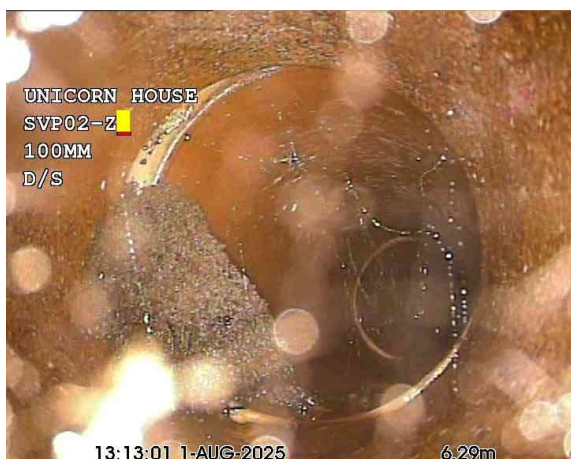
SVP02\_5923512c-d3be-4a7d-b6e2-49a29d370f2b\_20250807\_121634\_694.jpg, 00:00:59, 6.29 m  
Roots, mass at joint, 30% cross-sectional area loss

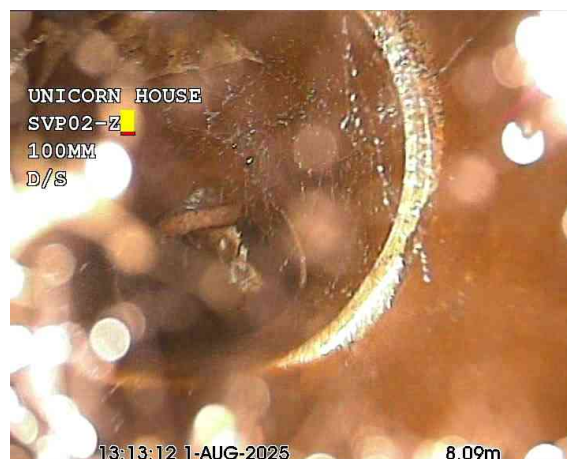
| Scale: | 1:63 | Position [m] | Code | Observation | MPEG | Photo | Grade | | |
|---|---|---|---|---|---|---|---|---|---|
| | | 8.09 | JDM | Joint displaced, medium | 00:01:10 | SVP02_8f<br>bf373b-25<br>dc-43e1-a | 1 / 3 | | |

SVP02\_8fbf373b-25dc-43e1-ae19-91f47e5ada06\_20250807\_121832\_101.jpg, 00:01:10, 8.09 m  
Joint displaced, medium

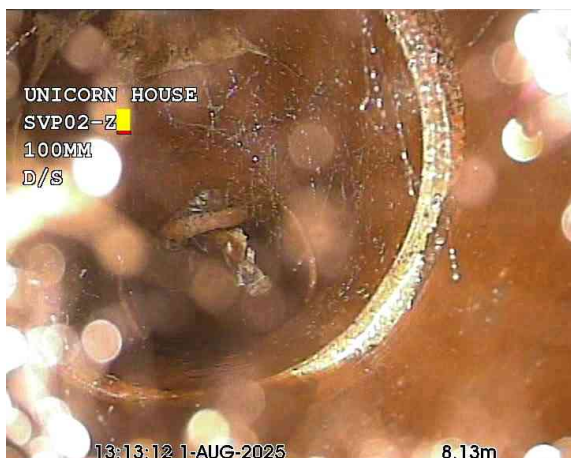
| Scale: | 1:63 | Position [m] | Code | Observation | MPEG | Photo | Grade | | |
|---|---|---|---|---|---|---|---|---|---|
| | | 8.13 | H | Hole in drain or sewer from 10 o'clock to 12 o'clock | 00:01:10 | SVP02_3c<br>0ea611-f6<br>95-43ce-8 | 4 | | |

SVP02\_3c0ea611-f695-43ce-85b2-98727351eb38\_20250807\_121906\_317.jpg, 00:01:10, 8.13 m  
Hole in drain or sewer from 10 o'clock to 12 o'clock

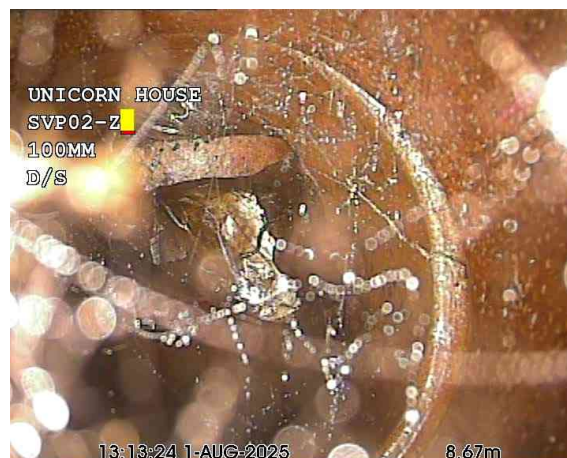
| Scale: | 1:63 | Position [m] | Code | Observation | MPEG | Photo | Grade | | |
|---|---|---|---|---|---|---|---|---|---|
| | | 8.67 | FLJ | Fracture, longitudinal at joint at 3 o'clock | 00:01:22 | SVP02_e7<br>3e7fc4-fdc<br>4-44e0-b5 | 3 / 2 | | |

SVP02\_e73e7fc4-fdc4-44e0-b572-71987eb8e0ba\_20250811\_100731\_273.jpg, 00:01:22, 8.67 m  
Fracture, longitudinal at joint at 3 o'clock

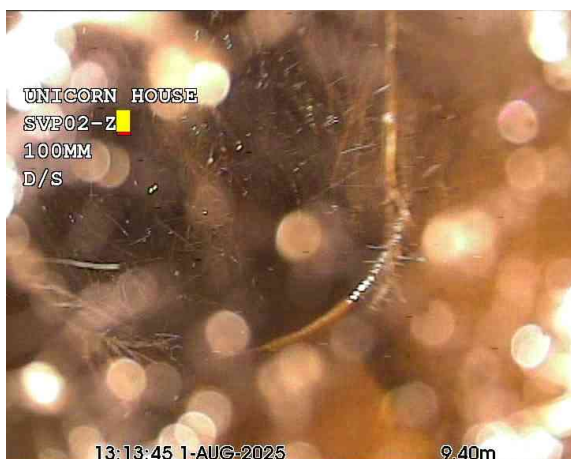
SVP02\_34a6ac0c-34bb-4ce6-a6cf-01257af3c8d2\_20250811\_101025\_819.jpg, 00:01:43, 9.40 m  
Roots, fine at joint
