Hopwood College

Milnrow Chapel

Proposed Concrete Repairs  
Elevations Sheet 2 of 2

| CONTRACT No: | P15715 | DRAWING No: | 211 |

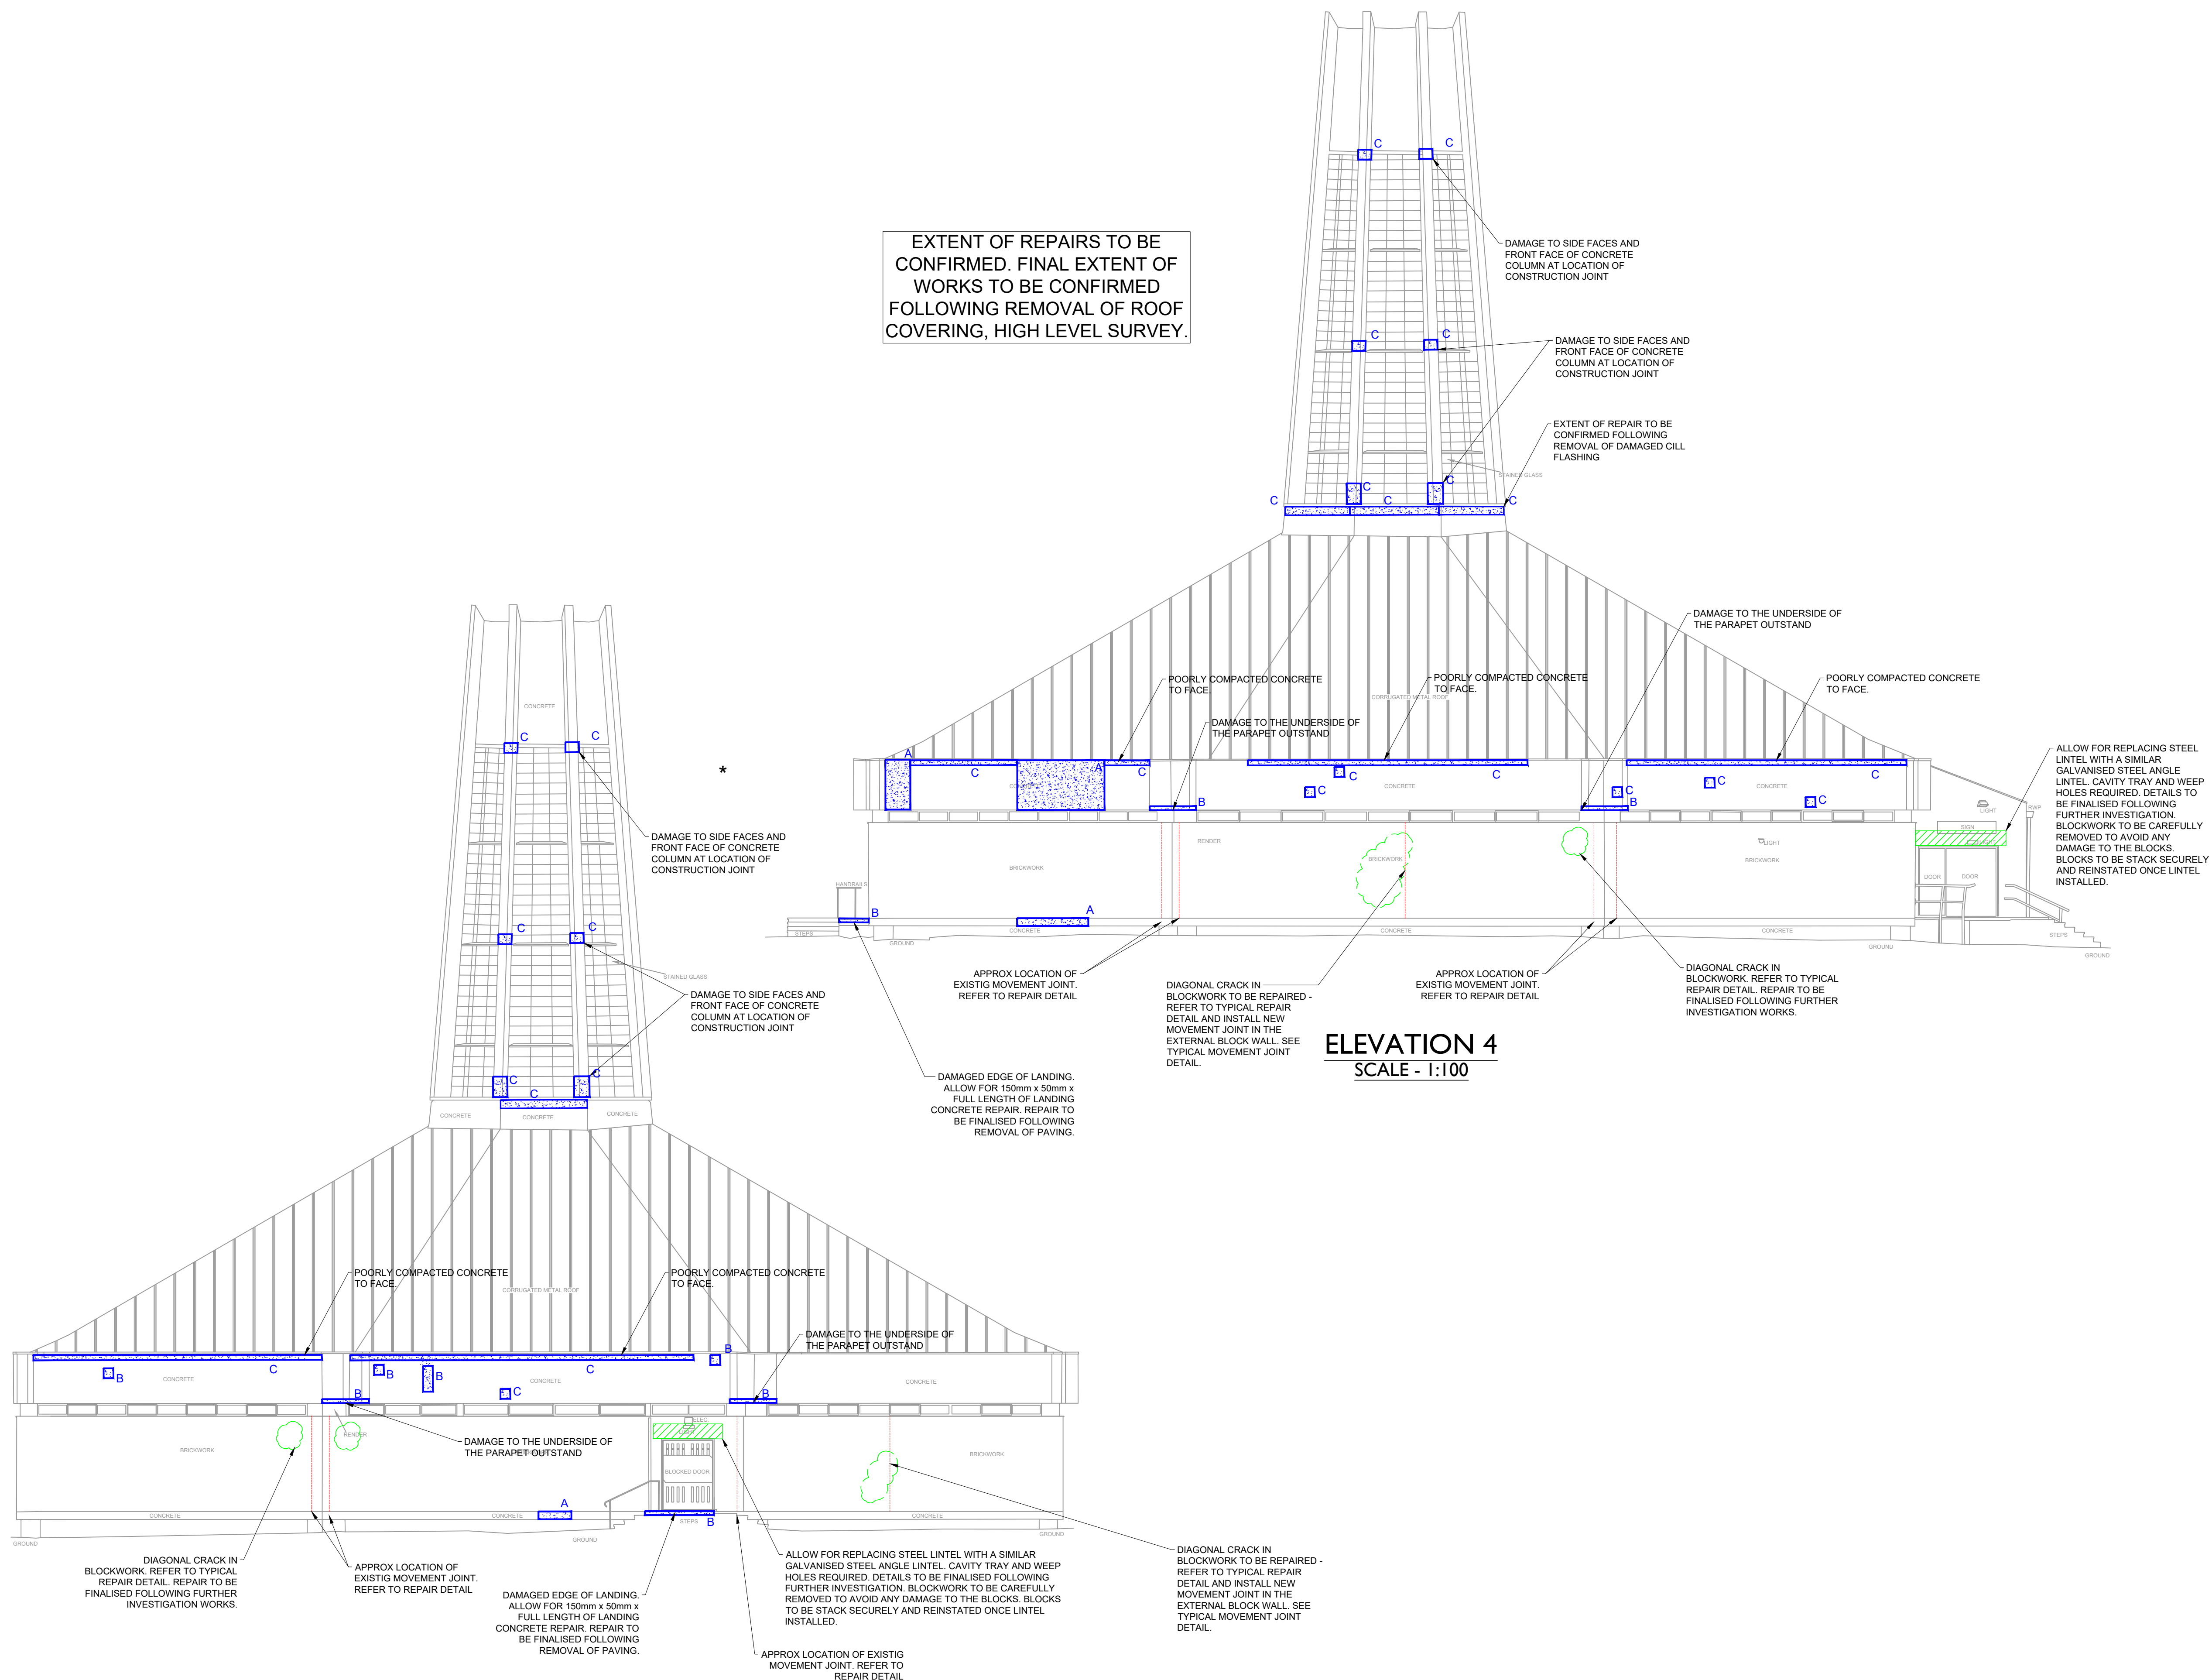
EXTENT OF REPAIRS TO BE  
CONFIRMED. FINAL EXTENT OF  
WORKS TO BE CONFIRMED  
FOLLOWING REMOVAL OF ROOF  
COVERING, HIGH LEVEL SURVEY.
