| Hopwood College |
| Milnrow Chapel |

Proposed Concrete Repairs  
Elevations Sheet 1 of 2

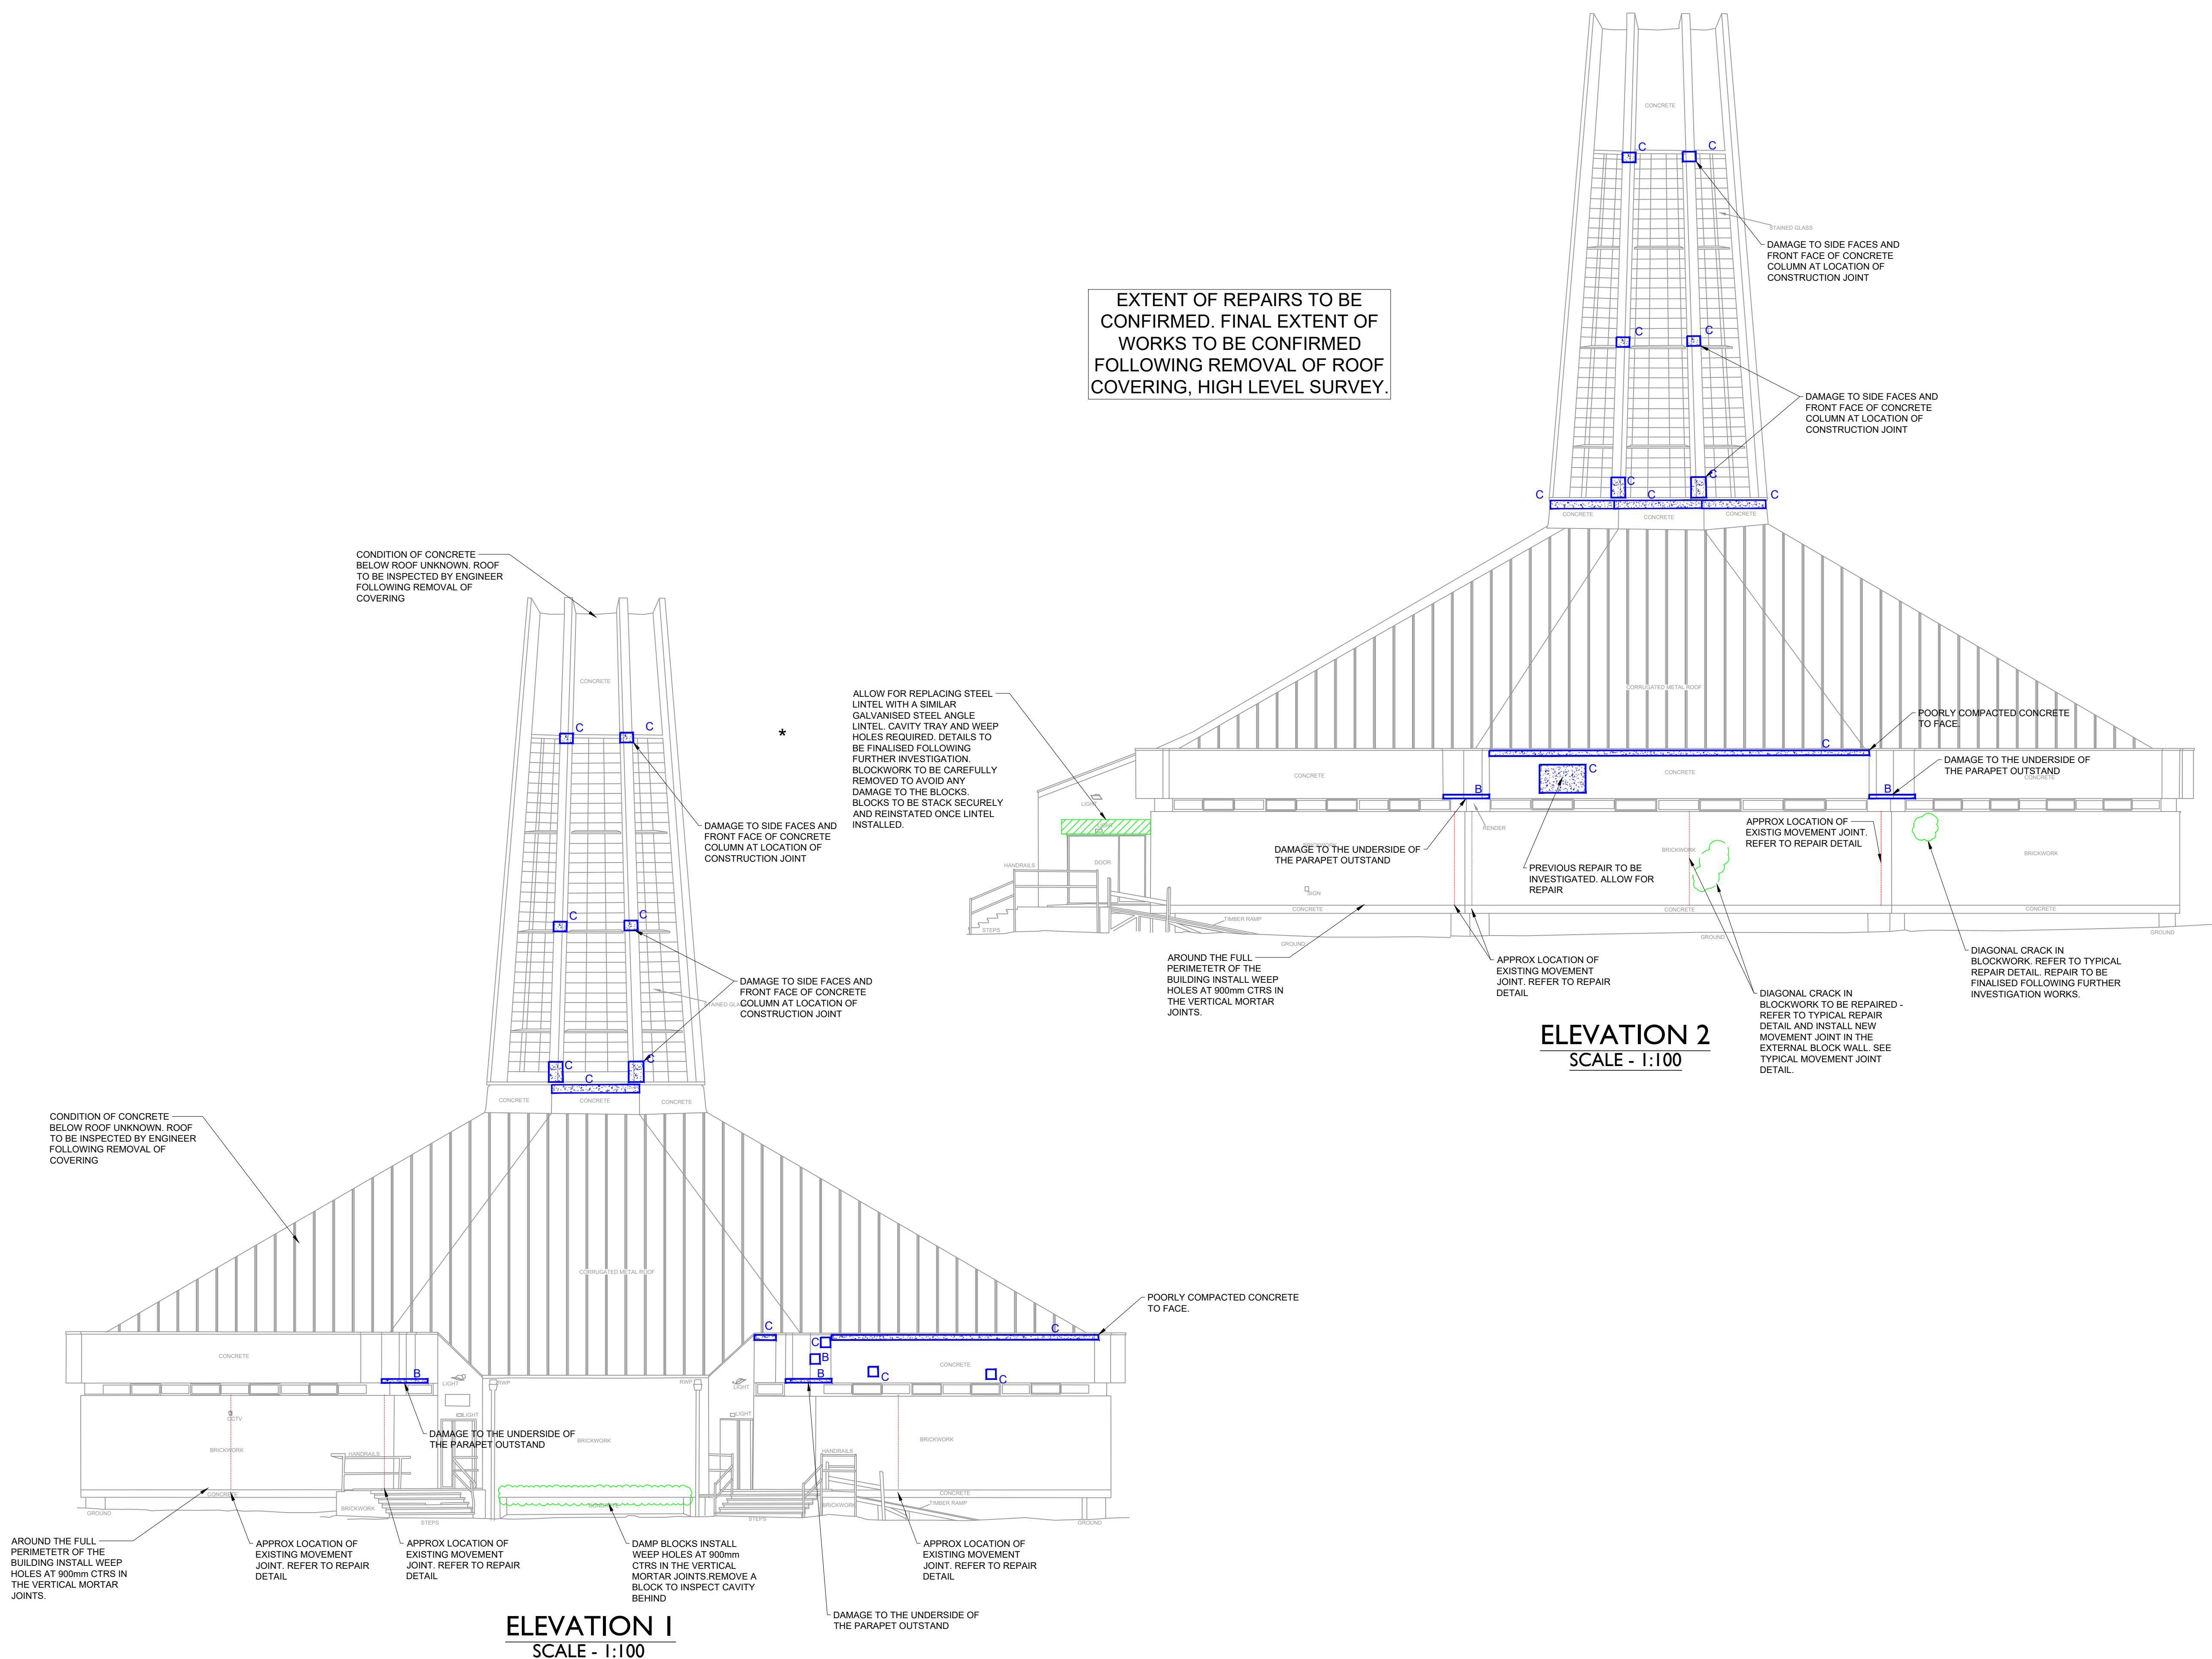
**A** DENOTES AREA OF CORRODED STEEL (REFER TO REPAIR DETAIL A)
-

**B** DENOTES AREA OF LOOSE CONCRETE (REFER TO REPAIR DETAIL B)
-

**C** DENOTES AREA OF DAMP CONCRETE / CONCRETE WITH SURFACE DEGRADATION (REFER TO REPAIR DETAIL C)
