# Heritage Assessment

Lower Cleggswood Farm, Heald Lane,  
Littleborough

May 2025

# Building Condition Report - Farm houses and stone barn Revision 2

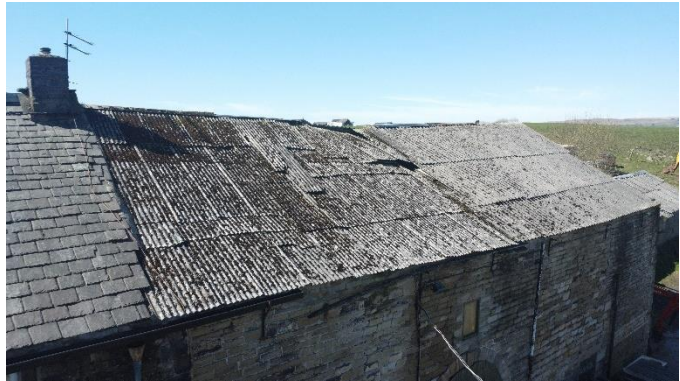
### 1. Barn

Roof covering missing to gable end.

Missing stone from head of the wall with vegetation present.

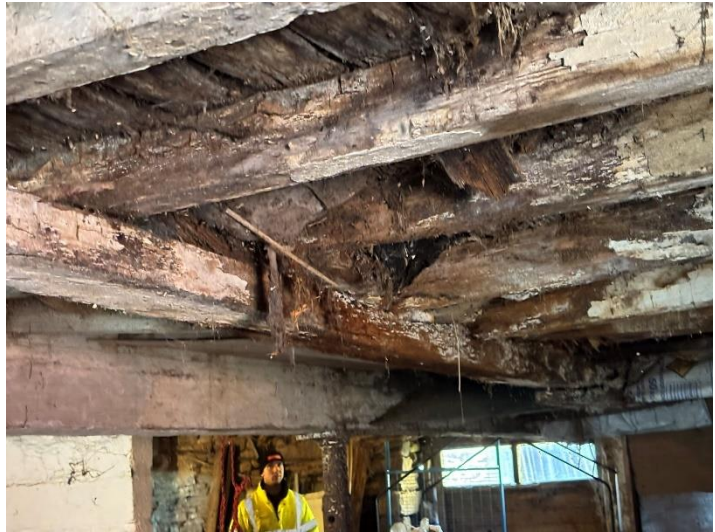
8. Barn – Ground floor

Modern internal load bearing wall.

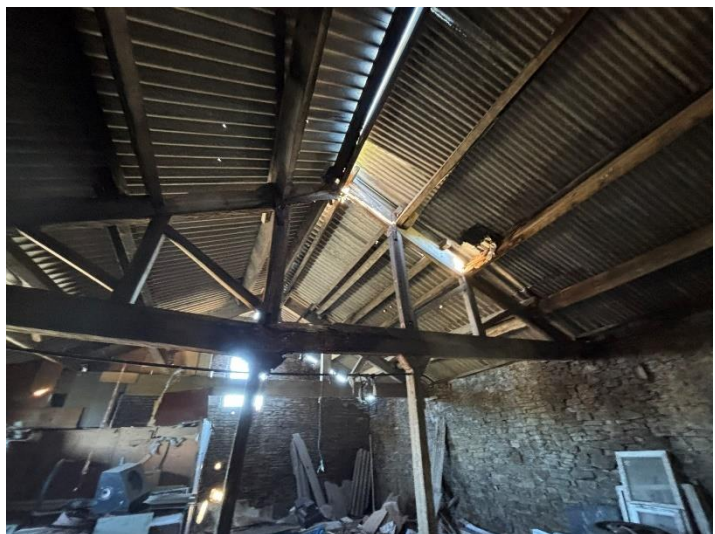
10. Barn – First floor

Central roof truss split and suffering wet rot at the ridge.

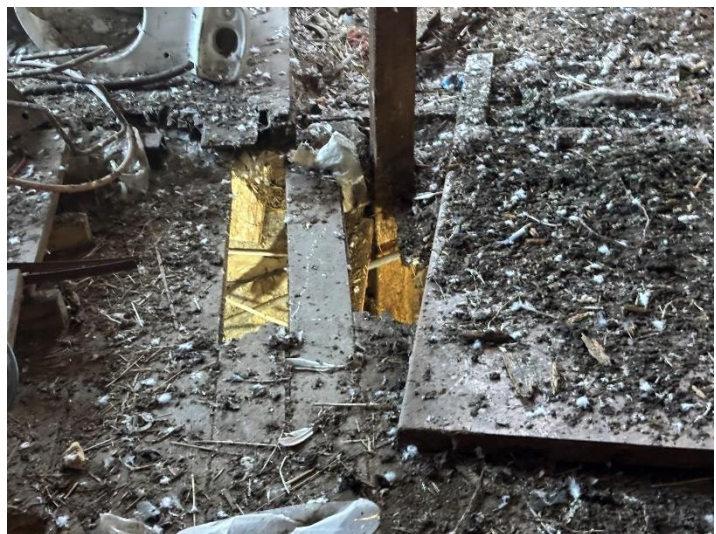
13. Barn – Ground floor

Evidence of wood boring beetle damage to upper floor structure.

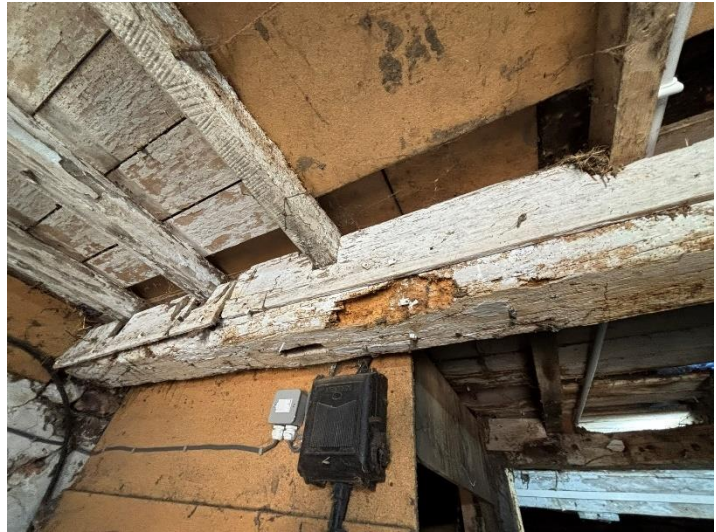
14. Barn – Ground floor

Upper floor structure primary beam rotted away at junction with external wall.

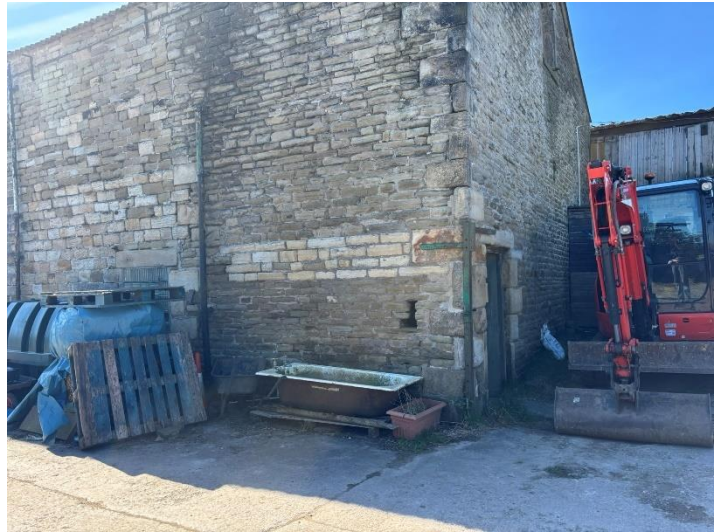
17. Barn - Gable elevation

Missing stone work to top left side.

Hay window open with no weather proofing.

Pockets/recesses in wall visible to right side.

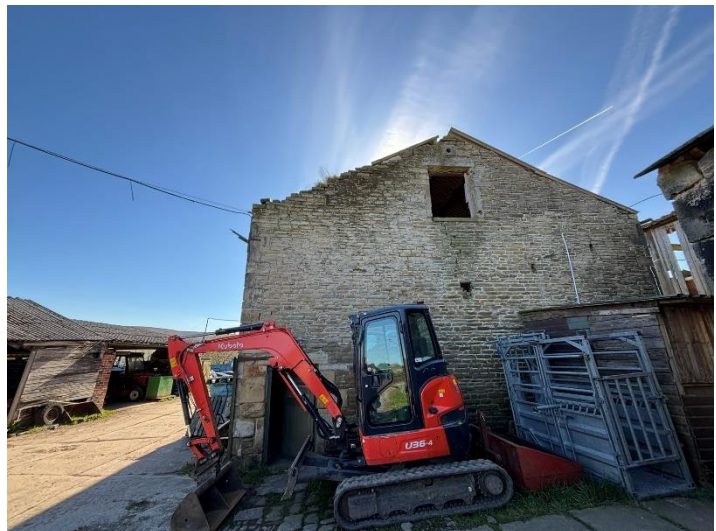
18. Barn – Gable elevation

Crack beneath hay window.

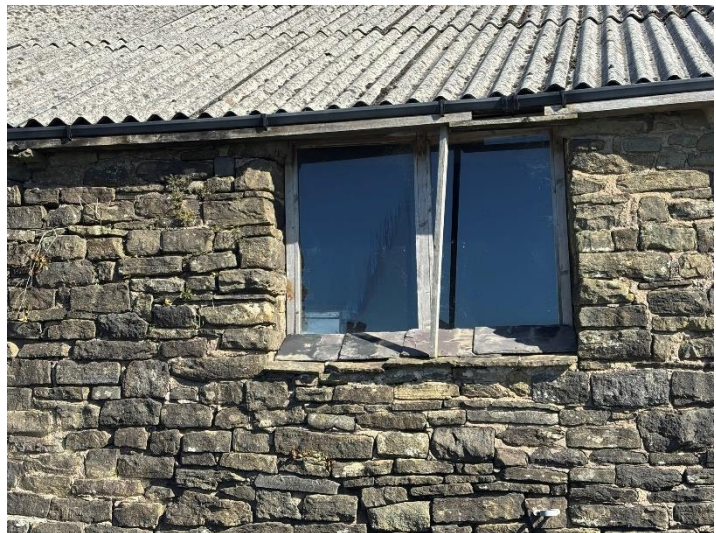
21. Barn – Rear elevation

Timber doors and windows in poor condition with wet rot present.

Steel lintel above deflecting downward in the centre.

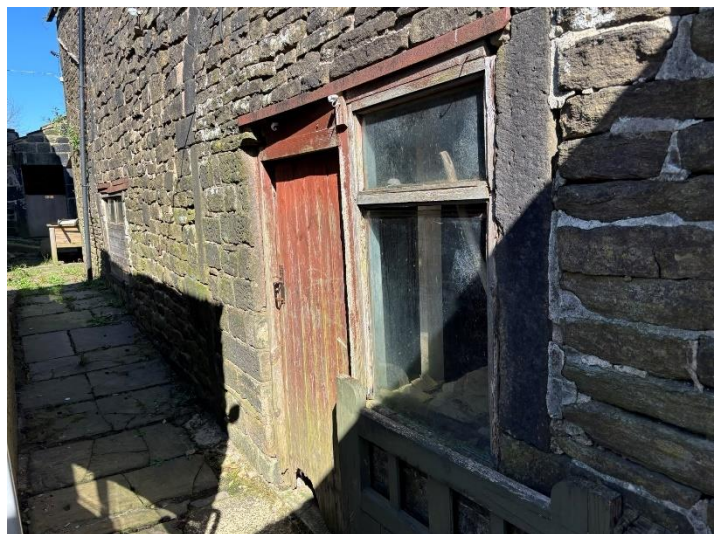
22. Barn – Rear elevation

Missing infill to arch way.

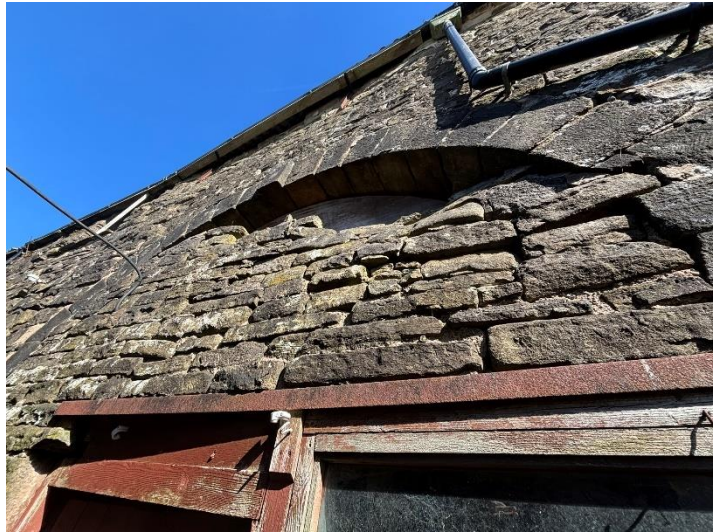
23. Barn – Rear elevation

Bowing visible to wall

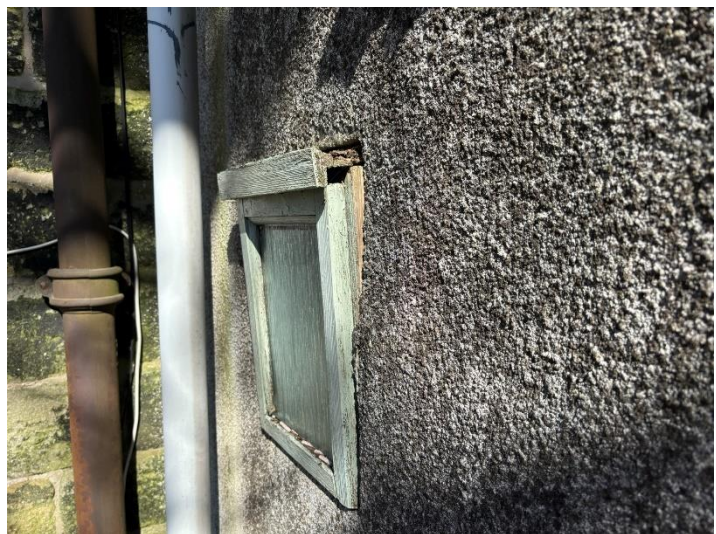
31. House 01 – Side elevation

Wet rot to timber window in lean to.

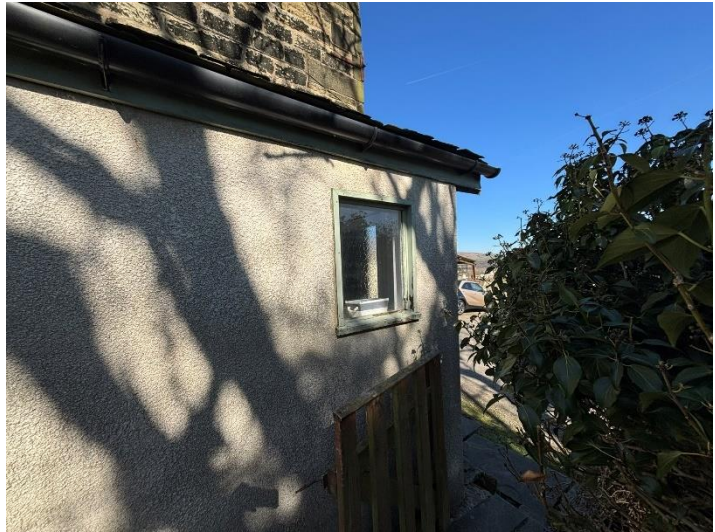
32. House 01 – Side elevation

Timber window frames in poor condition.

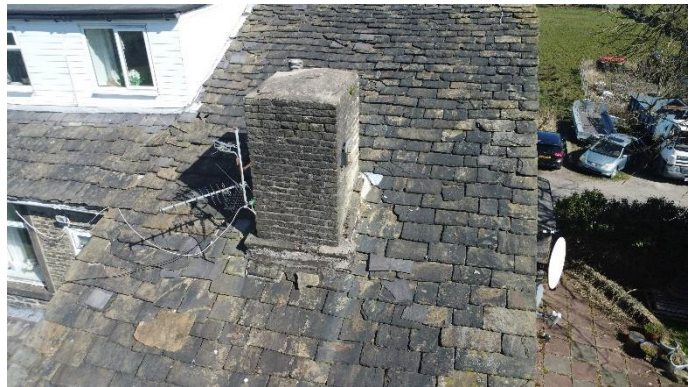
36. House 01 – Rear elevation

Poor detailing to rear of chimney with evidence of prior repairs.

Cracking present to wall of the chimney.

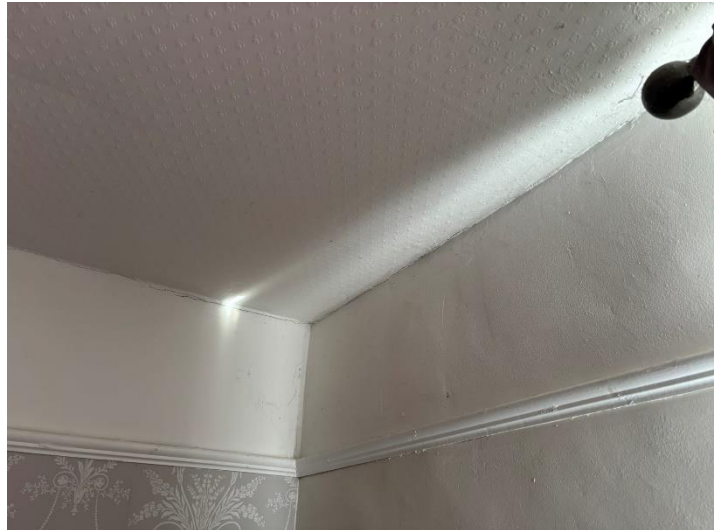
39. House 01 – First Floor  
Bedroom 01

Damage to ceiling above water  
tank.

Lath and plaster construction  
visible.

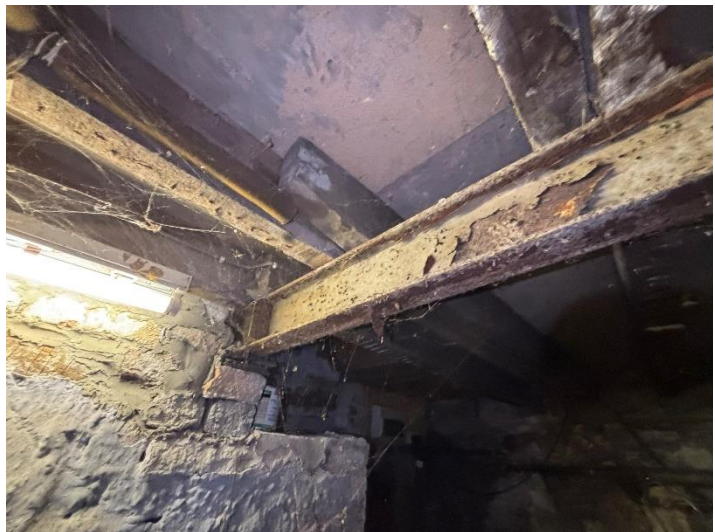
49. House 01 – Basement

Floor obscured by debris.

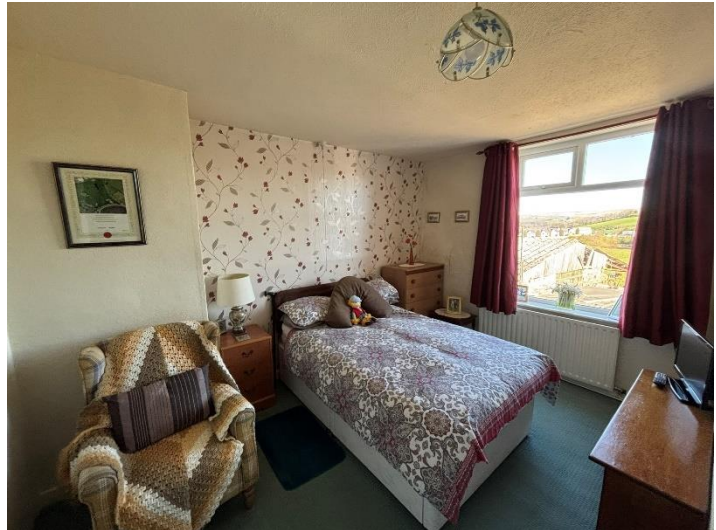
78. House 02 – First floor front bedroom

Damage to internal finished from external downpipe leak.

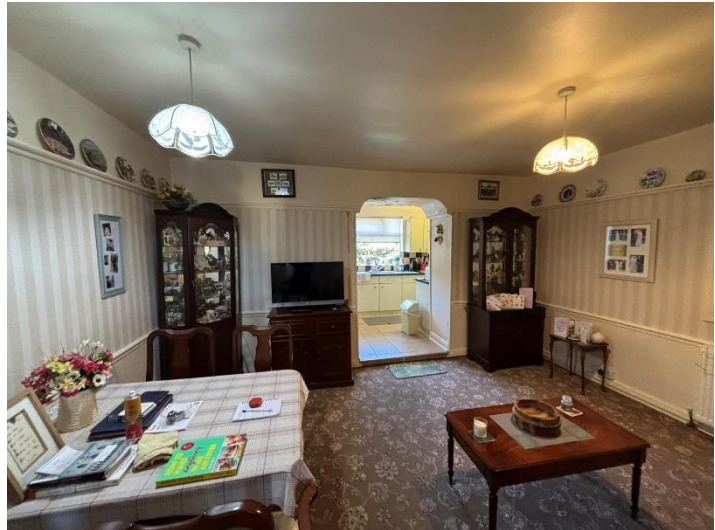
84. House 02 – Reception room 02

Damage to ceiling from  
bathroom leak.

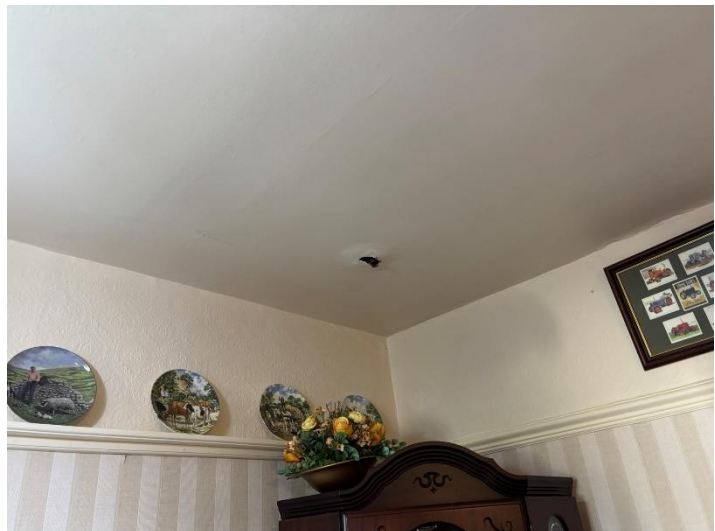
85. House 02 – Reception room 02

Damage to ceiling at opening  
to kitchen.

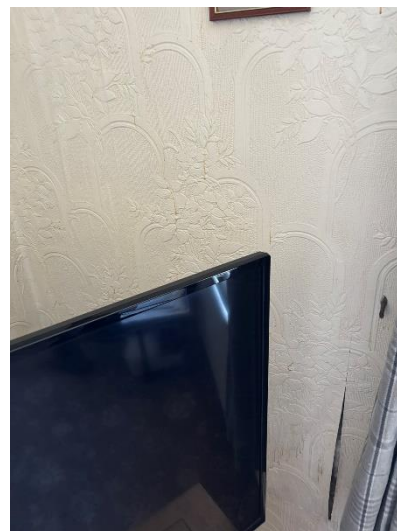
91. House 02 – Damage to finishes to internal face of external wall due to downpipe leak.
