(224FA – 095) 95 MARLAND FOLD, ROCHDALE OL11 4RF.

## **STRUCTURAL SITE CONDITION REPORT**

### **REPORT ON EXISTING HOUSE STRUCTURAL SURVEY**

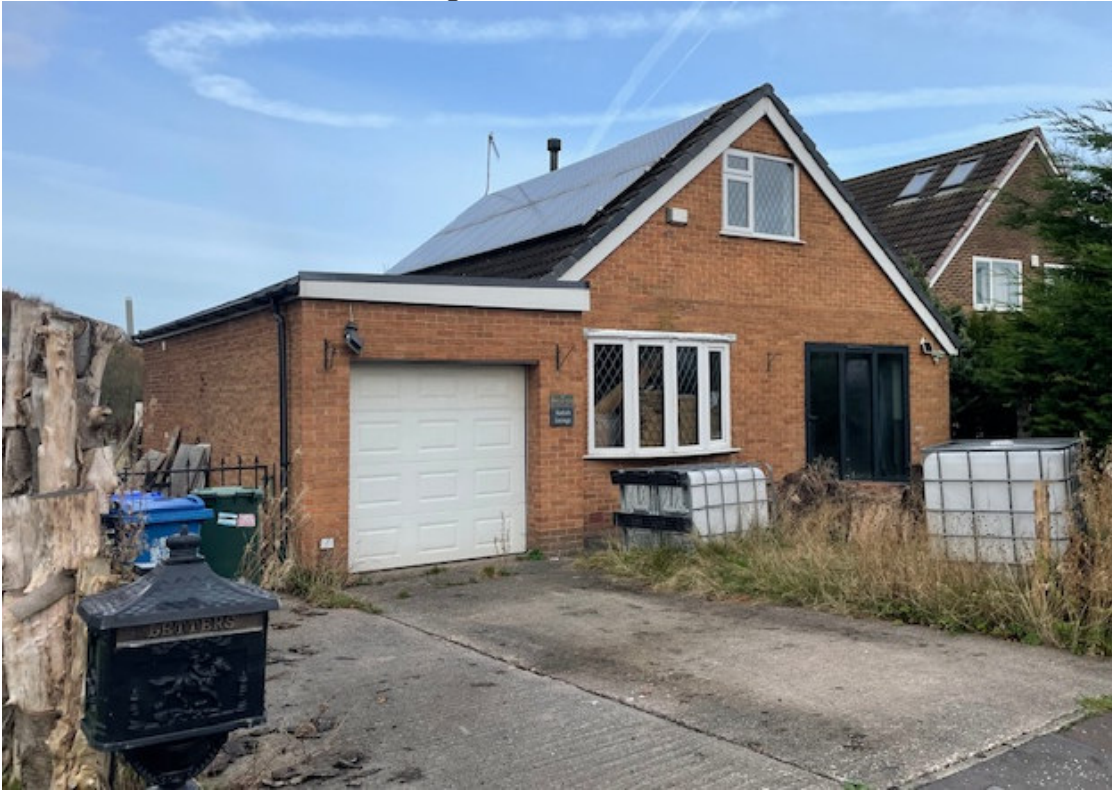
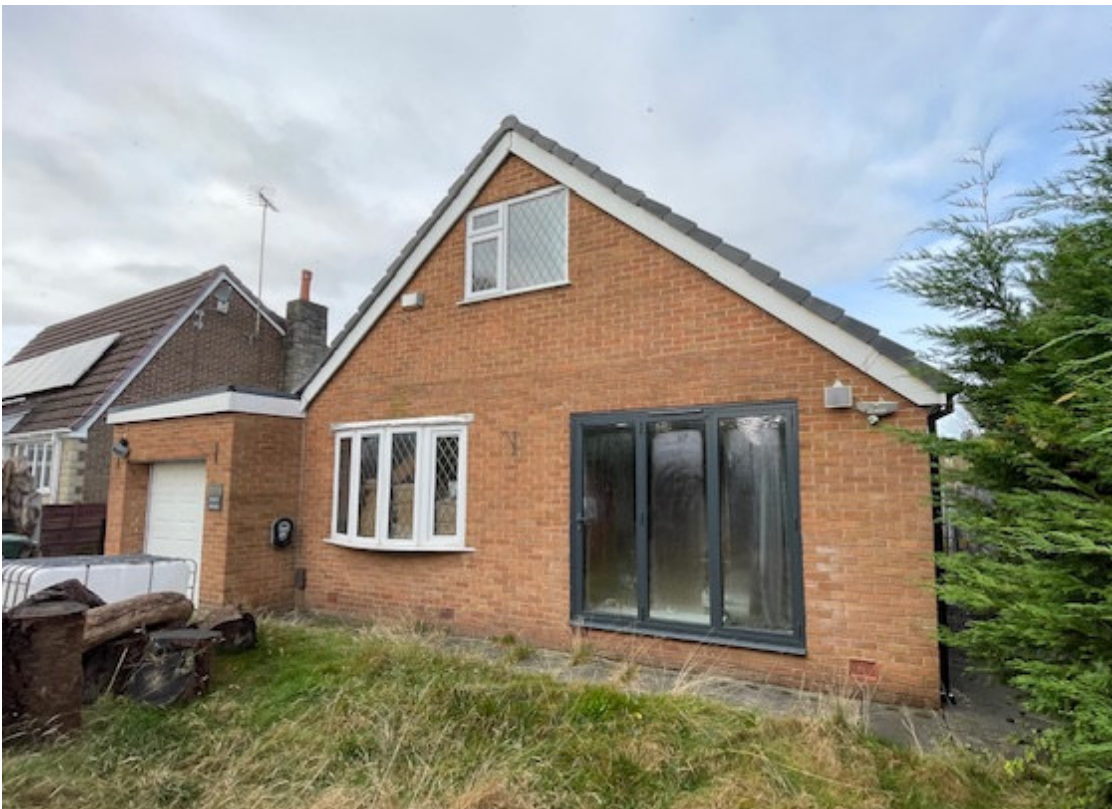
**The front elevation of the property.**

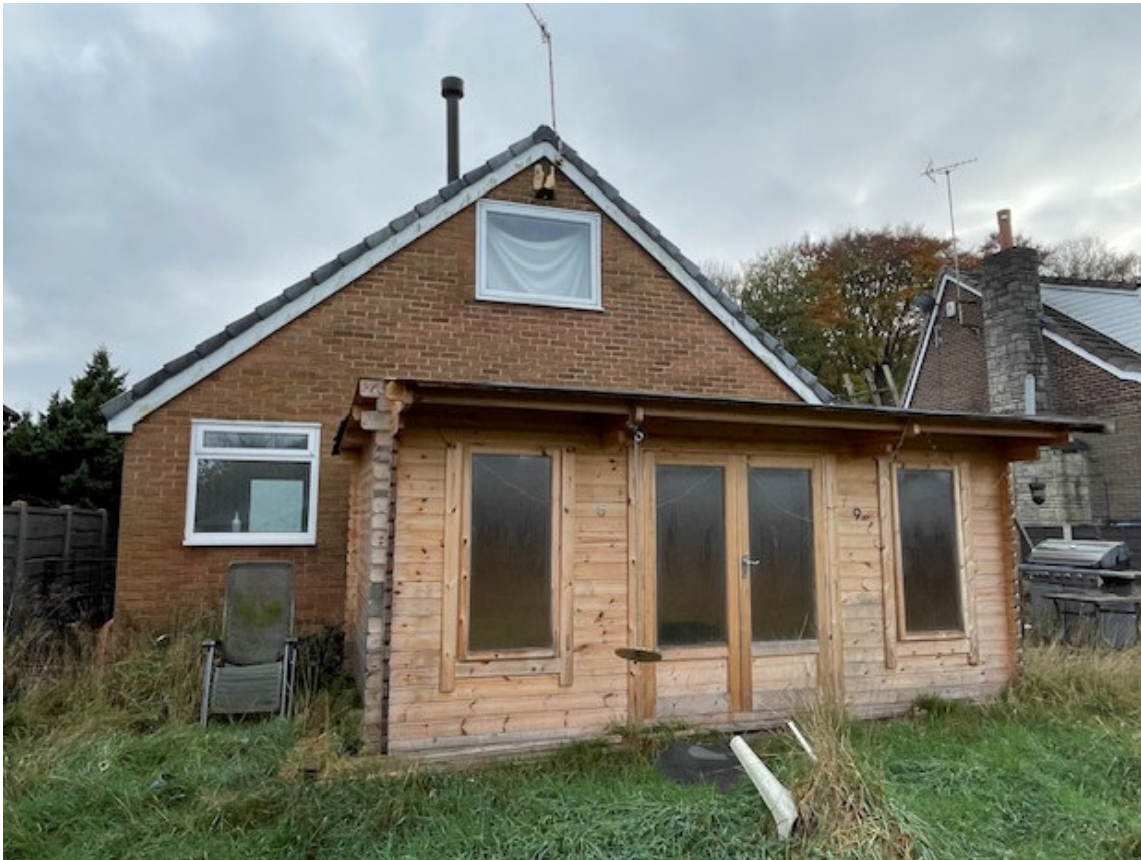
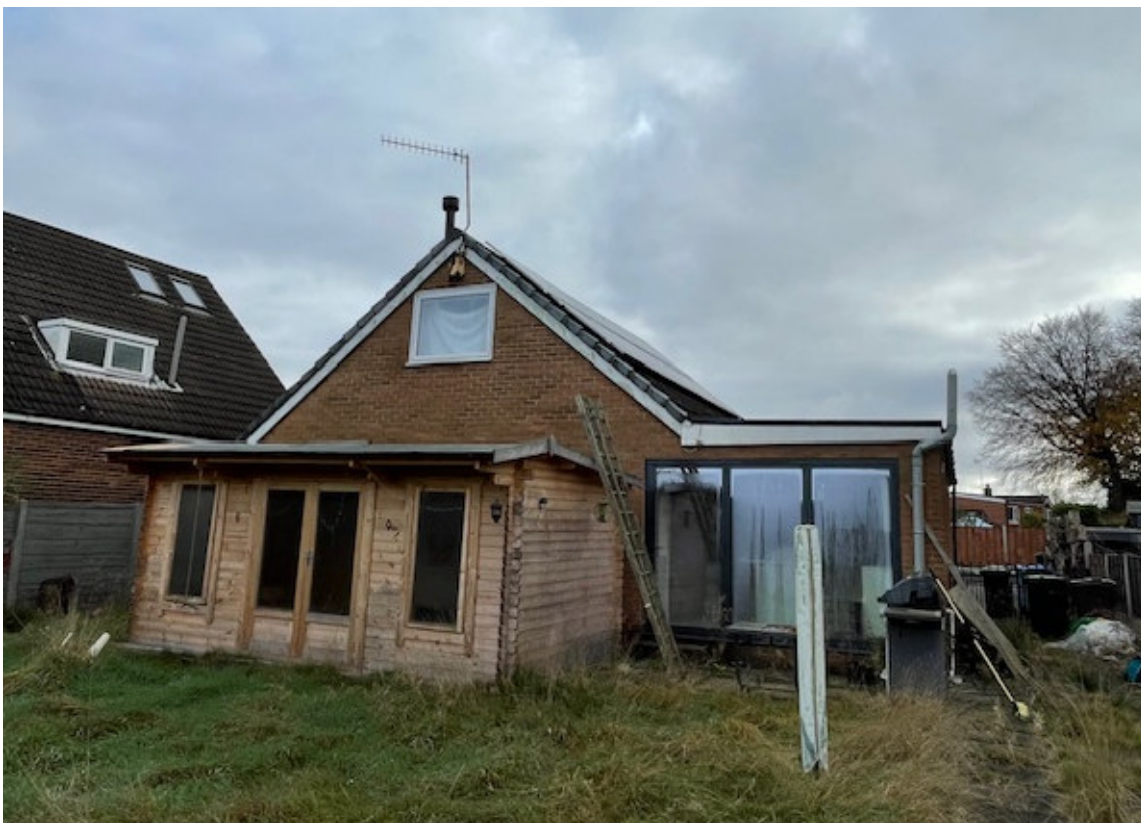
The rear elevation of the property.

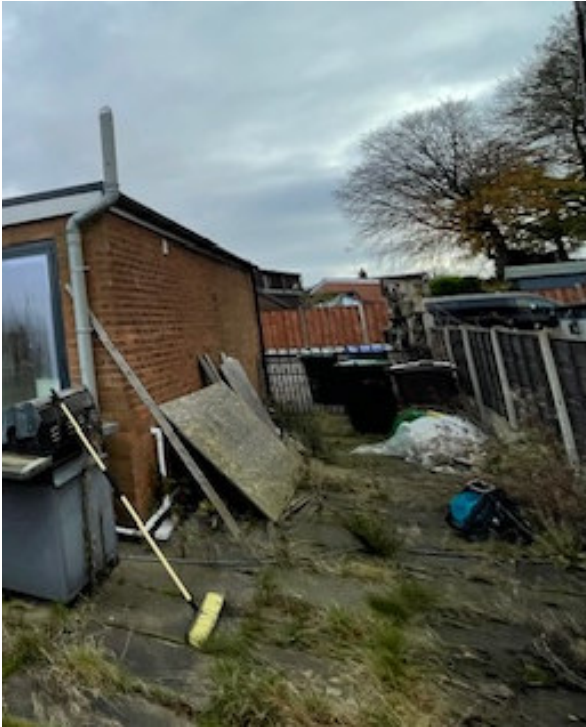
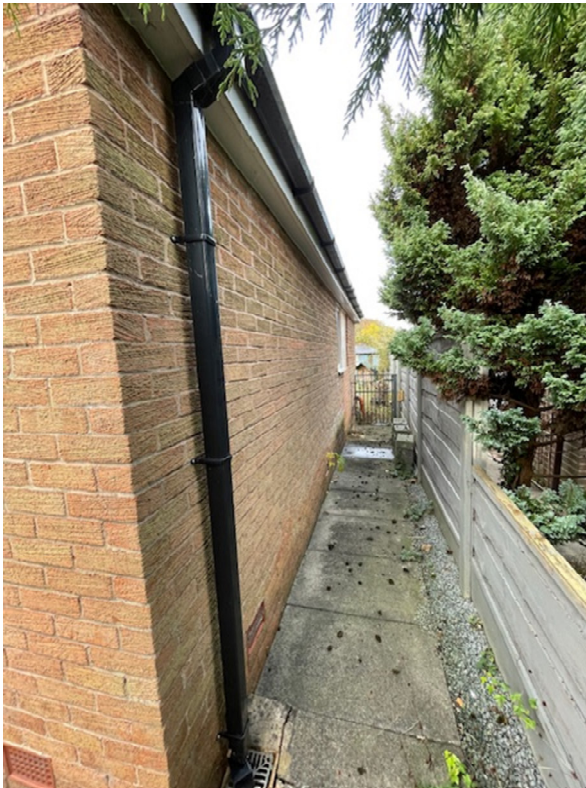
**The side elevations of the property.**

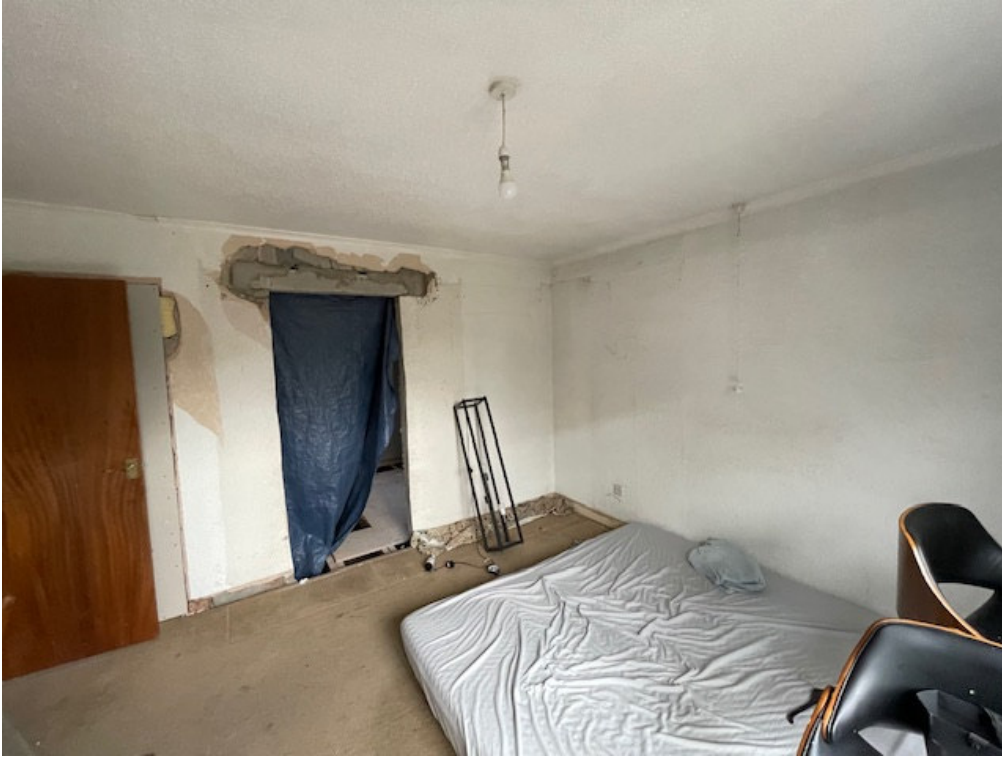
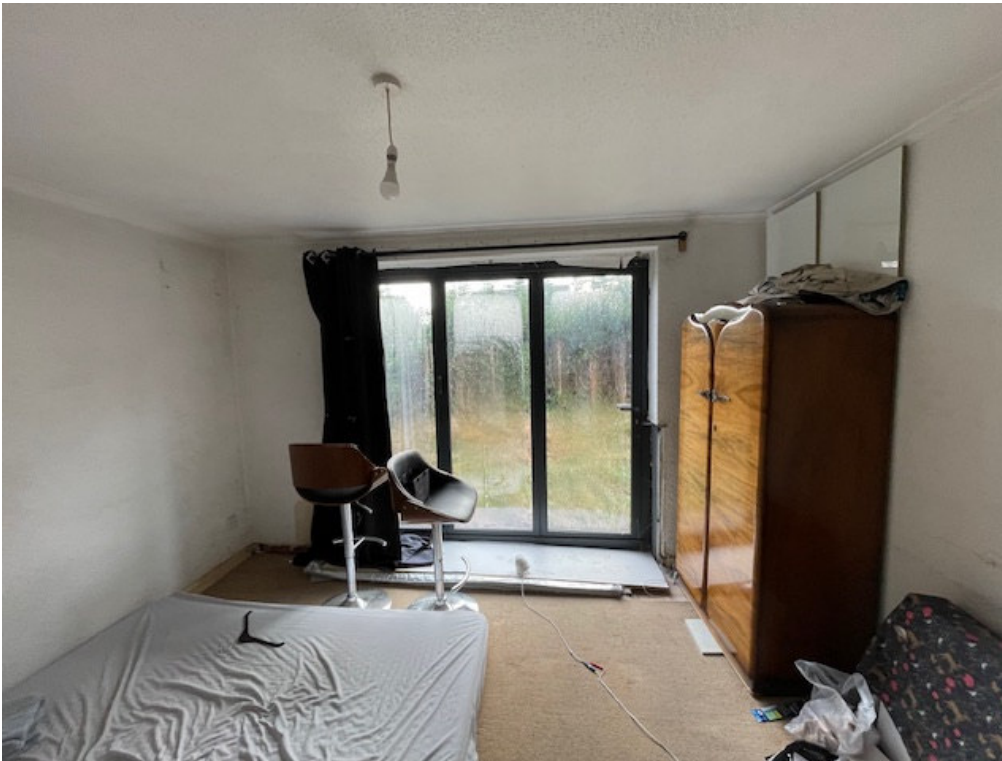
**Picture showing entrance inside to the house through the front patio door.**

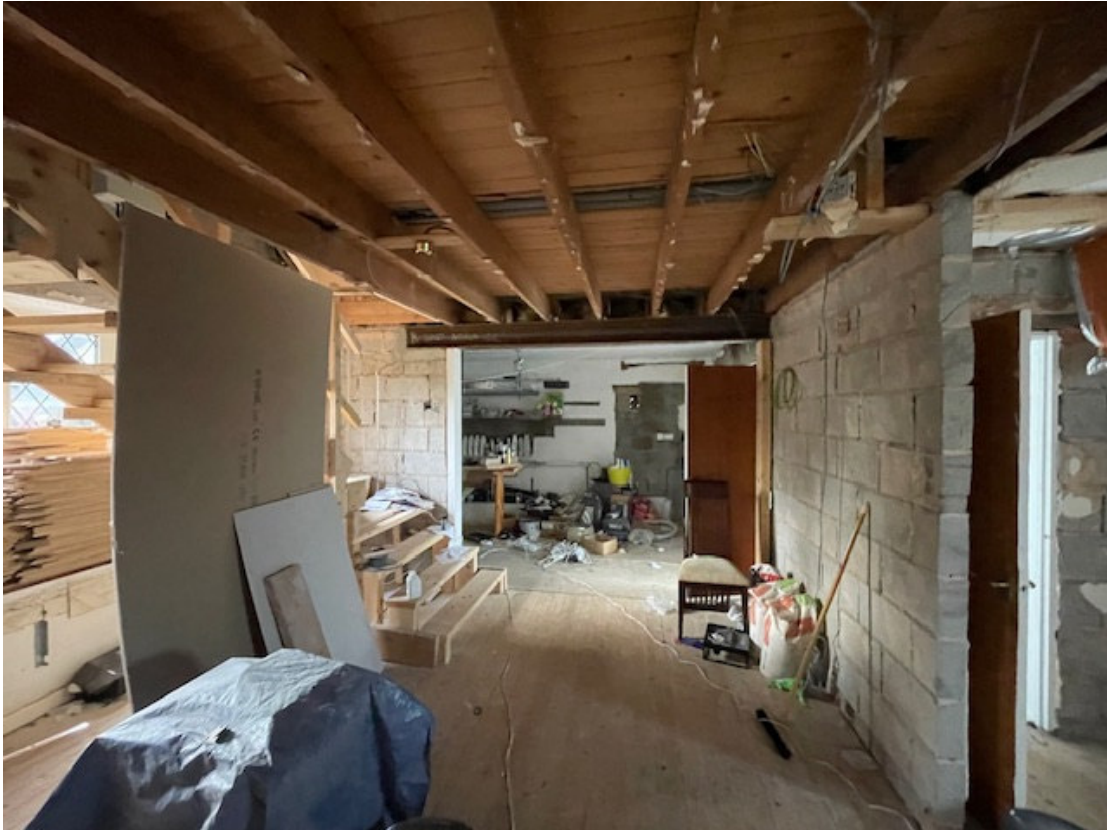
Photo showing the Living Room with Enlarged Opening to the Garage.

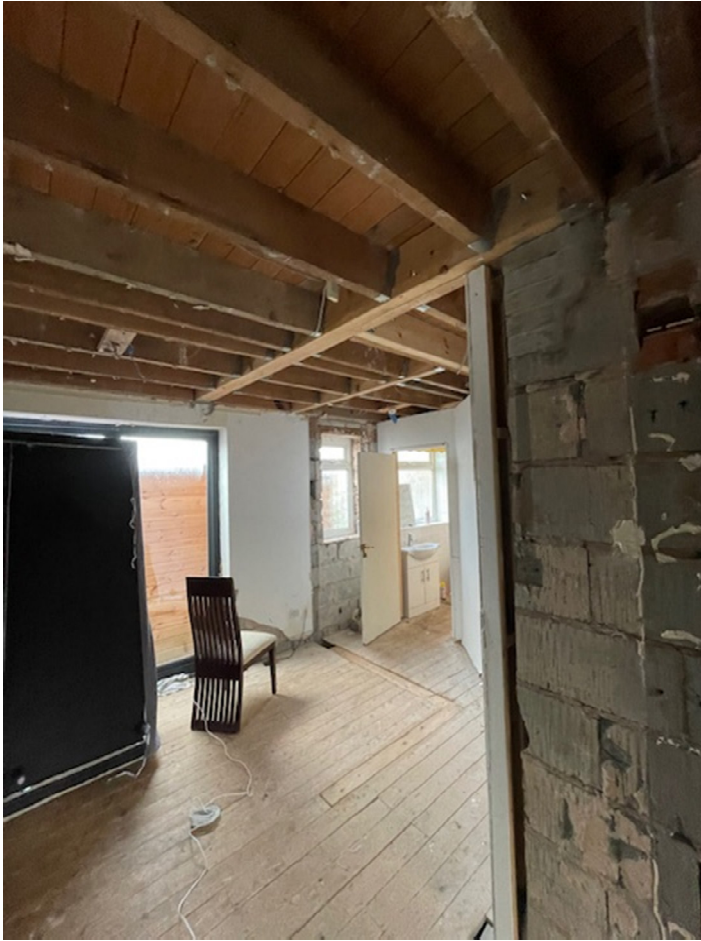
**Photo Showing Dining Room with a Toilet – No Visible/Allowance for Shower/Bathroom.**

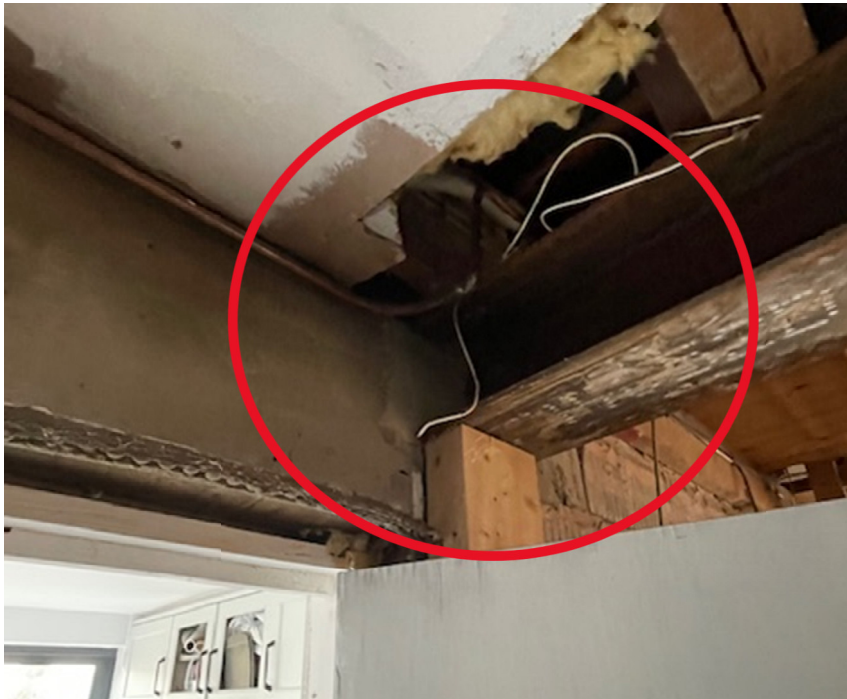
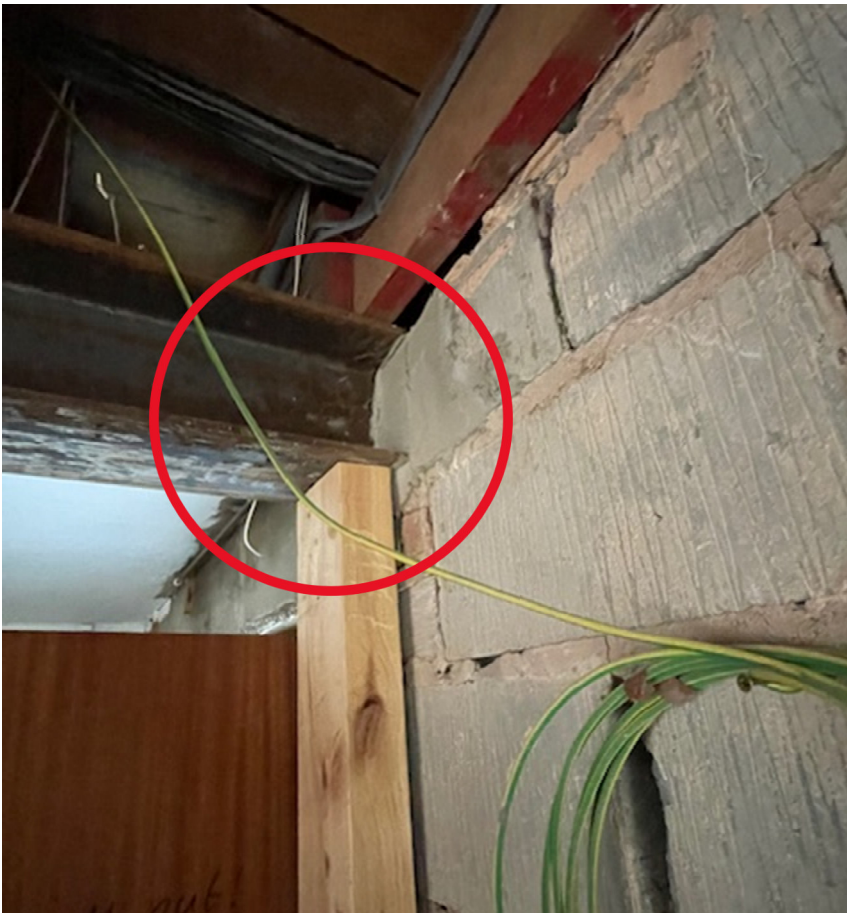
Incompliance transfer steel beam end supported on timber packing and a free standing timber post.

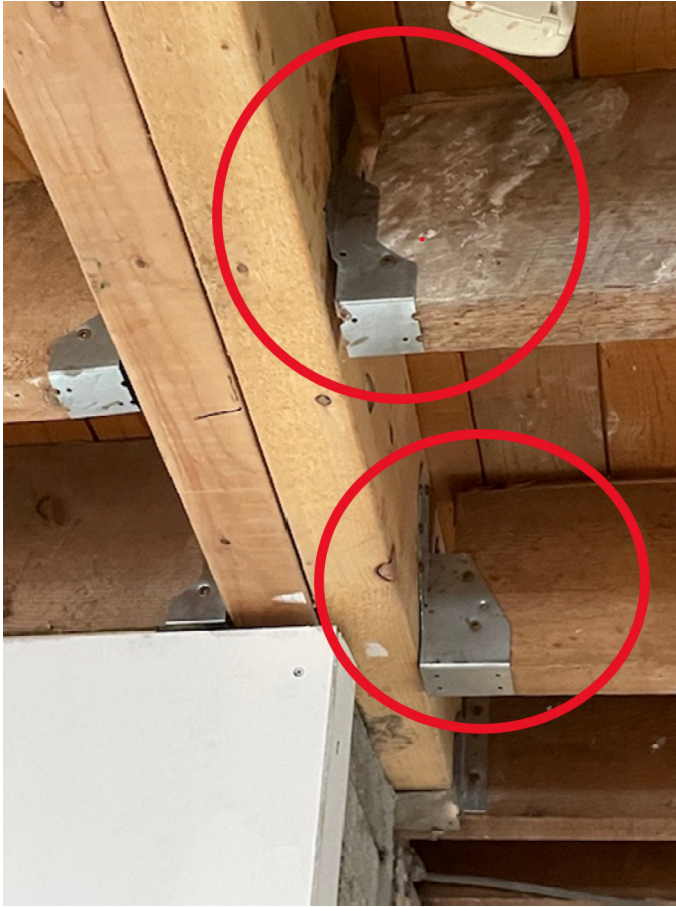
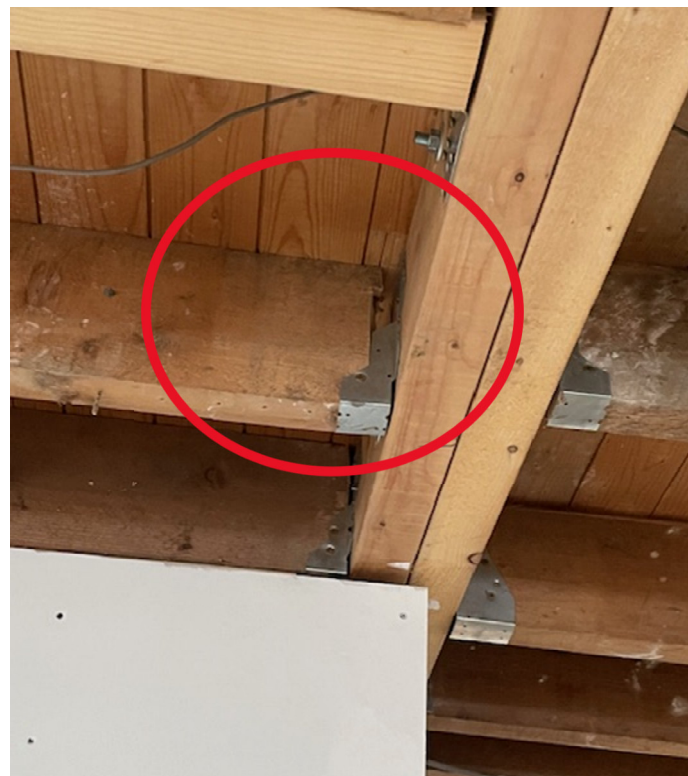
Photos showing typical **incompliance of bearing** of timber floor joints.

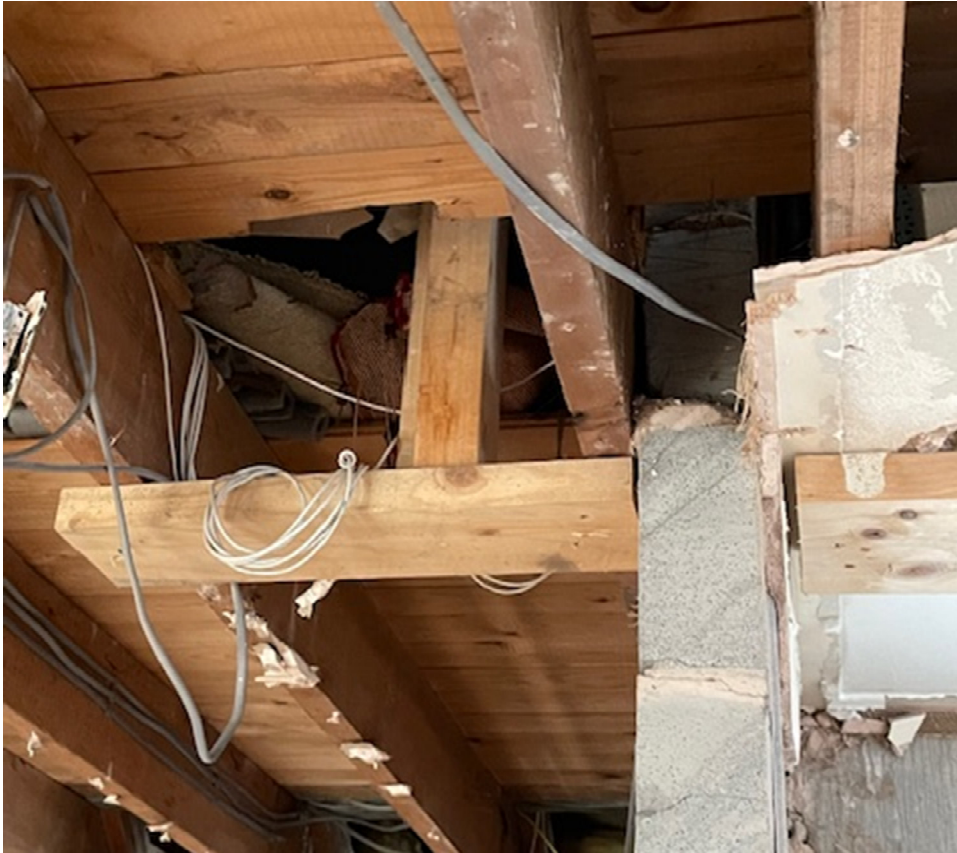
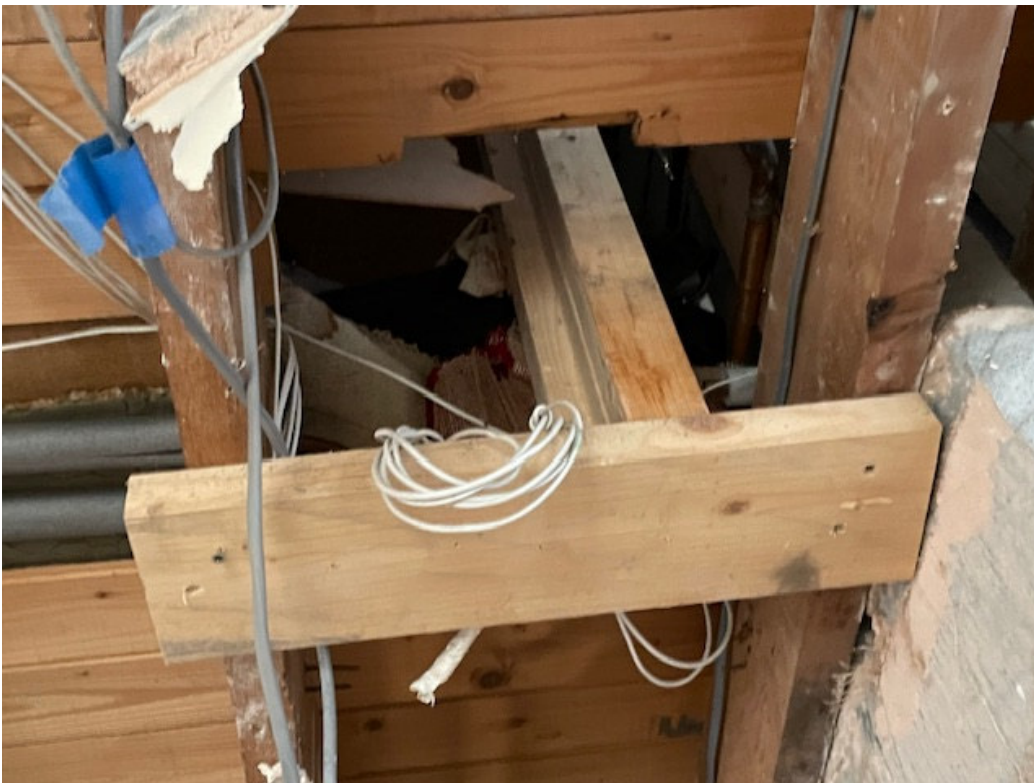
Photos showing **incompliance detail** of Timber Post Propping a Roof Purlin Supporting on a slender transfer timber member which fixed with a screw each end onto floor joists.

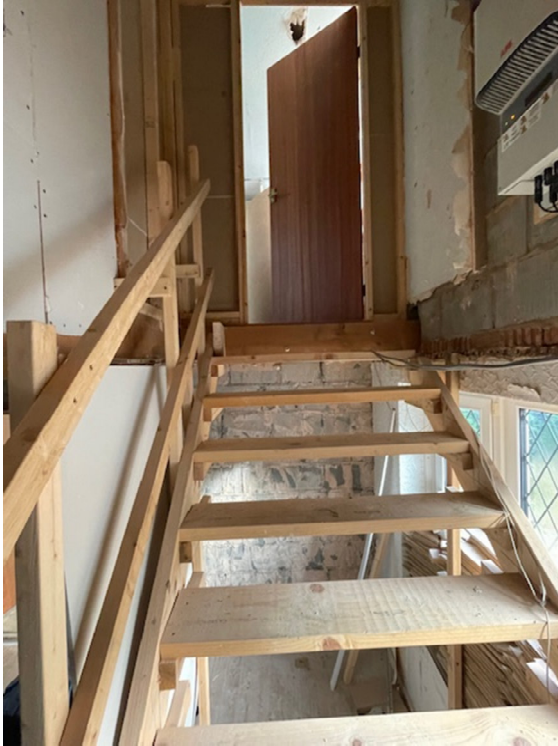
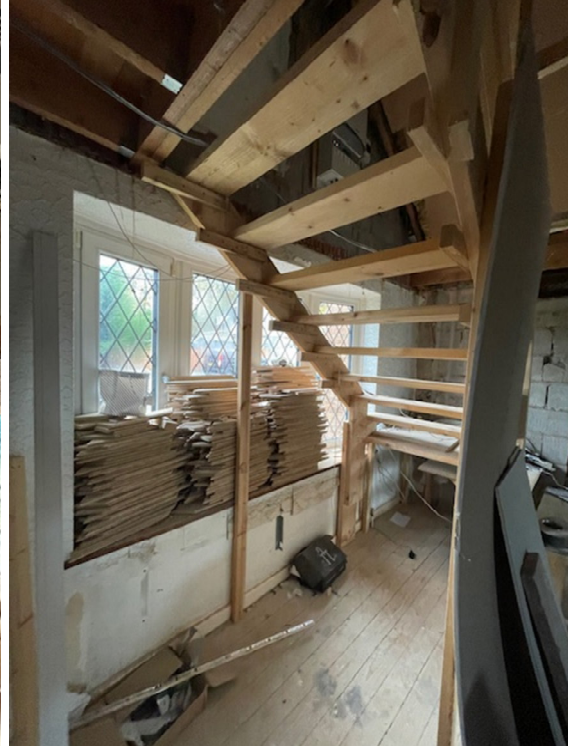
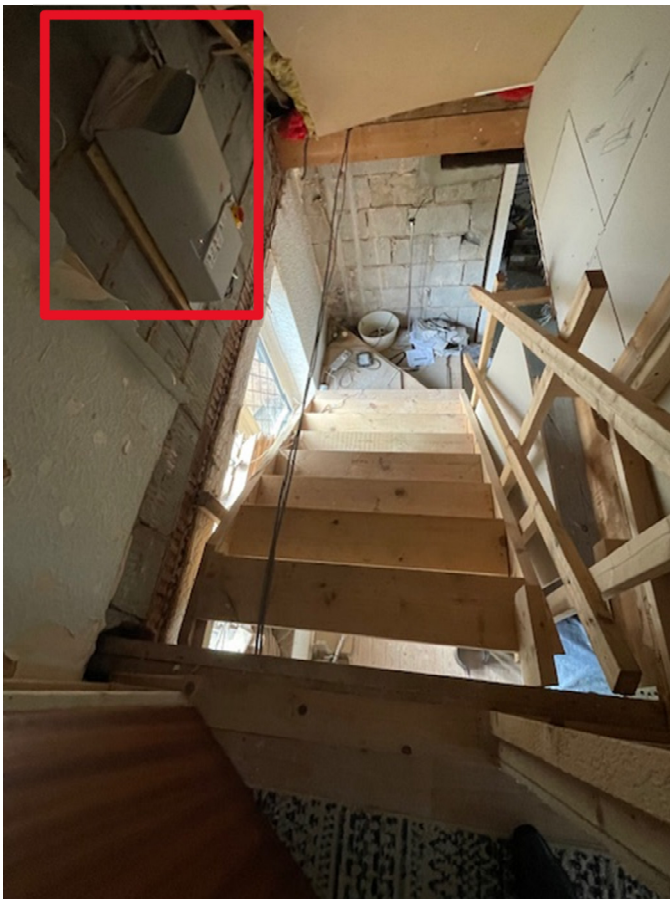
**Incompliance** of timber staircase – no landing on the top-flight, large gap, Electricity board adjacent to stair flight, Open treads, and supports.
