# Structural Appraisal of the Church Inn, Castle Hill Road, Bury, BL9 6UH

**Inspection date and time:**

3<sup>rd</sup> April 2025, 08:00AM.

01 Second Revision

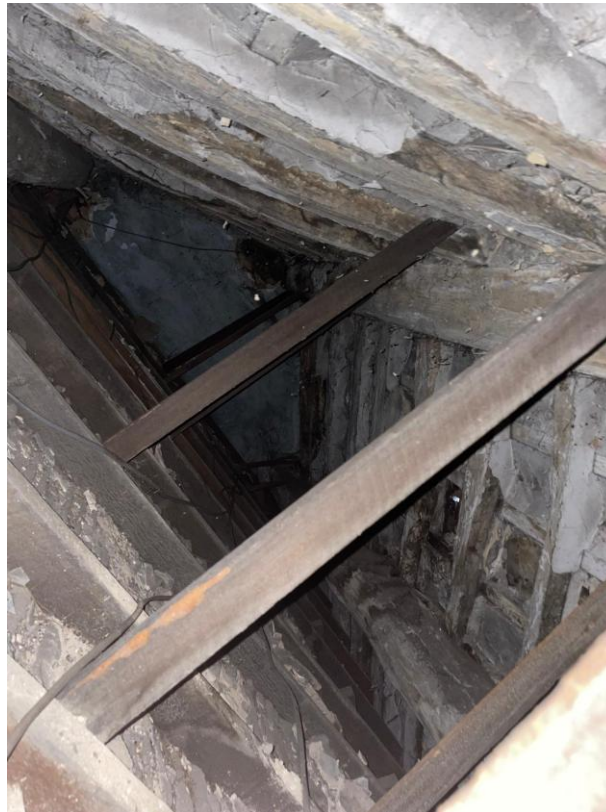
The roof timber structure is in a poor and potentially unstable structural condition. Visible sagging of the ridge line and purlins and evidence of water ingress throughout. Evidence of rot in principal trusses, rafters and wall plates were visible during the inspection.

**Figure 4:** Deteriorated, sagging roof structure

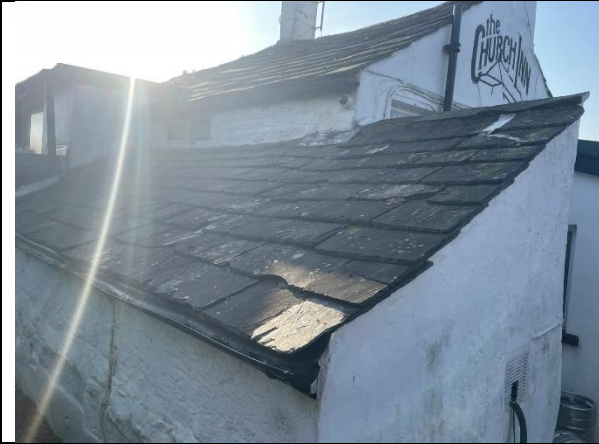
| Site Visit Photos – 03/04/25 | |
|---|---|
| North elevation single storey stone built extension. Rendered to gable. Bulging to North elevation this is can be generally considered to be consistent with a property of this age and type. | North elevation showing single storey flat roof 1970's extension. Generally in good structural condition. |

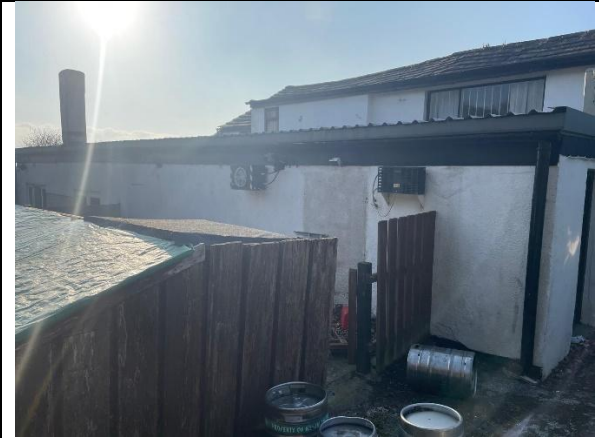
| Site Visit Photos – 03/04/25 | |
|---|---|
| North elevation showing single storey flat roof 1970's extension. Generally in good structural condition. | North elevation showing sagging roof ridge on original structure. |

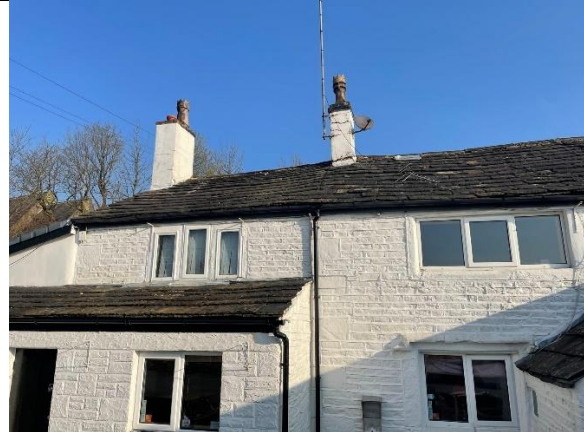
South elevation showing single storey porch extension (later than original structure). Generally in good structural condition.

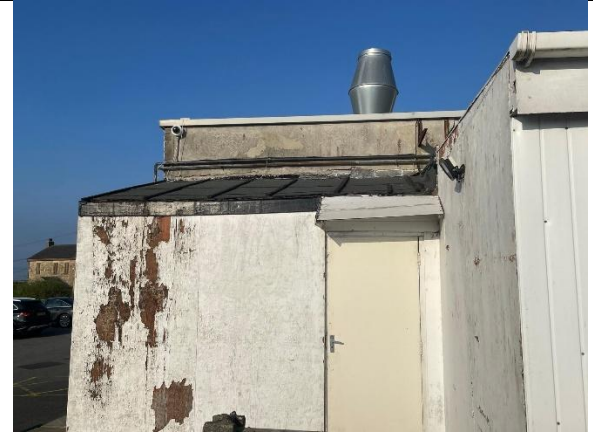
East elevation showing single storey timber clad extension. Showing signs of deterioration. Demolished in proposed plans.

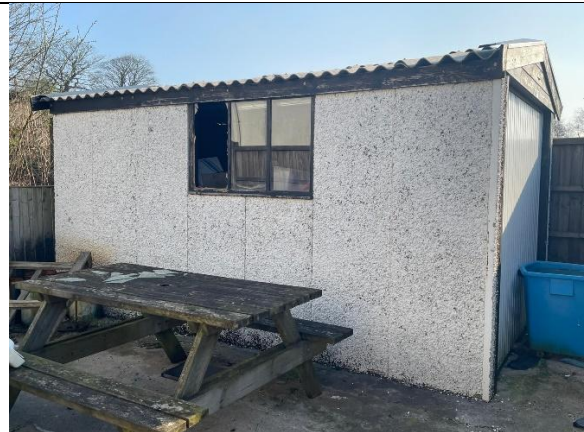
Outbuilding to the East. Demolished in proposed plans.

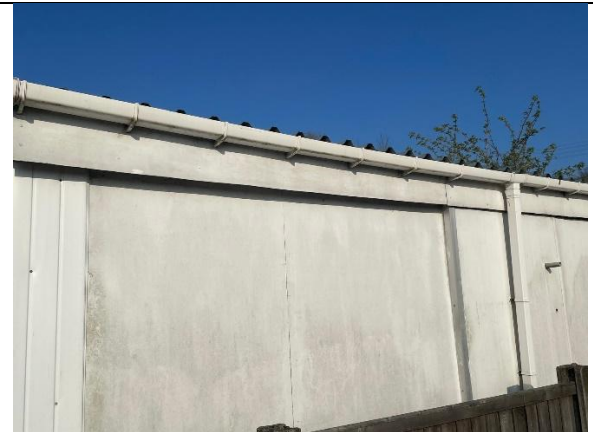
East elevation showing single storey timber clad extension. Demolished in proposed plans.

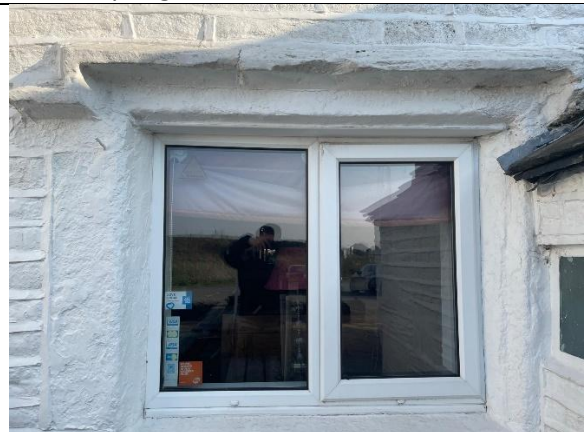
South elevation original window surround. Generally in good structural condition.

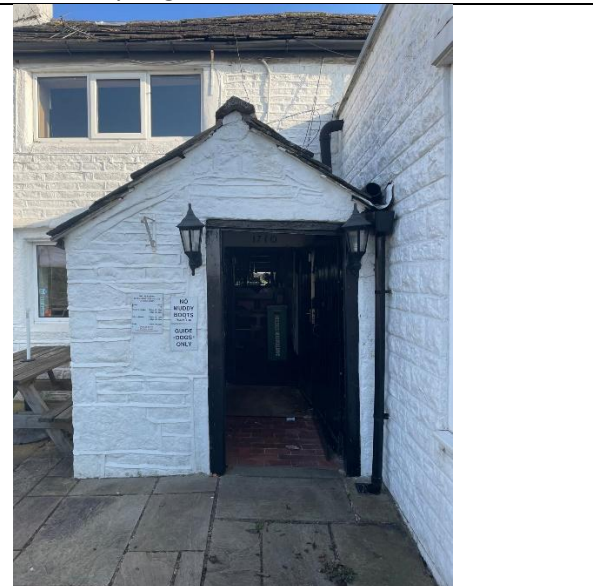
South elevation original porch entrance. Generally in good structural condition.

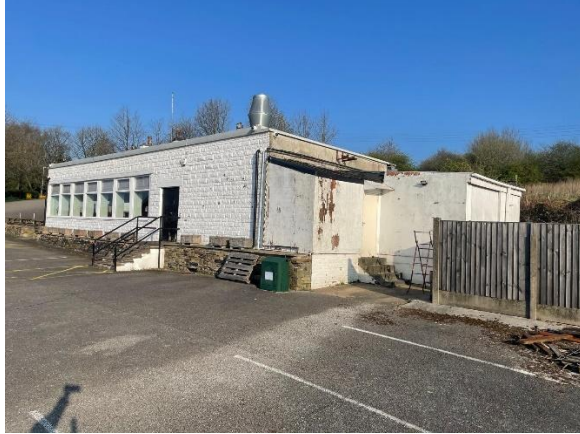
South elevation showing single storey stone built flat roof 1970's extension. Generally in good structural condition.

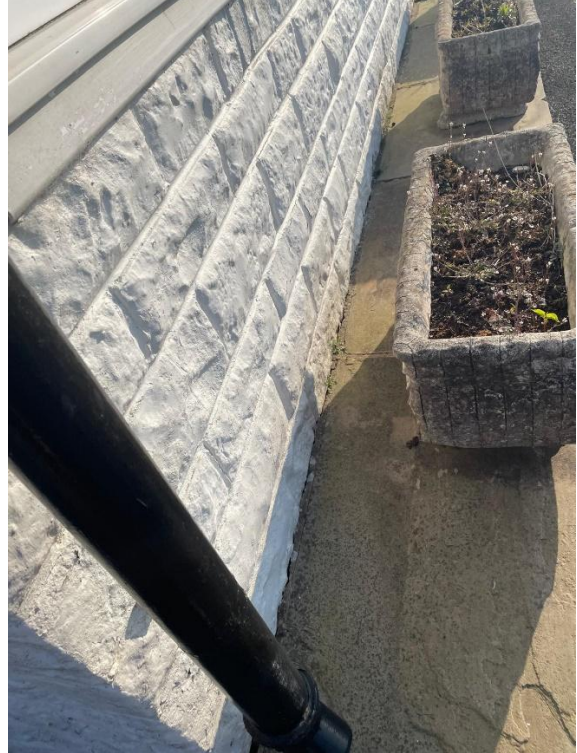
South elevation showing single storey stone built flat roof 1970's extension. Generally in good structural condition.

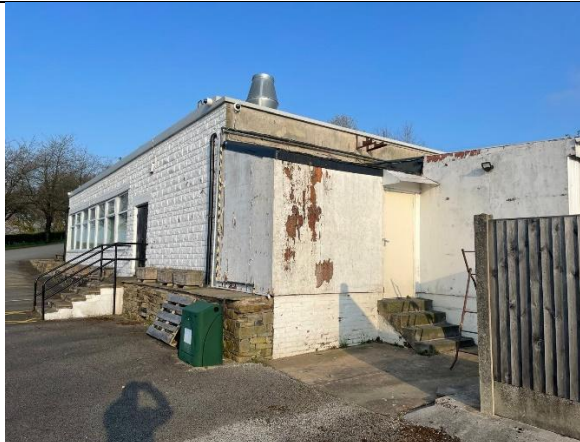
South/East elevation showing single storey stone built flat roof 1970's extension. Generally in good structural condition. Further inspection required following demolition of adjoining timber structure.

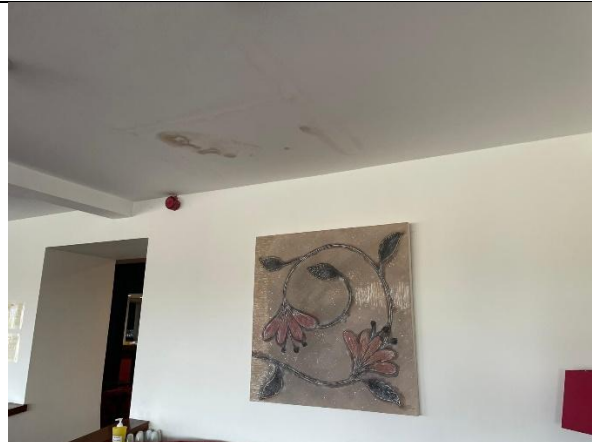
Ground floor internal, evidence of water ingress due to dilapidated roof structure.

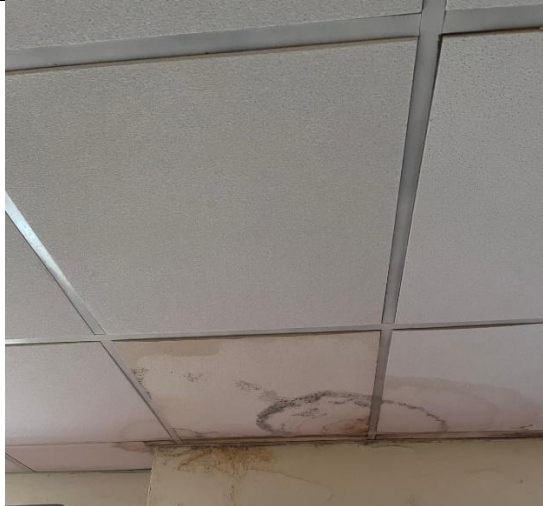
Ground floor internal, evidence of water ingress due to dilapidated roof structure. Areas of collapsed ceiling tiles and plaster due to water ingress from the failing roof.

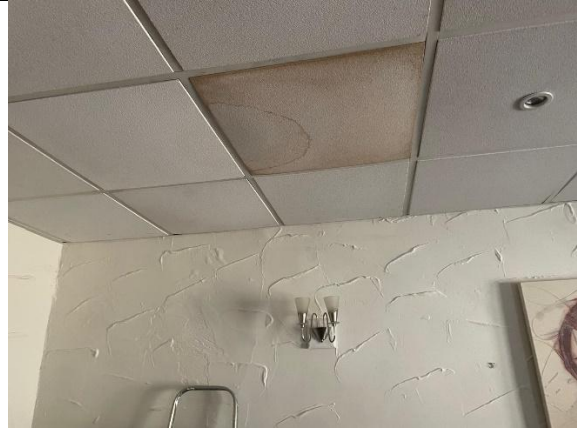
Ground floor internal, evidence of water ingress due to dilapidated roof structure. Areas of collapsed ceiling tiles and plaster due to water ingress from the failing roof.

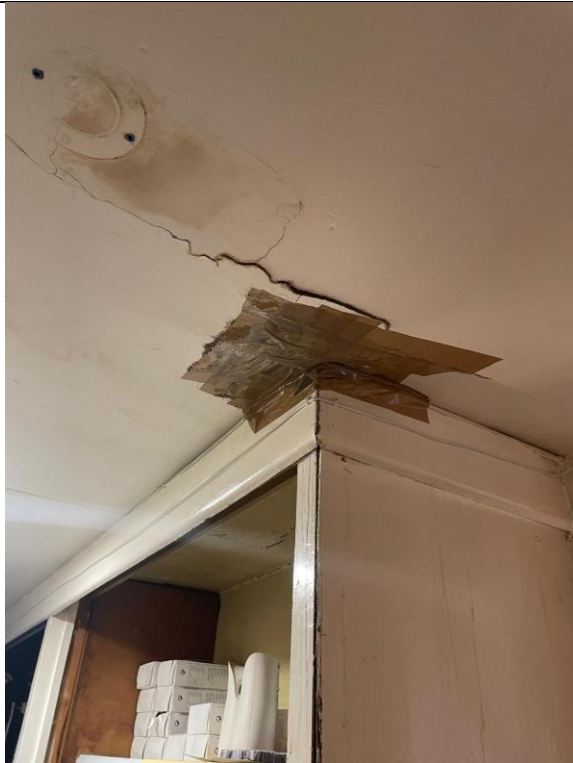
First floor internal, evidence of water ingress due to dilapidated roof structure. Areas of collapsed ceiling tiles and plaster due to water ingress from the failing roof.

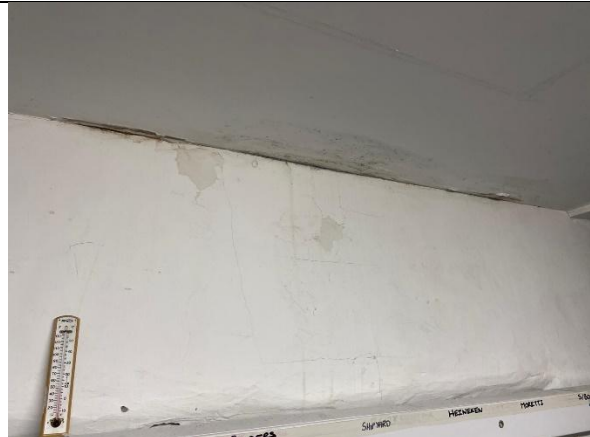
First floor internal ceiling line, evidence of damp and water ingress due to dilapidated roof structure.

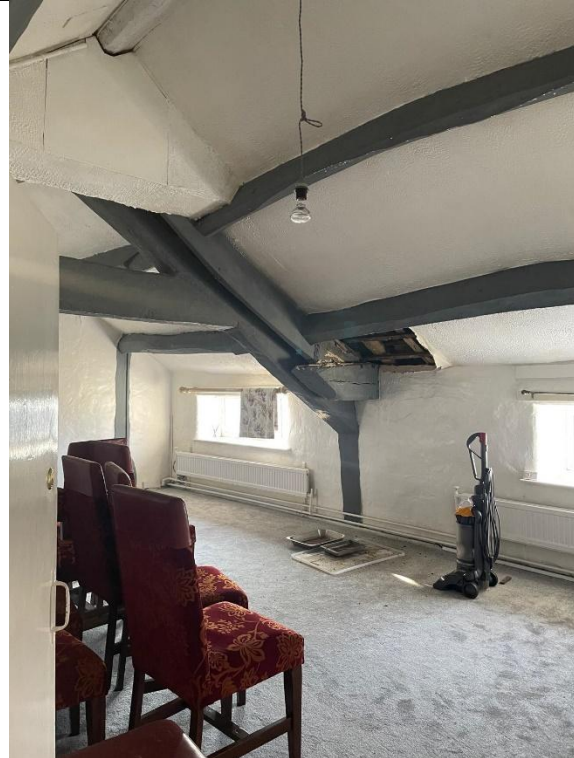
First floor internal, evidence of water ingress due to dilapidated roof structure. Evidence of deformation and movement in roof structure.

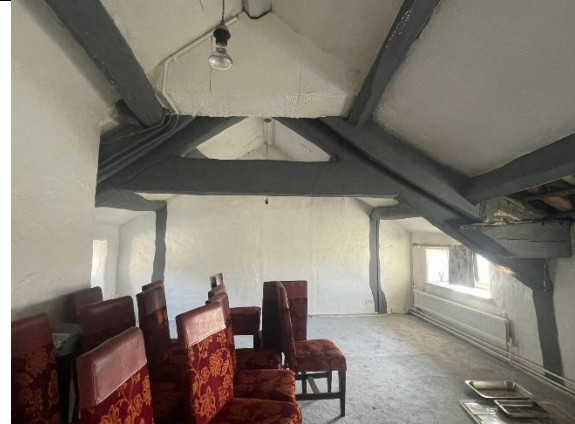
First floor internal, evidence of water ingress due to dilapidated roof structure. Evidence of deformation and movement in roof structure.

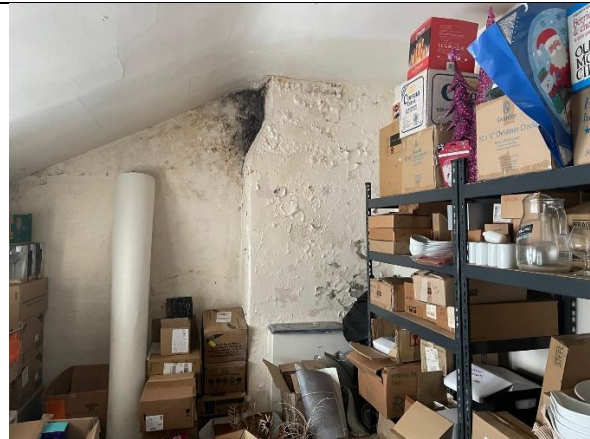
First floor internal, evidence of water ingress causing damp and mould due to dilapidated roof structure.

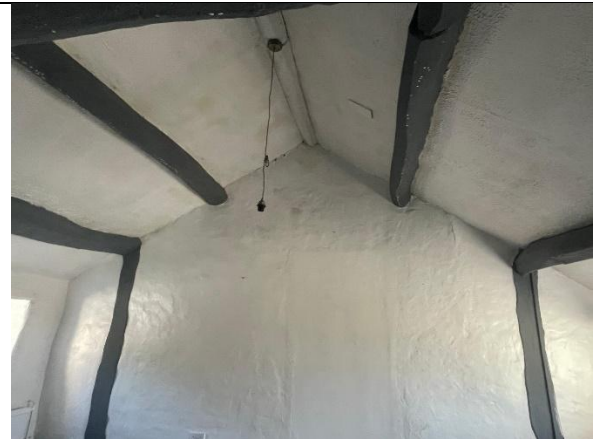
First floor internal, evidence of water ingress causing damp and mould due to dilapidated roof structure.

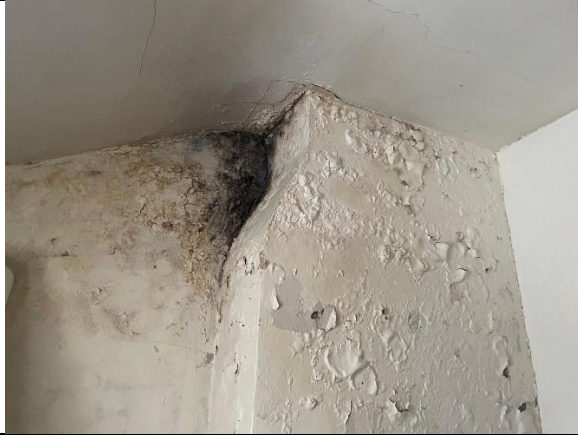
First floor internal, evidence of water ingress causing damp and mould due to dilapidated roof structure.

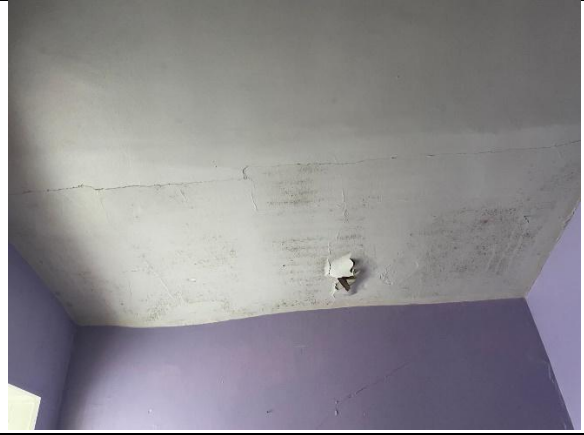
First floor internal, evidence of water ingress due to dilapidated roof structure. Areas of collapsed ceiling tiles and plaster due to water ingress from the failing roof.

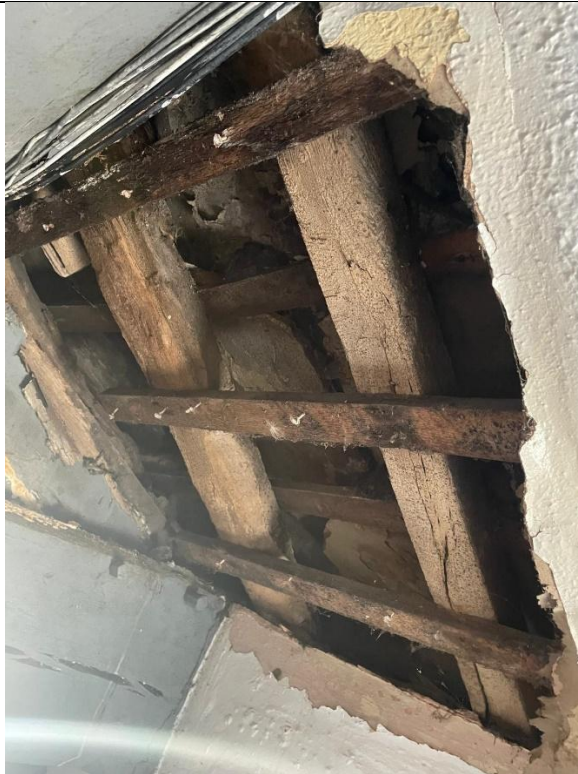
First floor internal, exposed roof structure due to water ingress. Evidence of rot, timber decay and lack of membrane and insulation.

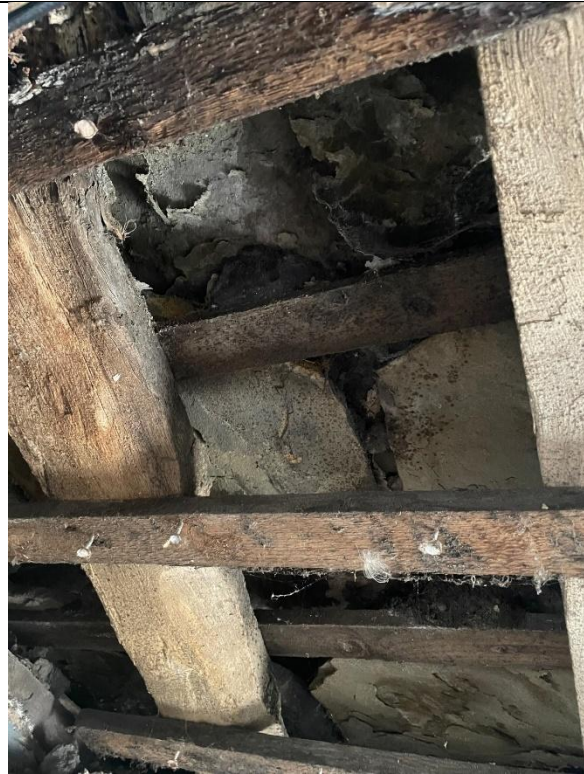
First floor internal, exposed roof structure due to water ingress. Evidence of rot, timber decay and lack of membrane and insulation.

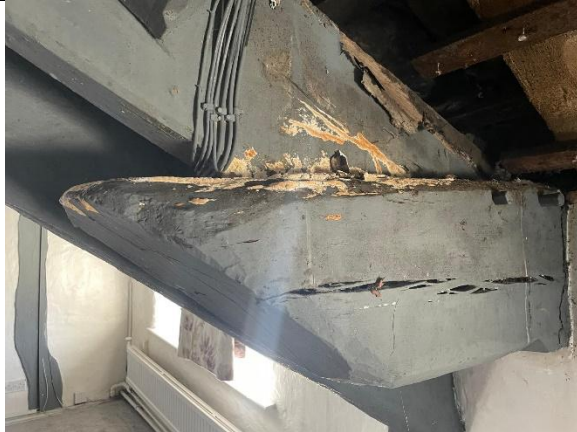
First floor internal, exposed roof truss evidence of rot, timber decay and possible insect infestation in exposed timbers.

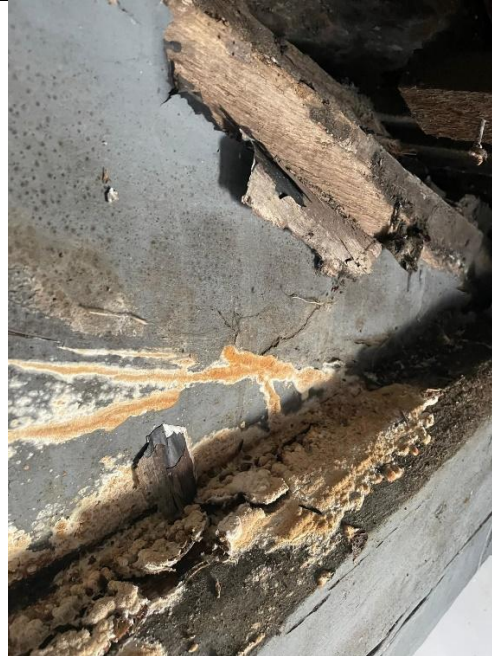
First floor internal, exposed roof truss evidence of rot, timber decay and possible insect infestation in exposed timbers.

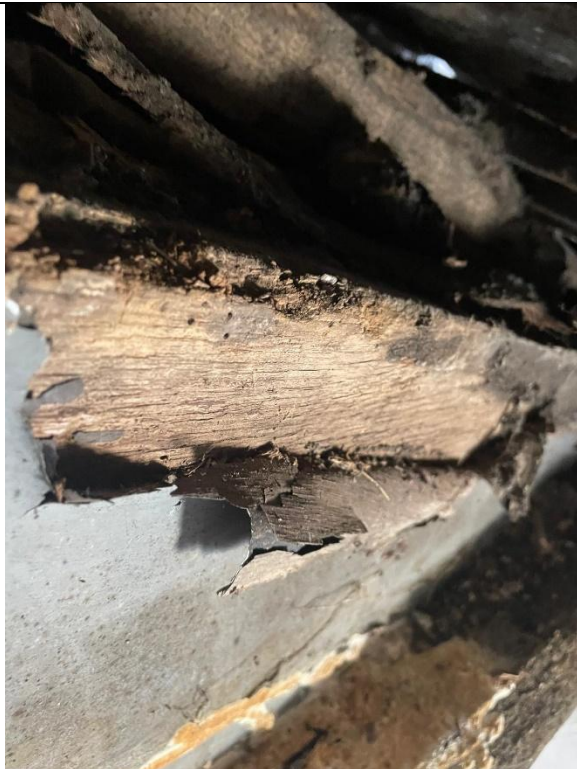
First floor internal, exposed roof truss evidence of rot, timber decay and possible insect infestation in exposed timbers.

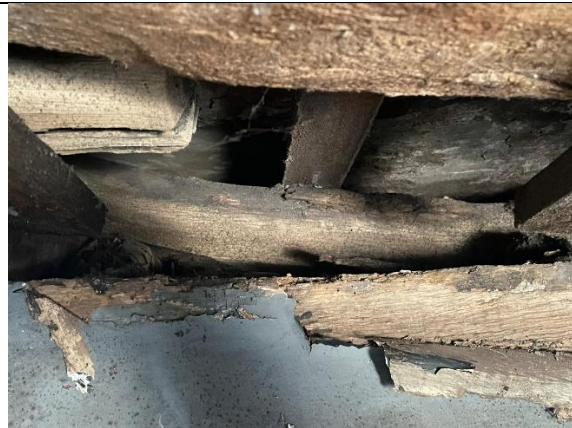
First floor internal, exposed roof purlin evidence of rot, timber decay and possible insect infestation in exposed timbers.

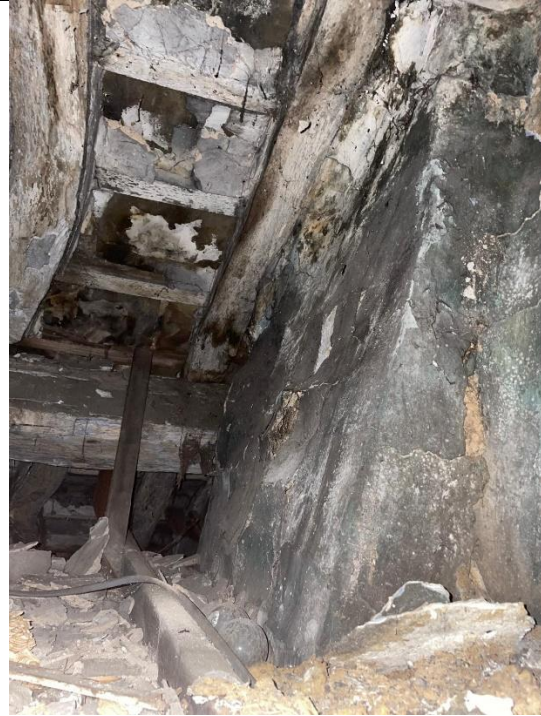
Loft space evidence of damp, rot, timber decay and possible insect infestation in exposed roof structure. Evidence of extensive failing historic repairs.

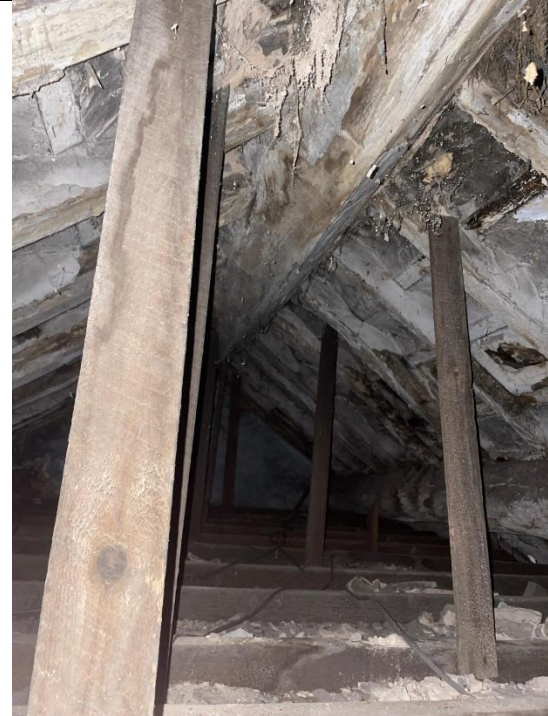
Loft space evidence of damp, rot, timber decay and possible insect infestation in exposed roof structure. Evidence of extensive failing historic repairs.

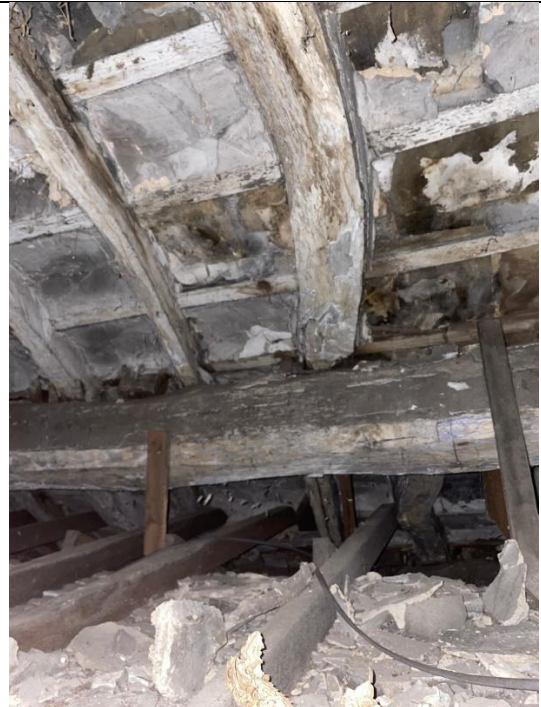
Loft space evidence of damp, rot, timber decay and possible insect infestation in exposed roof structure. Evidence of extensive failing historic repairs.

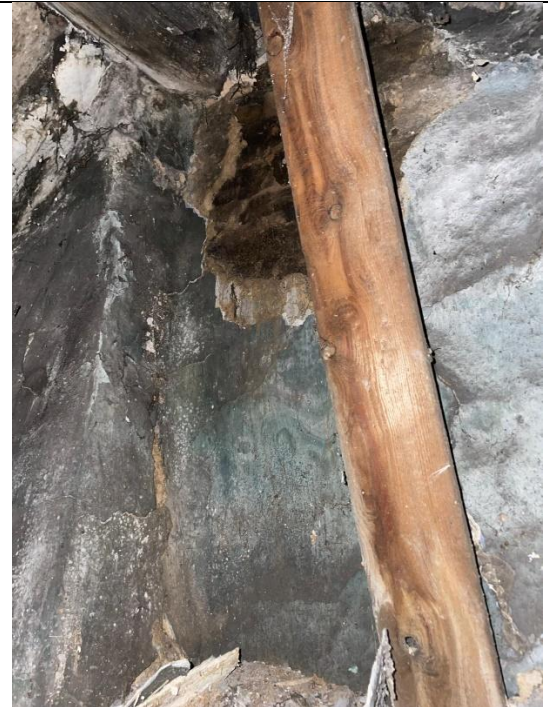
Loft space evidence of damp, rot, timber decay and possible insect infestation in exposed roof structure. Evidence of extensive failing historic repairs.

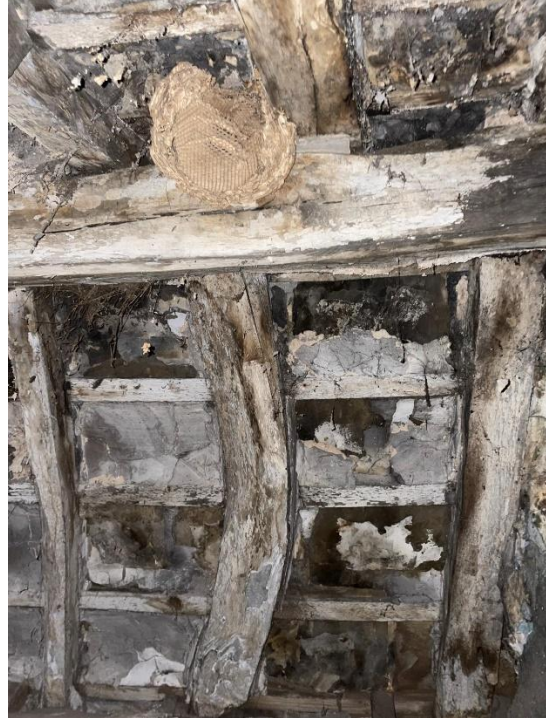
Loft space evidence of damp, rot, timber decay and possible insect infestation in exposed roof structure. Evidence of extensive failing historic repairs.

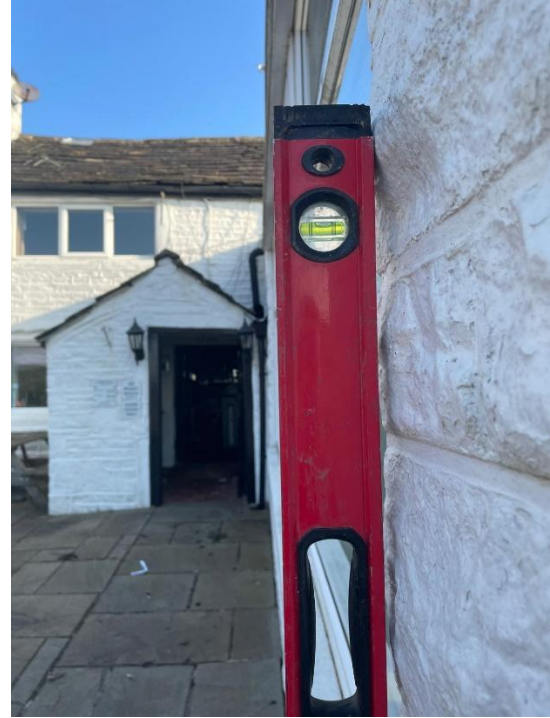
West elevation of South facing single storey stone built flat roof 1970's extension. Load bearing wall generally plumb and in good condition.

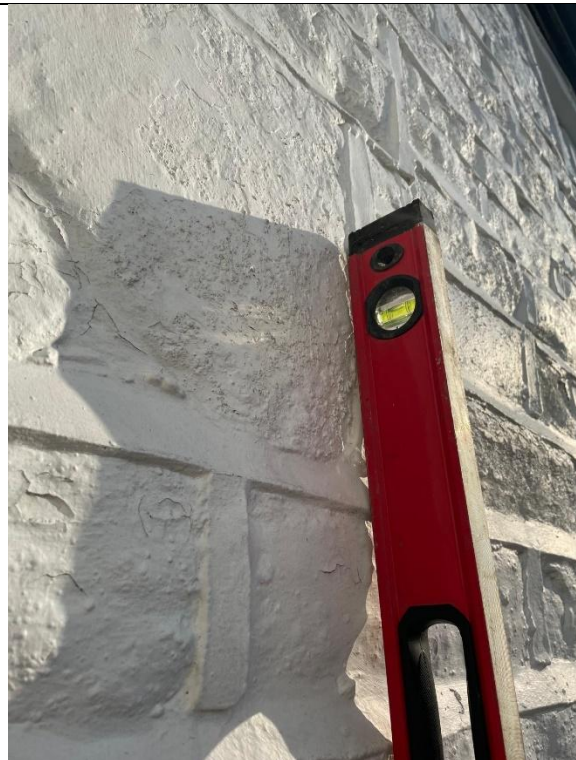
Original structure. Load bearing wall generally plumb and in good condition.

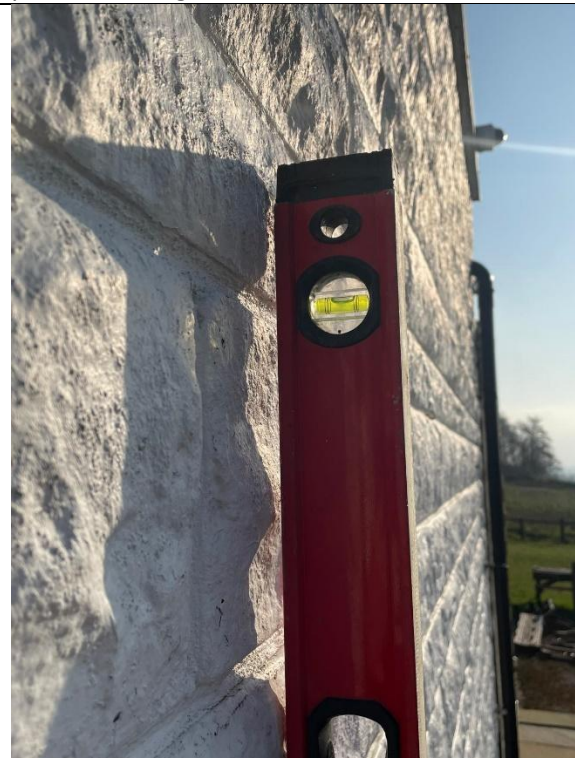
South facing single storey stone built flat roof 1970's extension. Load bearing wall generally plumb and in good condition.
