## **Heap Bridge RCA**

| Condition + Encroachment Reporting Sheet: RIVERS and STREAMS | | | |
|---|---|---|---|
| Site name/location: | Heap Bridge | Unique river section reference: | JE8731-25 |

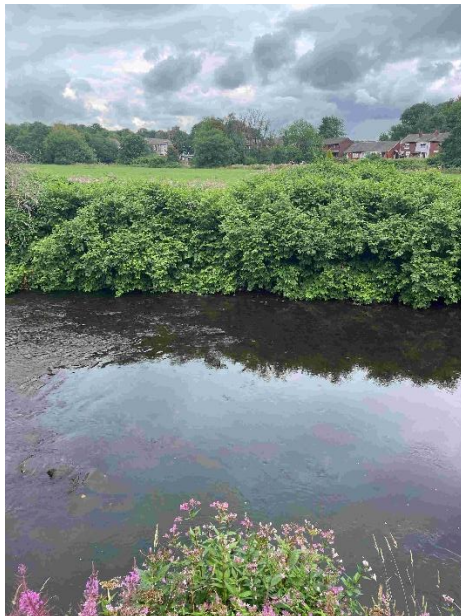
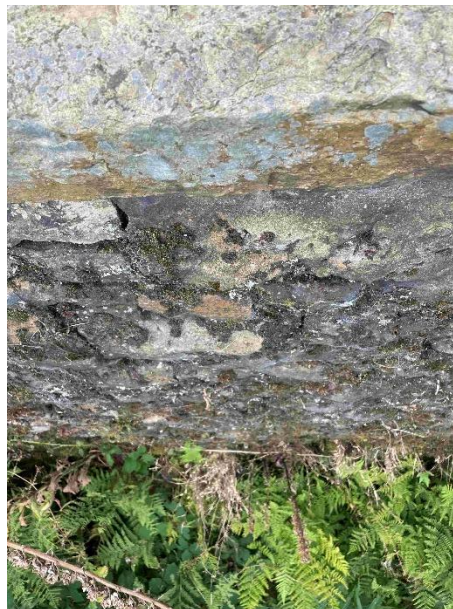
The extensive walled section on the left bank coupled with the extensive Japanese knotweed on the inaccessible right bank, limited possibilities to exercise net gain. The eradication of INNS with Section One (Modules Four and Five), would increase the preliminary score to 1.0364, still someway from the next condition category ("Fairly Good") at 1.4.

***Module Two: Japanese knotweed. Module 2, Stone Bank, left, Module Three***

| Condition + Encroachment Reporting Sheet: RIVERS and STREAMS | | | |
|---|---|---|---|
| Control of INNS along left bank. | | | |

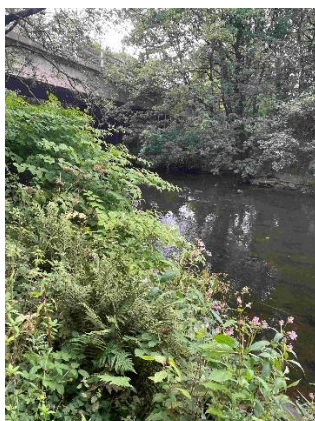
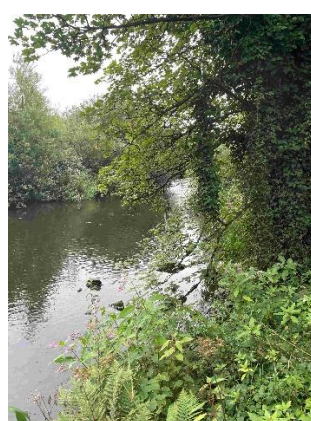
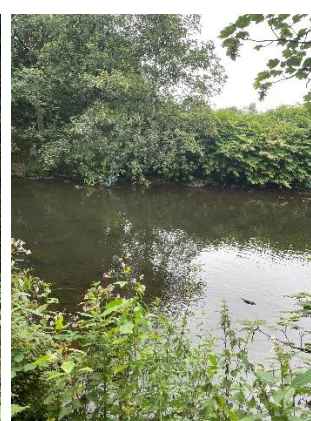
***Module Five: Right bank, upstream and mid channel***
