Timber repairs to dormer windows

Touchstones Art Gallery, Rochdale

Roof Zone 1  
Roofplan - West Dormer Window Repairs

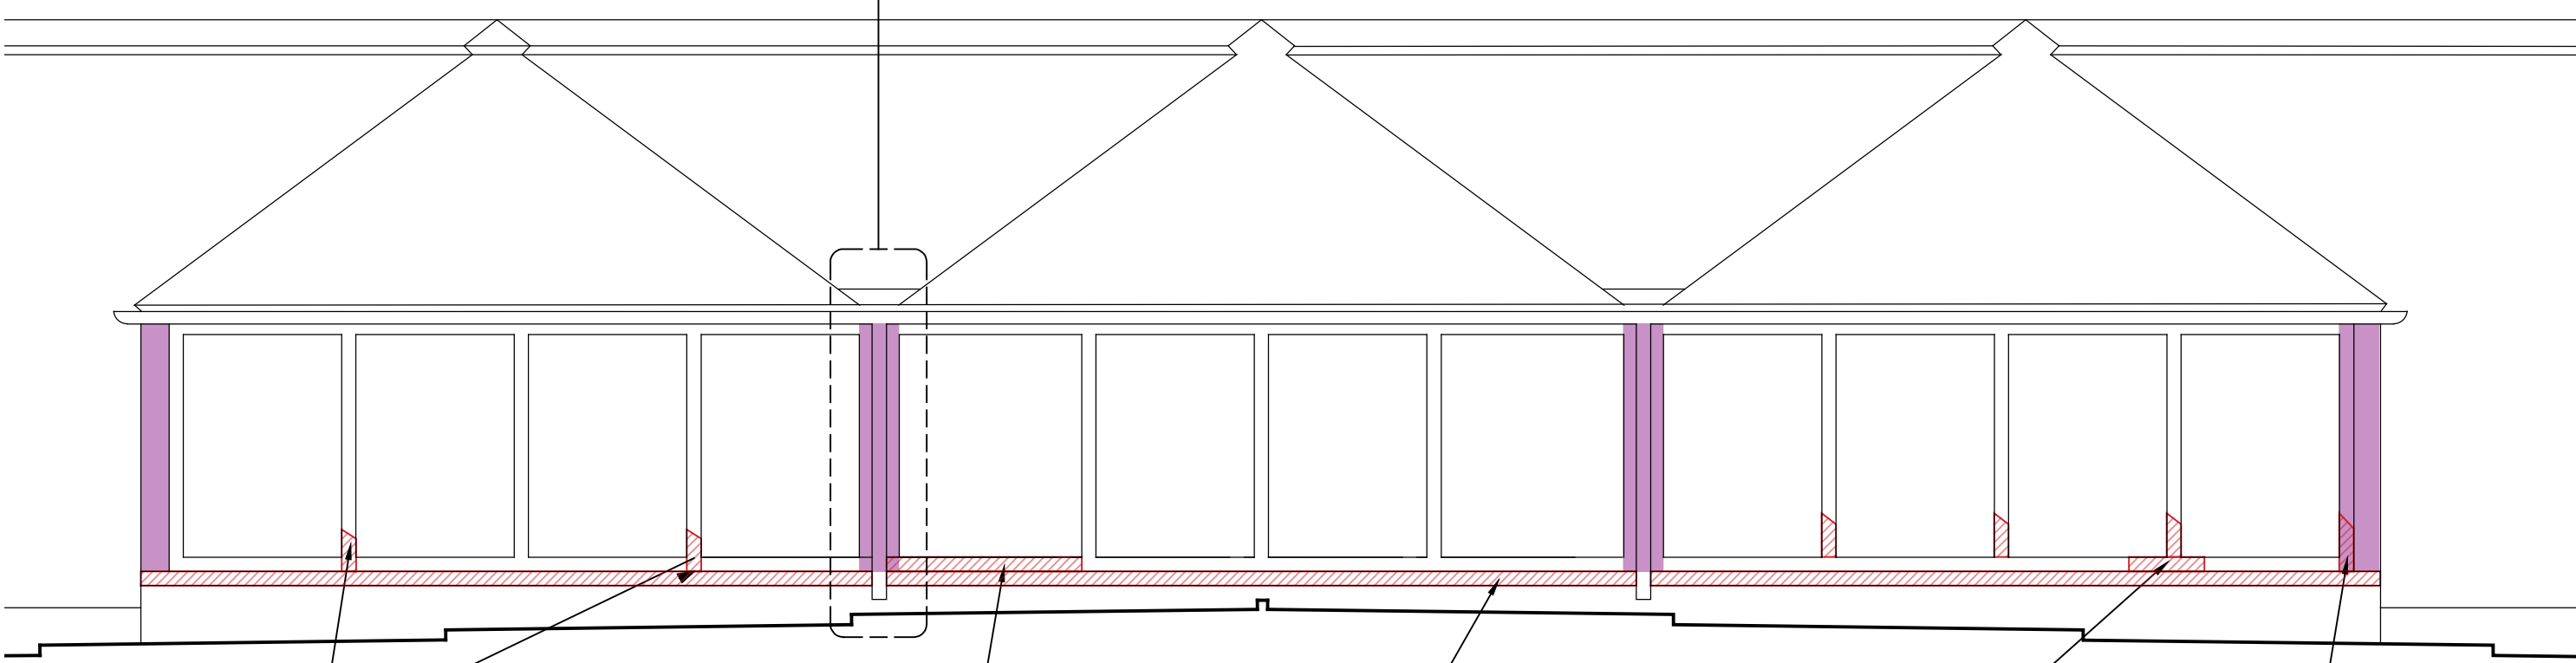
05 West Dormer Elevation  
1:nts @ A1

Rot to cill. Allow to renew full length of cill as NBS G20.

Rot to cill. Allow to replace as NBS G20 to match existing.

Allow for splice repairs at bottom of post as NBS C51.

Replace beading as NBS G20 to match existing profile throughout the length of the dormers.

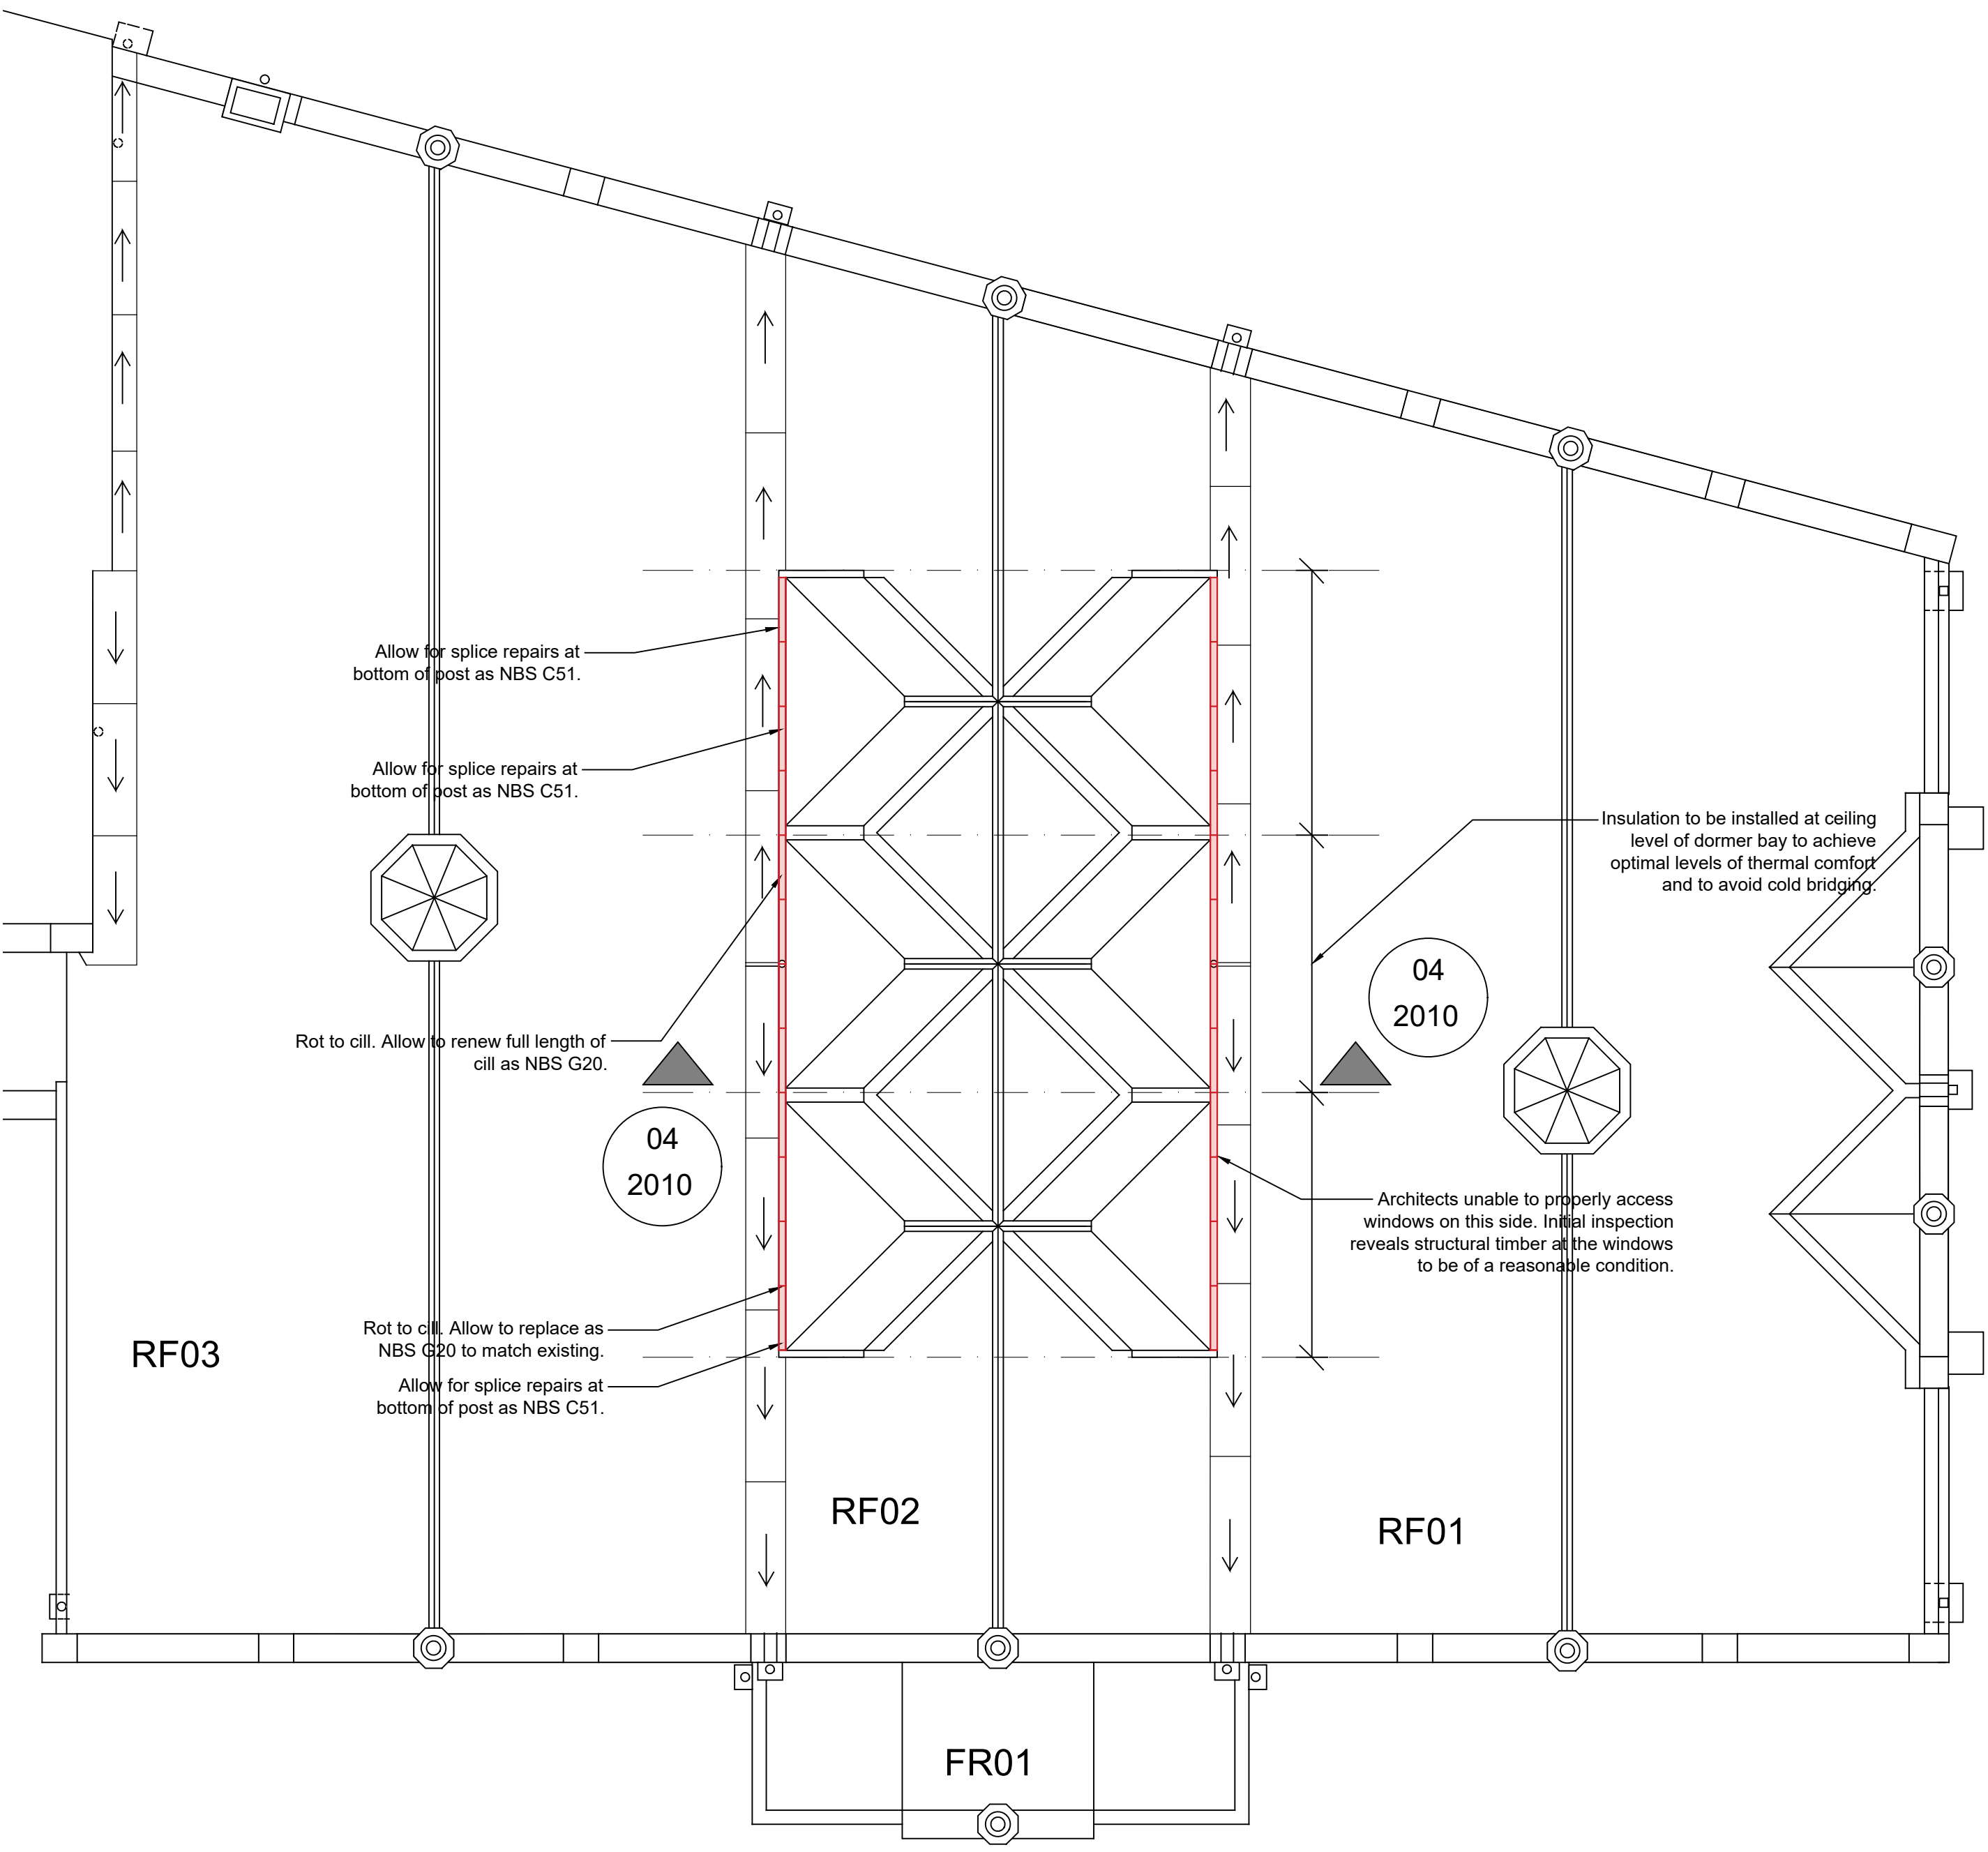
01 Roofplan - Dormer Repairs  
1:50 @ A1

Rot to cill. Allow to renew full length of cill as NBS G20.

Rot to cill. Allow to replace as NBS G20 to match existing.

Architects unable to properly access windows on this side. Initial inspection reveals structural timber at the windows to be of a reasonable condition.

Dormer windows over 3nos. bays. Each bay is split into 4nos. windows. Allow to replace bead underneath the cill as NBS G20 to match existing.

Allow to install new code 5 lead flashing as NBS H71 and LSA guidelines over timber frames separating dormer windows.

Allow for splice repairs at bottom of post as NBS C51.

Insulation to be installed at ceiling level of dormer bay to achieve optimal levels of thermal comfort and to avoid cold bridging.
