Date: 16th July 2025  
Reference: 16465-V14

## GAS MEMBRANE VALIDATION – EDENFIELD ROAD, NORDEN

| <b>Project Name:</b> | Edenfield Road, Norden |
| <b>Plots:</b> | 15-16 |

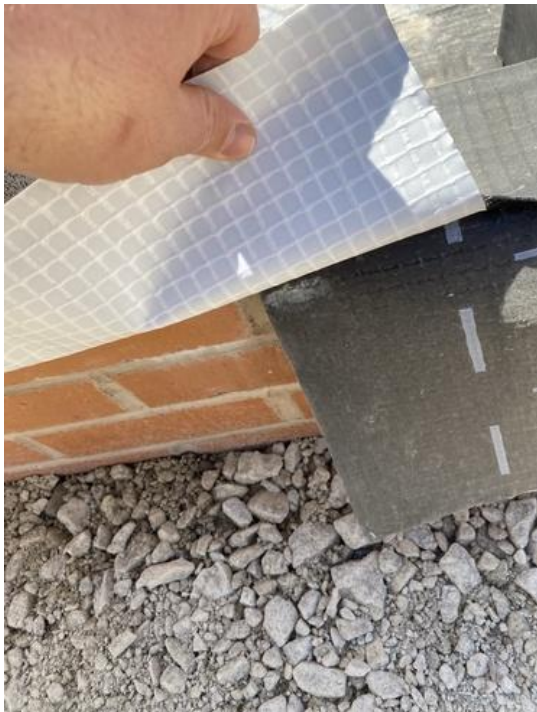
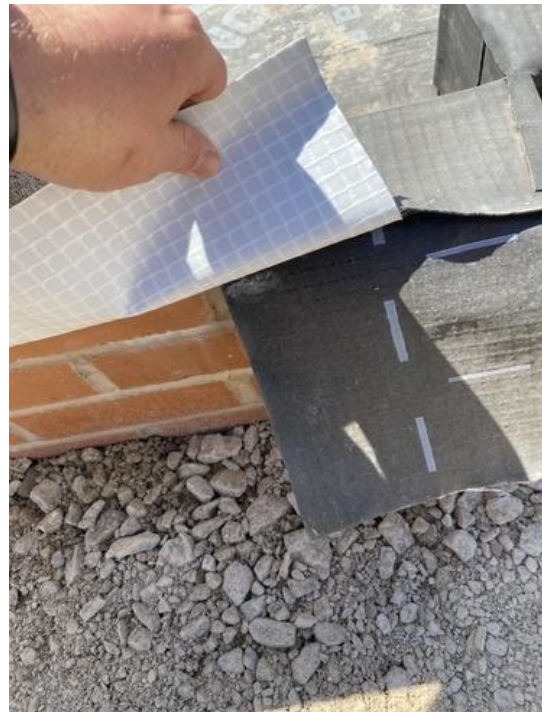
| <b>Are Joints lapped and sealed in accordance with manufacturer's requirements/ specification?</b> | | Yes |

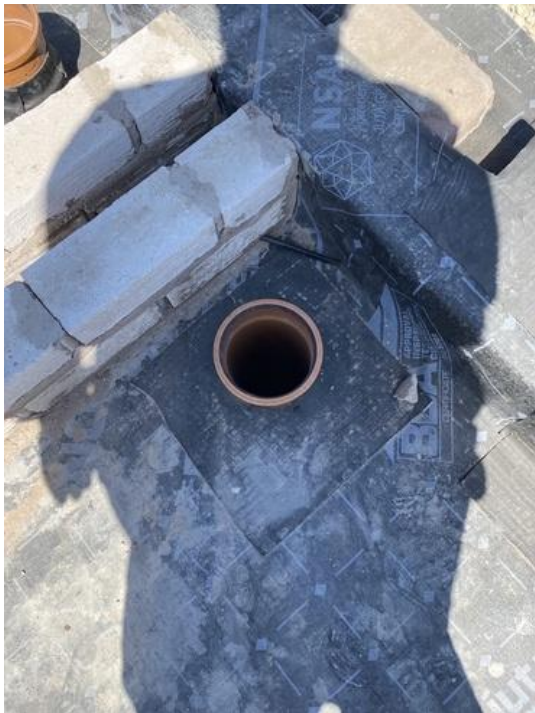
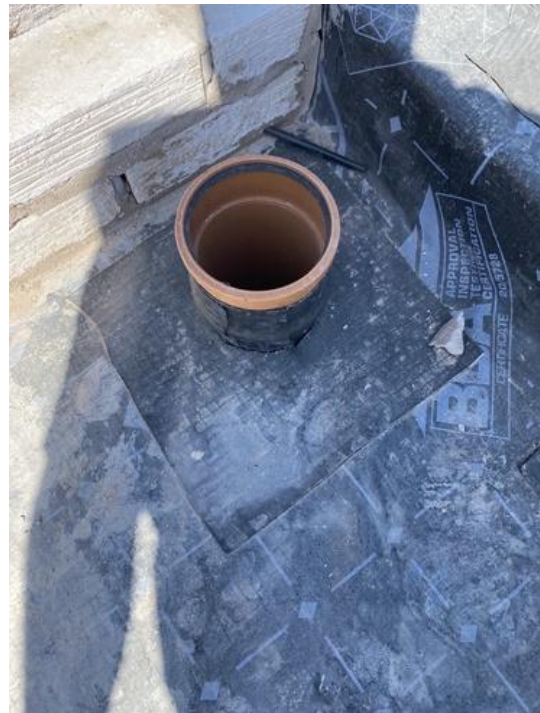
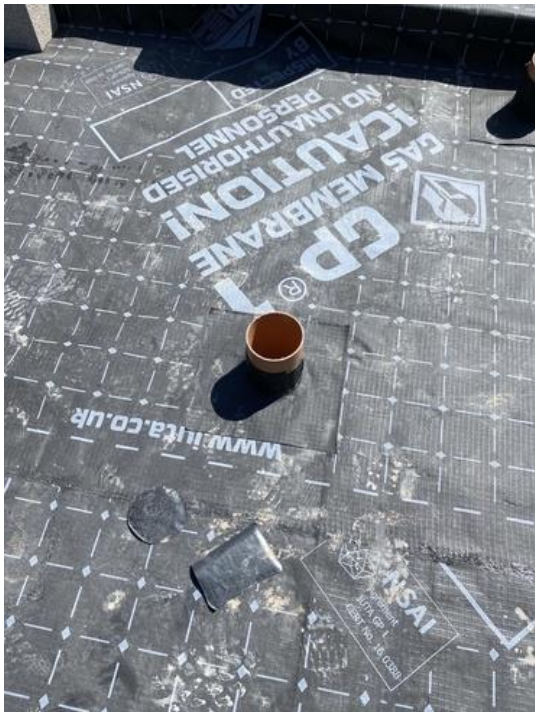
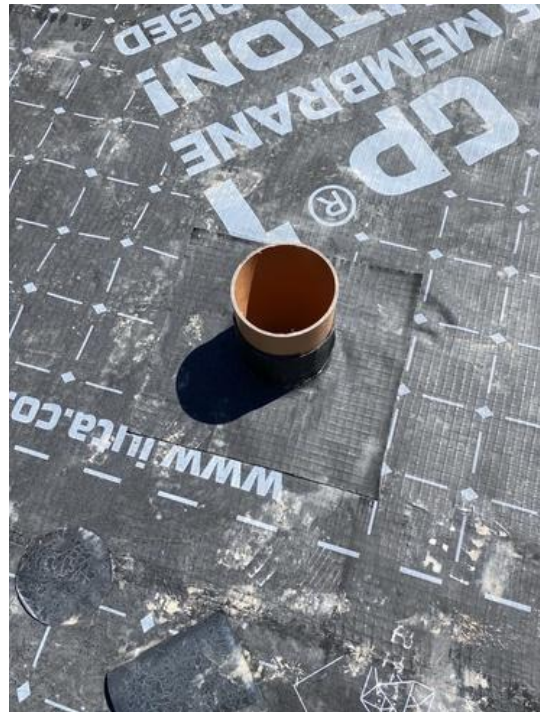
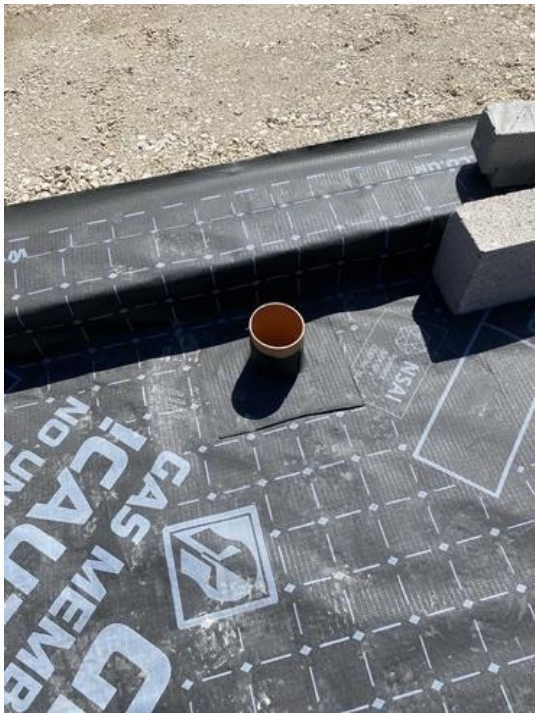
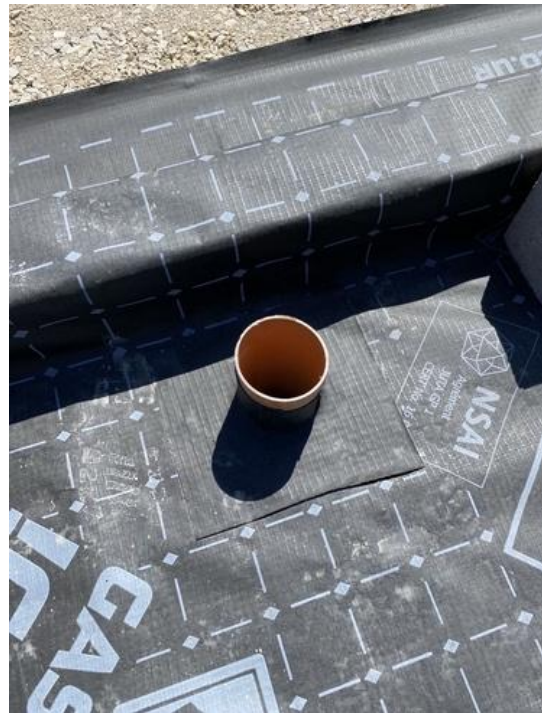
**Service entries seals: Top hats seal arrangements fixed around service entries? Use of Jubilee clips or Bitumastic Sealant**

Pass

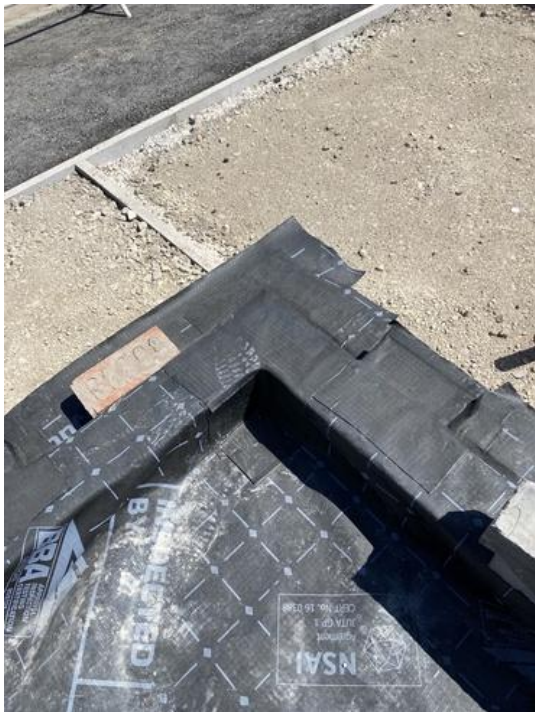
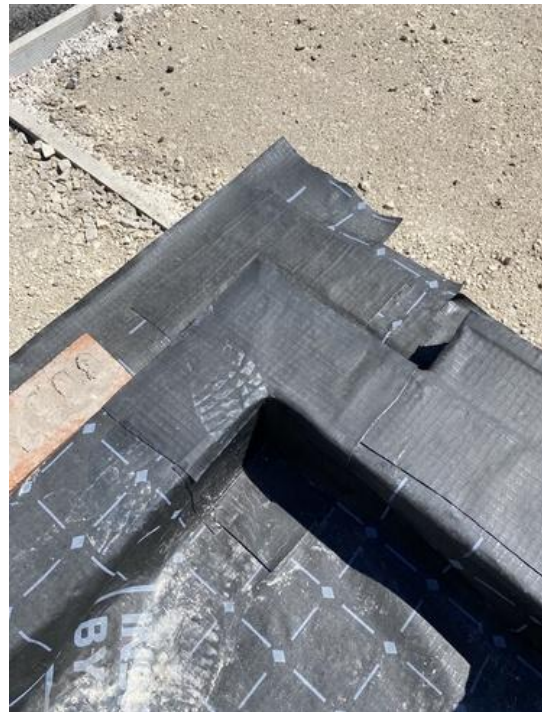
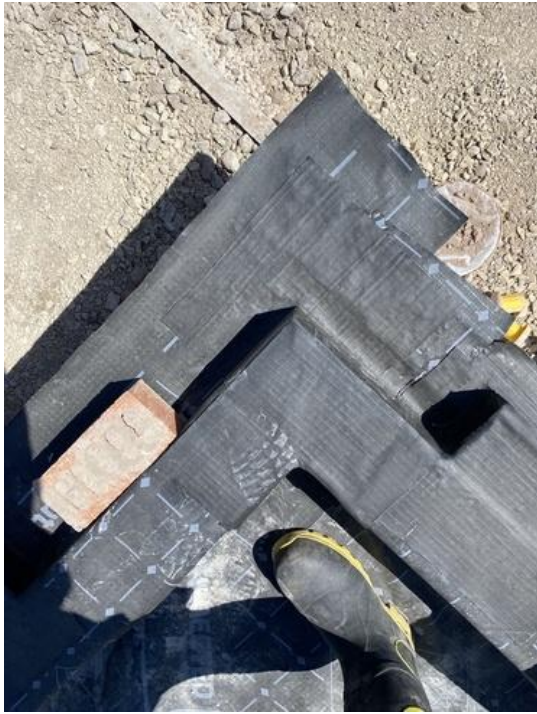
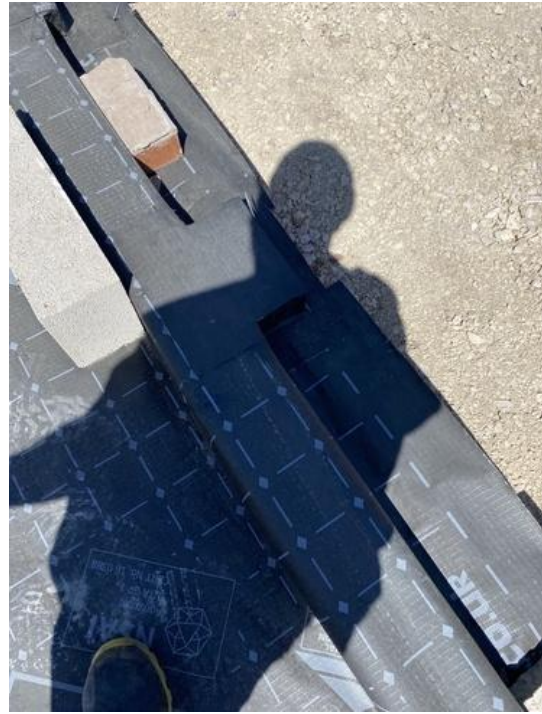
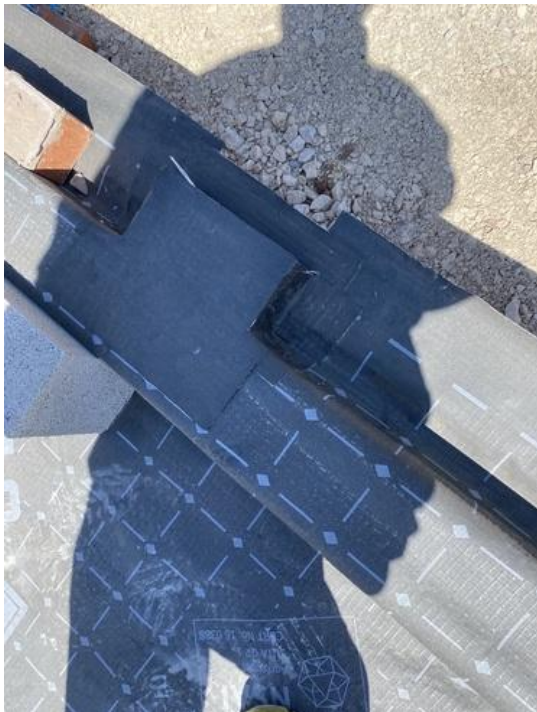
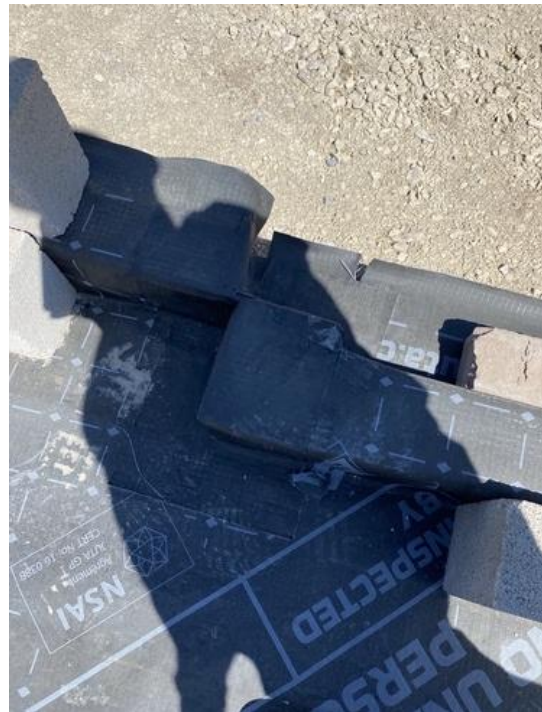
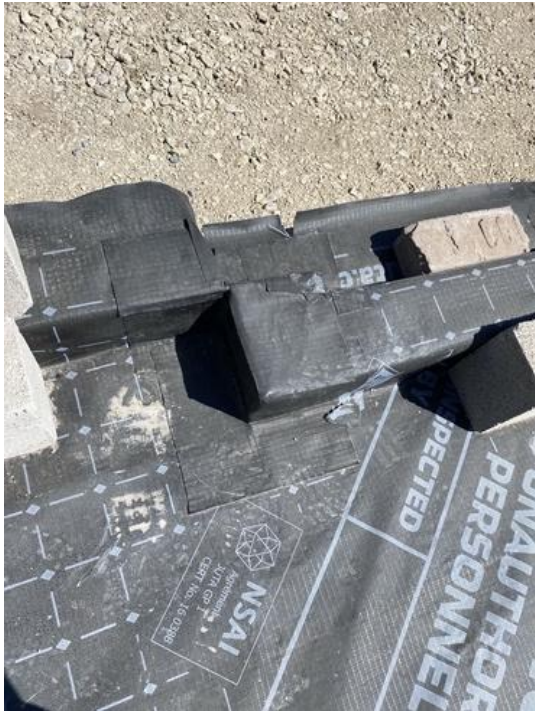
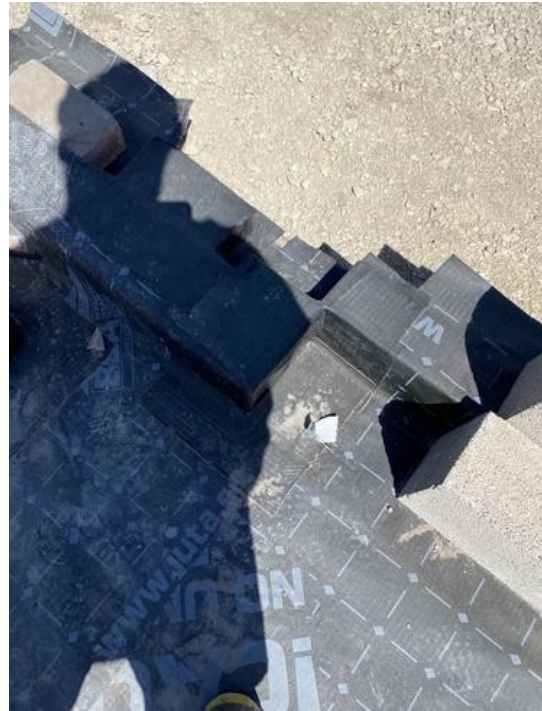
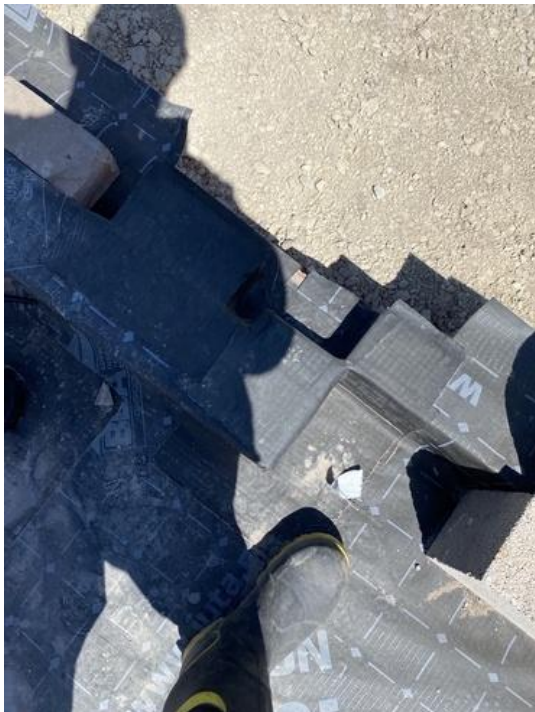
**Corners / Internal joints: Check all corners are correctly formed or contractor has used preformed corners.**

Pass

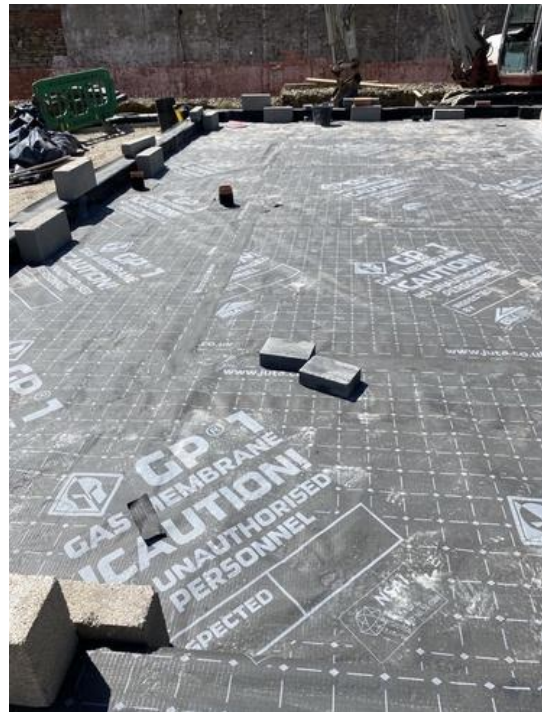
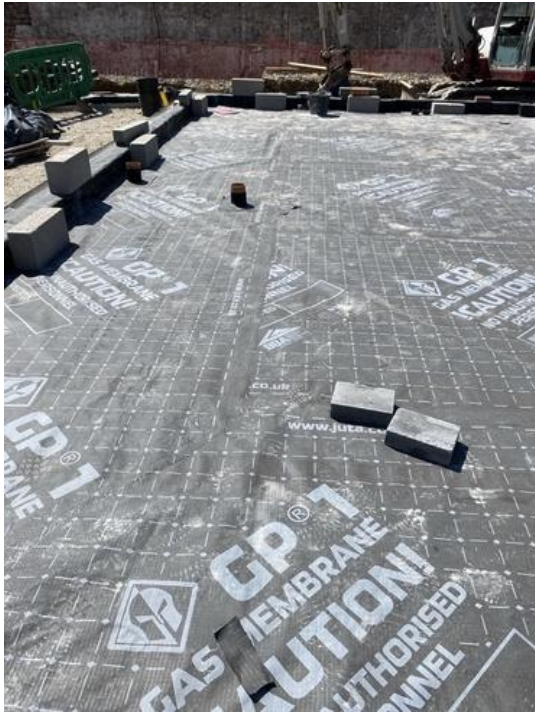
**Are folds running in line with joints? (no joints cutting across folds)**

Pass

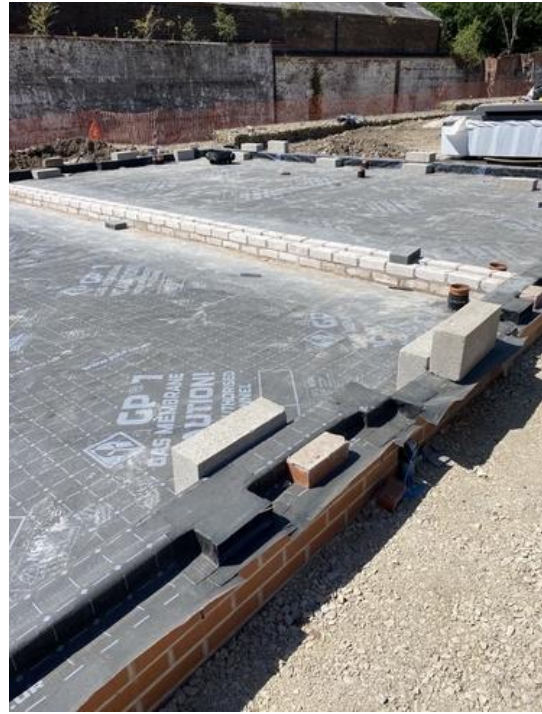
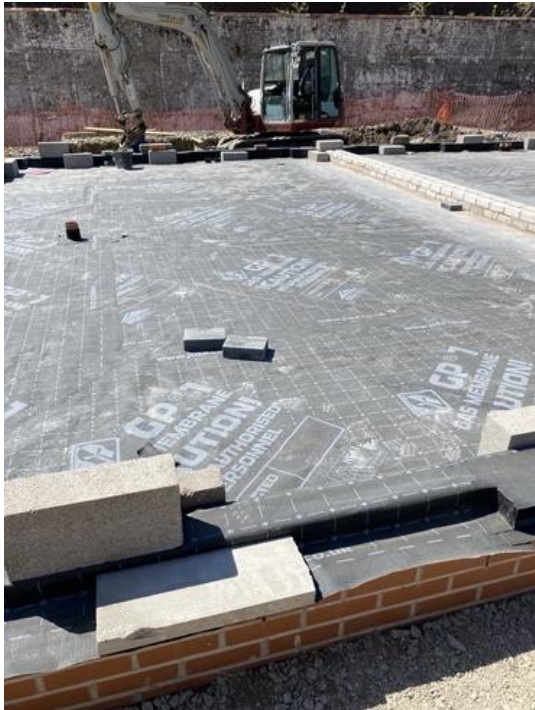
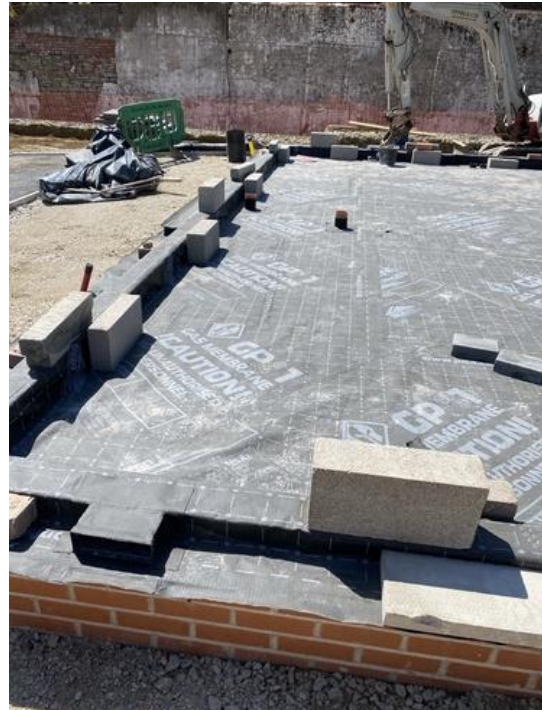
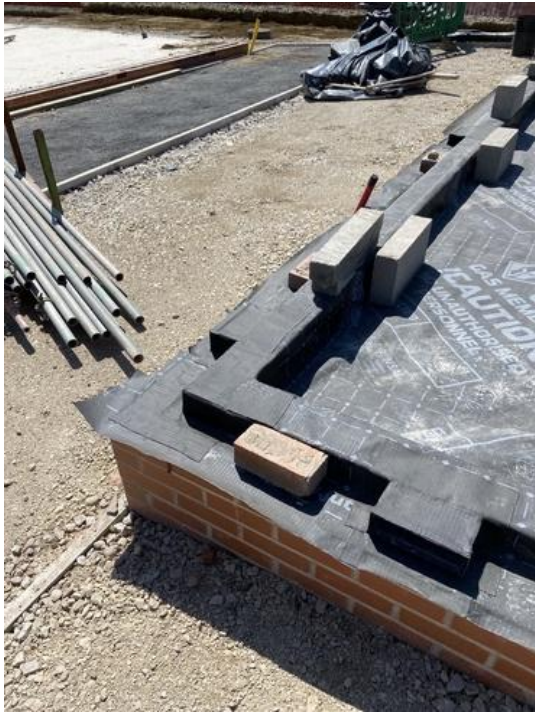
**Extent of Coverage: Is the membrane covering the entire plot? Does membrane span over outside walls?**

Yes

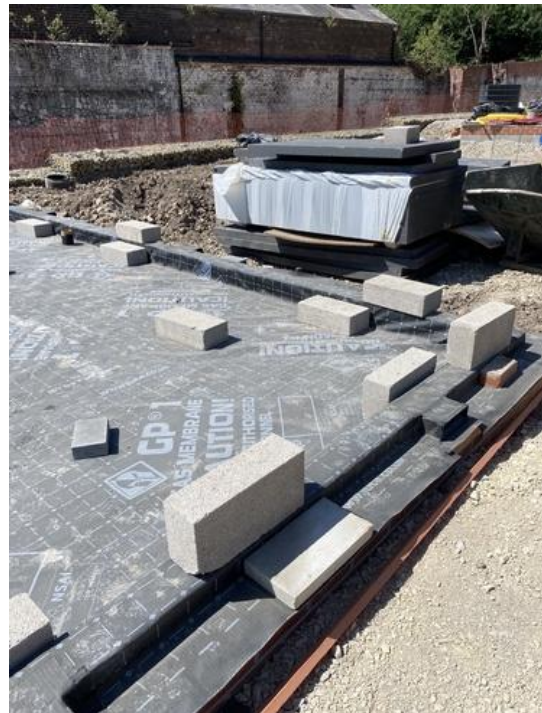
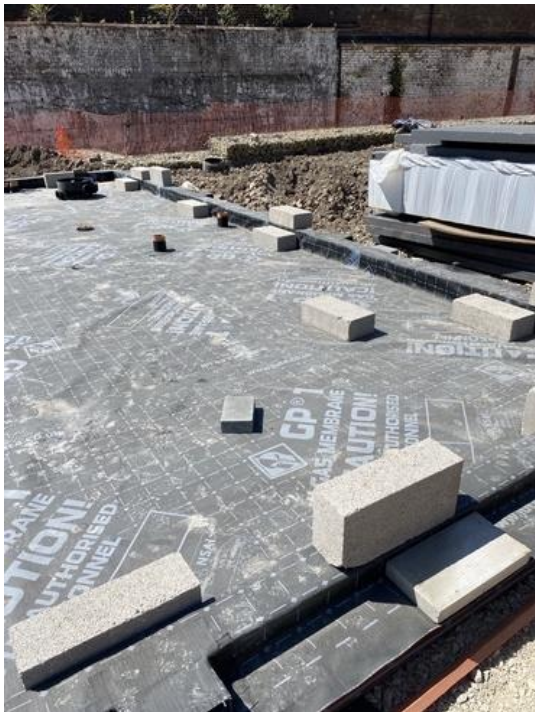
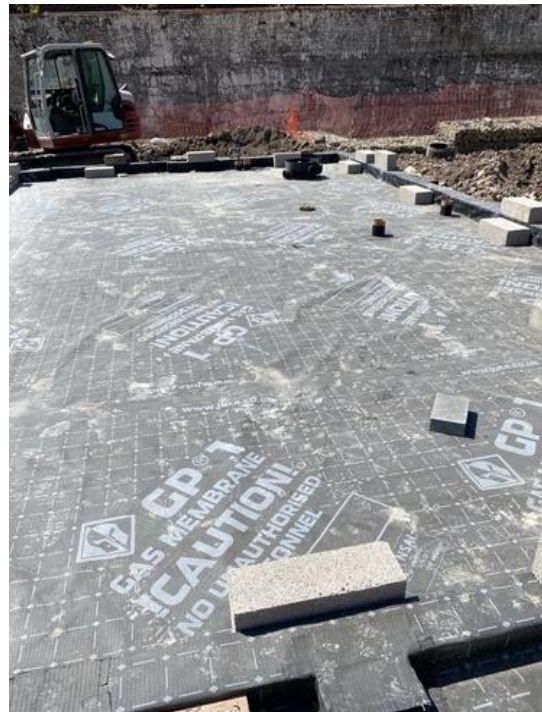
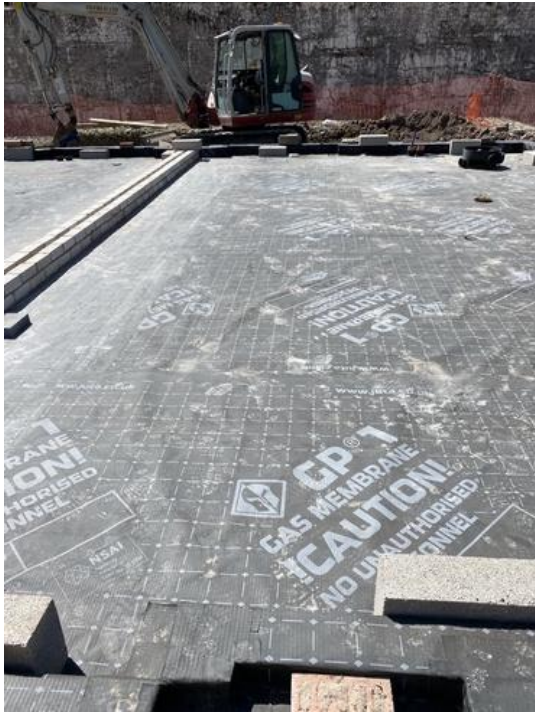
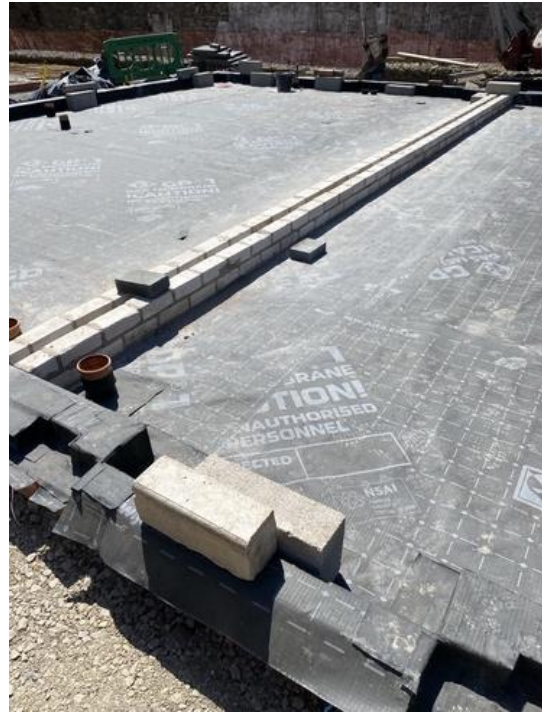
| <b>Gas Membrane Condition: Open punctures, tears, rips, stretching, Presence of debris, Repairs, Signs of weakness such as raised or sunken indentations, Protection plan in place to restrict access to lain gas membrane? IF FAIL DESCRIPTION IN ACTIONS AND PHOTOS REQUIRED</b> | | <div>Pass</div> <div> </div> <div> <p>Photo 42</p> <p>Photo 43</p> <p>Photo 44</p> <p>Photo 45</p> <p>Photo 46</p> </div> |

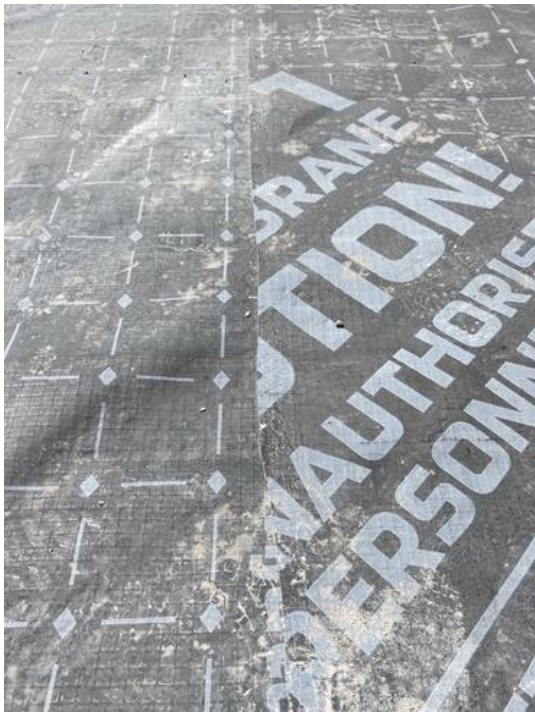
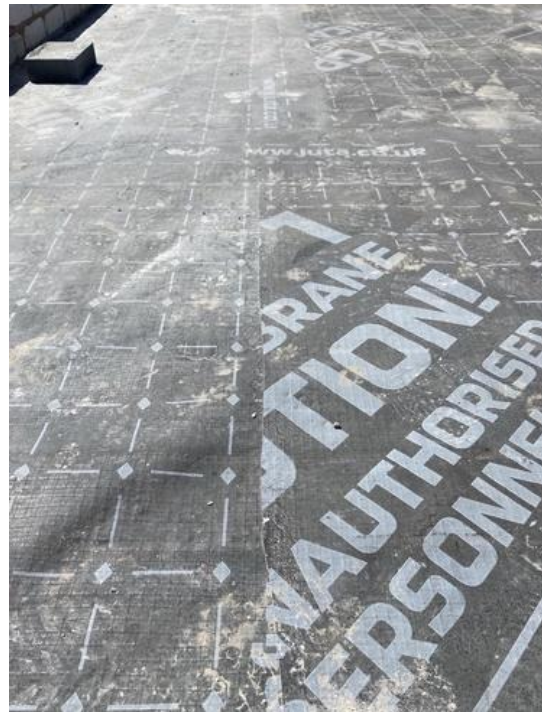
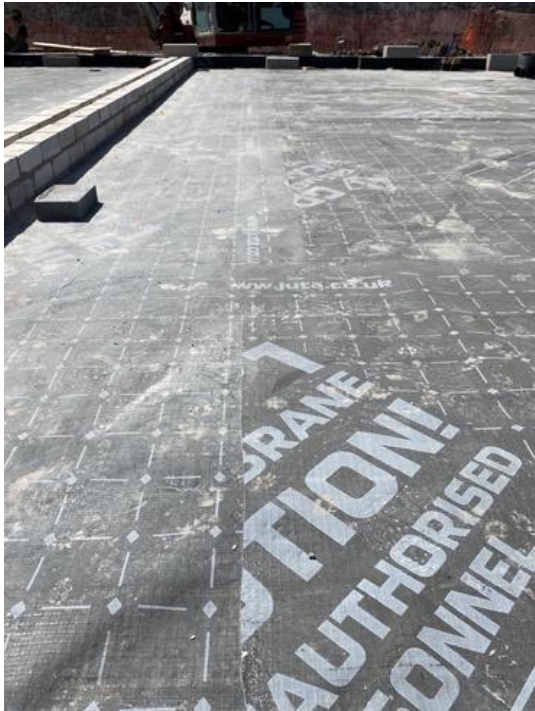
| Are welds complete? | | Yes |

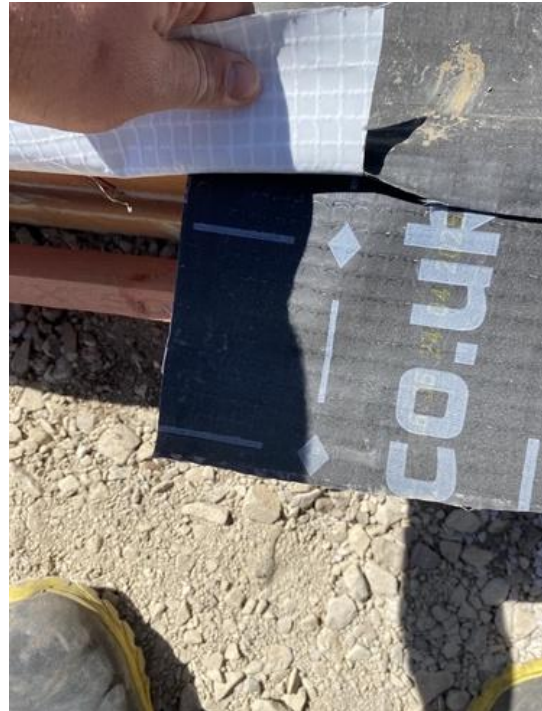
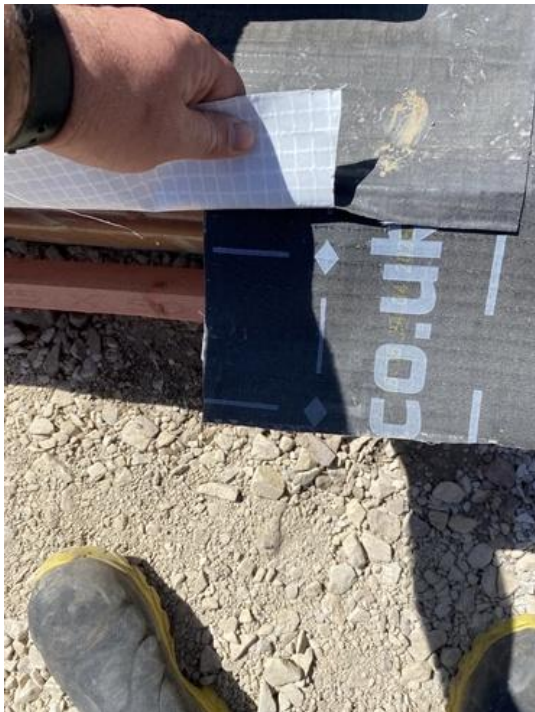
| Are Joints lapped and sealed in accordance with manufacturer's requirements/ specification? | | Yes |

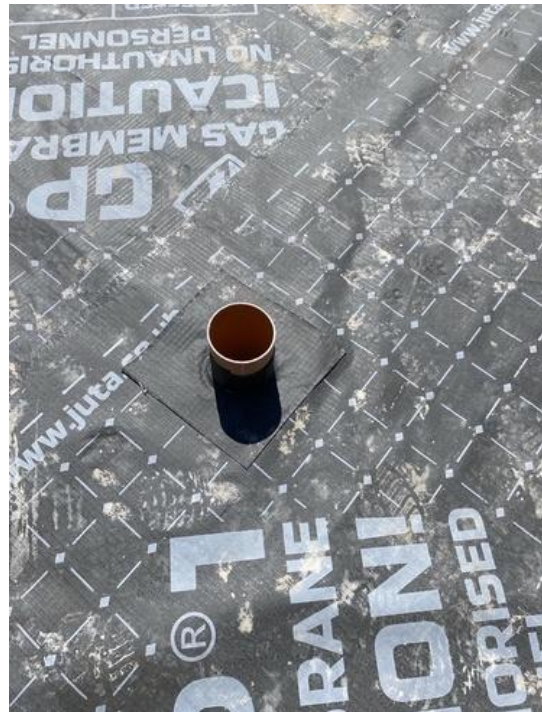
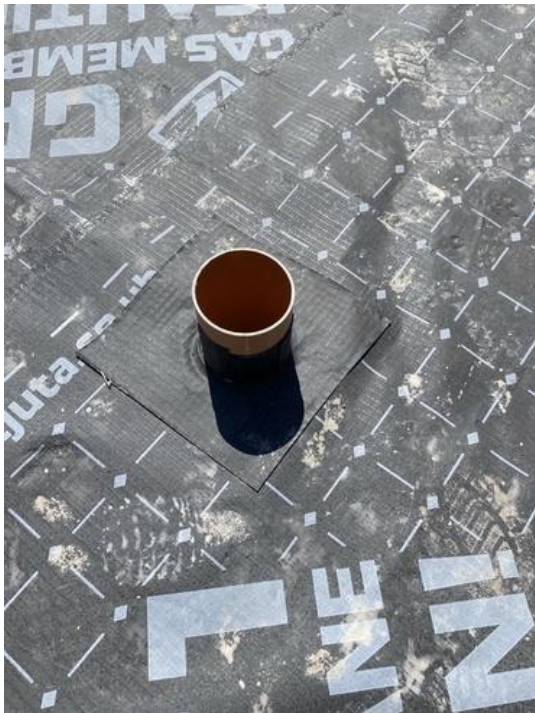
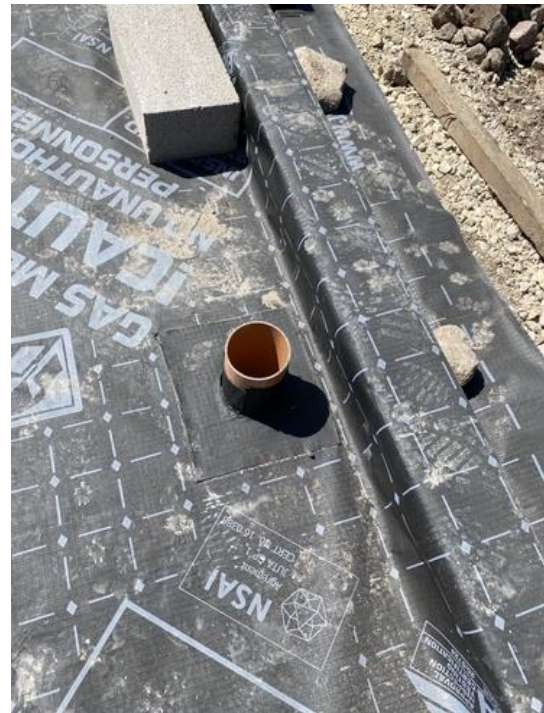
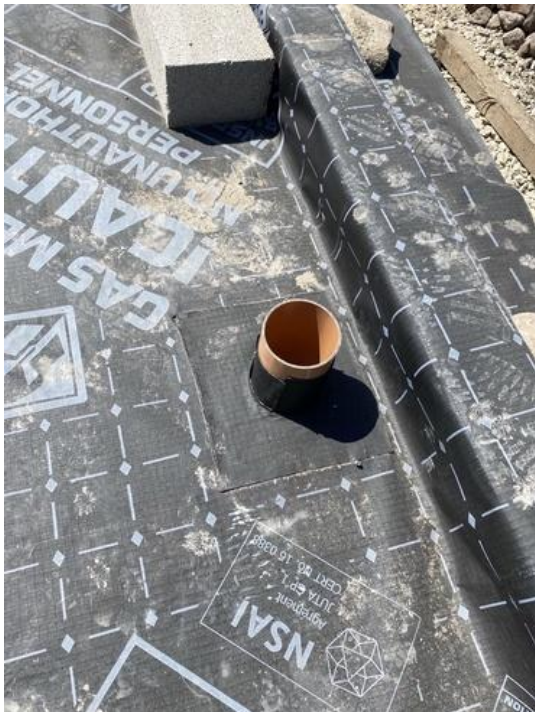
**Service entries seals: Top hats seal arrangements fixed around service entries? Use of Jubilee clips or Bitumastic Sealant**

Pass

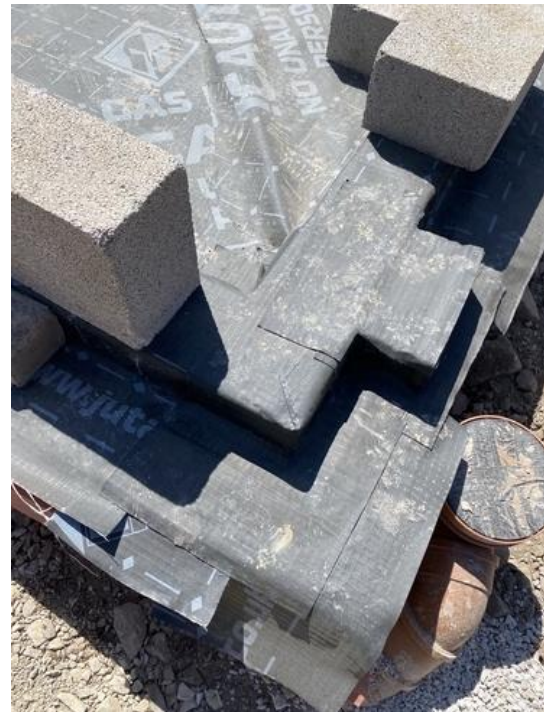
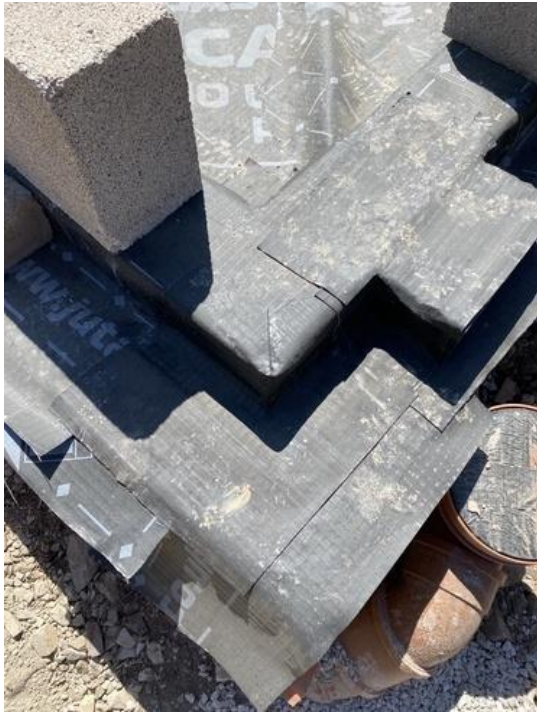
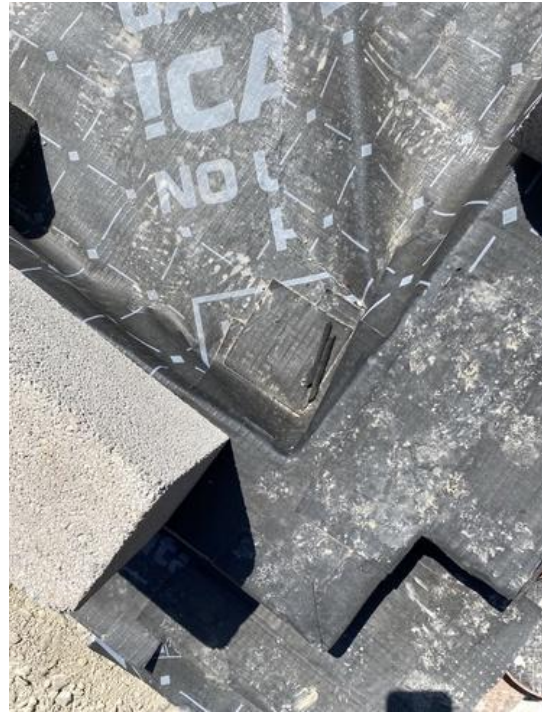
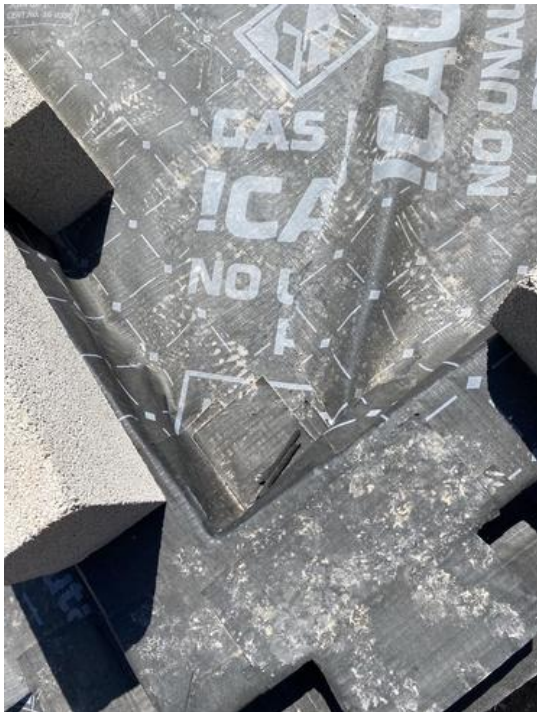
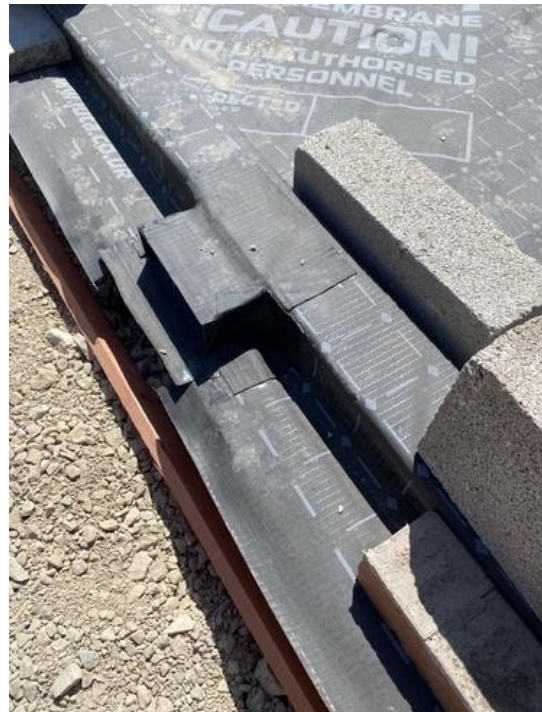
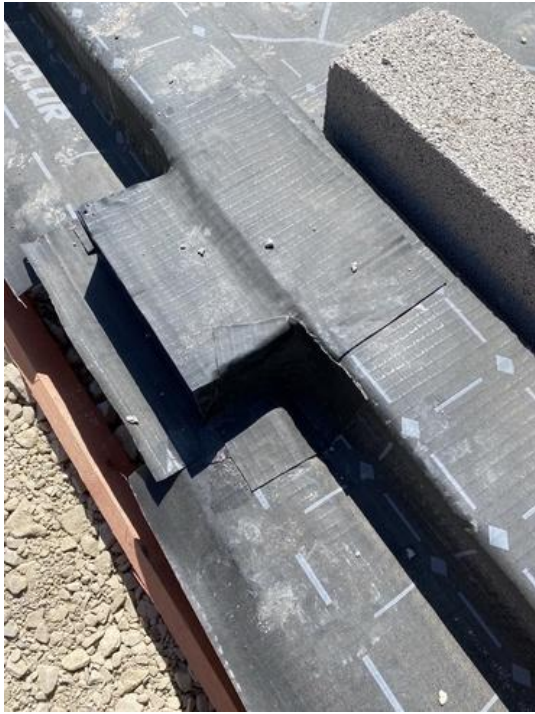
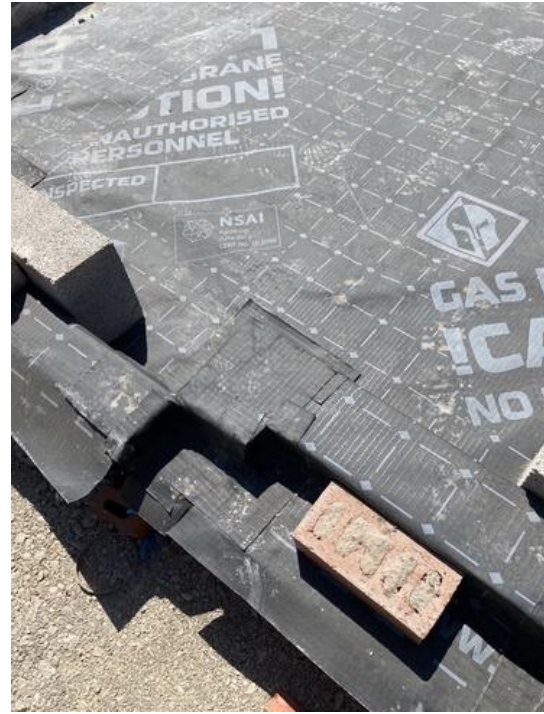
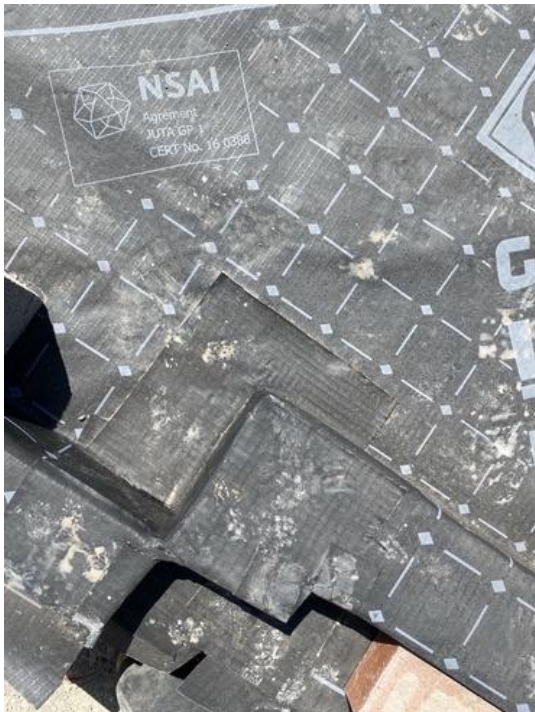
**Corners / Internal joints: Check all corners are correctly formed or contractor has used preformed corners.**

Pass

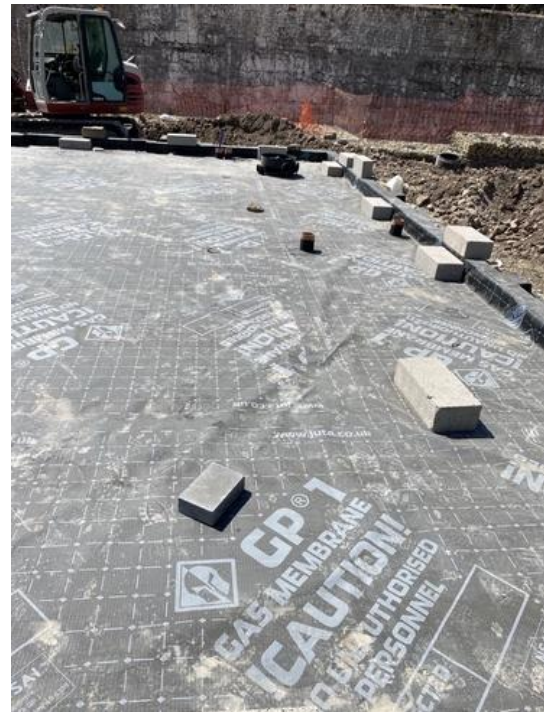
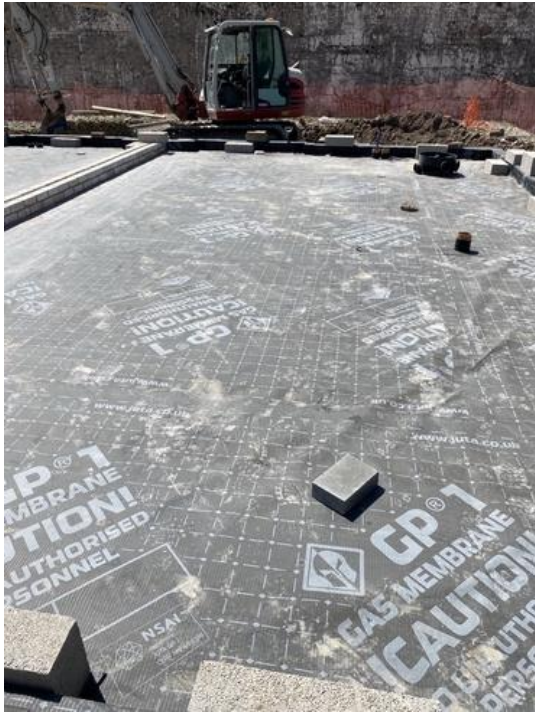
**Are folds running in line with joints? (no joints cutting across folds)**

Pass

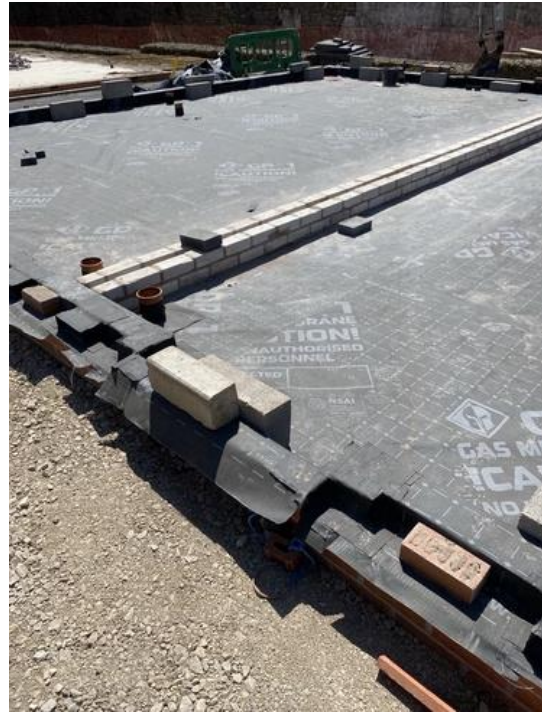
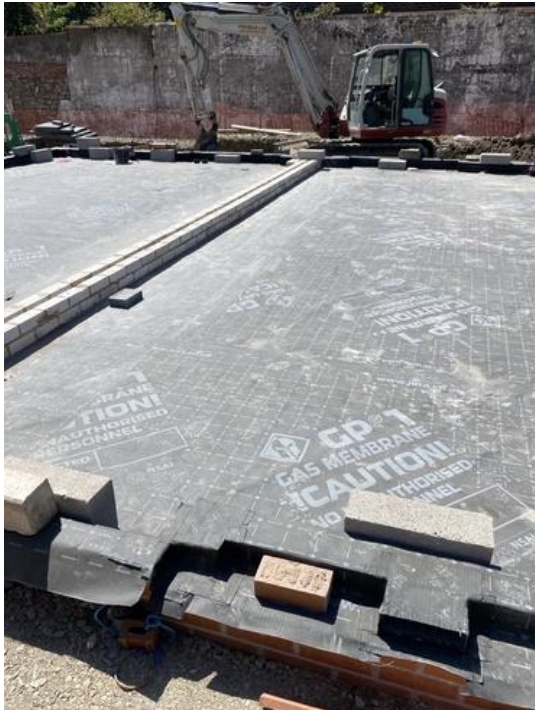
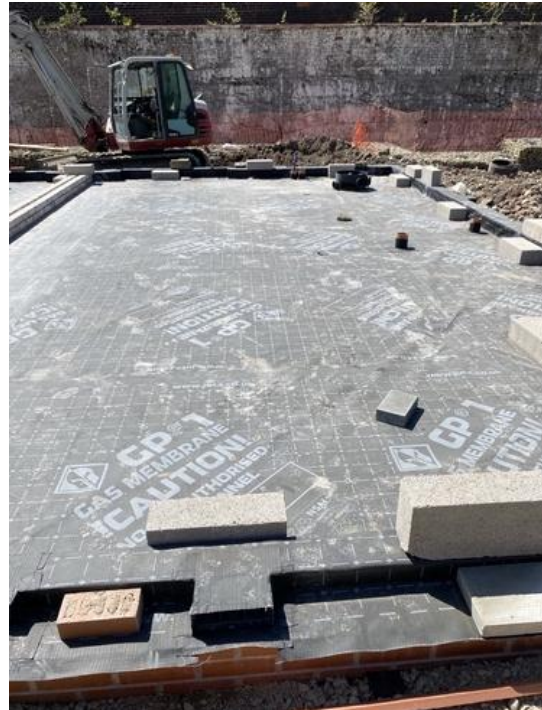
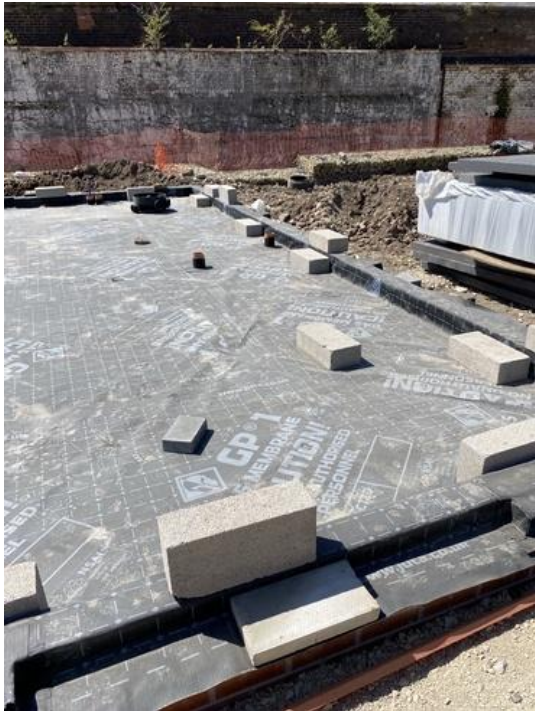
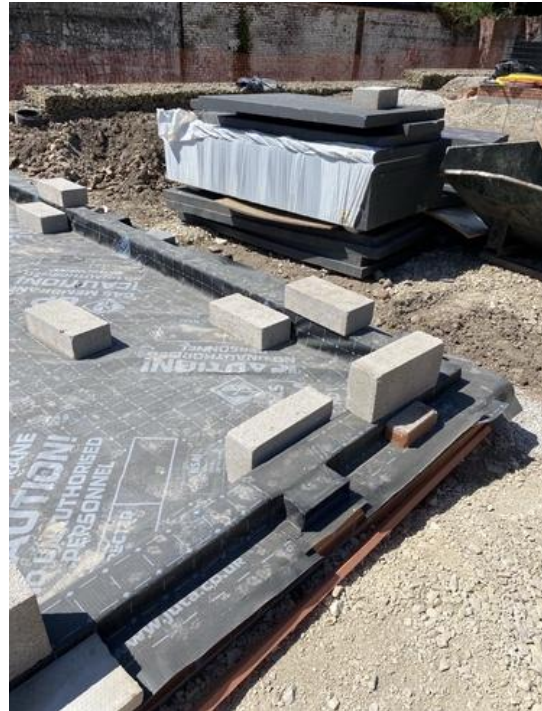
**Extent of Coverage: Is the membrane covering the entire plot? Does membrane span over outside walls?**

Yes
