Date: 2<sup>nd</sup> May 2025  
Reference: 16465-V4

## GAS MEMBRANE VALIDATION – EDENFIELD ROAD, NORDEN

| <b>Project Name:</b> | Edenfield Road, Rochdale |
| <b>Project Number:</b> | 16465 |

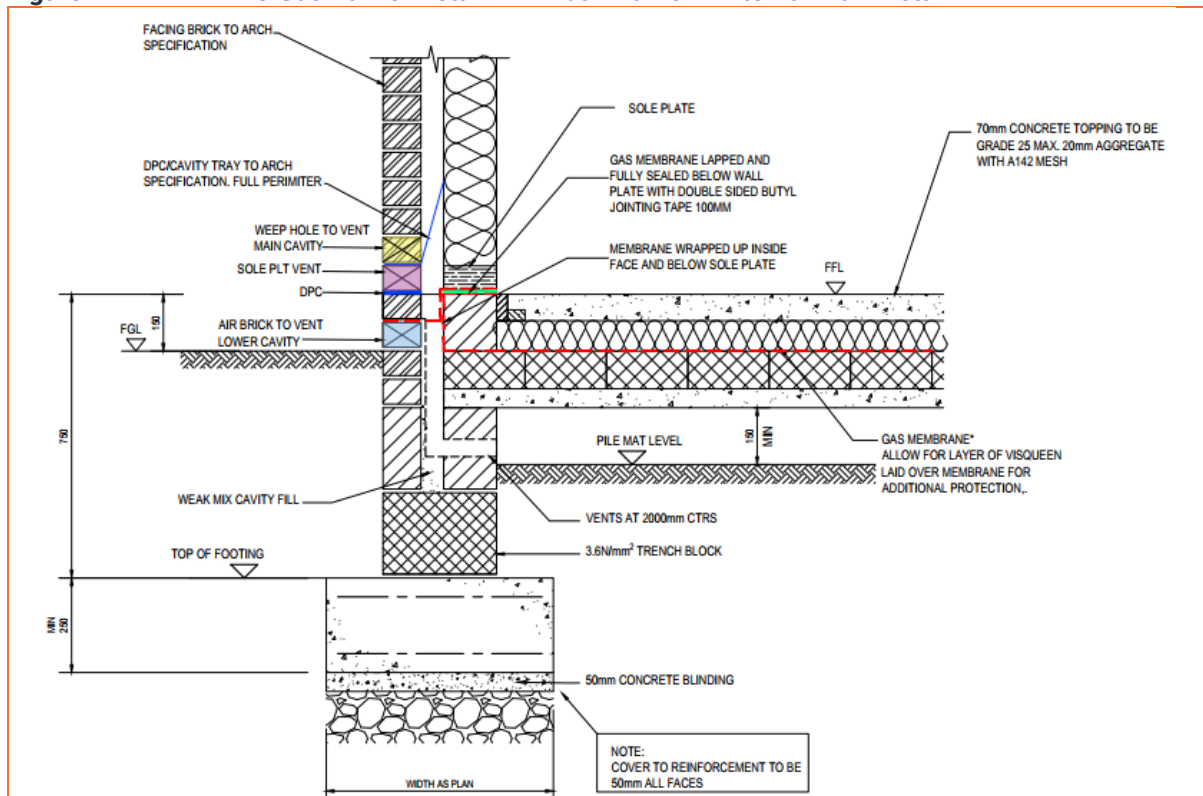
**Figure 1 NHBC Gas Barrier Detail – Timber Frame – External Wall Detail**

- EDE-AJP-XX-00-DR-S-9991, Rev P01, dated February 2025 – NHBC Gas Barrier Detail – Timber Frame – External Wall Detail – Gas membrane lapped and fully sealed below wall plate with double sided butyl jointing tape 100 mm.

For plots where the membranes had already been installed at the time of the sub-structure redesign (Plots 1-10), remedial details in line with drawing EDE-AJP-XX-00-DR-S-9991, Rev P01, dated February 2025 and Figure 1 are to be installed.

It has been confirmed as part of the validation that the membrane utilised in the plots discussed herein matches that of **Figure 1**.

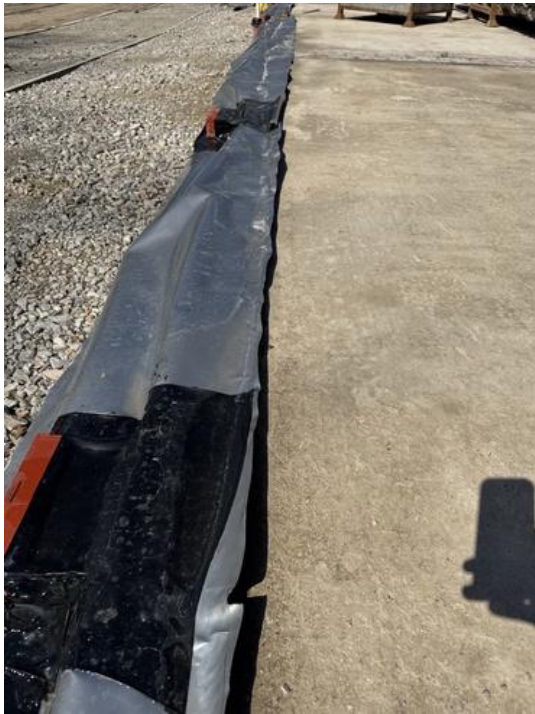
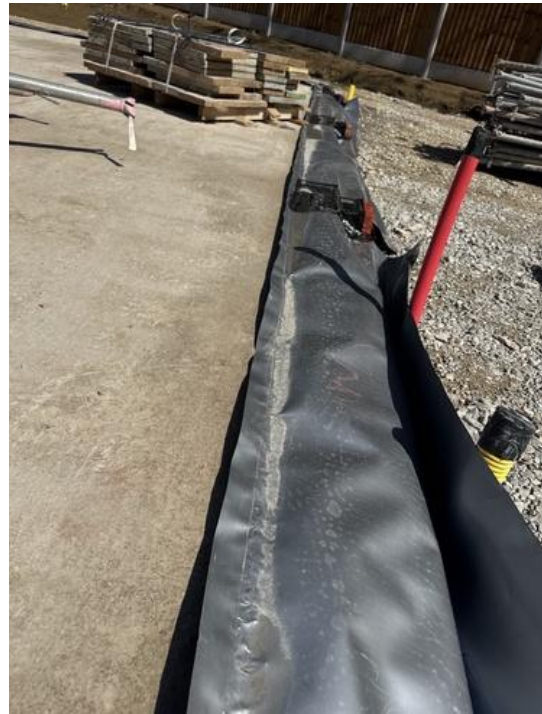
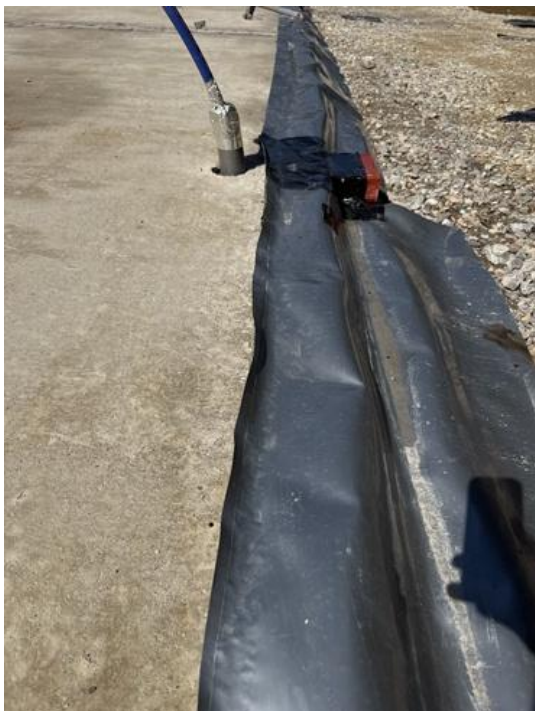
| <b>Gas Membrane Condition: Open punctures, tears, rips, stretching, Presence of debris, Repairs, Signs of weakness such as raised or sunken indentations, Protection plan in place to restrict access to laid gas membrane? IF FAIL DESCRIPTION IN ACTIONS AND PHOTOS REQUIRED</b> | Pass |
| <b>Are welds complete?</b> | Yes |

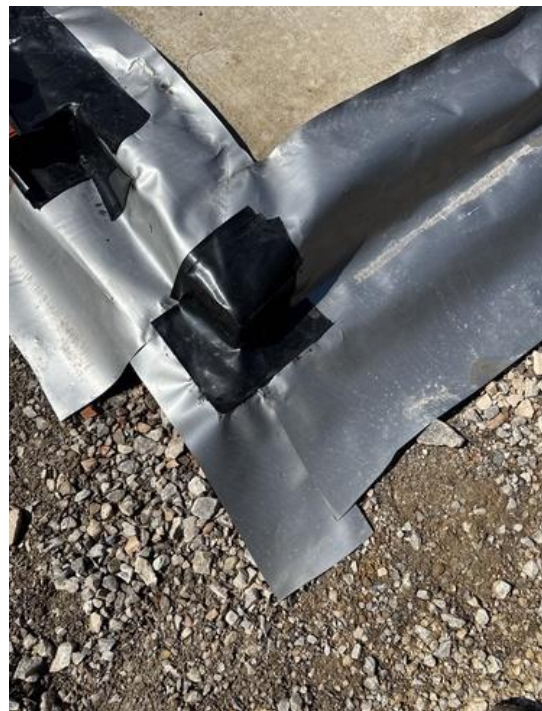
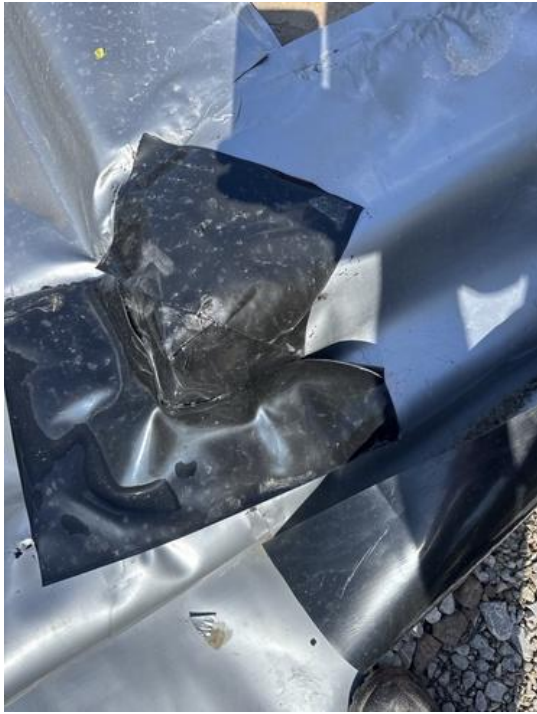
| <b>Corners / Internal joints: Check all corners are correctly formed or contractor has used preformed corners.</b> | Pass |

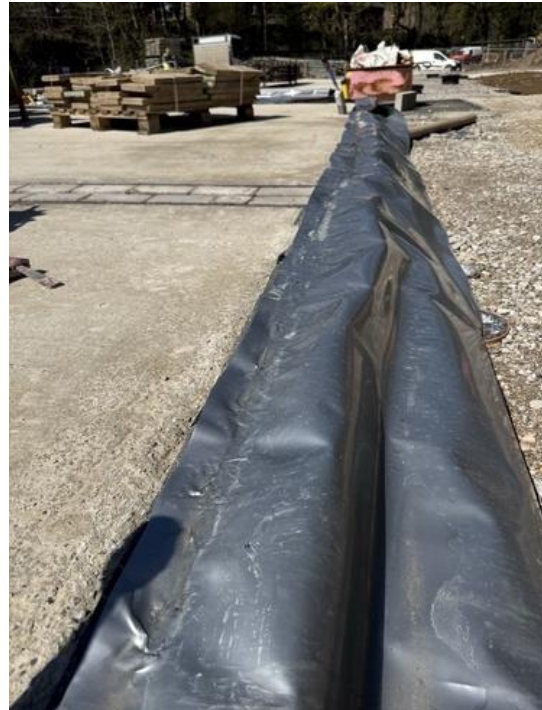
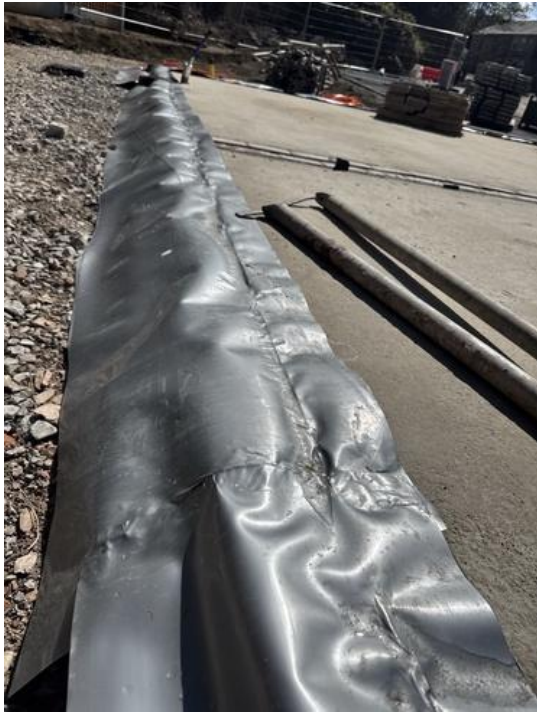
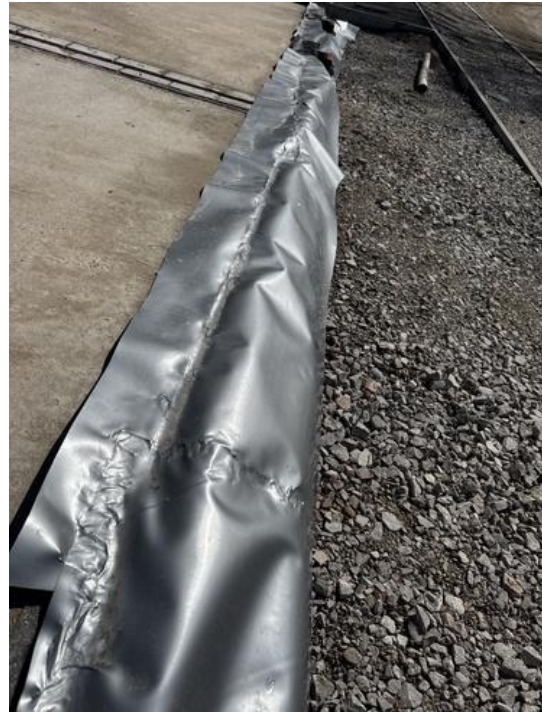
| Gas Membrane Condition: Open punctures, tears, rips, stretching, Presence of debris, Repairs, Signs of weakness such as raised or sunken indentations, Protection plan in place to restrict access to lain gas membrane? IF FAIL DESCRIPTION IN ACTIONS AND PHOTOS REQUIRED | Pass |
| Are welds complete? | Yes |

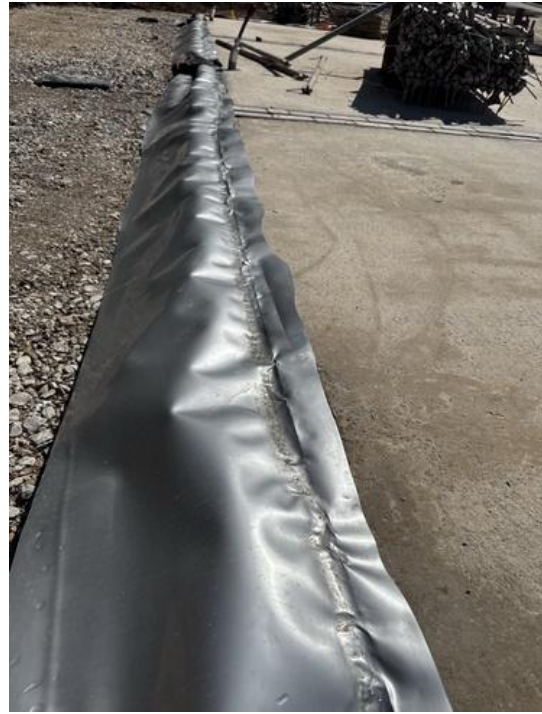
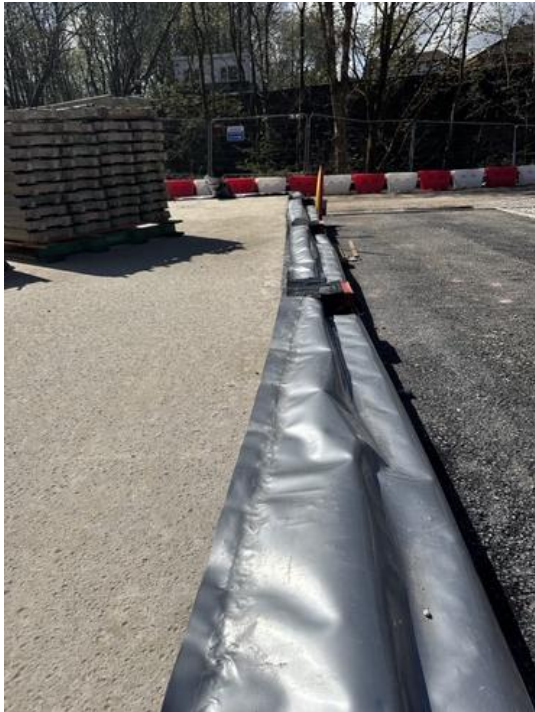
| Gas Membrane Condition: Open punctures, tears, rips, stretching, Presence of debris, Repairs, Signs of weakness such as raised or sunken indentations, Protection plan in place to restrict access to lain gas membrane? IF FAIL DESCRIPTION IN ACTIONS AND PHOTOS REQUIRED | Pass | |
| Are welds complete? | Yes | |

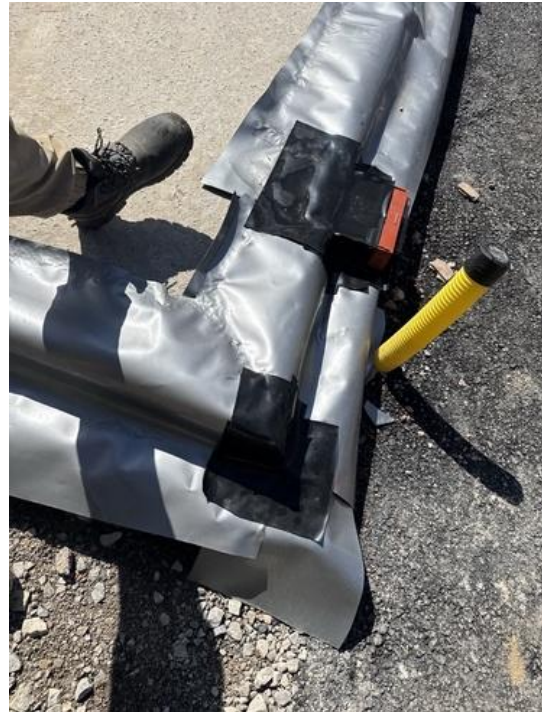
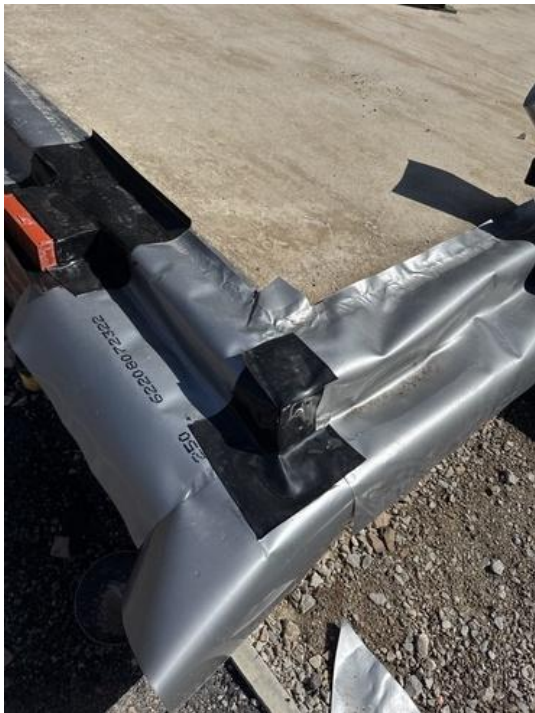
| Service entries seals: Top hats seal arrangements fixed around service entries? Use of Jubilee clips or Bitumastic Sealant | Pass | |
| Corners / Internal joints: Check all corners are correctly formed or contractor has used preformed corners. | Pass | |

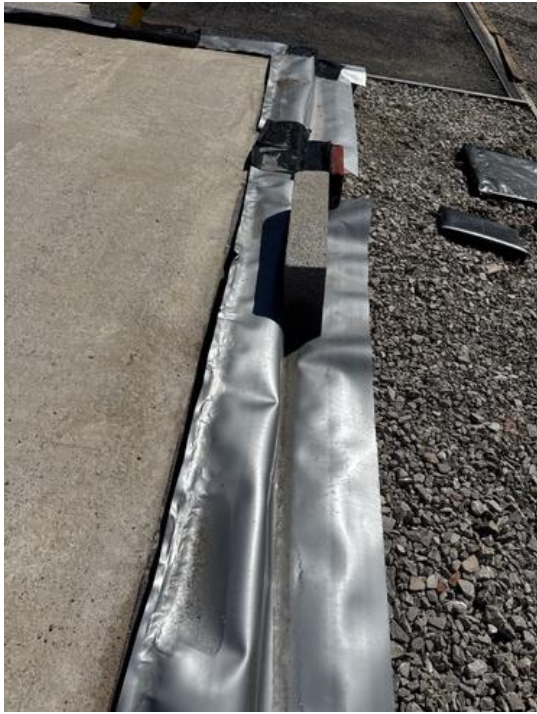
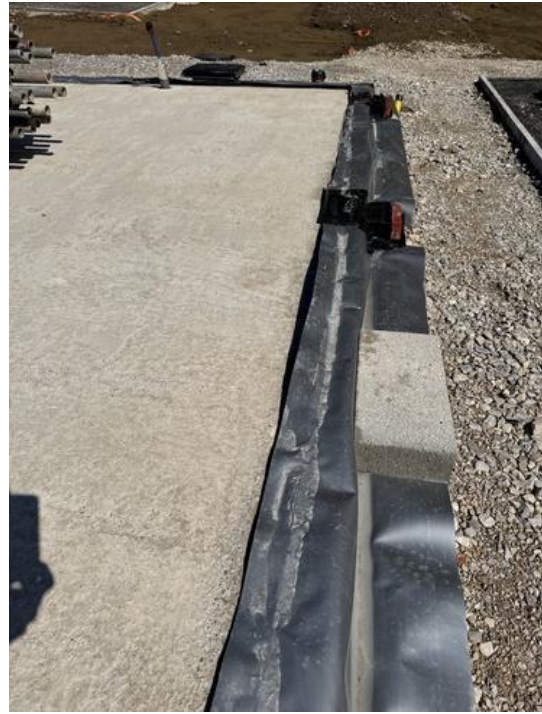
| Gas Membrane Condition: Open punctures, tears, rips, stretching, Presence of debris, Repairs, Signs of weakness such as raised or sunken indentations, Protection plan in place to restrict access to lain gas membrane? IF FAIL DESCRIPTION IN ACTIONS AND PHOTOS REQUIRED | Pass | |
| Are welds complete? | Yes | |

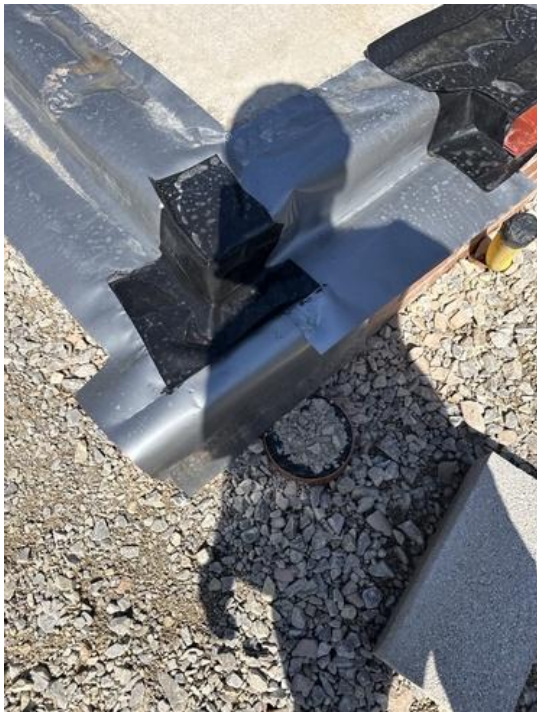
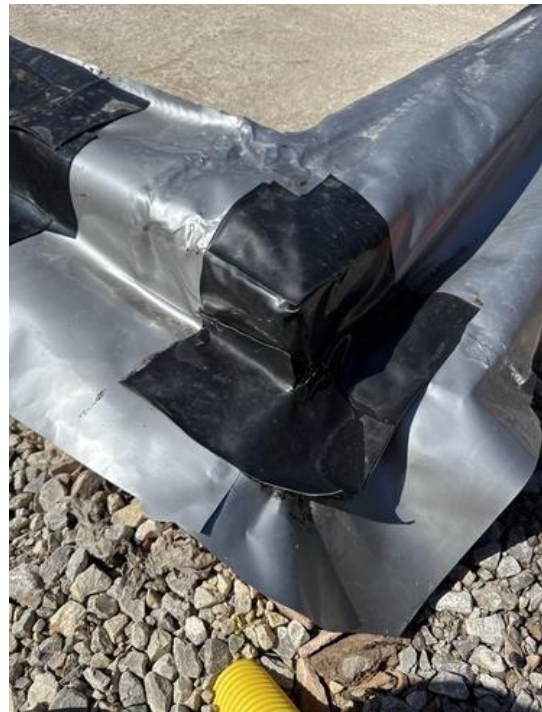
| Corners / Internal joints: Check all corners are correctly formed or contractor has used preformed corners. | Pass | |

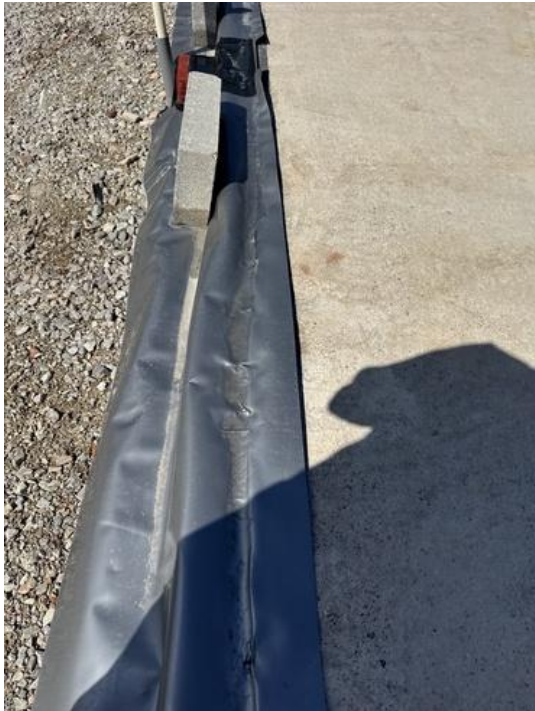
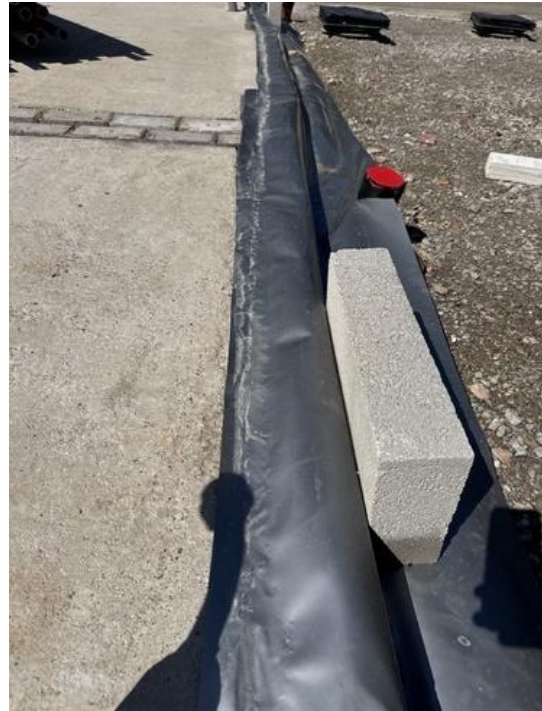
| Gas Membrane Condition: Open punctures, tears, rips, stretching, Presence of debris, Repairs, Signs of weakness such as raised or sunken indentations, Protection plan in place to restrict access to lain gas membrane? IF FAIL DESCRIPTION IN ACTIONS AND PHOTOS REQUIRED | Pass | |
| Are welds complete? | Yes | |
