Date: 28<sup>th</sup> May 2025  
Reference: 16465-V8

## GAS MEMBRANE VALIDATION – EDENFIELD ROAD, NORDEN

| <b>Project Name:</b> | Edenfield Road, Rochdale |
| <b>Project Number:</b> | 16465 |

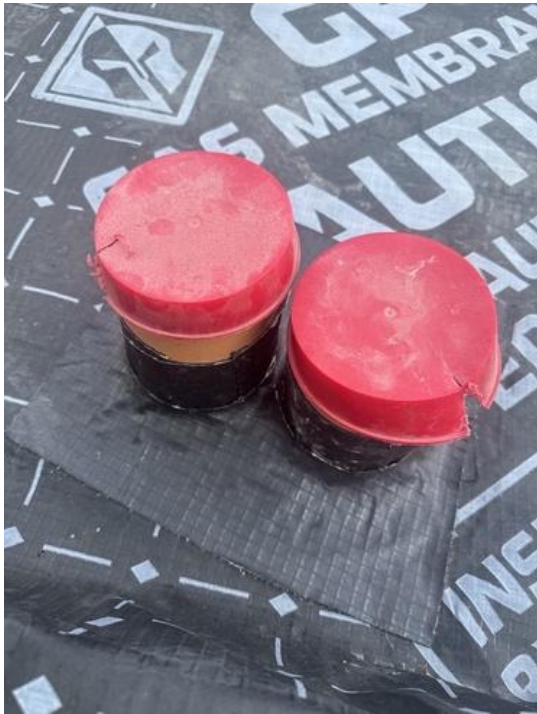
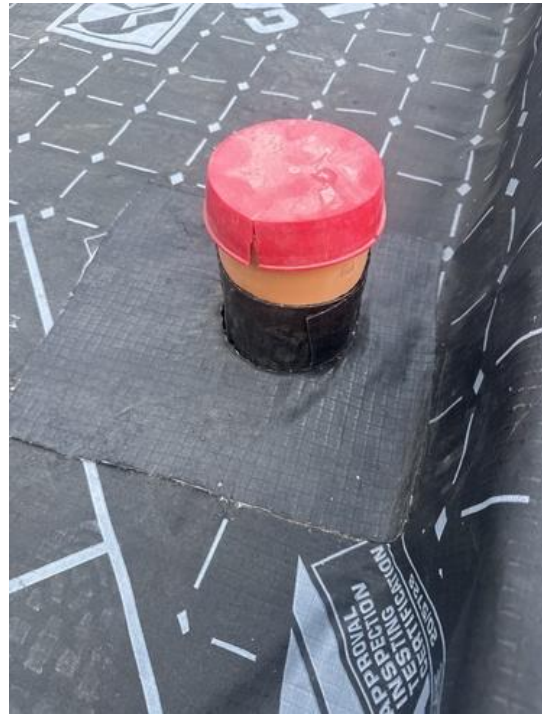
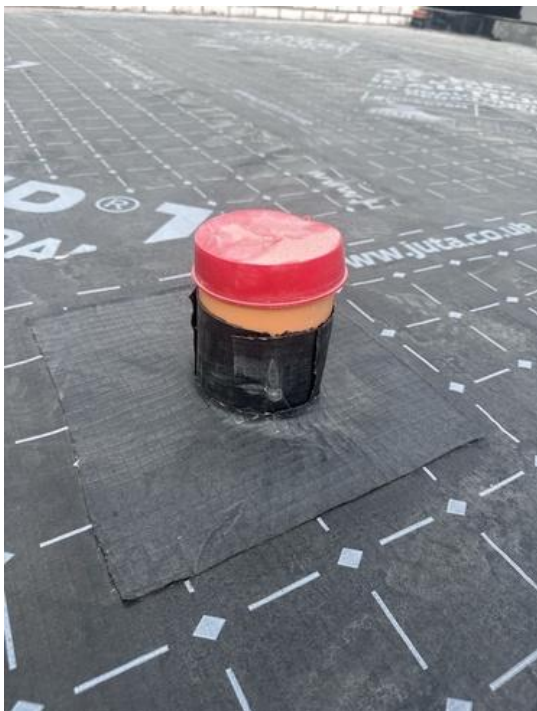
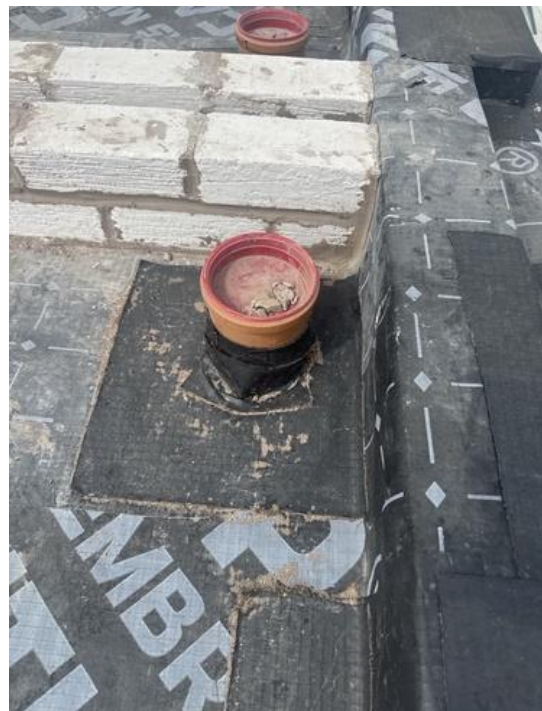
| <b>Service entries seals: Top hats seal arrangements fixed around service entries? Use of Jubilee clips or Bitumastic Sealant</b> | Pass |

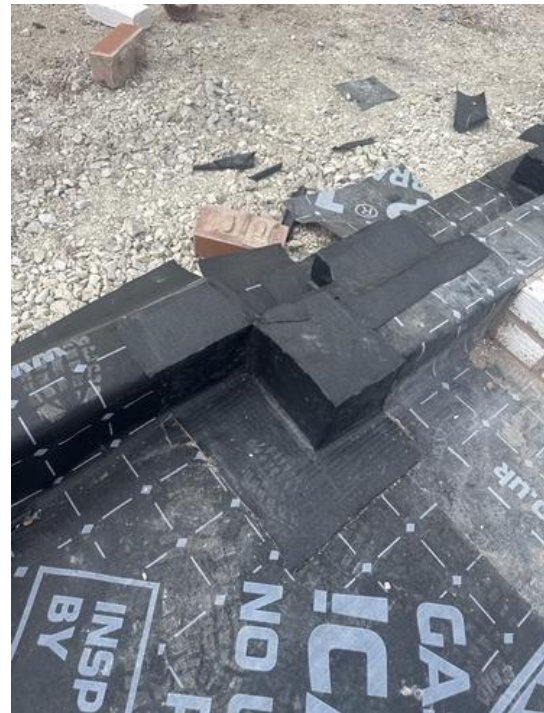
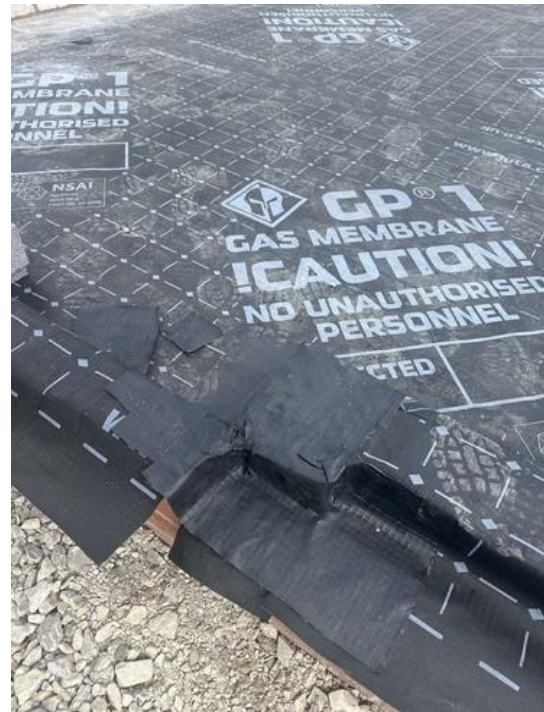
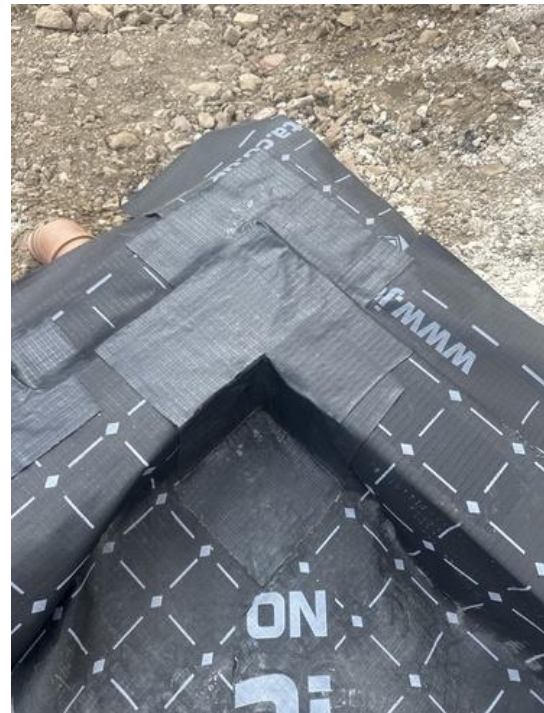
| <b>Corners / Internal joints: Check all corners are correctly formed or contractor has used preformed corners.</b> | Pass |

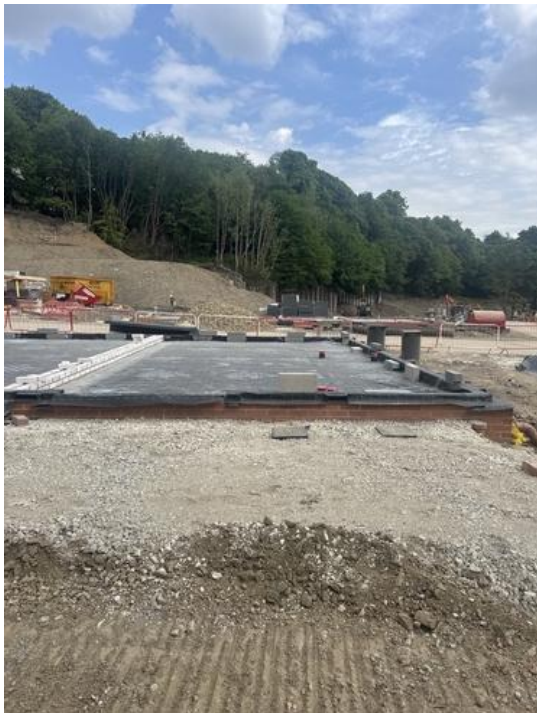
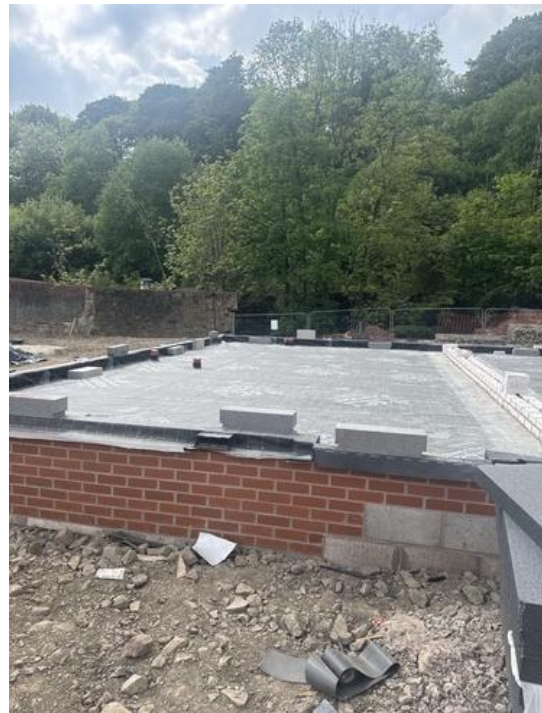
**Extent of Coverage: Is the membrane covering the entire plot? Does membrane span over outside walls?**

Yes

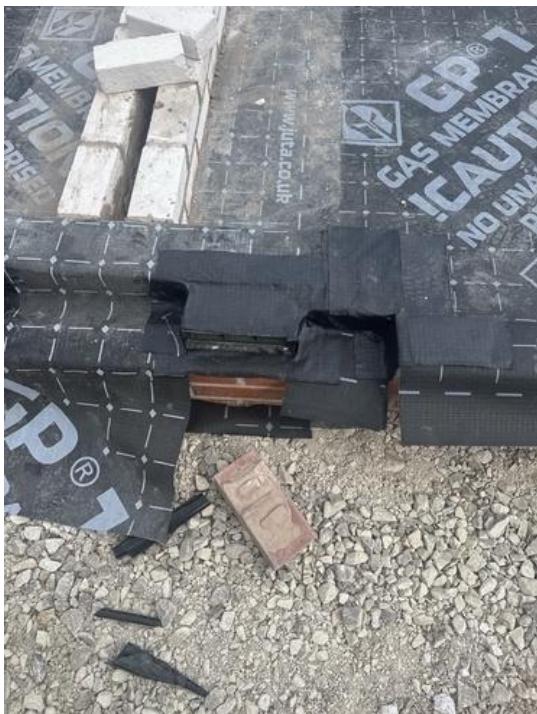
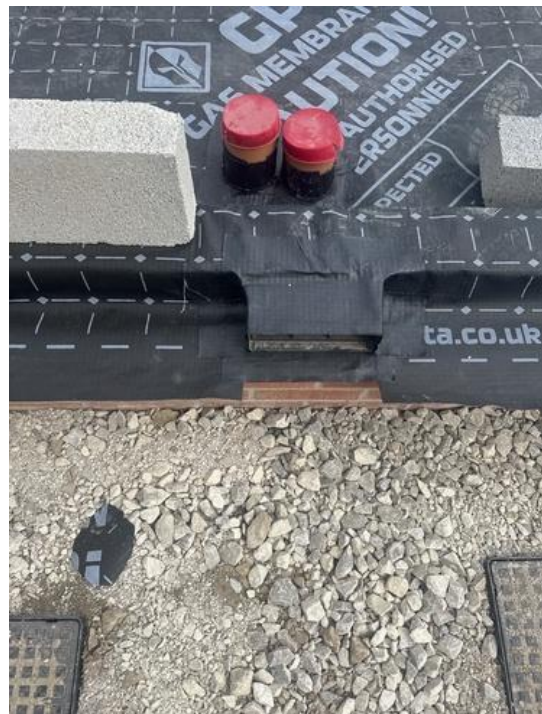
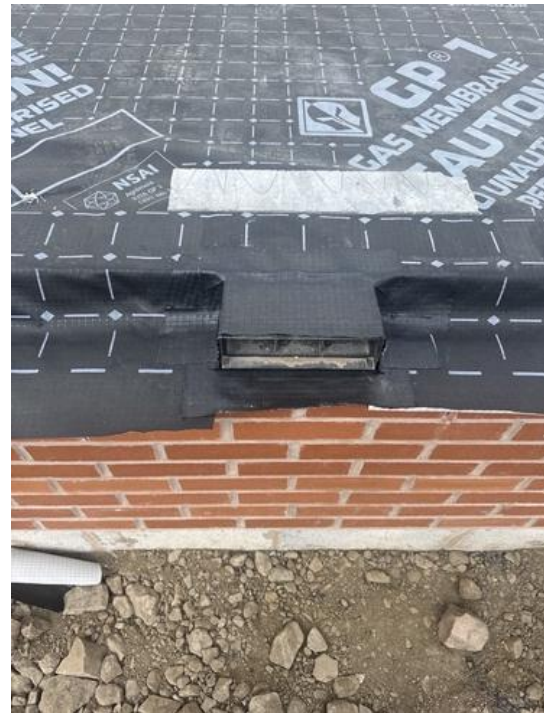
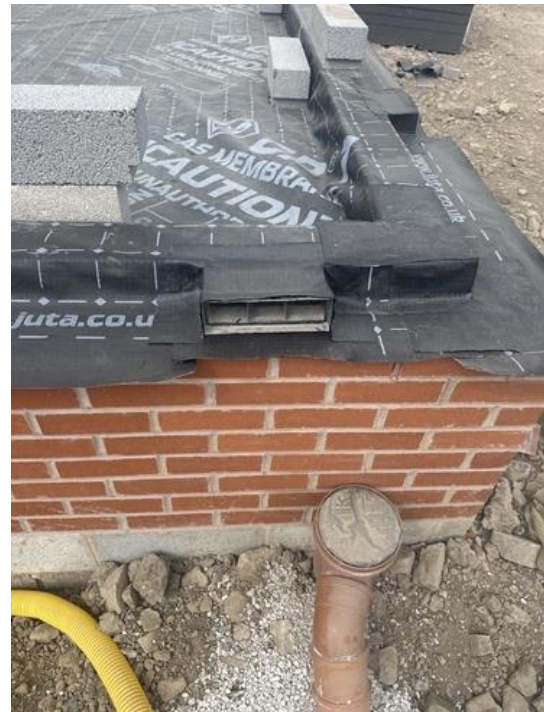
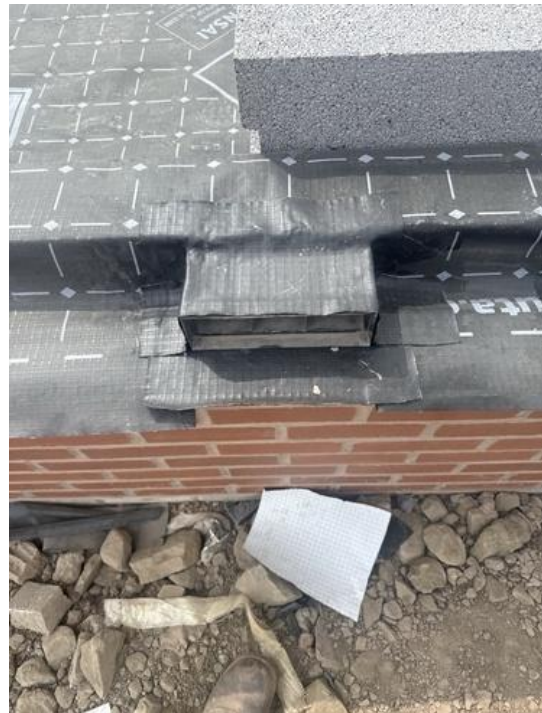
**External Wall Air bricks: Numbers, size. positions as design drawing? (Minimum of 3 walls)**

Pass

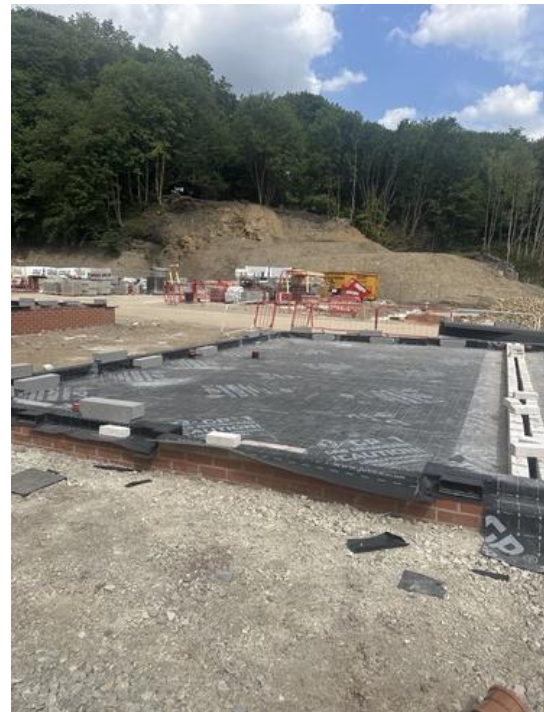
Photo 40

**Extent of Coverage: Is the membrane covering the entire plot? Does membrane span over outside walls?**

Yes

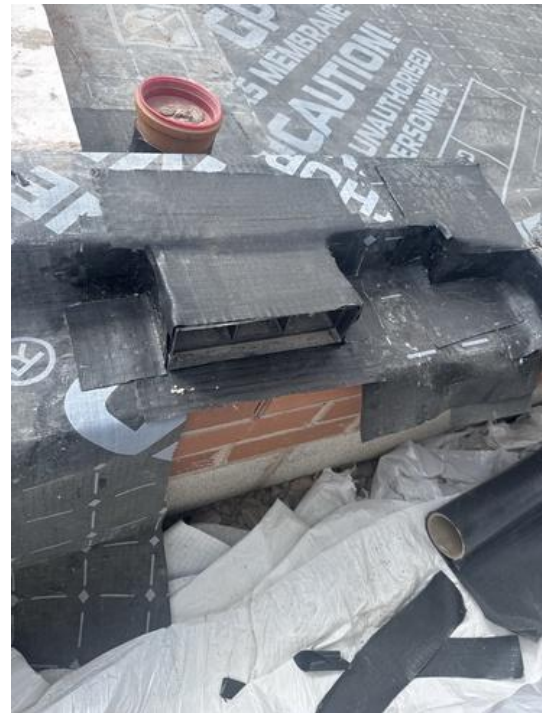
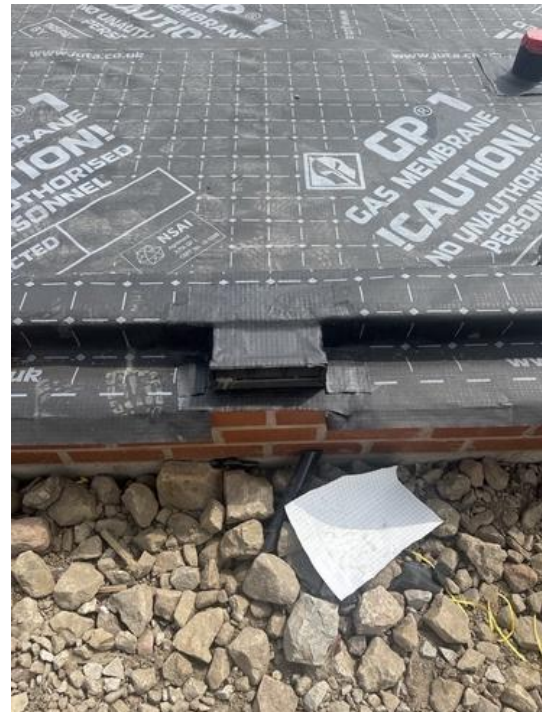
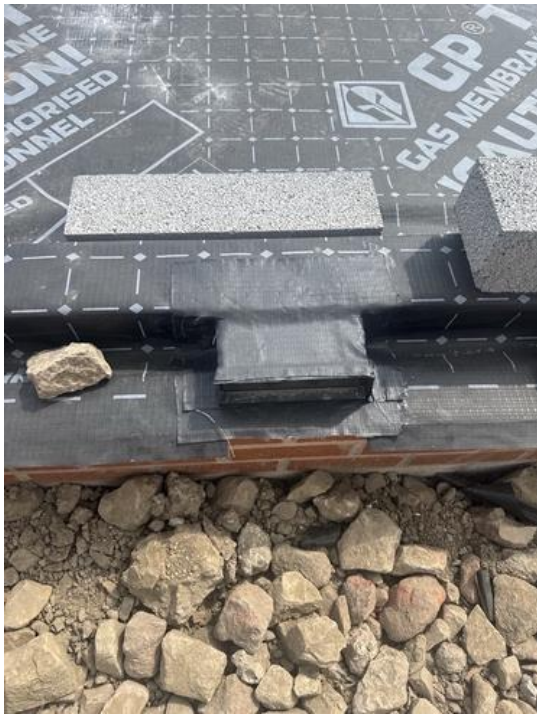
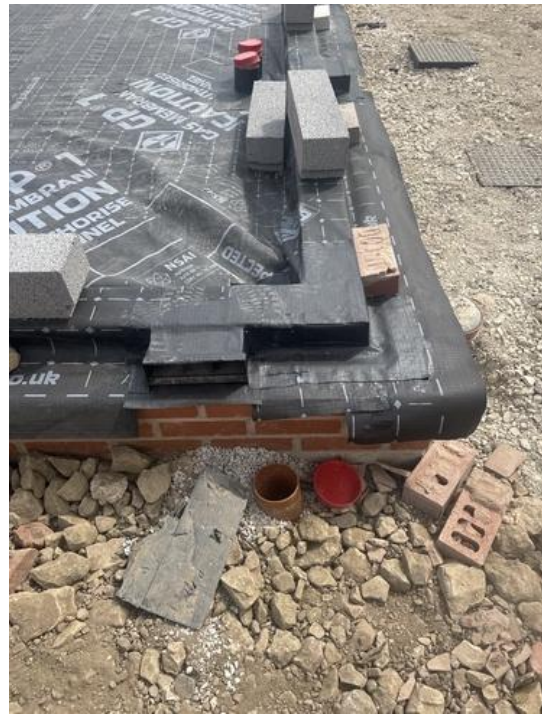
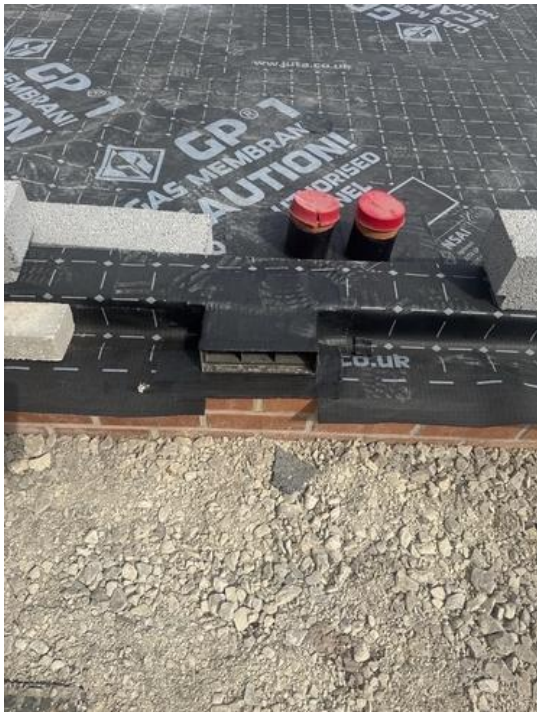
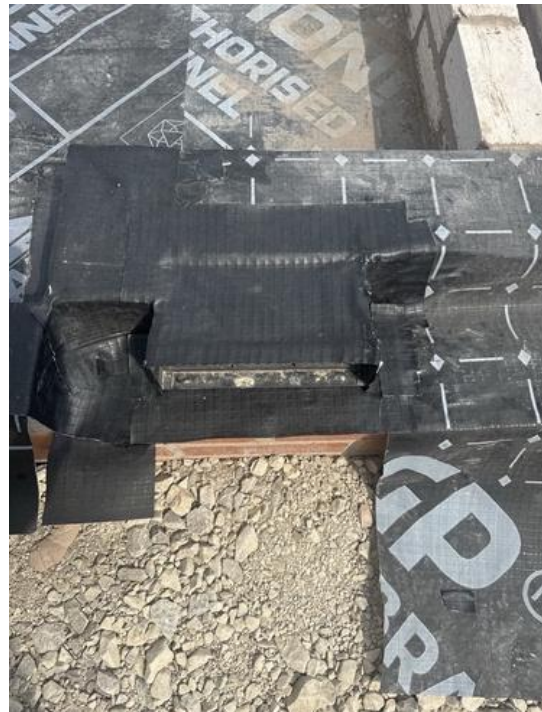
**External Wall Air bricks: Numbers, size. positions as design drawing? (Minimum of 3 walls)**

Pass

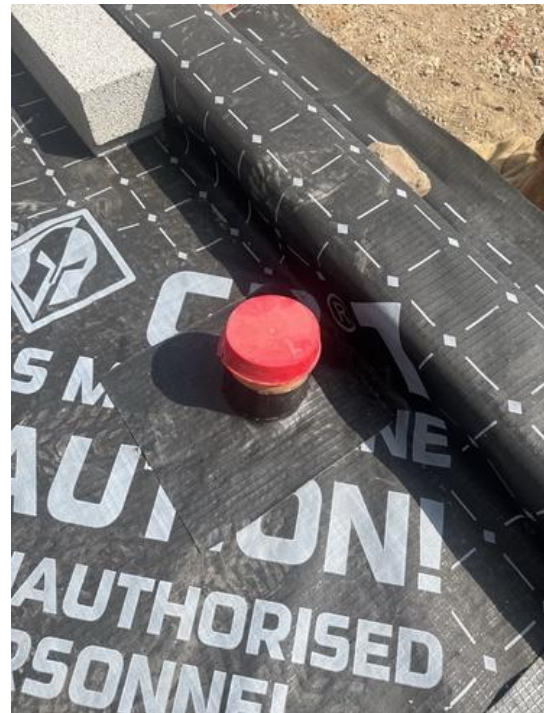
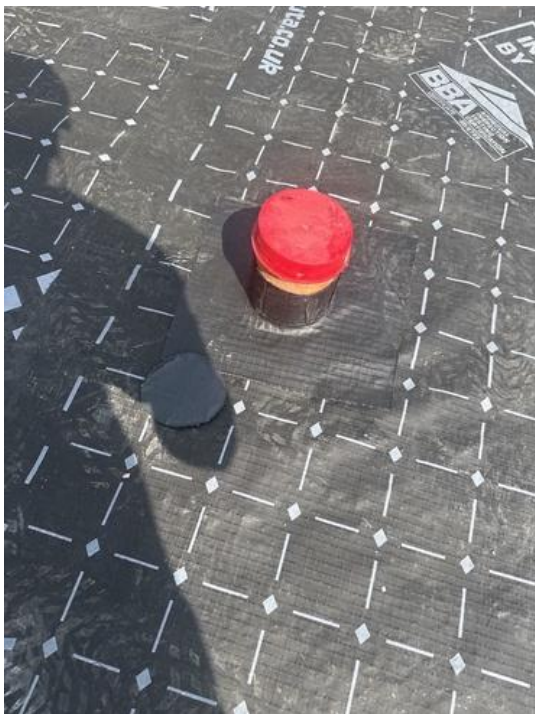
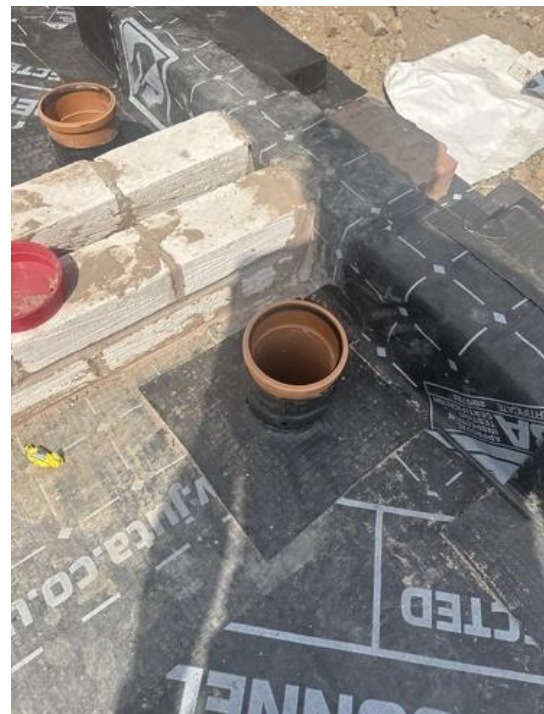
| Service entries seals: Top hats seal arrangements fixed around service entries? Use of Jubilee clips or Bitumastic Sealant | Pass | |

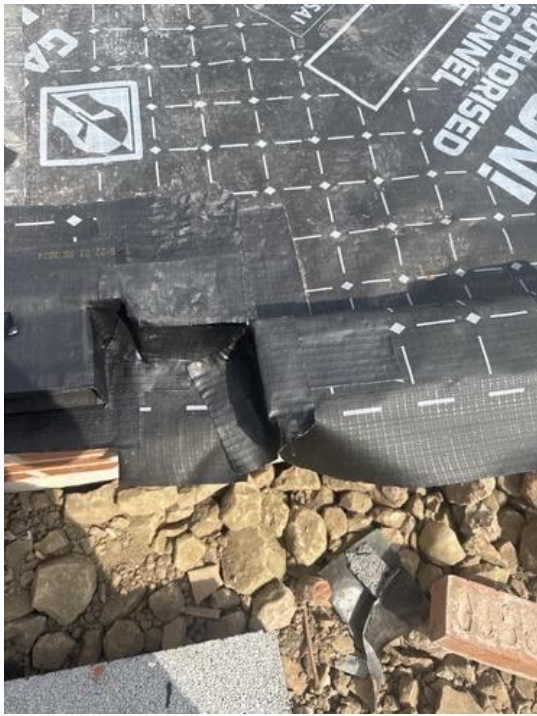
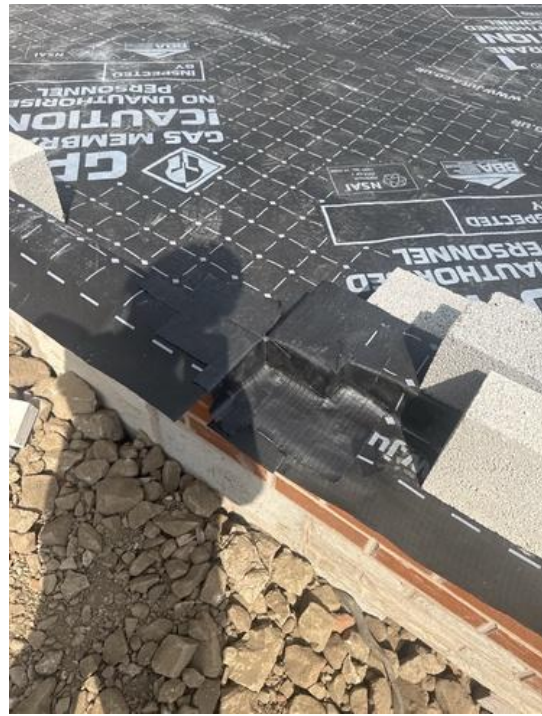
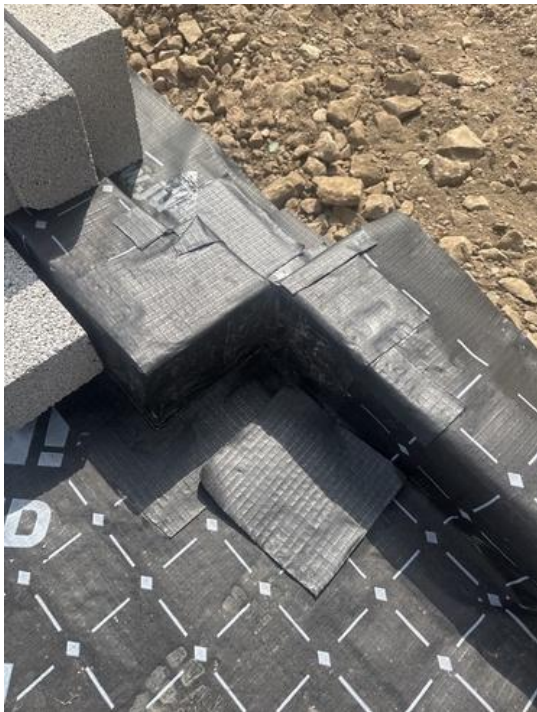
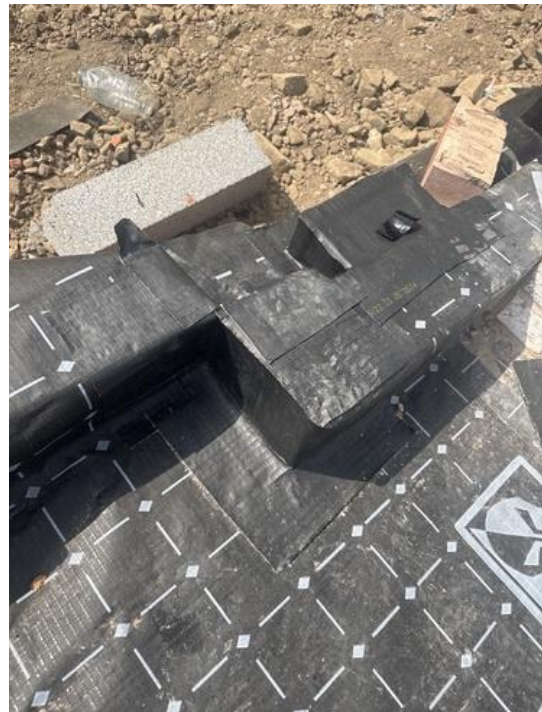
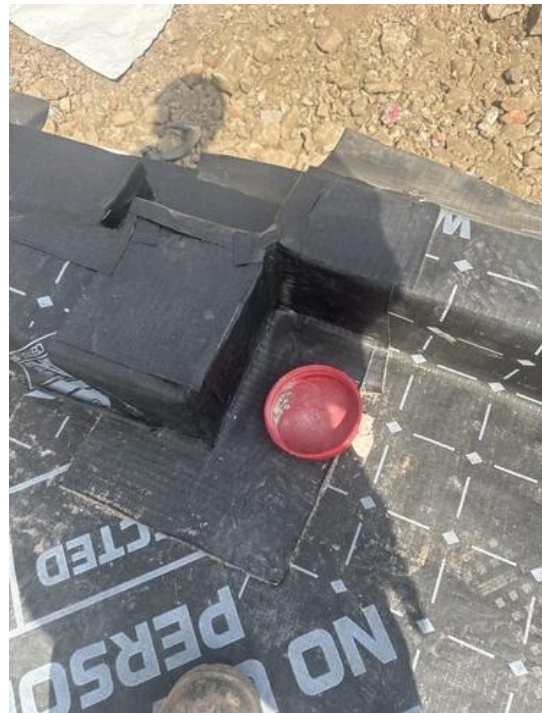
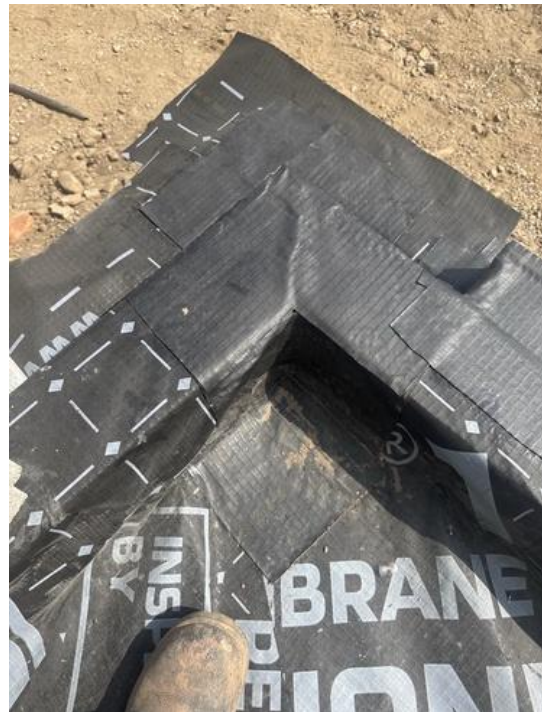
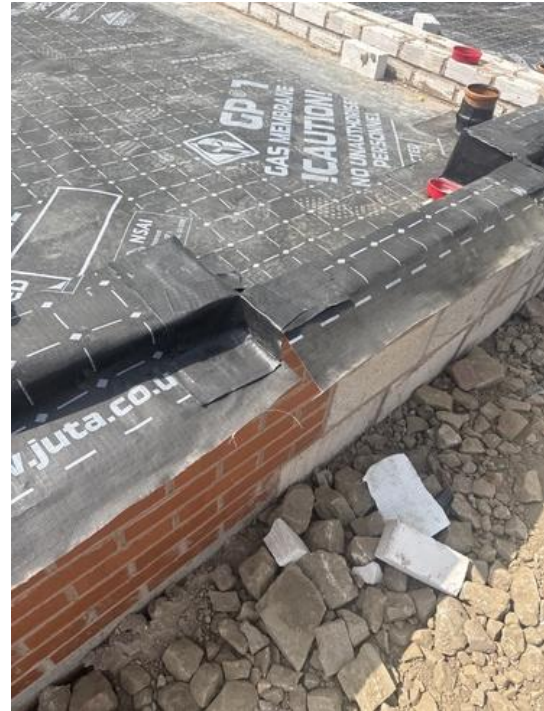
| Corners / Internal joints: Check all corners are correctly formed or contractor has used preformed corners. | Pass | |

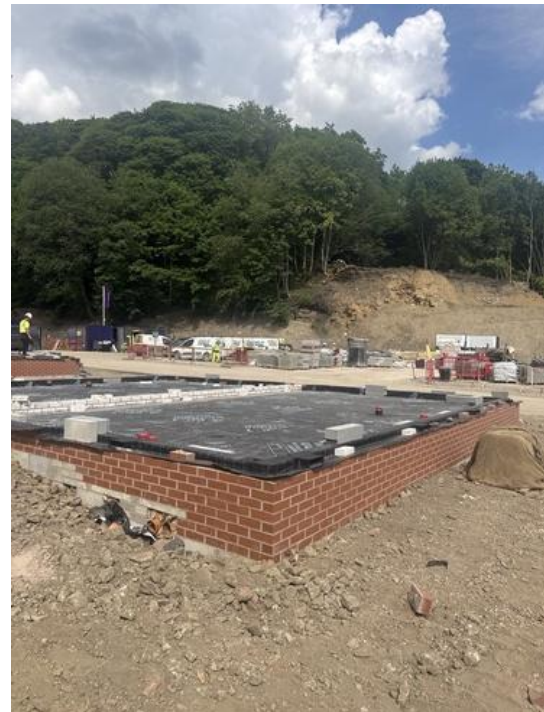
Photo 64

**Extent of Coverage: Is the membrane covering the entire plot? Does membrane span over outside walls?**

Yes

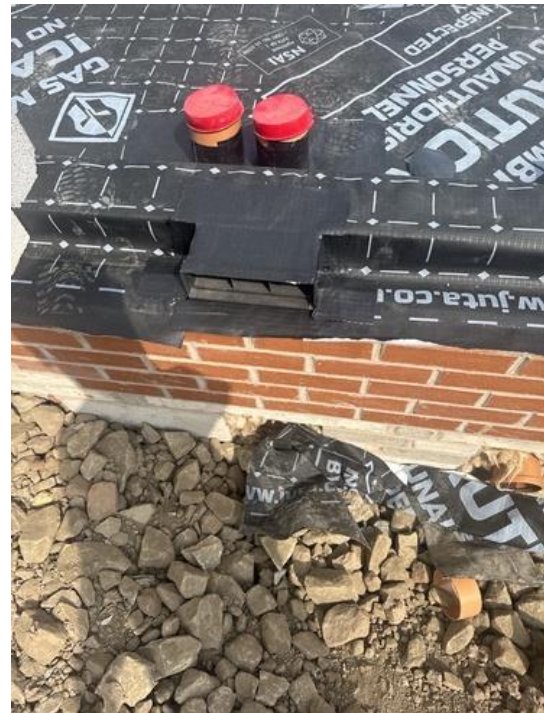
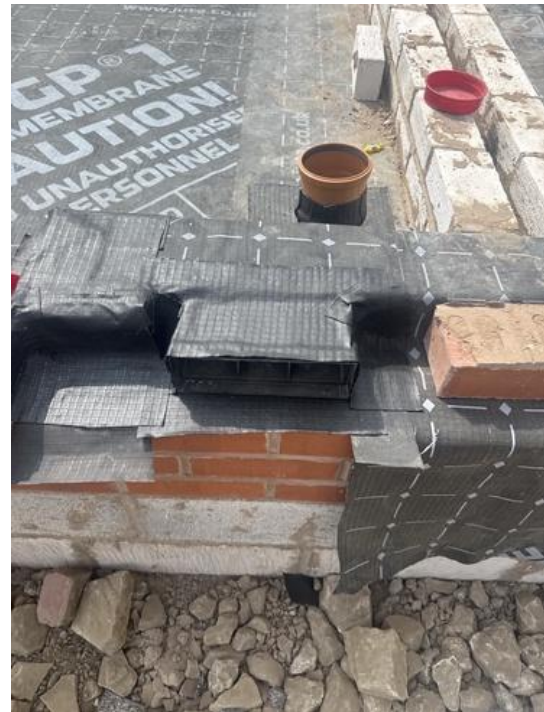
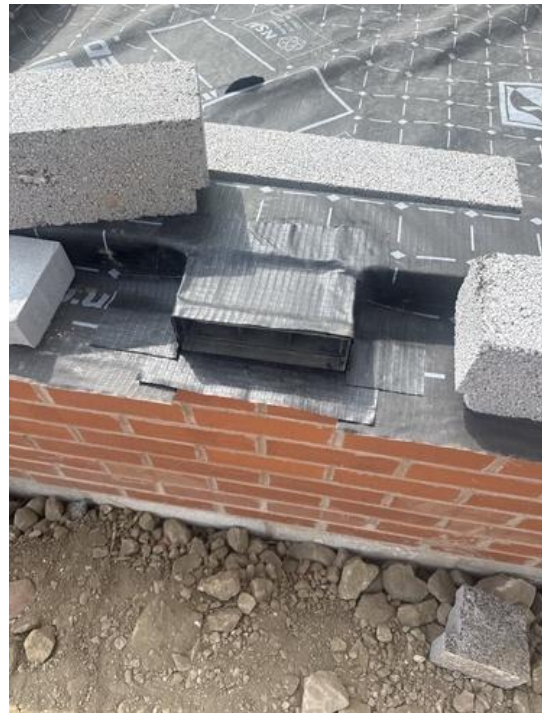
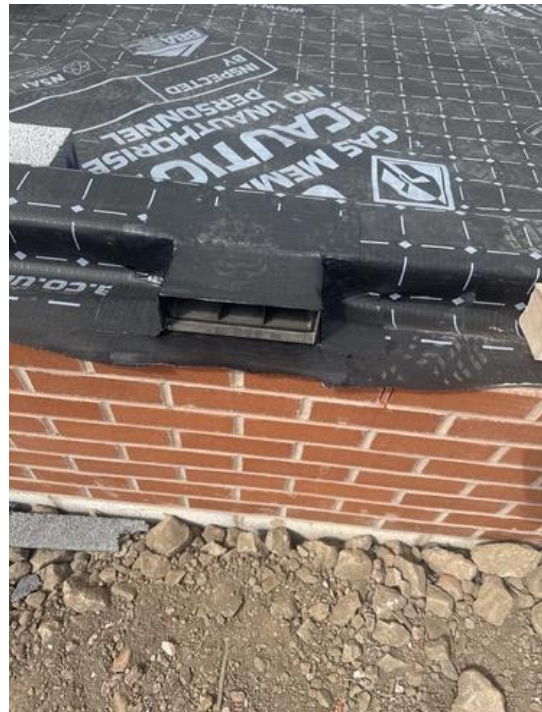
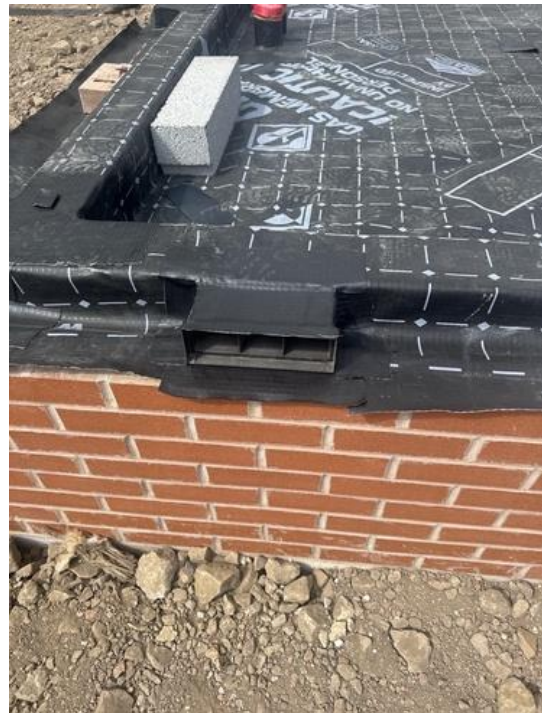
**External Wall Air bricks: Numbers, size. positions as design drawing? (Minimum of 3 walls)**

Pass

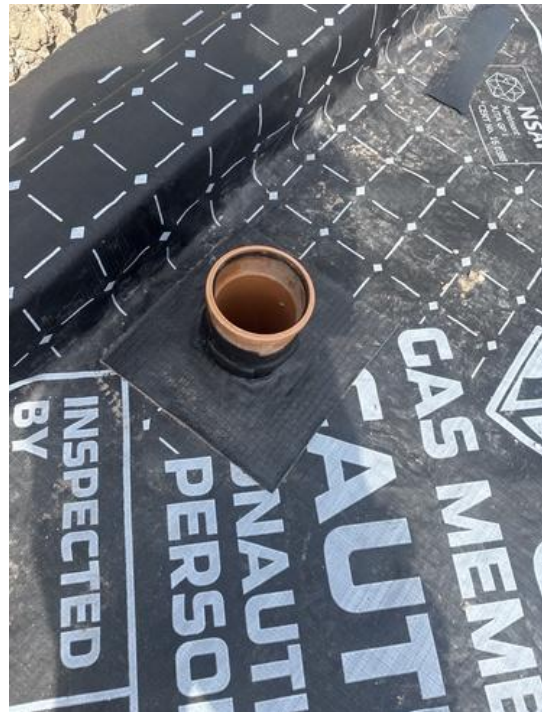
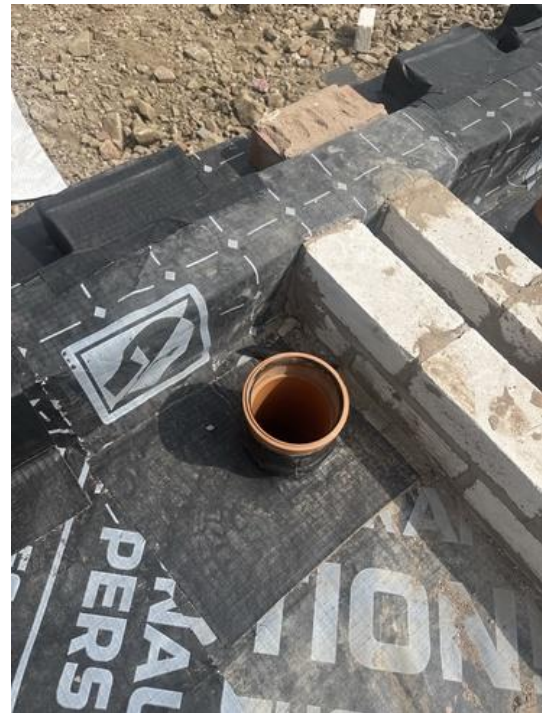
| Service entries seals: Top hats seal arrangements fixed around service entries? Use of Jubilee clips or Bitumastic Sealant | Pass | |

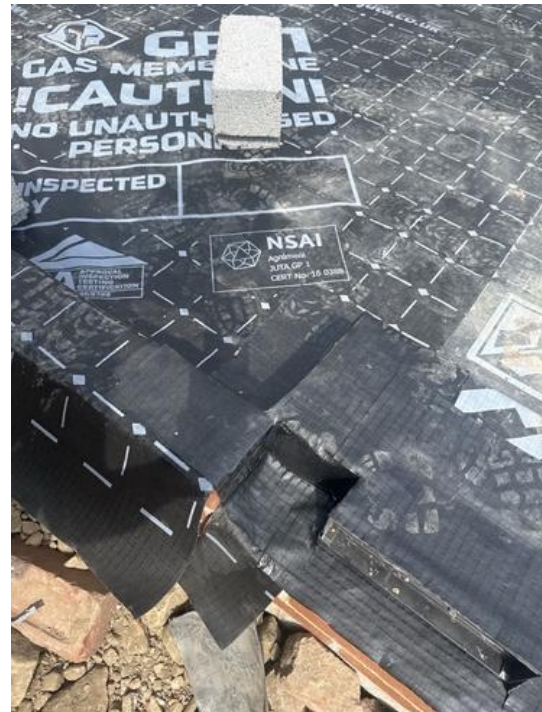
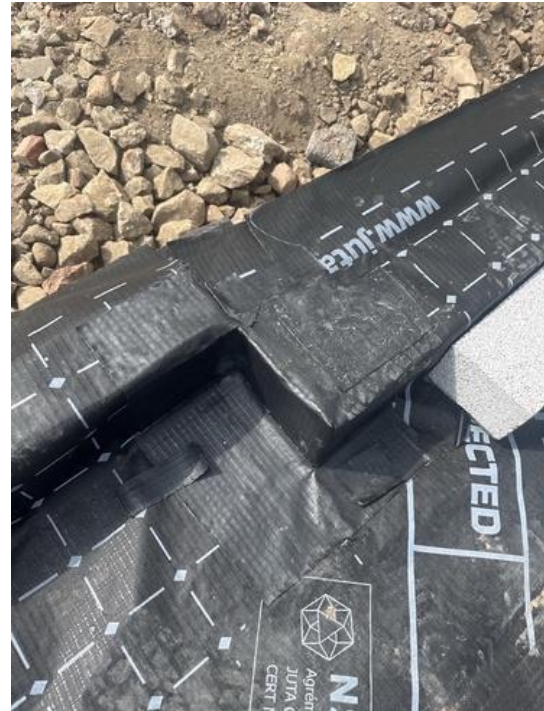
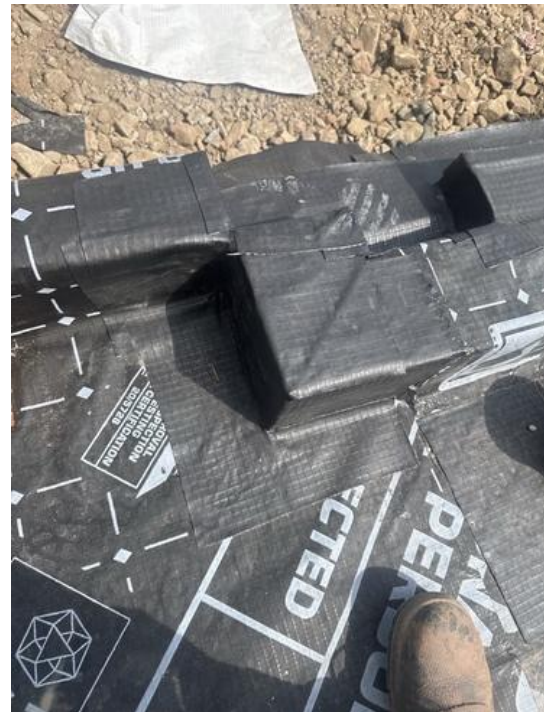
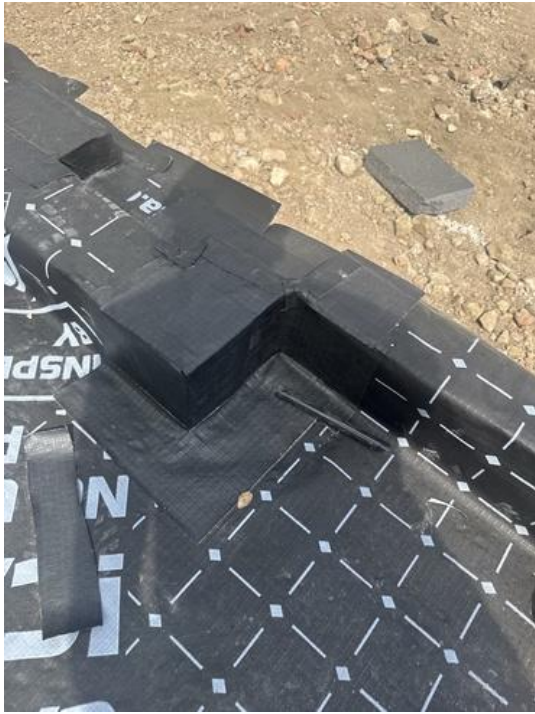
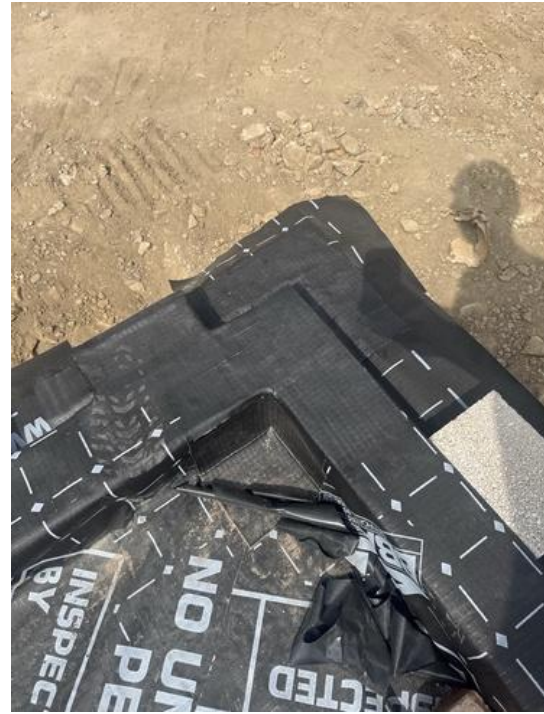
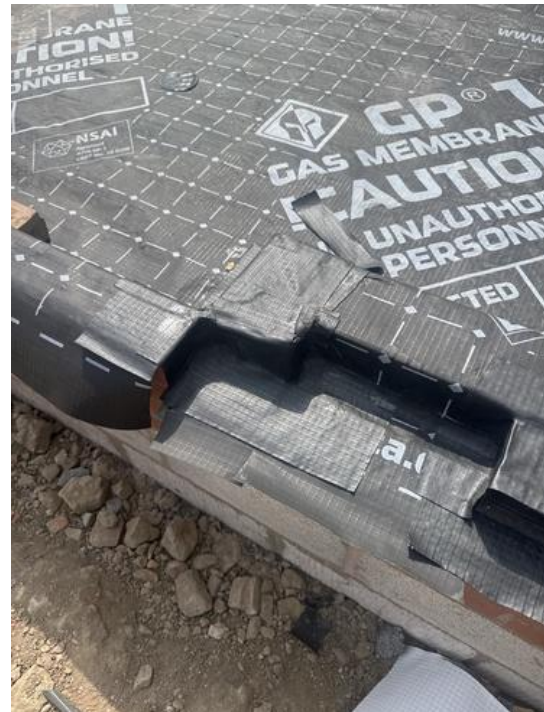
| Corners / Internal joints: Check all corners are correctly formed or contractor has used preformed corners. | Pass | |

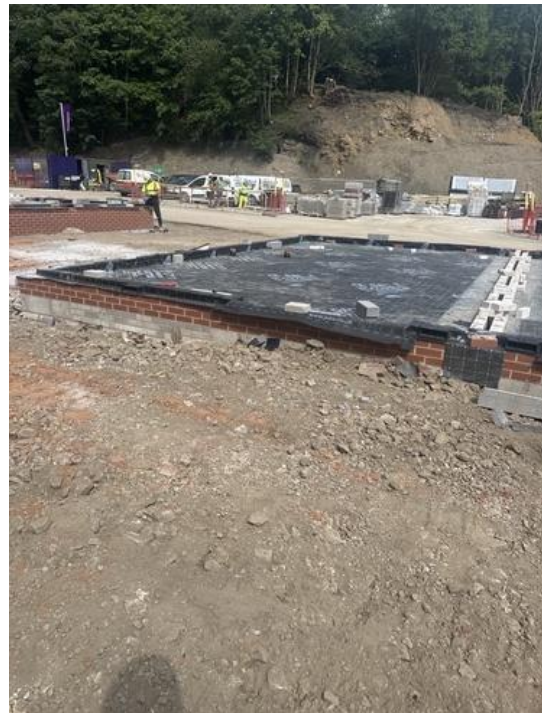
Photo 90

**Extent of Coverage: Is the membrane covering the entire plot? Does membrane span over outside walls?**

Yes

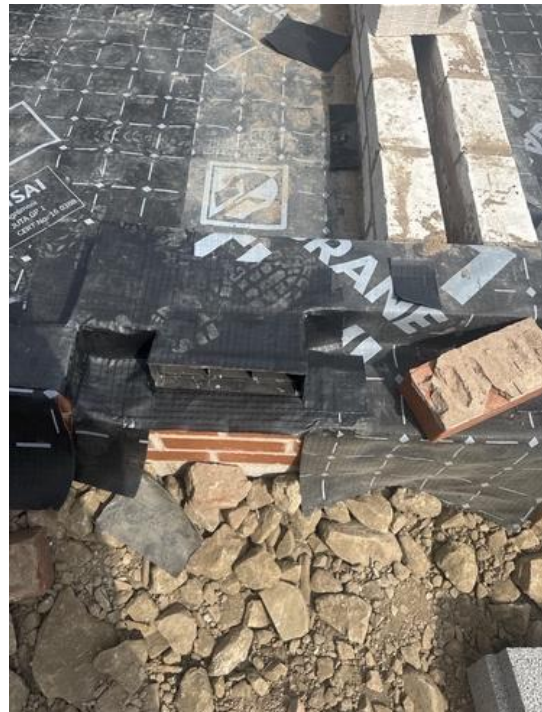
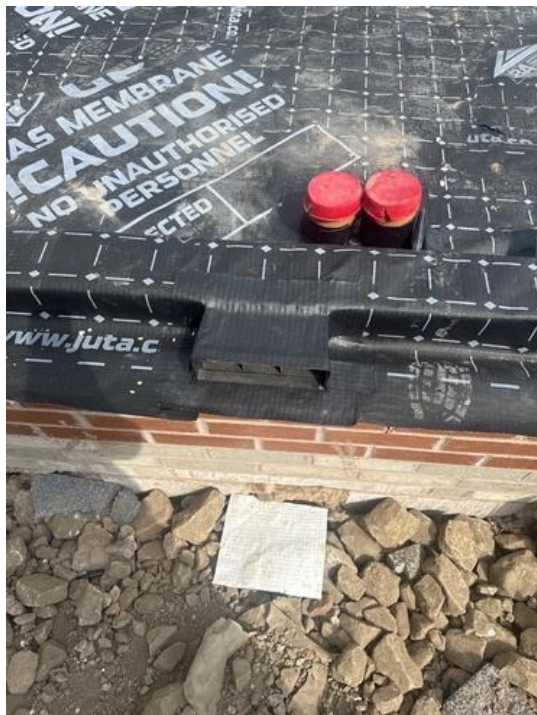
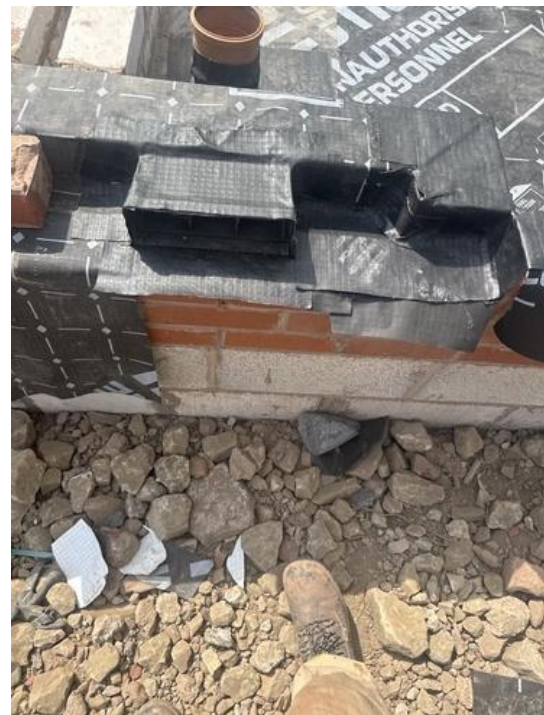
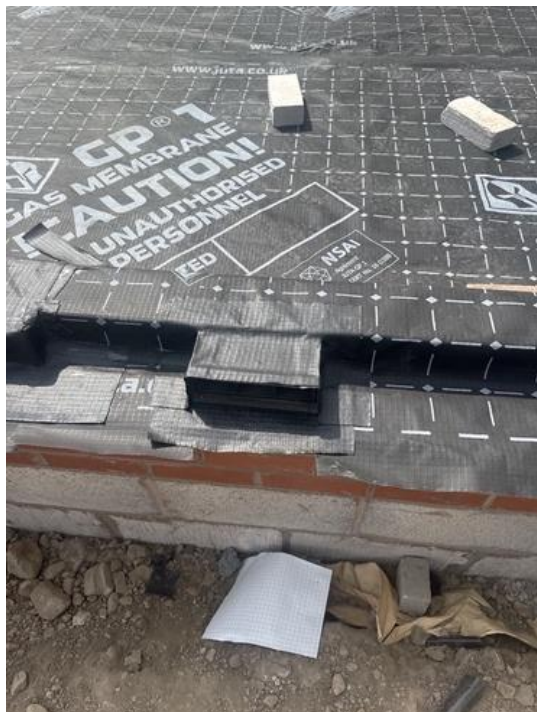
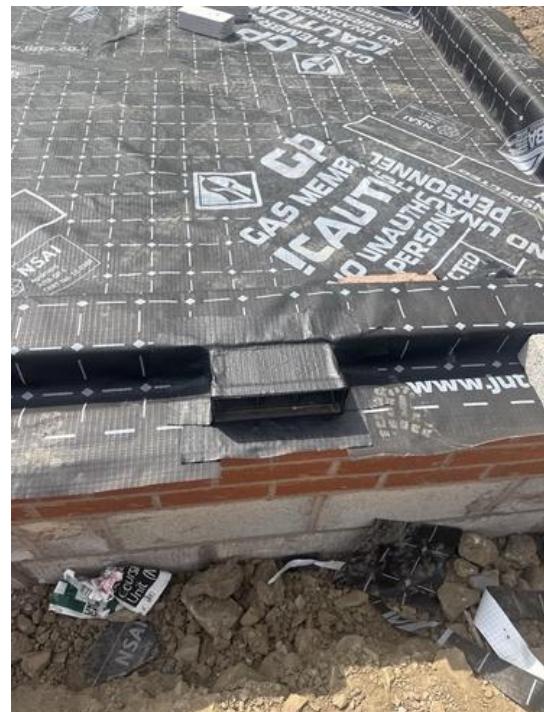
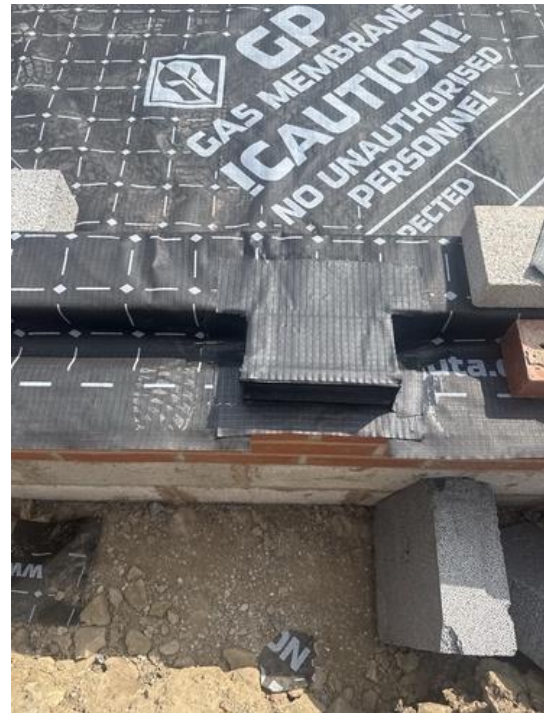
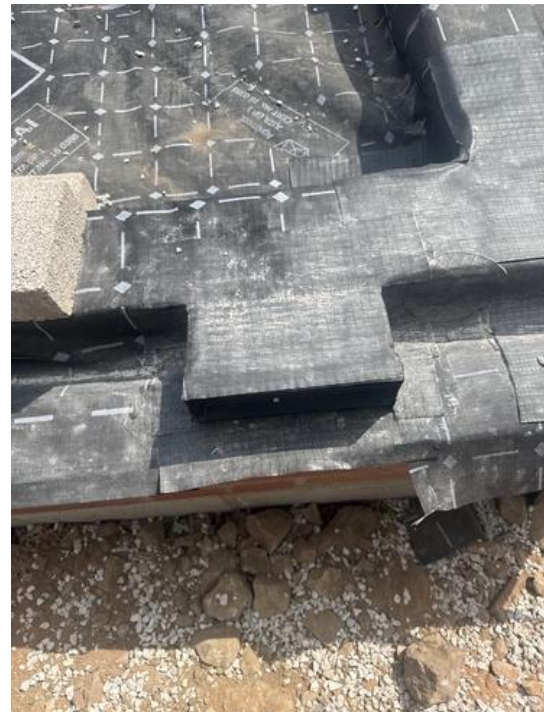
**External Wall Air bricks: Numbers, size. positions as design drawing? (Minimum of 3 walls)**

Pass
