Date: 16th June 2025  
Reference: 16465-V12

## GAS MEMBRANE VALIDATION – EDENFIELD ROAD, NORDEN

| <b>Project Number:</b> | 16-465 |
| <b>Plots:</b> | 11-12 |

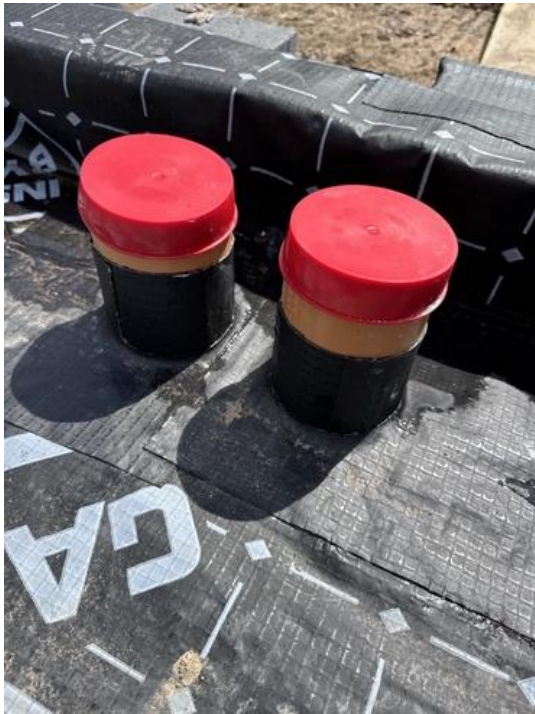
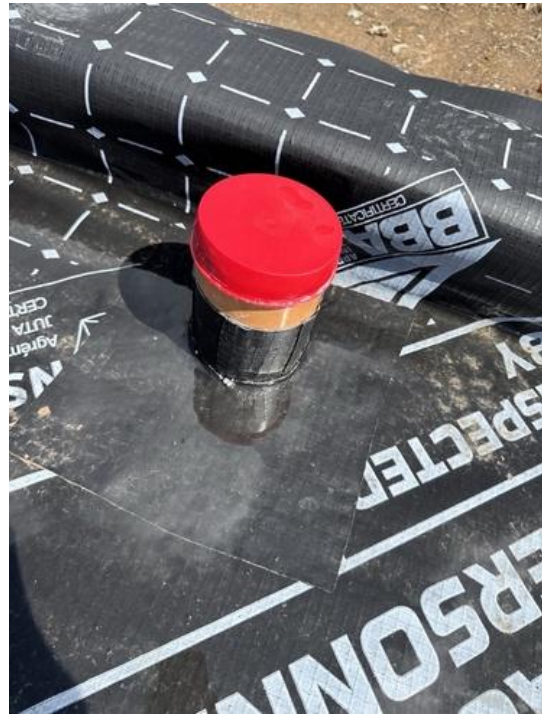
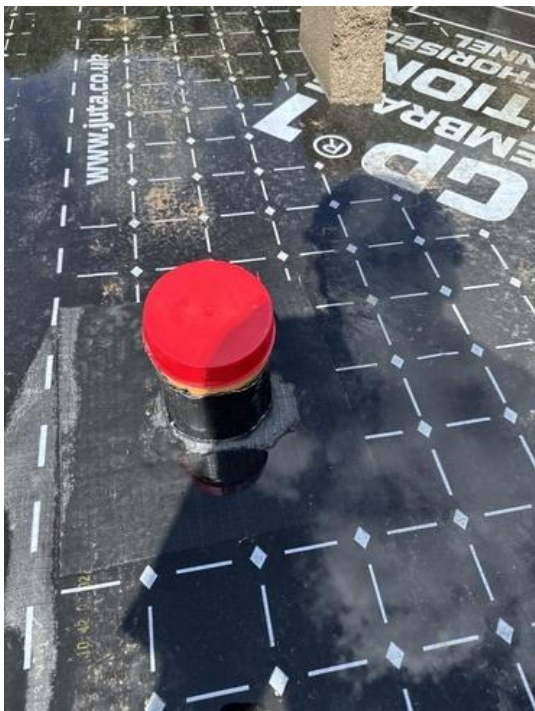
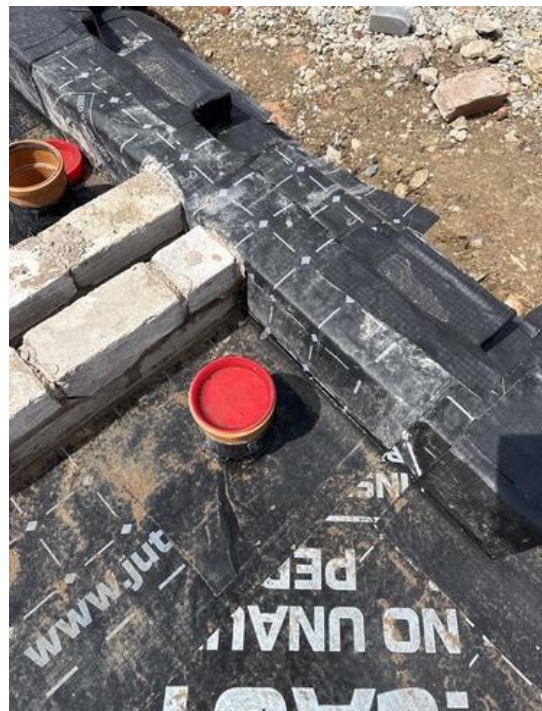
| <b>Service entries seals: Top hats seal arrangements fixed around service entries? Use of Jubilee clips or Bitumastic Sealant</b> | Pass |

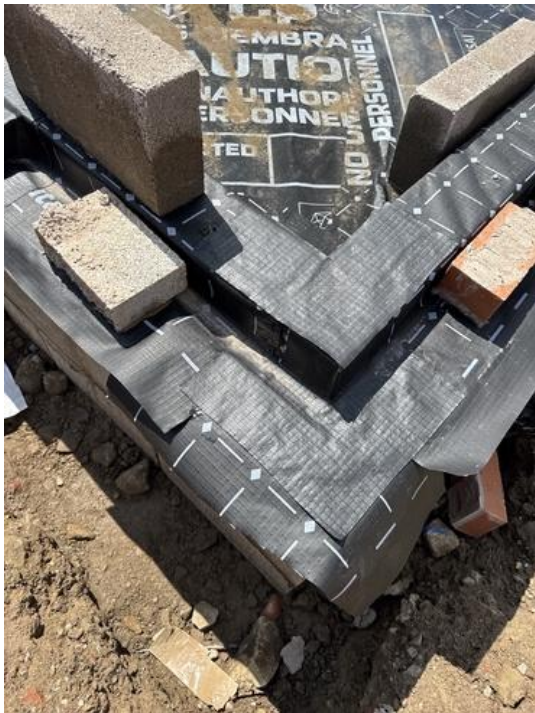
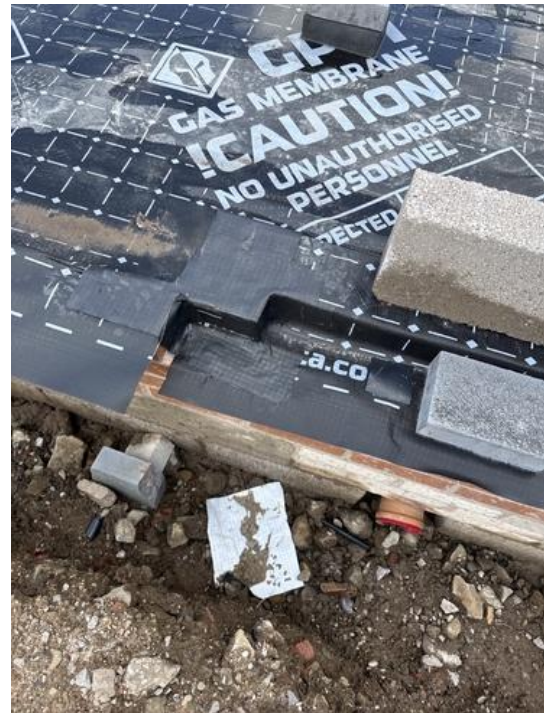
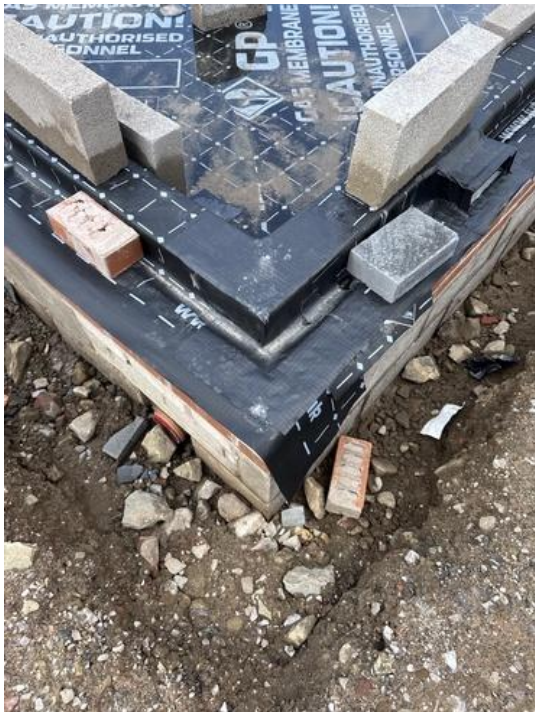
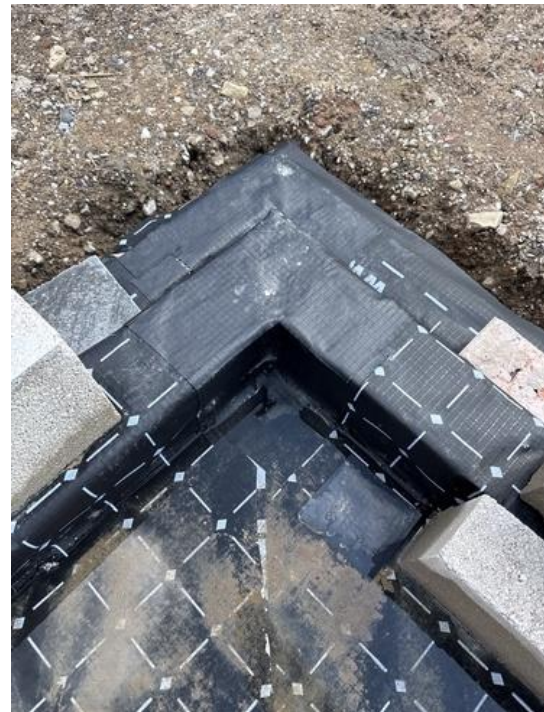
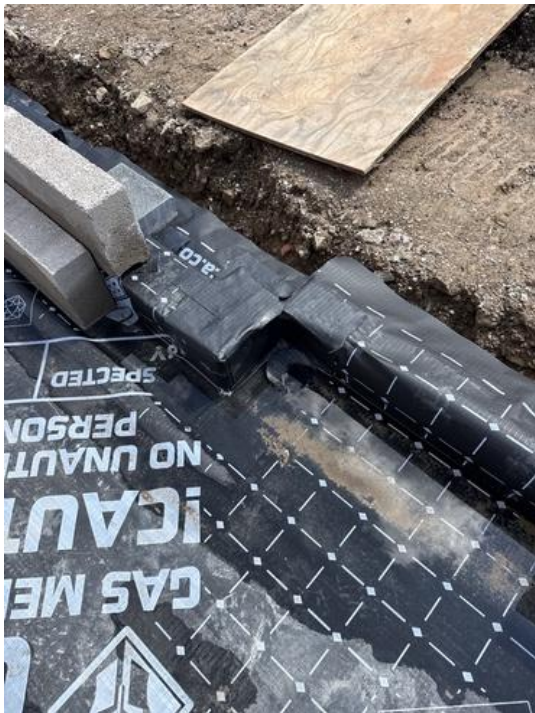
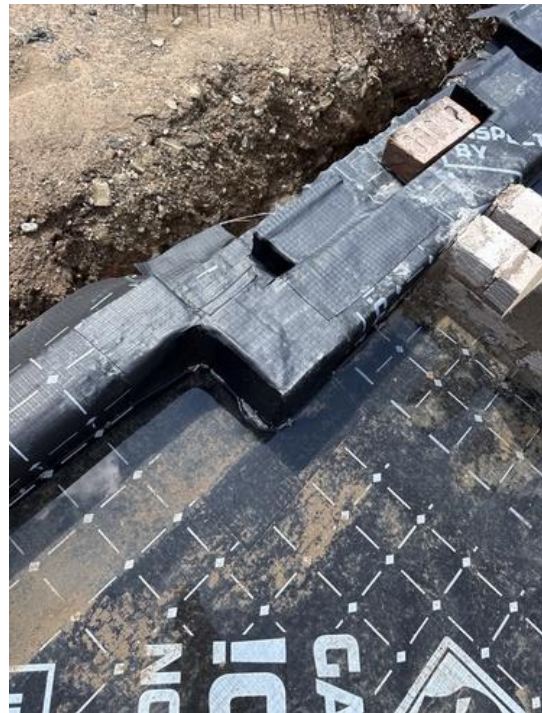
| <b>Corners / Internal joints: Check all corners are correctly formed or contractor has used preformed corners.</b> | Pass |

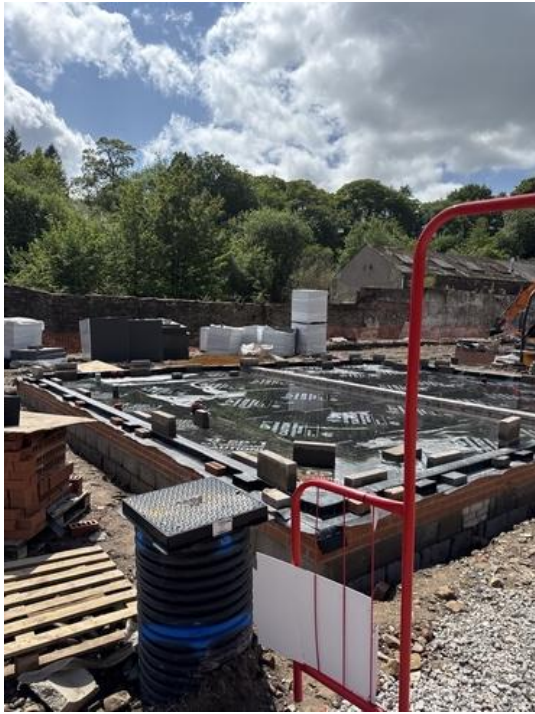
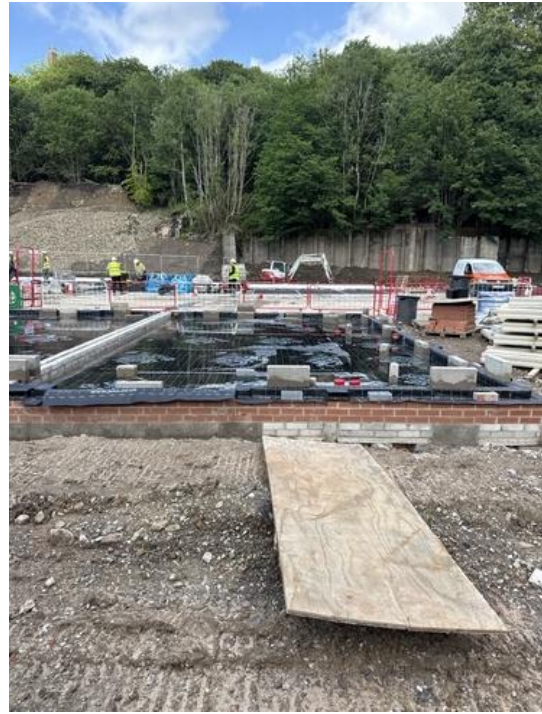
**Extent of Coverage: Is the membrane covering the entire plot? Does membrane span over outside walls?**

Yes

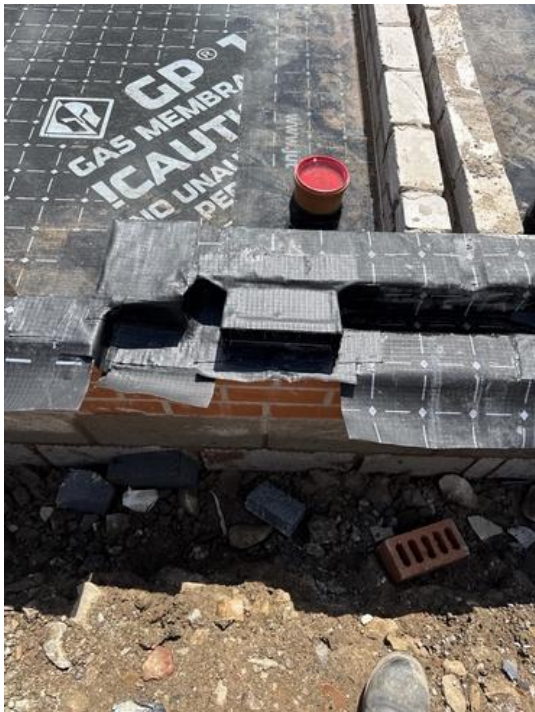
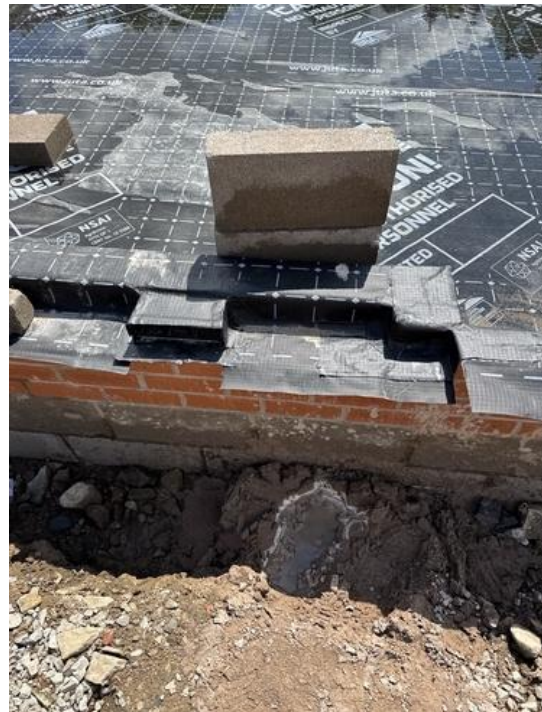
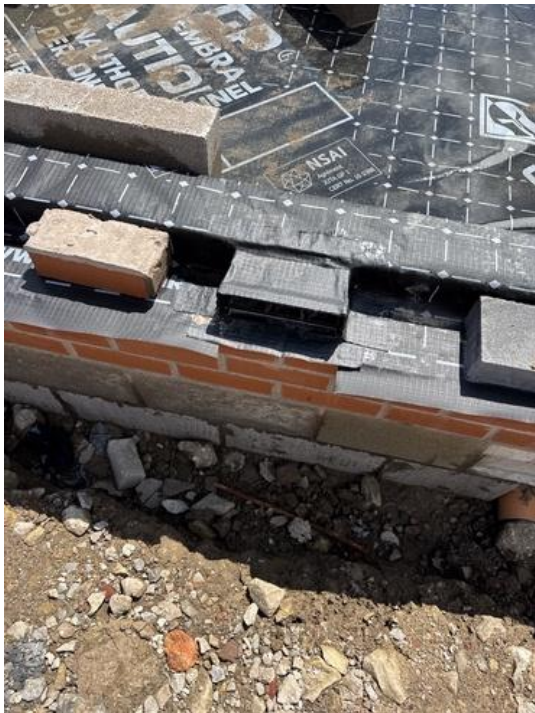
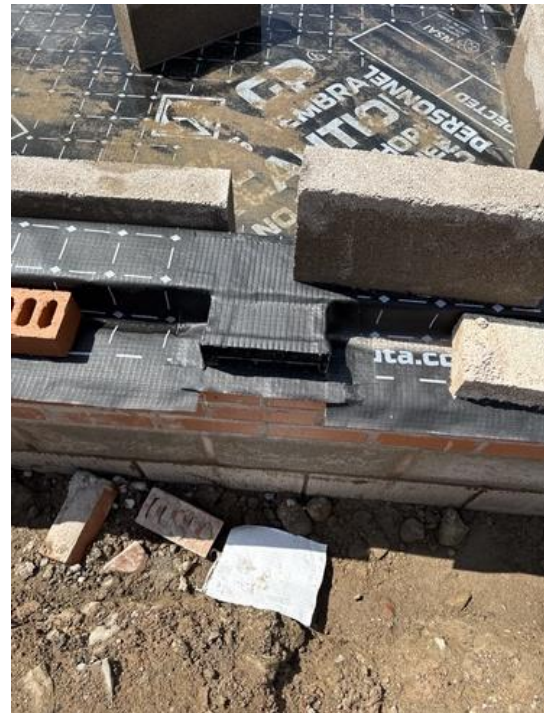
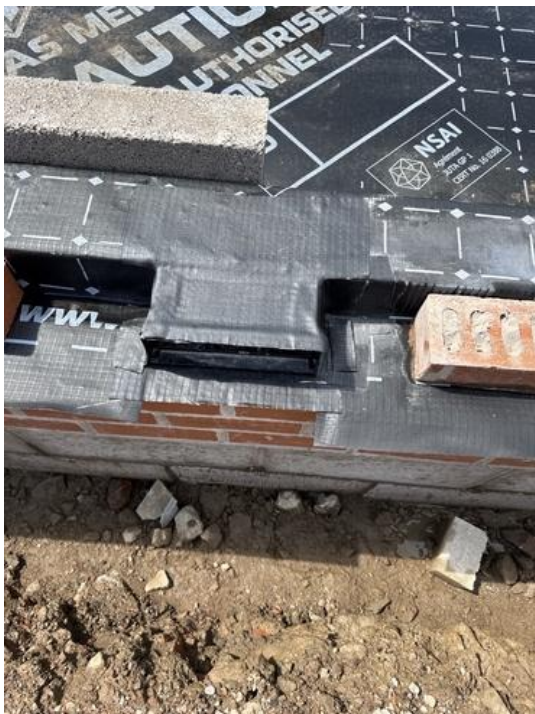
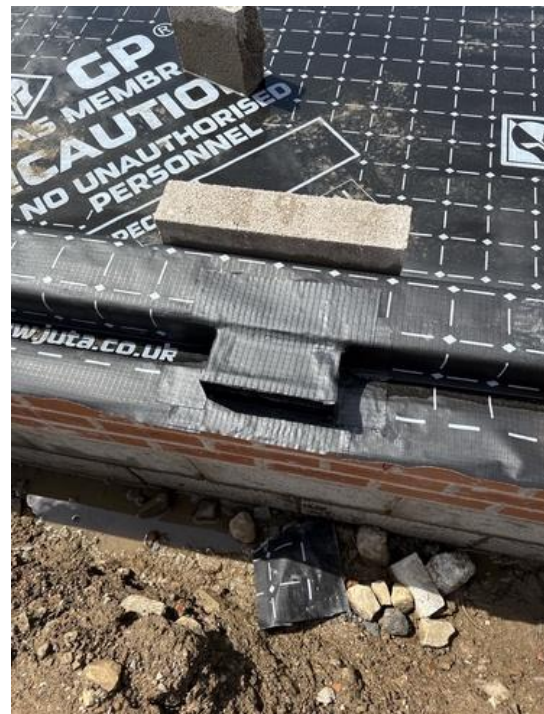
**External Wall Air bricks: Numbers, size. positions as design drawing? (Minimum of 3 walls)**

Pass

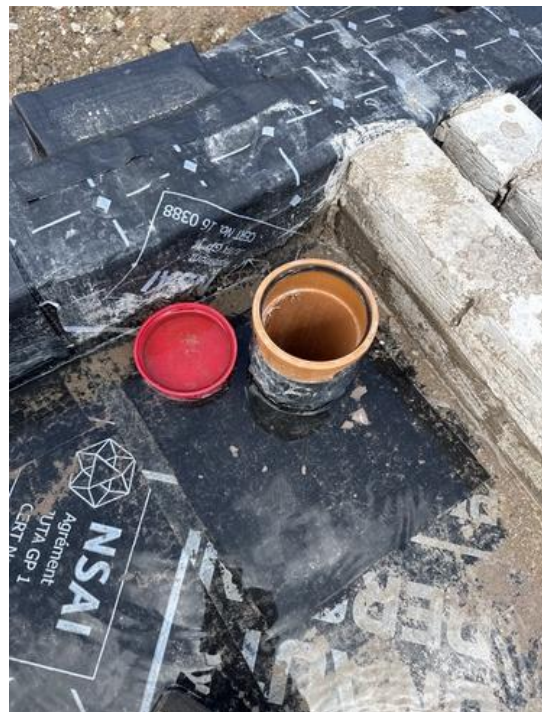
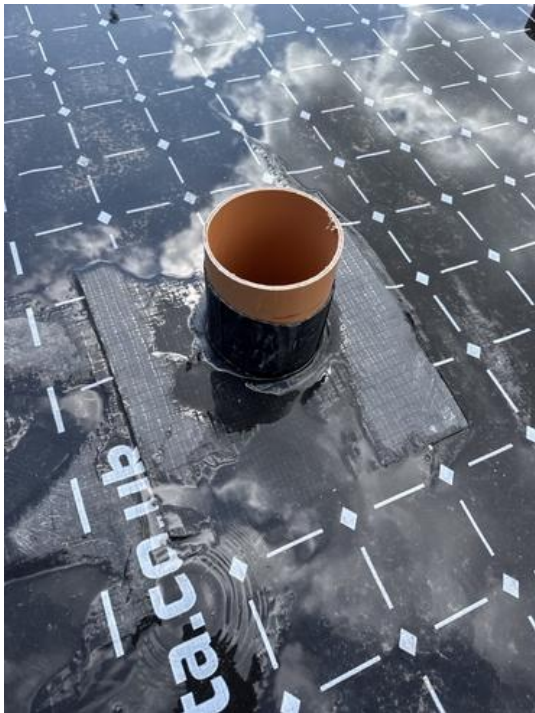
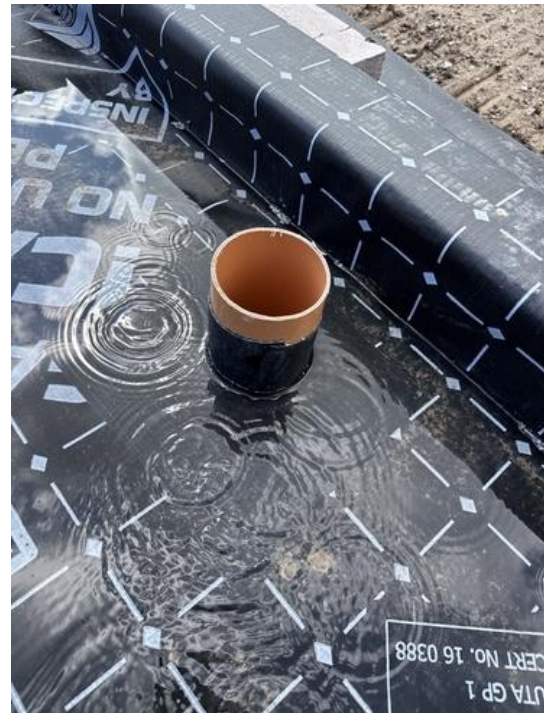
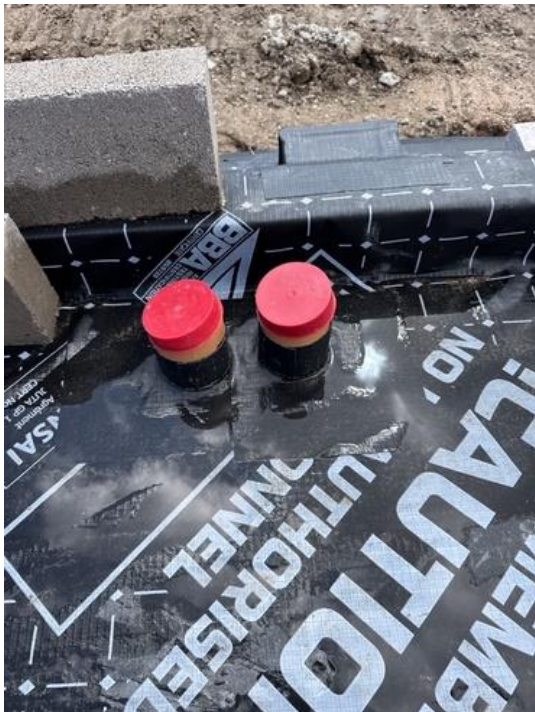
| <b>Service entries seals: Top hats seal arrangements fixed around service entries? Use of Jubilee clips or Bitumastic Sealant</b> | Pass | |

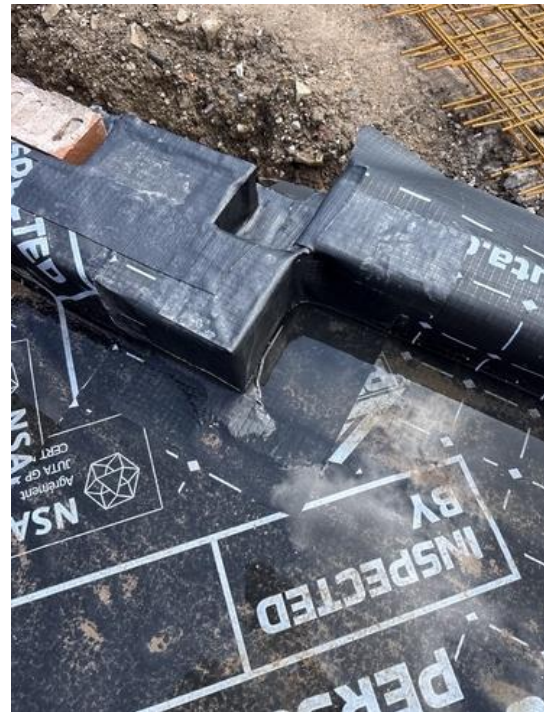
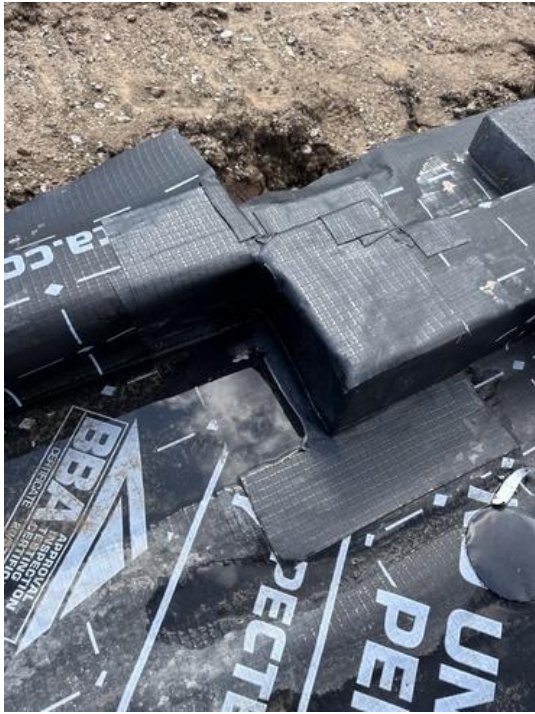
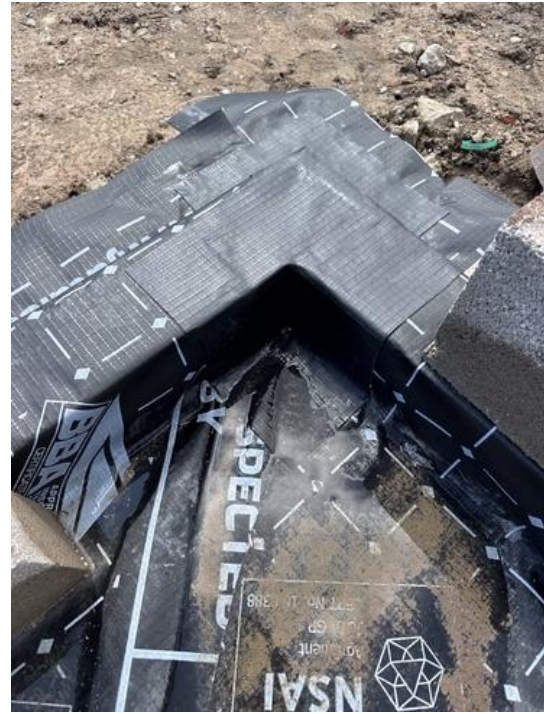
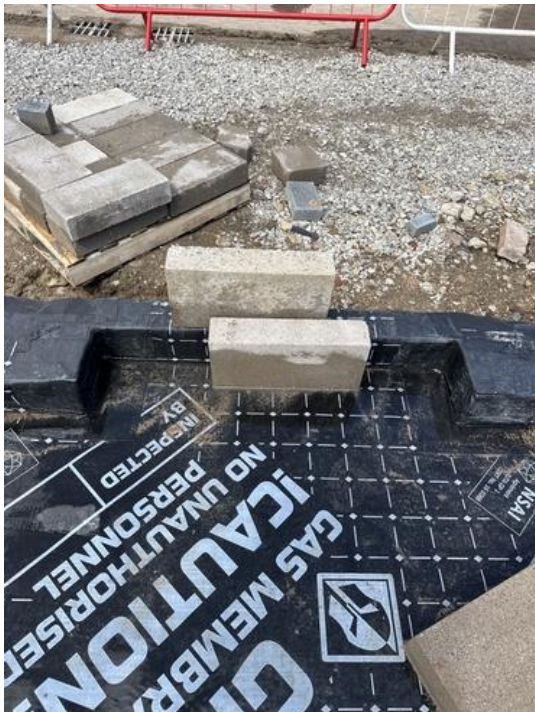
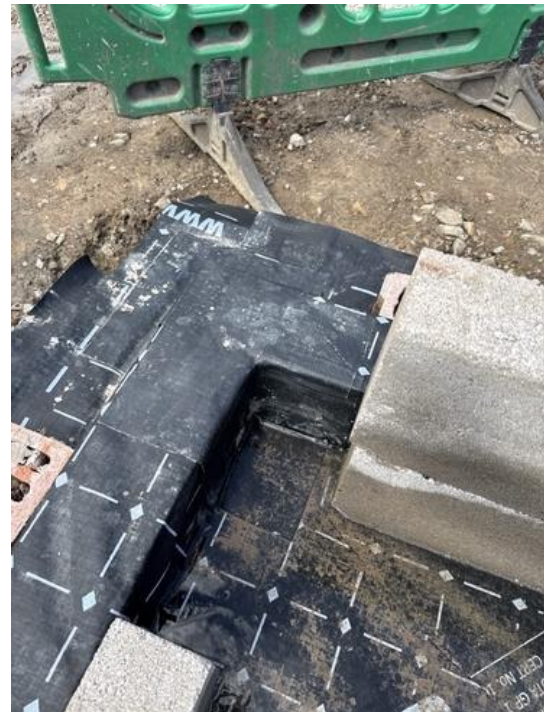
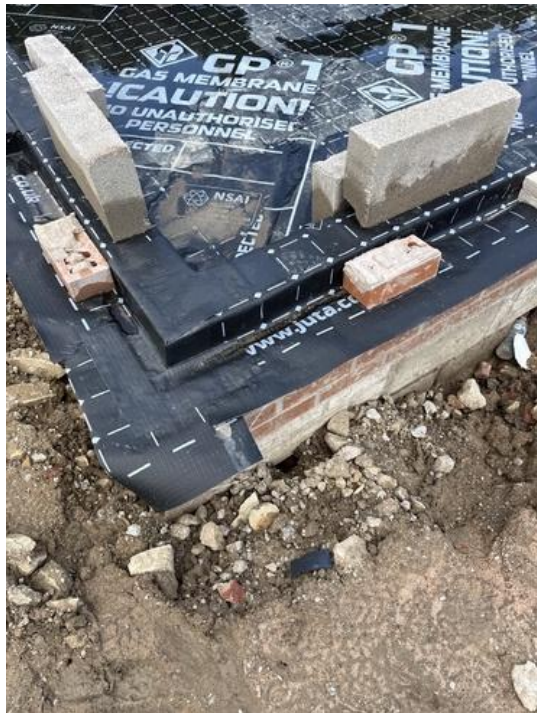
| <b>Corners / Internal joints: Check all corners are correctly formed or contractor has used preformed corners.</b> | Pass | |

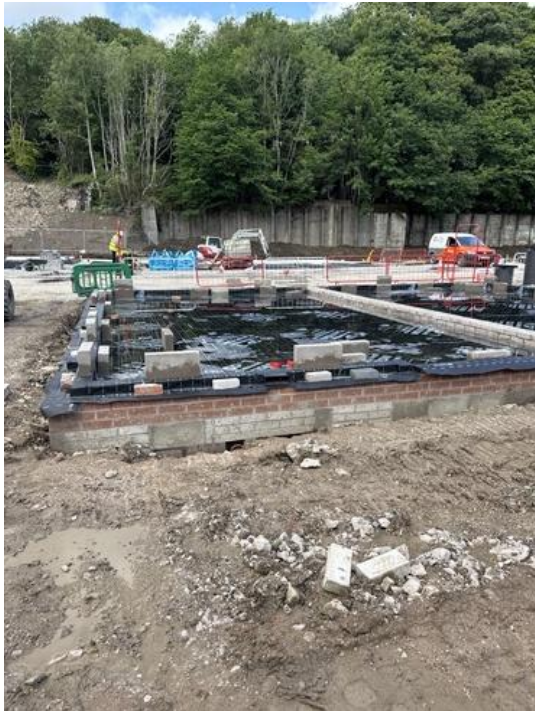
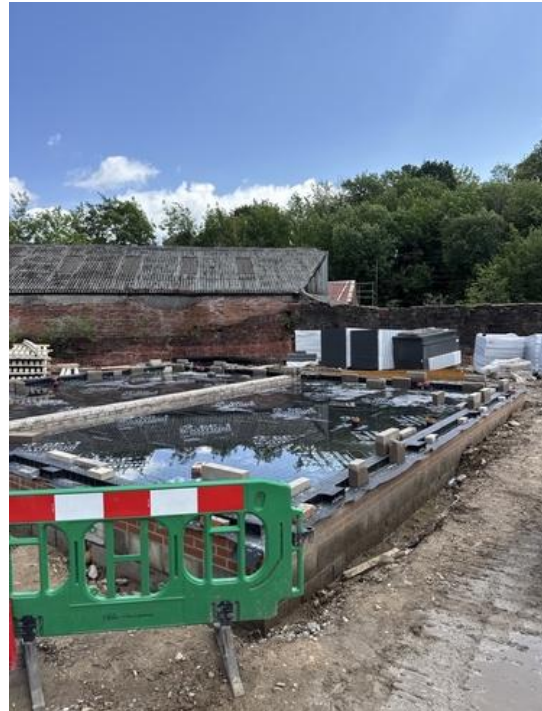
**Extent of Coverage: Is the membrane covering the entire plot? Does membrane span over outside walls?**

Yes

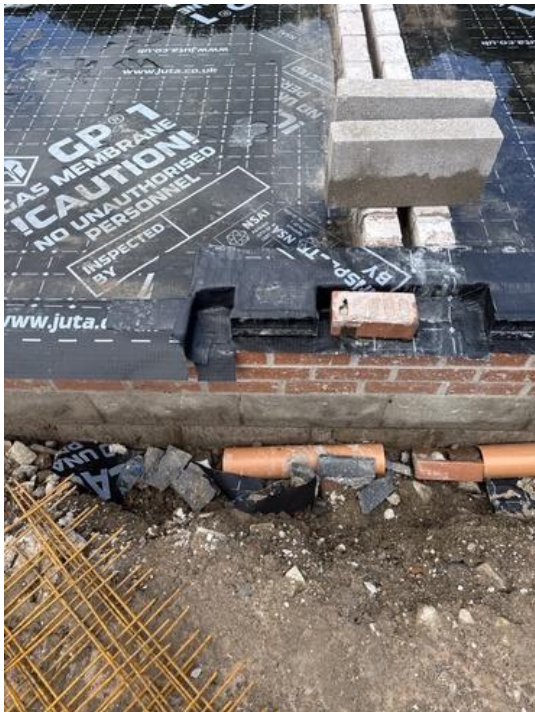
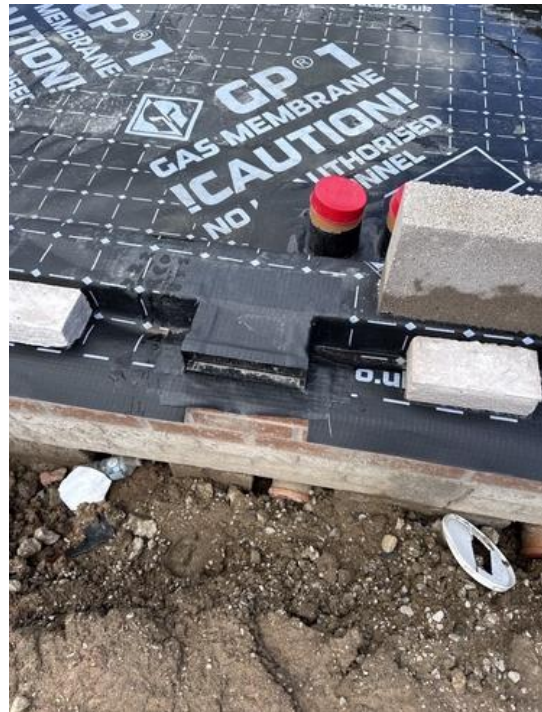
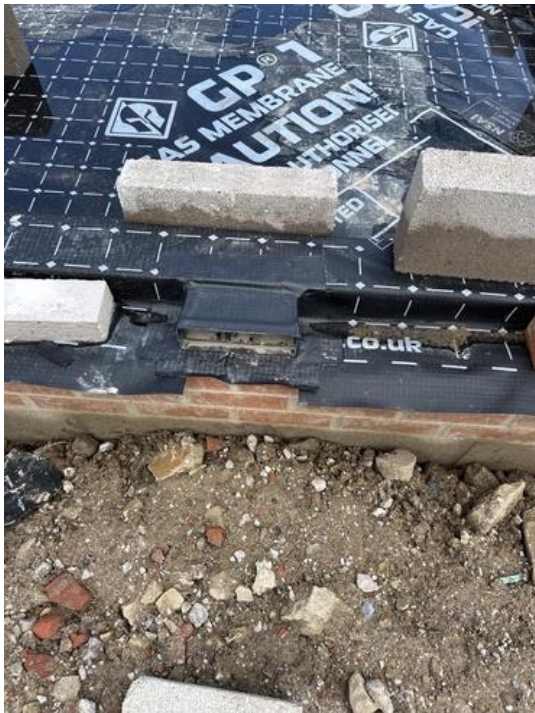
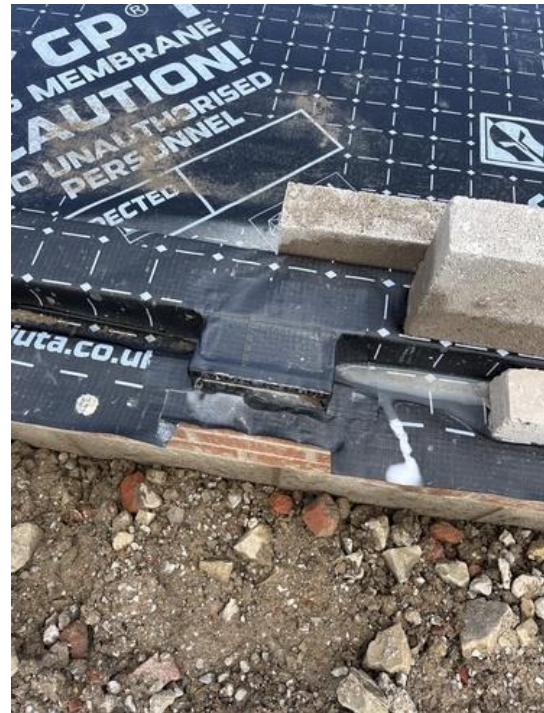
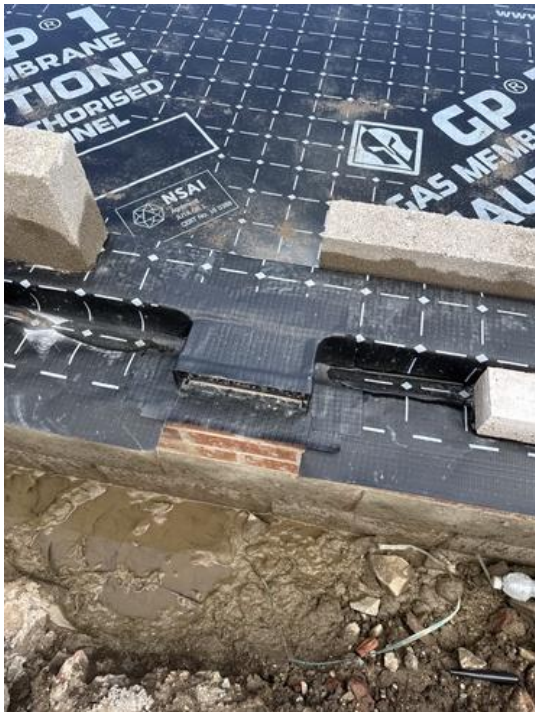
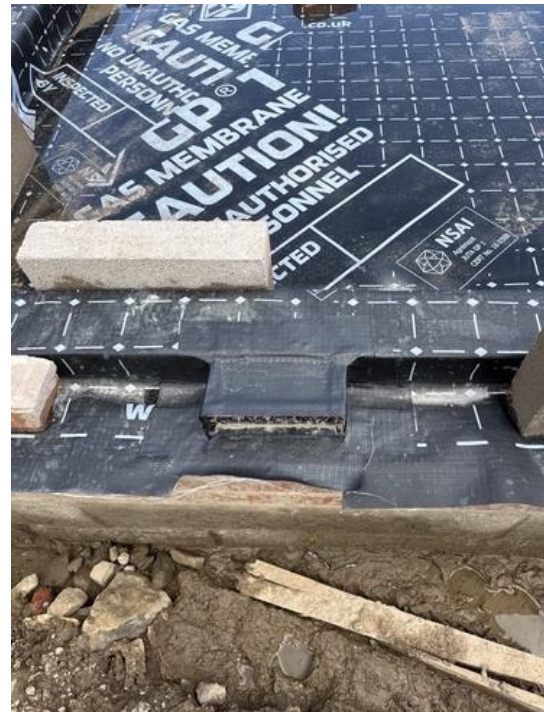
**External Wall Air bricks: Numbers, size. positions as design drawing? (Minimum of 3 walls)**

Pass

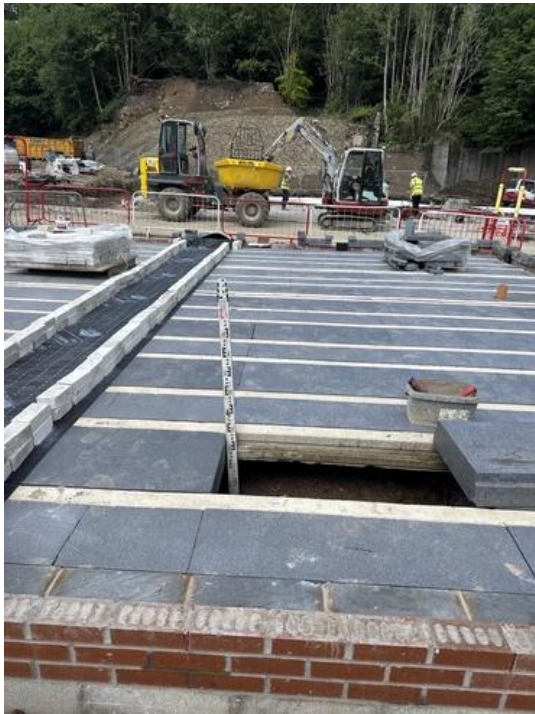
Photo 1

| Plot Number | 13 |
| Is the void clear? | Yes |
| Depth of Void | 200 |

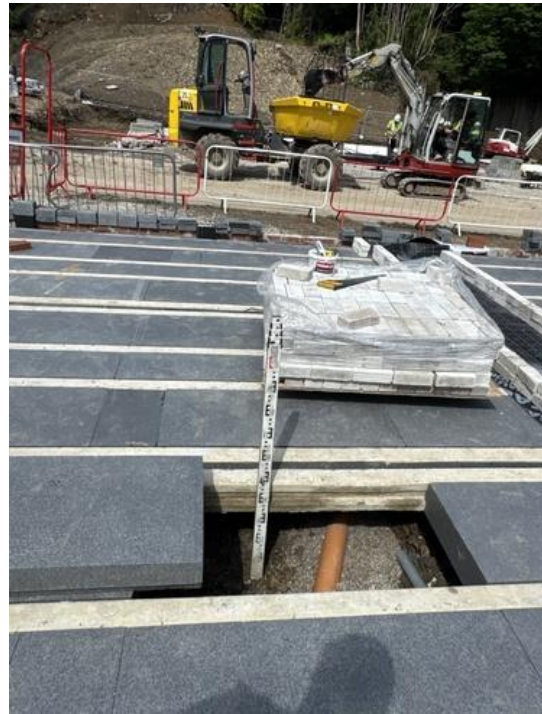
Photo 2

| Plot Number | 14 |
| Is the void clear? | Yes |
| Depth of Void | 300 |
