Date: 2<sup>nd</sup> May 2025  
Reference: 16465-V3

## GAS MEMBRANE VALIDATION – EDENFIELD ROAD, NORDEN

| <b>Project Name:</b> | Edenfield Road, Rochdale |
| <b>Plots:</b> | 7-10 |

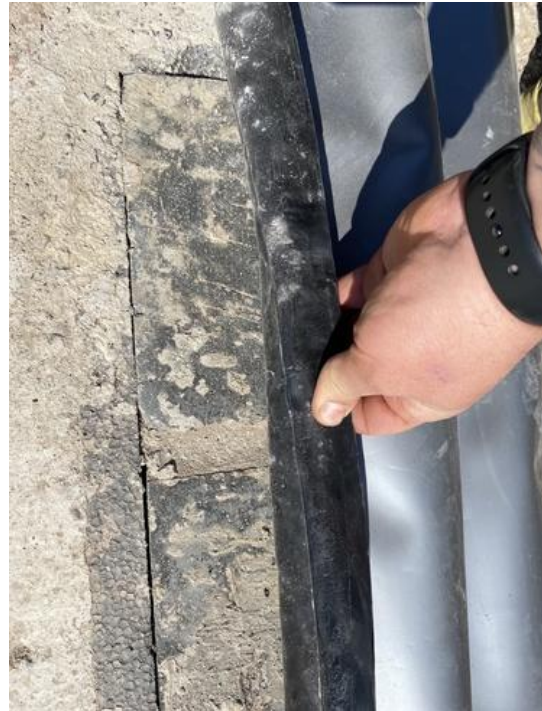
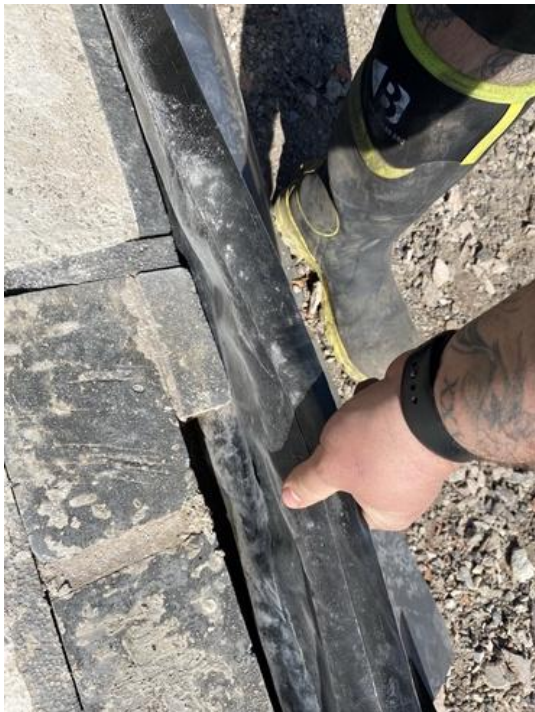
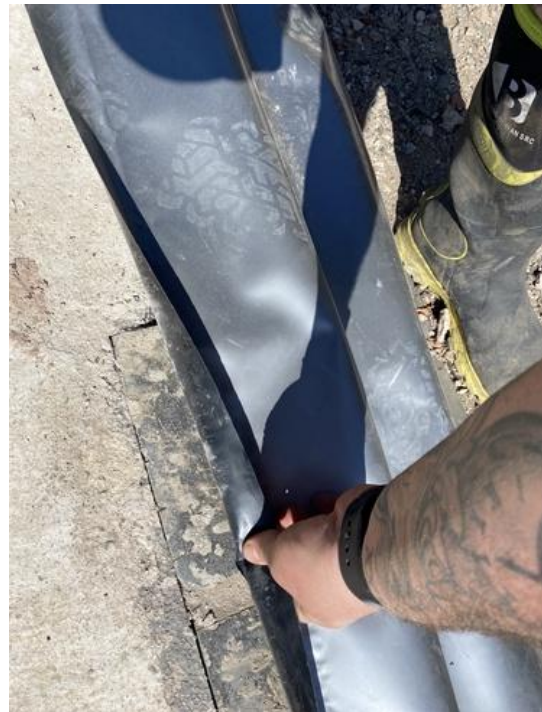
| <b>Are welds complete?</b> | | Yes |

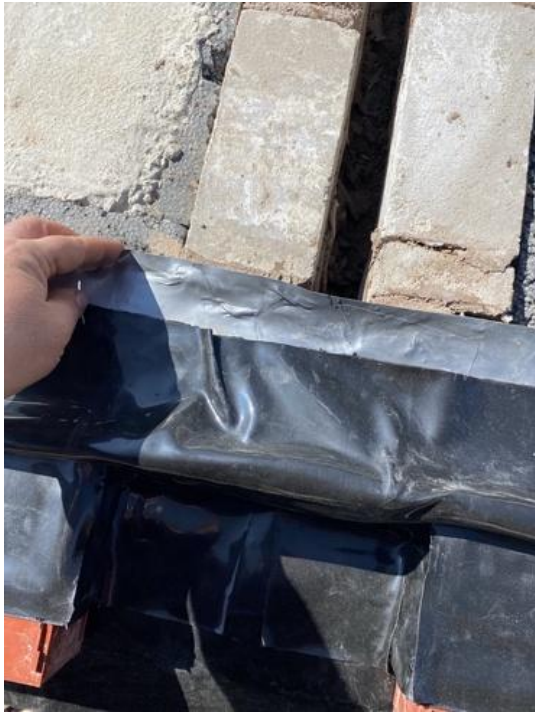
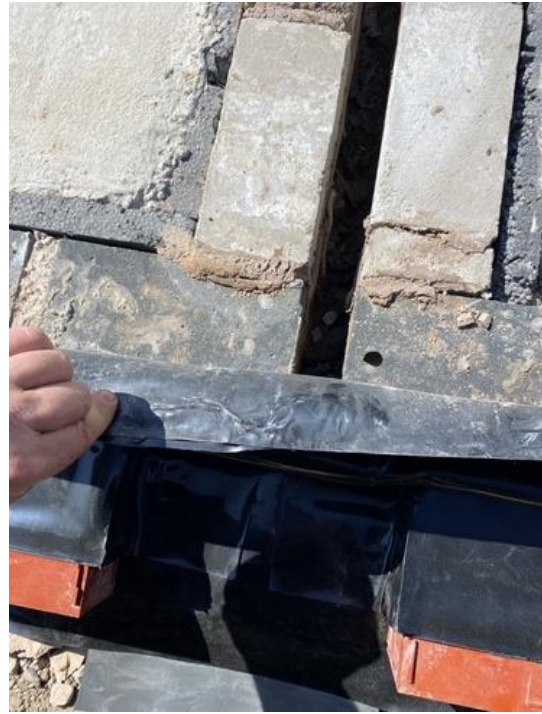
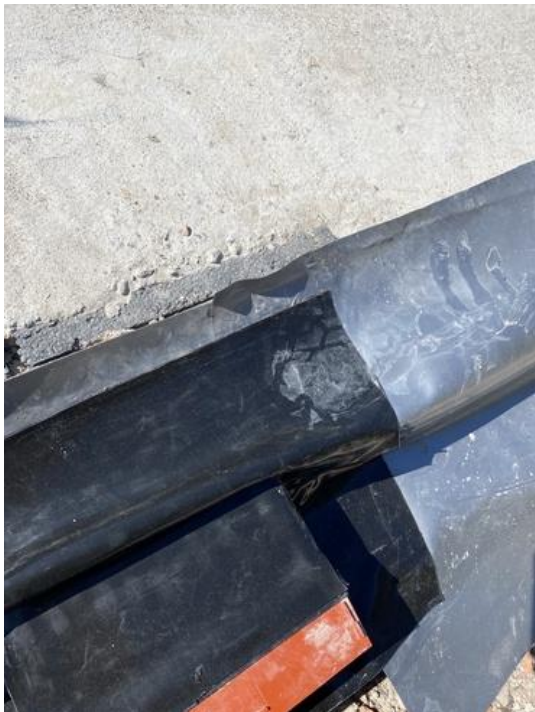
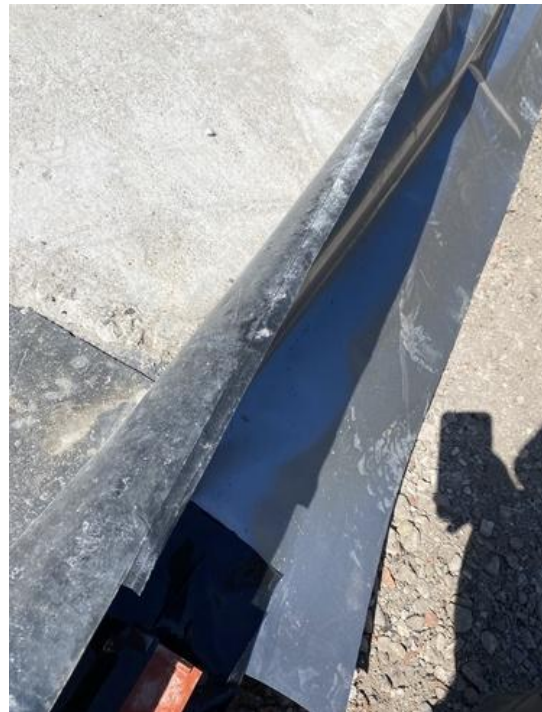
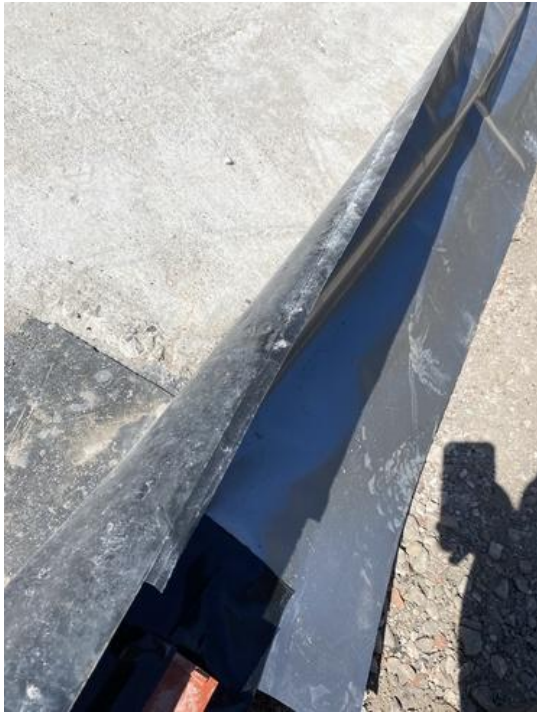
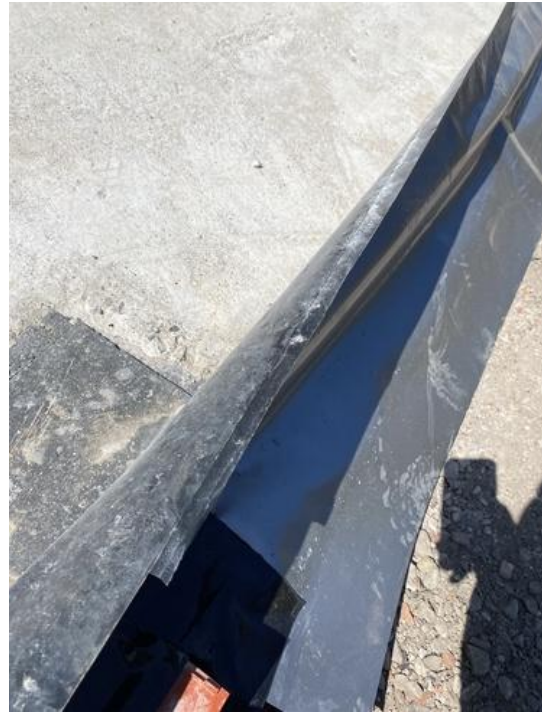
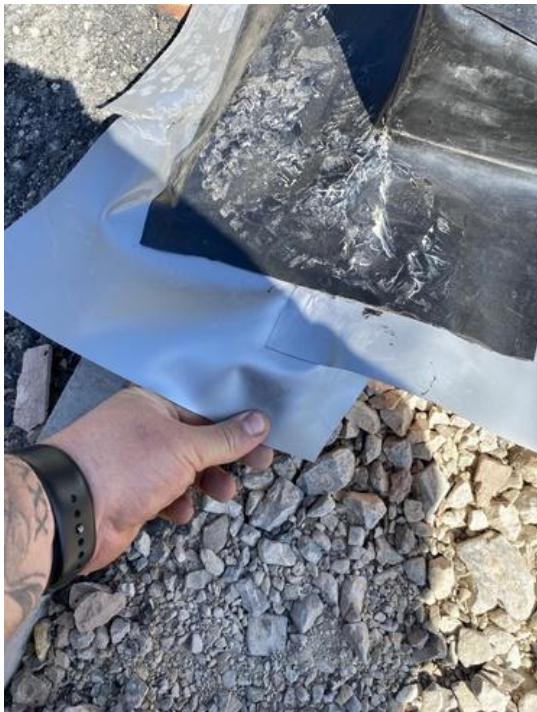
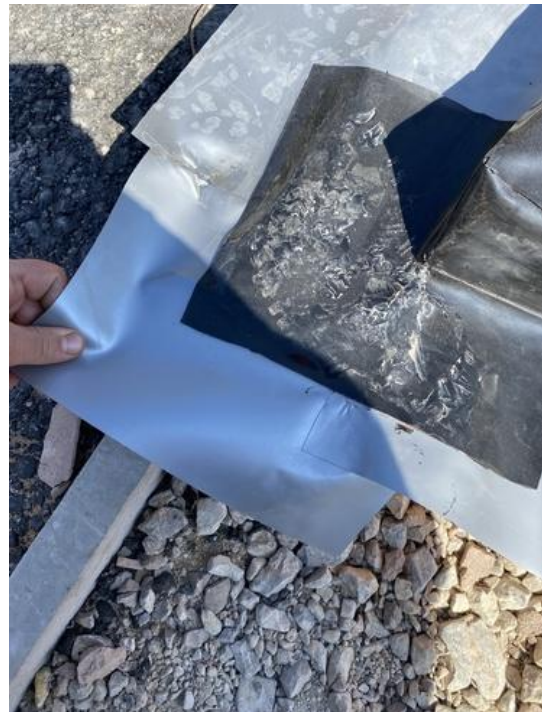
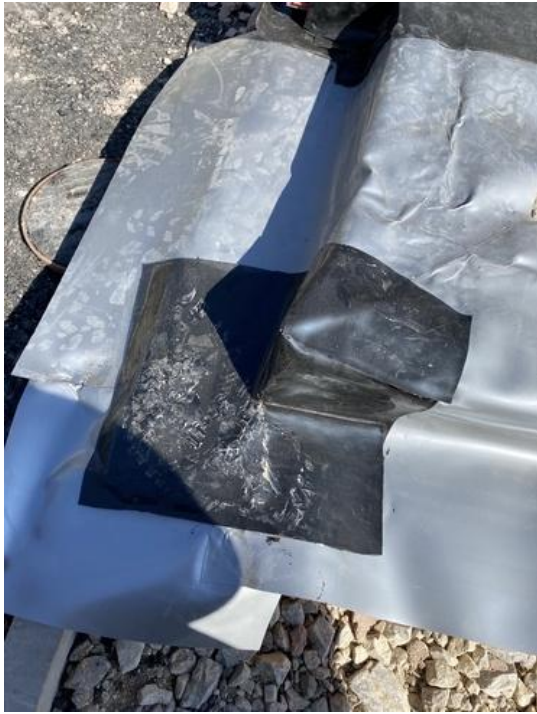
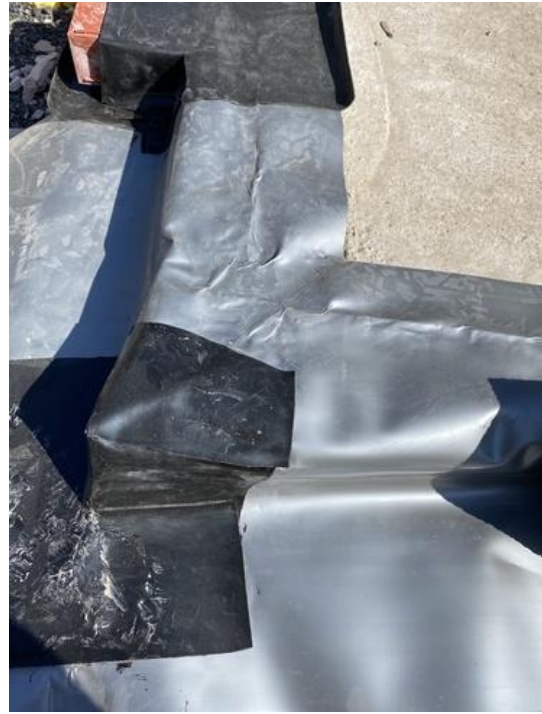
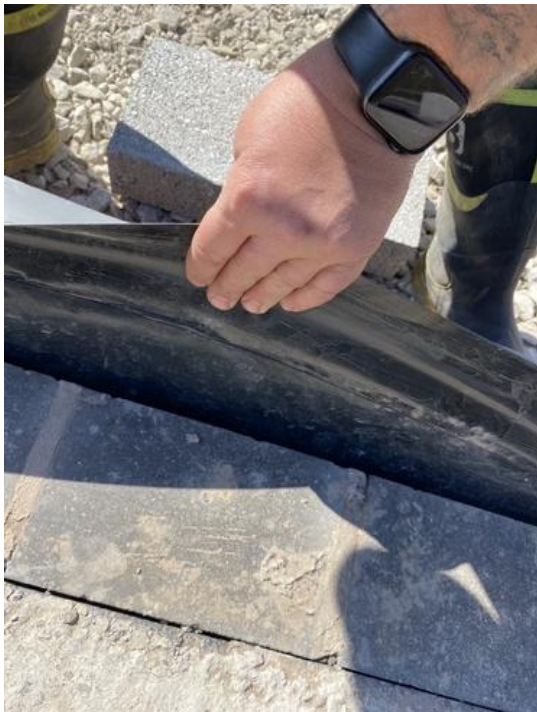
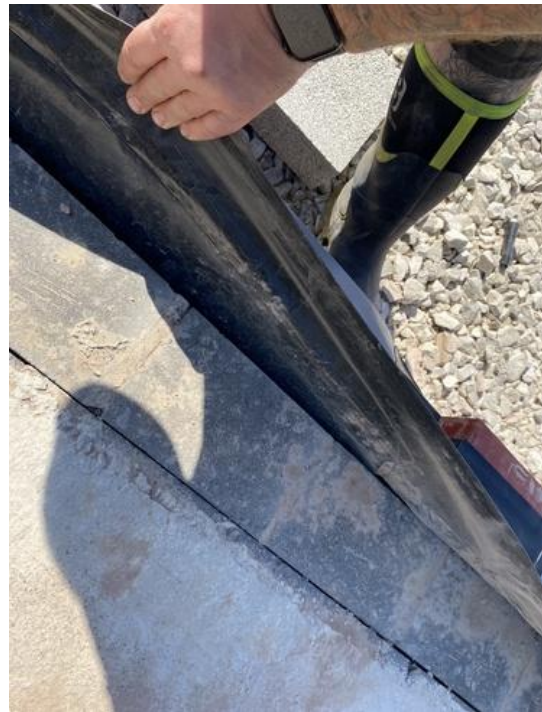
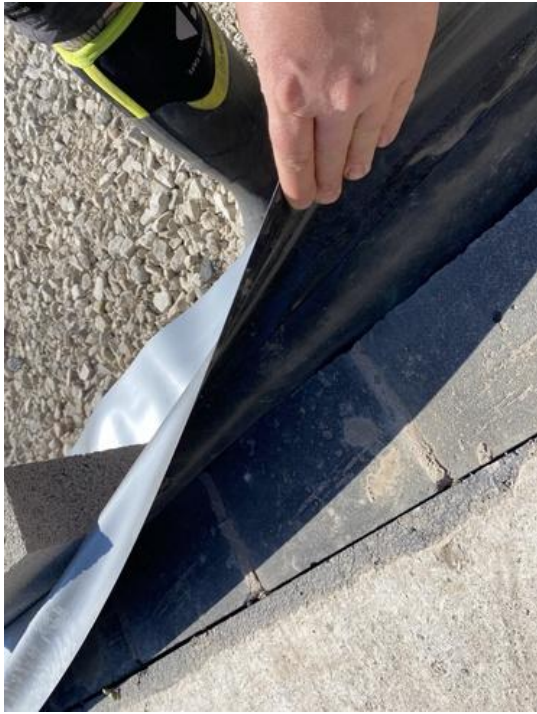
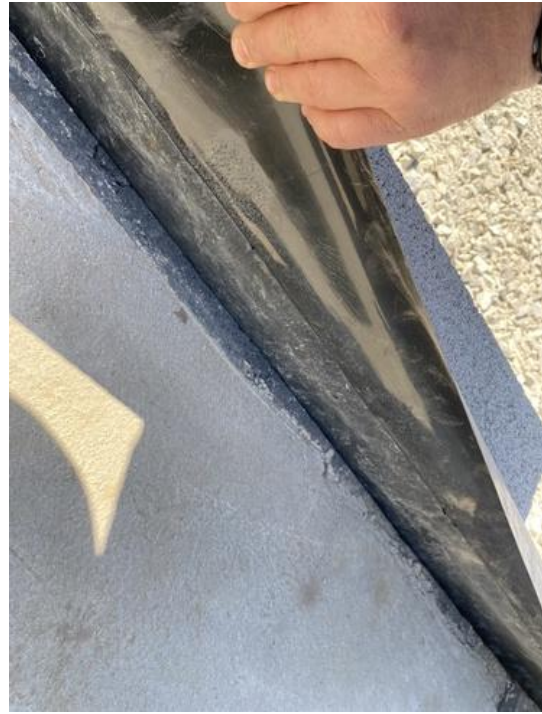
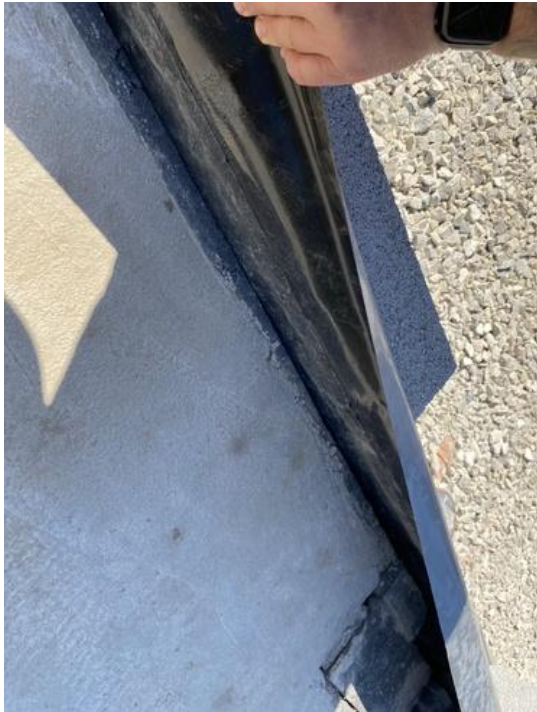
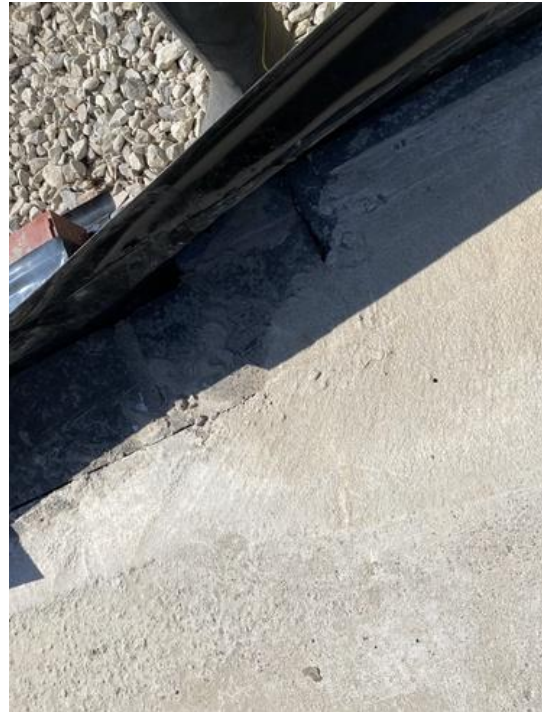
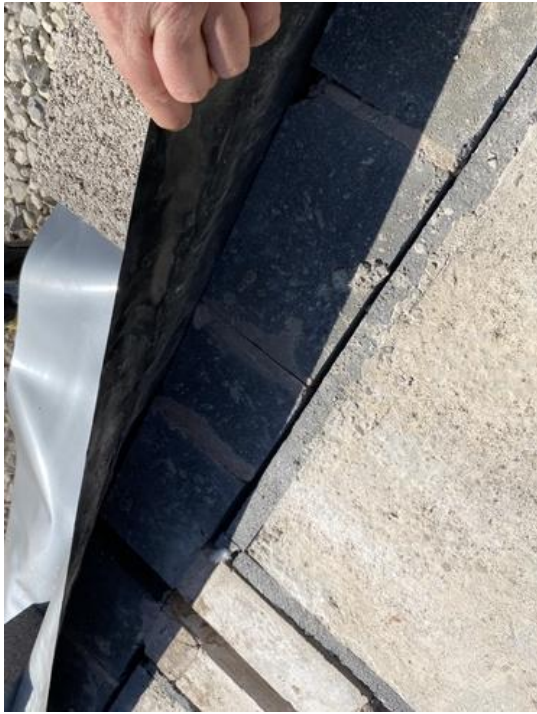
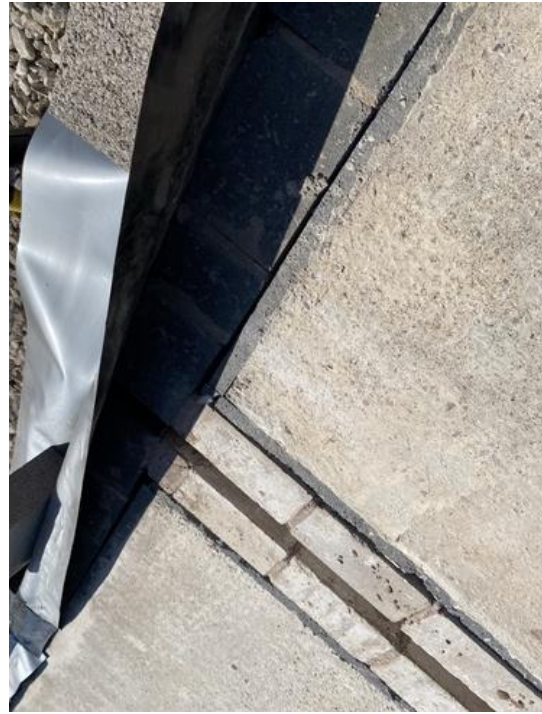
E3P inspected all joints including corner details, and can confirm that the membrane was overlapped in accordance with the manufacturer specification and heat welded.

**Are Joints lapped and sealed in accordance with manufacturer's requirements/ specification?**

Yes

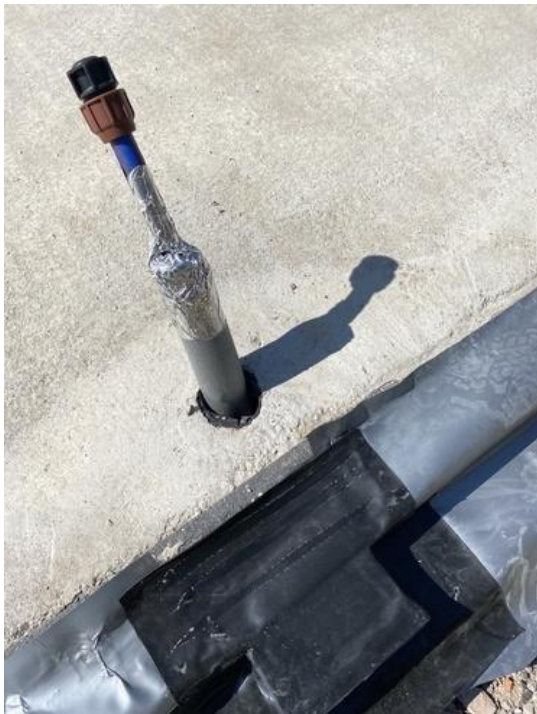
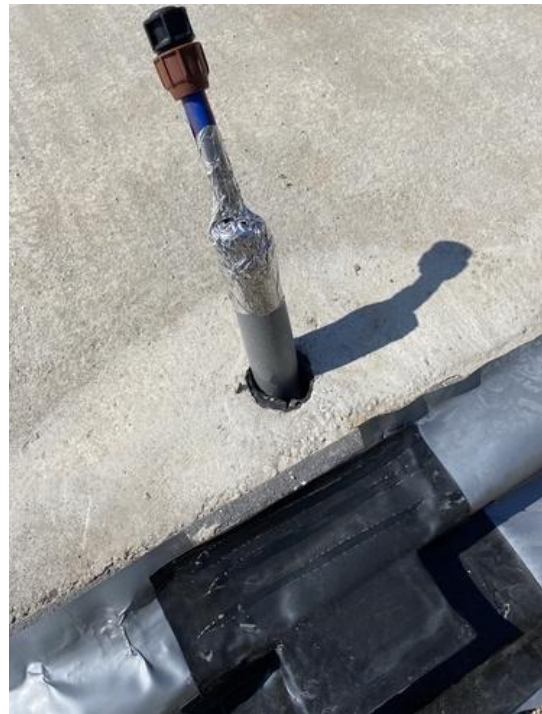
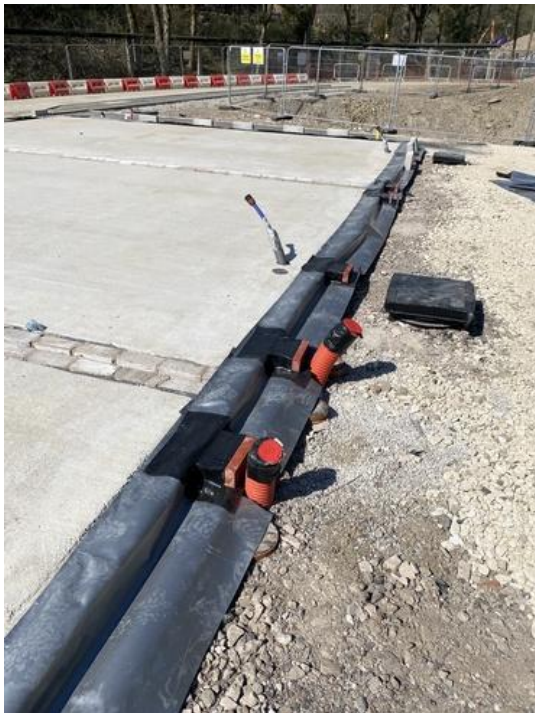
**Service entries seals: Top hats seal arrangements fixed around service entries? Use of Jubilee clips or Bitumastic Sealant**

Pass

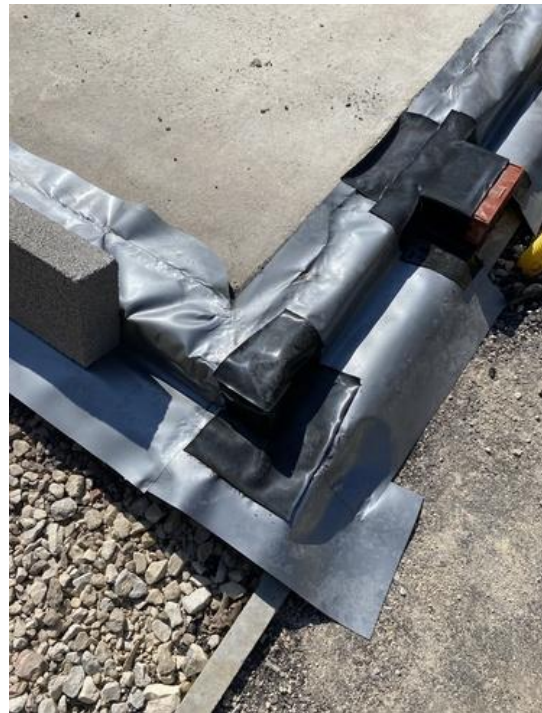
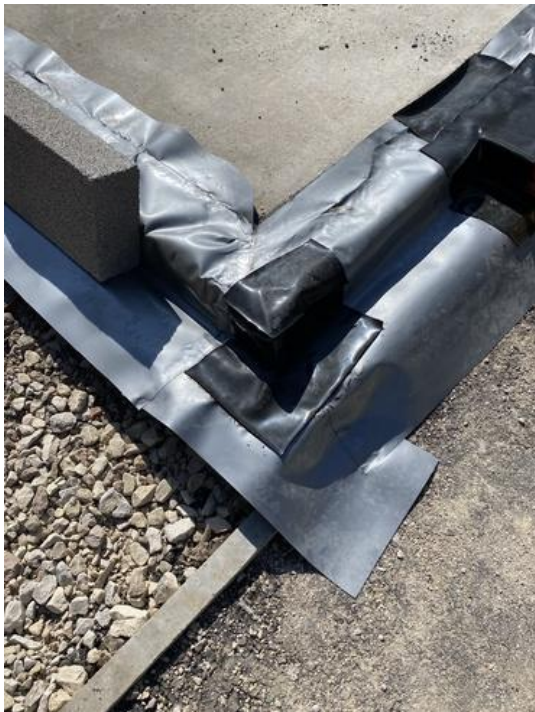
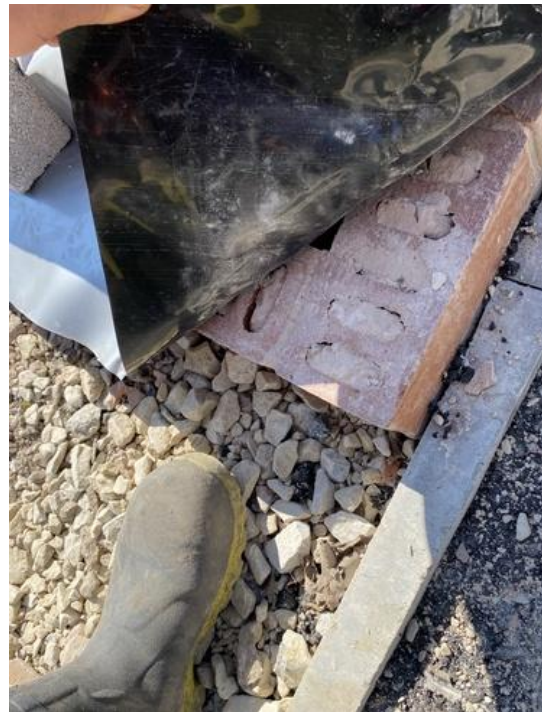
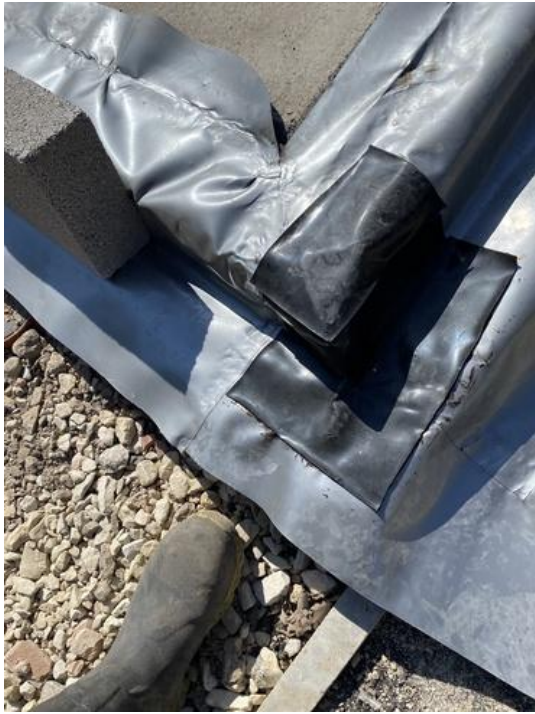
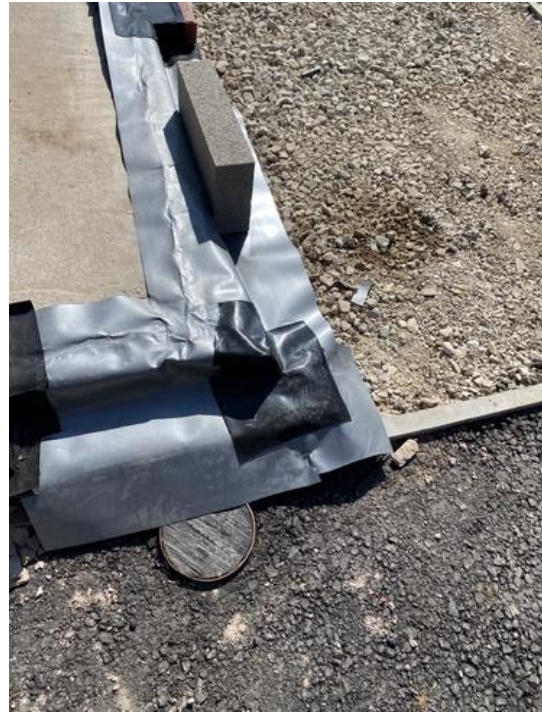
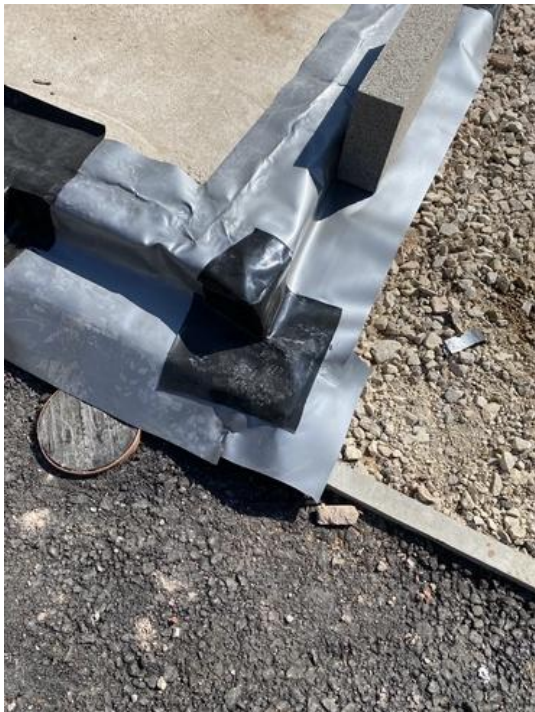
**Corners / Internal joints: Check all corners are correctly formed or contractor has used preformed corners.**

Pass

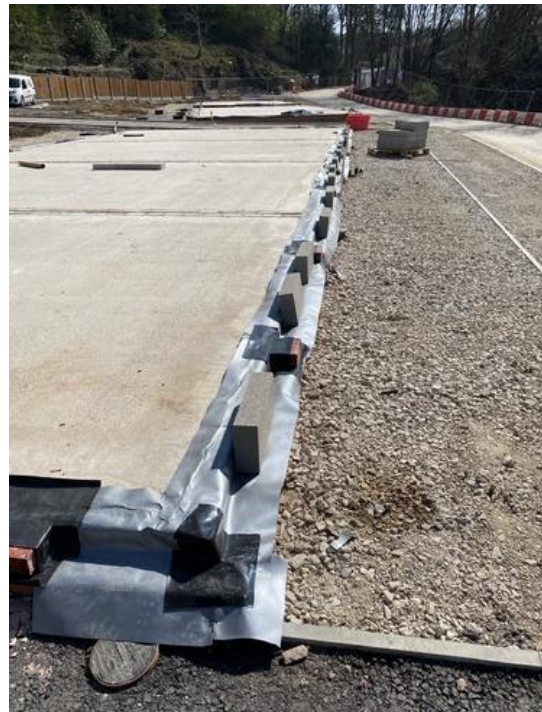
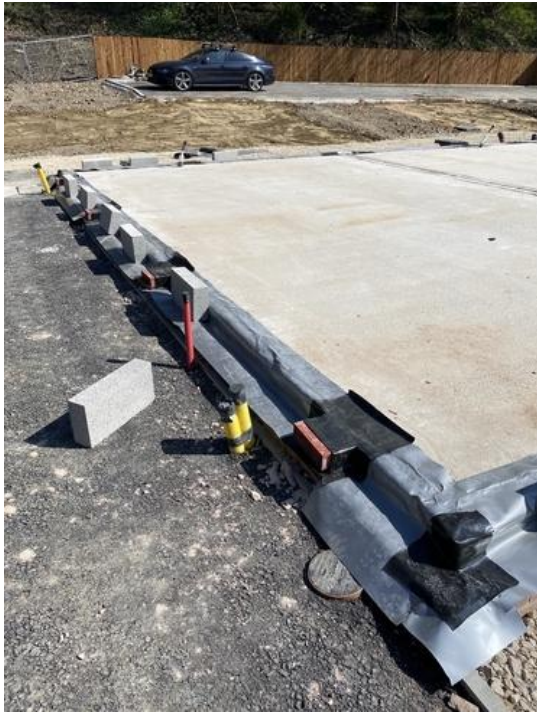
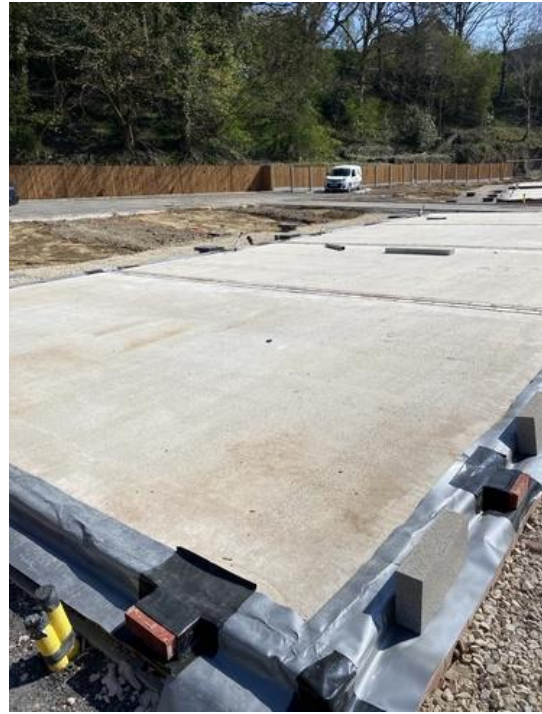
**Extent of Coverage: Is the membrane covering the entire plot? Does membrane span over outside walls?**

Yes

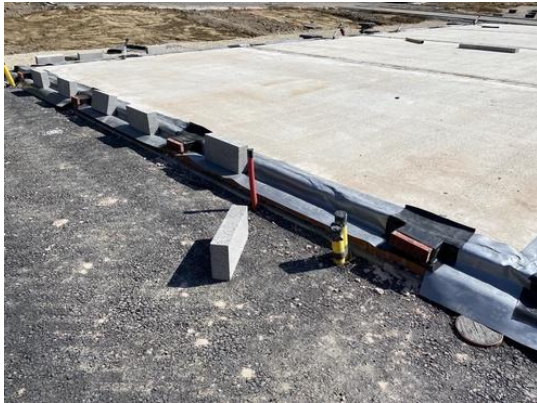
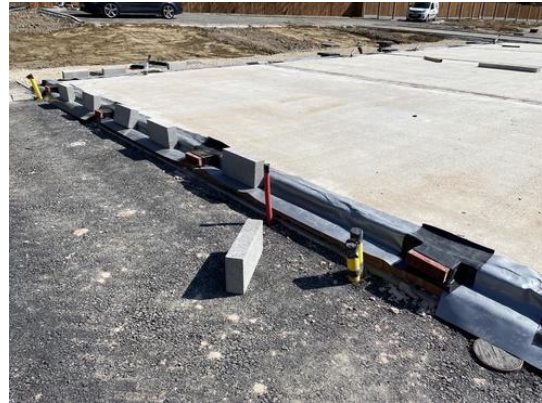
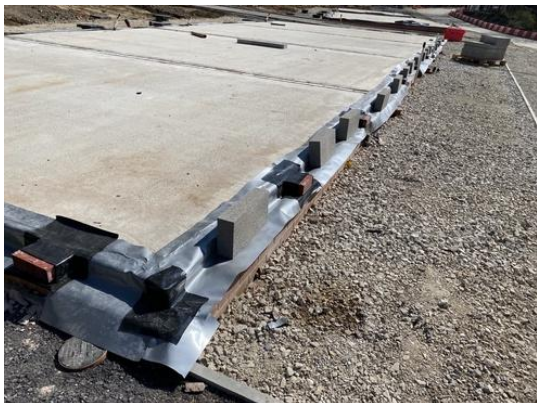
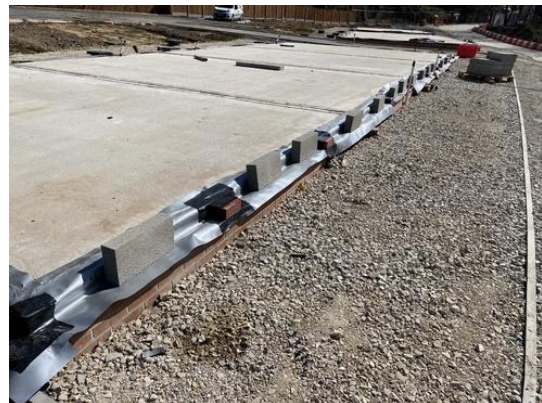
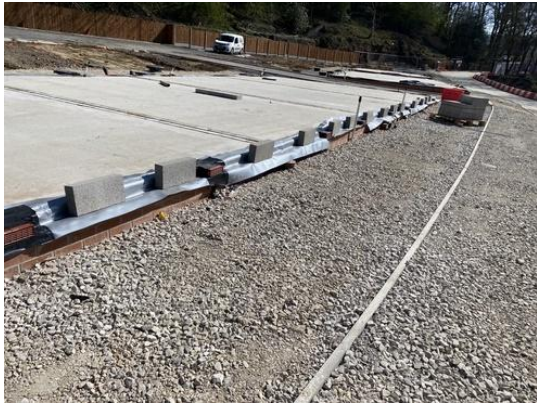
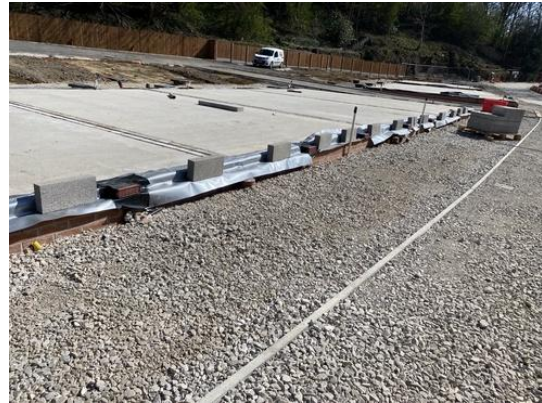
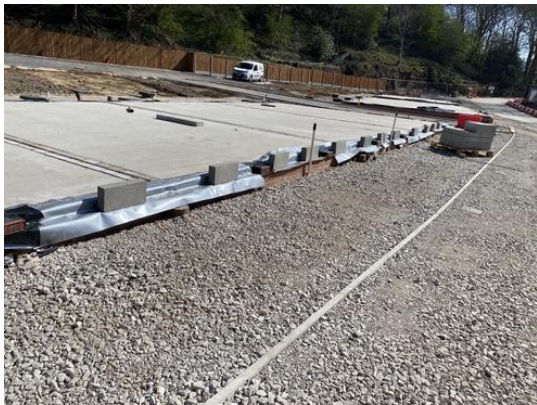
**External Wall Air bricks: Numbers, size. positions as design drawing? (Minimum of 3 walls)**

Pass
