Date: 28th May 2025  
Reference: 16465-V5

## GAS MEMBRANE VALIDATION – EDENFIELD ROAD, NORDEN

| <b>Client:</b> | Stonebond Group Ltd |
| <b>Plots:</b> | 17-19 |

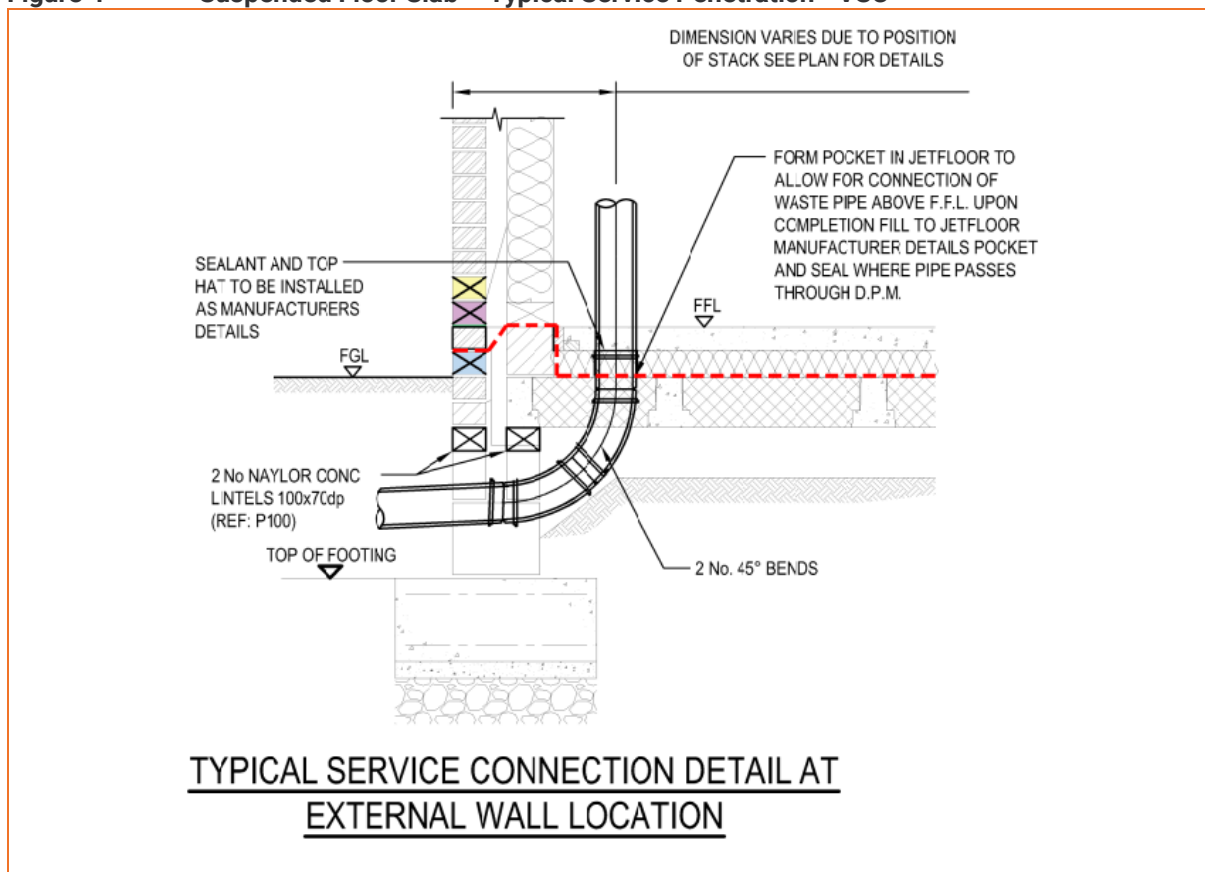
**Figure 4**      **Suspended Floor Slab – Typical Service Penetration - VSC**

Where any penetration or service duct is present within the floor area, E3P inspected each one in turn and can confirm that rigid black polyethylene top hat units have been adequately sealed against the membrane with double-sided jointing tape at both the base and the protruding pipe as well as being secured against the pipe with a metal jubilee clip.

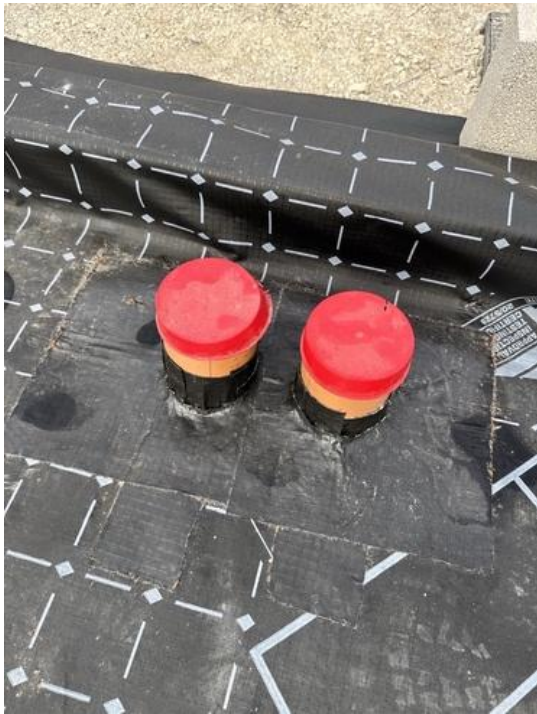
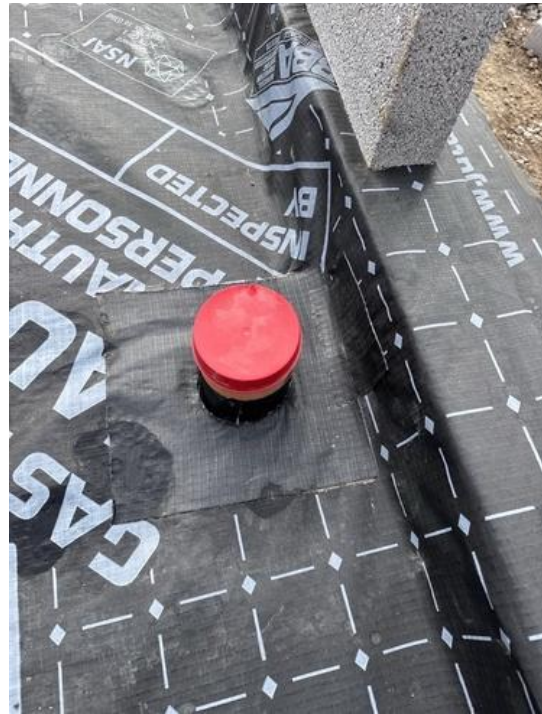
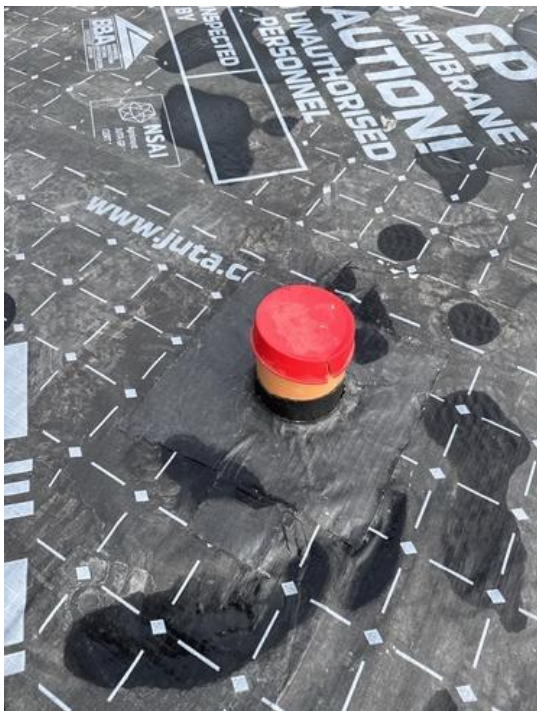
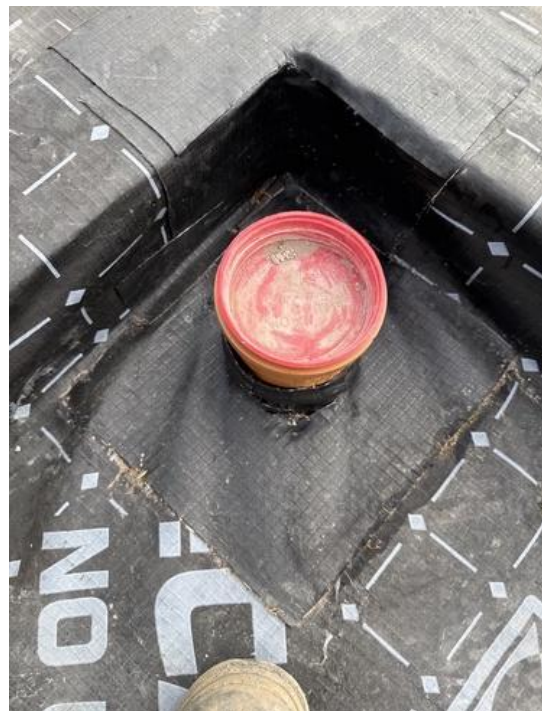
| <b>Service entries seals: Top hats seal arrangements fixed around service entries? Use of Jubilee clips or Bitumastic Sealant</b> | Pass |

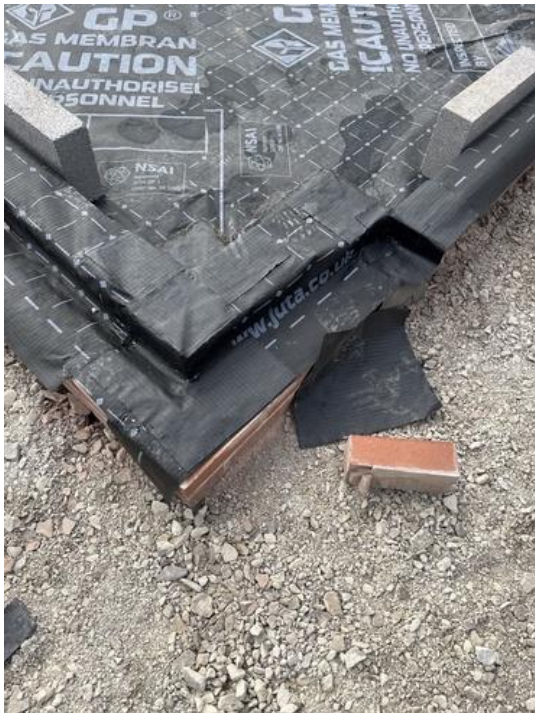
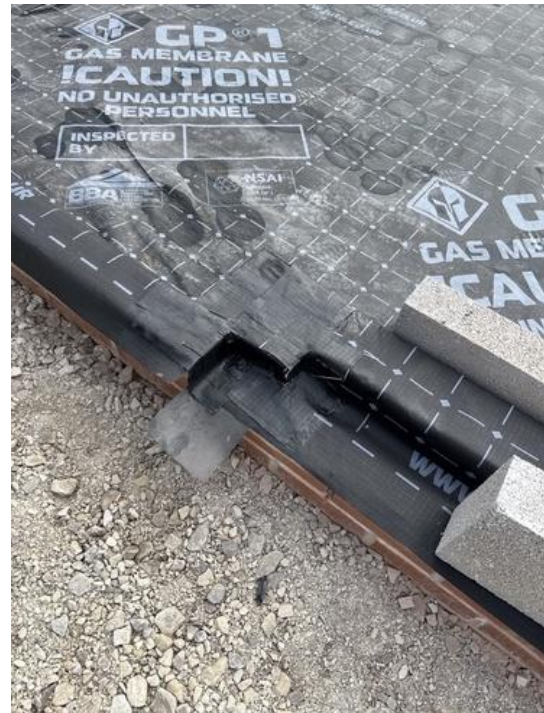
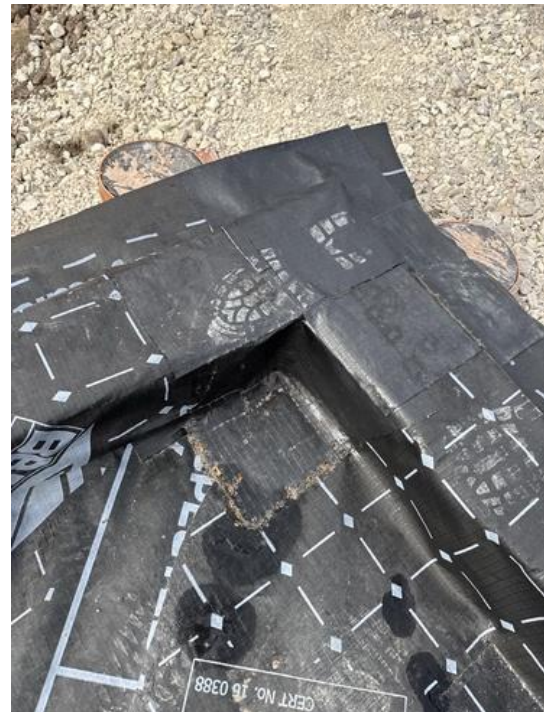
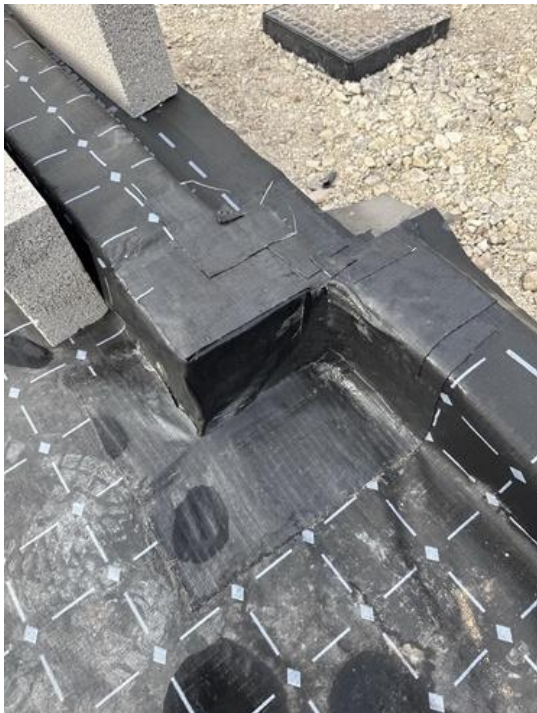
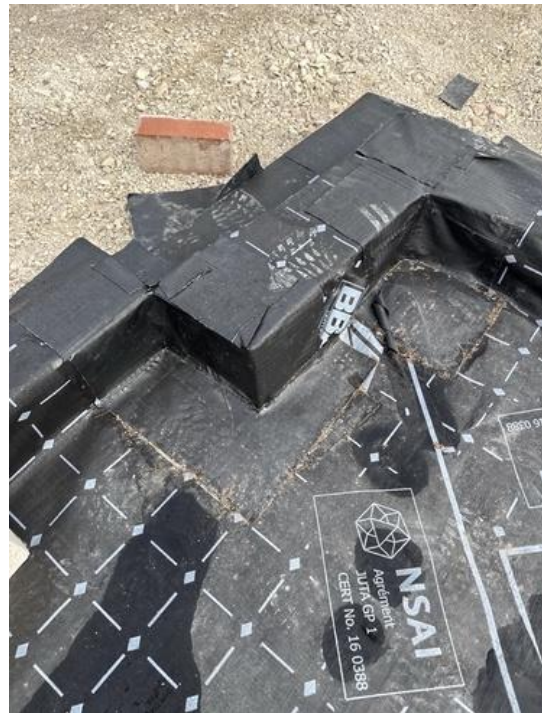
| <b>Corners / Internal joints: Check all corners are correctly formed or contractor has used preformed corners.</b> | Pass |

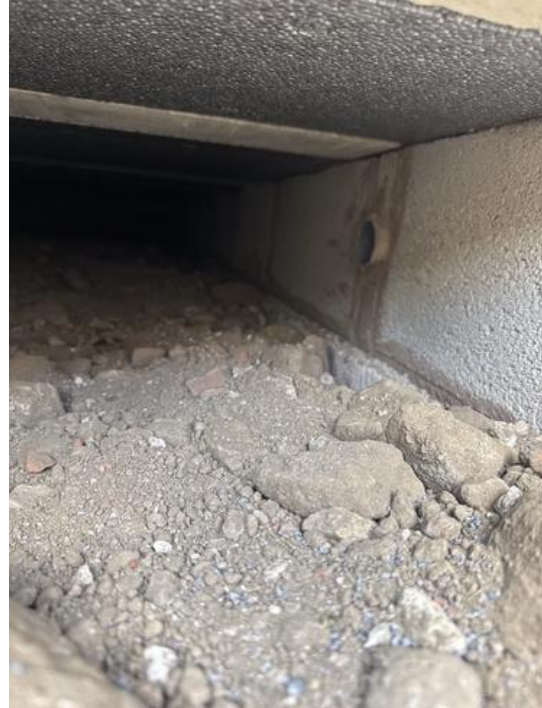
Photo 2

| Are Sleeper Walls Vented? | Yes |
