Date: 28th May 2025  
Reference: 16465-V7

## GAS MEMBRANE VALIDATION – EDENFIELD ROAD, NORDEN

| <b>Project Name:</b> | Edenfield Road, Rochdale |
| <b>Plots:</b> | 40-42 |

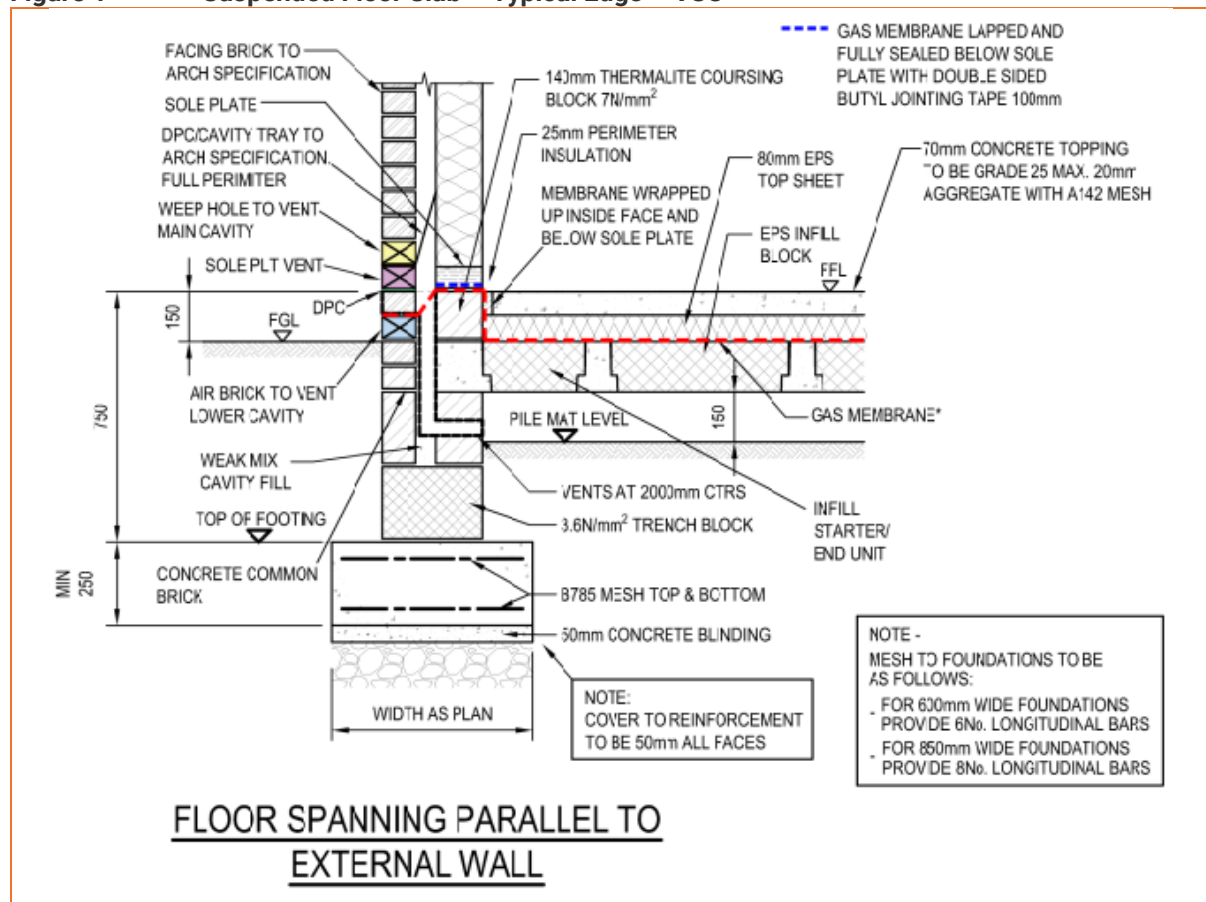
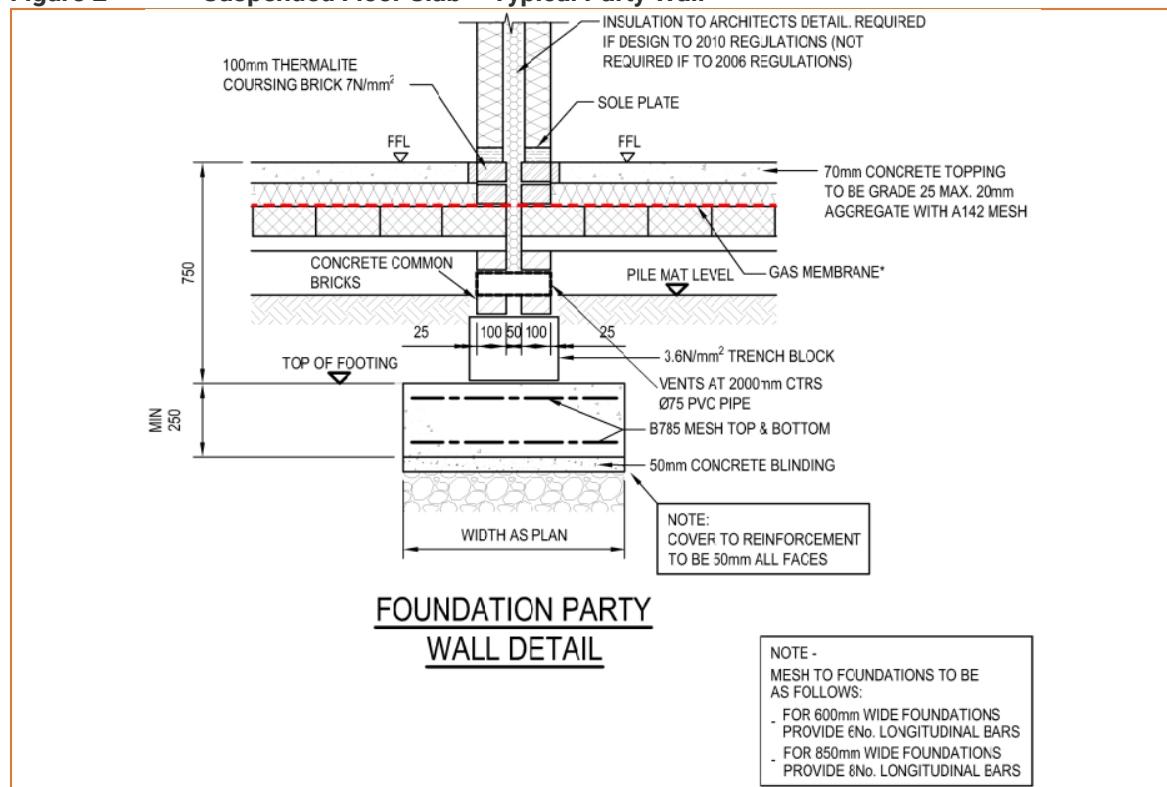
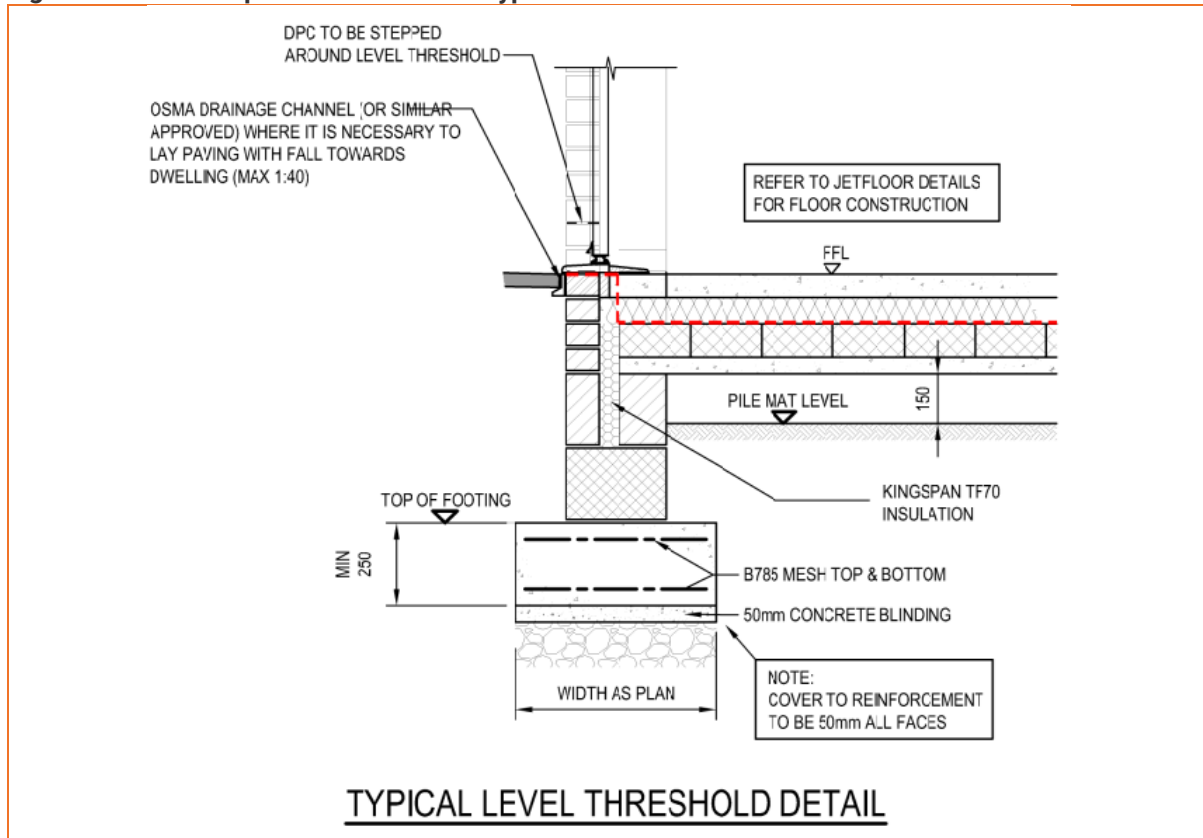
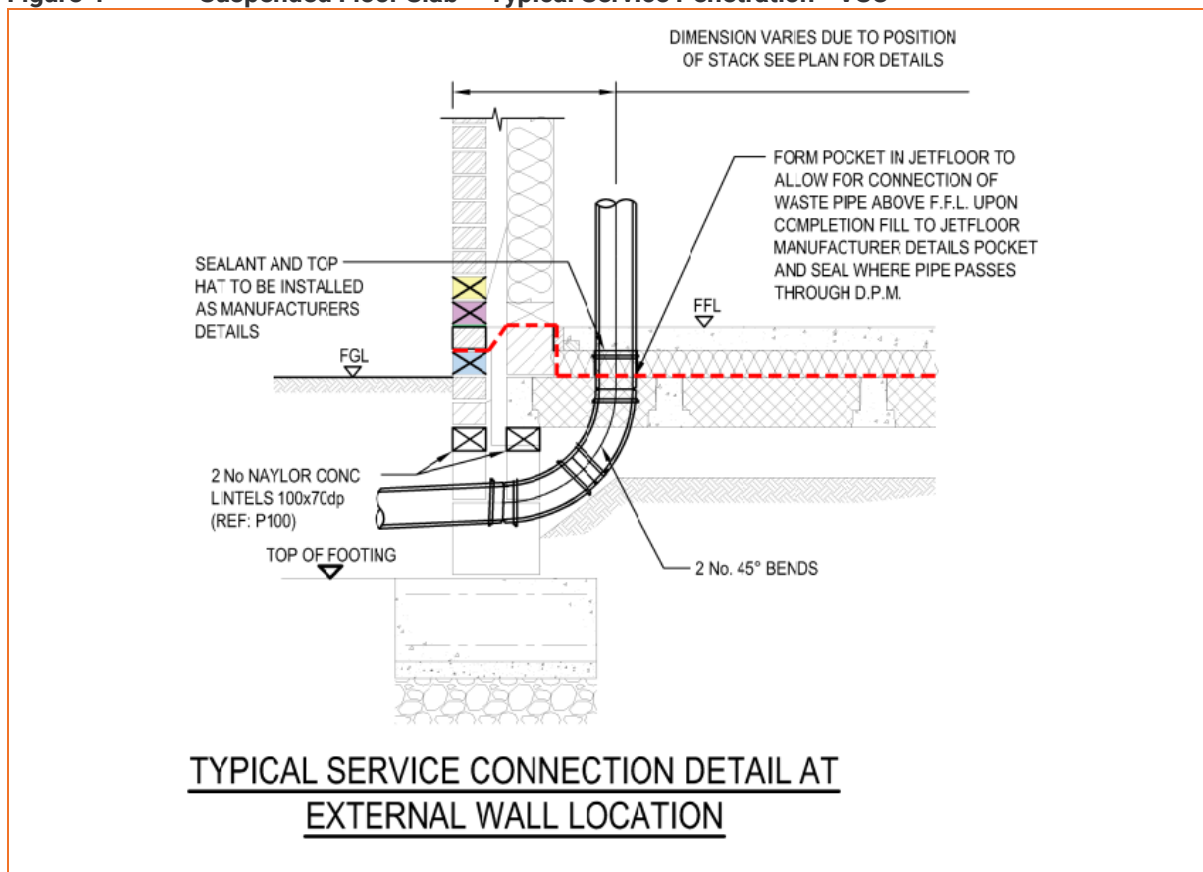
It has been confirmed as part of the validation that the membrane utilised in the plots discussed herein matches that of **Figures 1-4**.

The E3P Technician has inspected the installation of this membrane in line with the structural engineer's specifications in terms of placement and position (**Figures 1-4**), and the manufacturer's detail in terms of the workmanship.

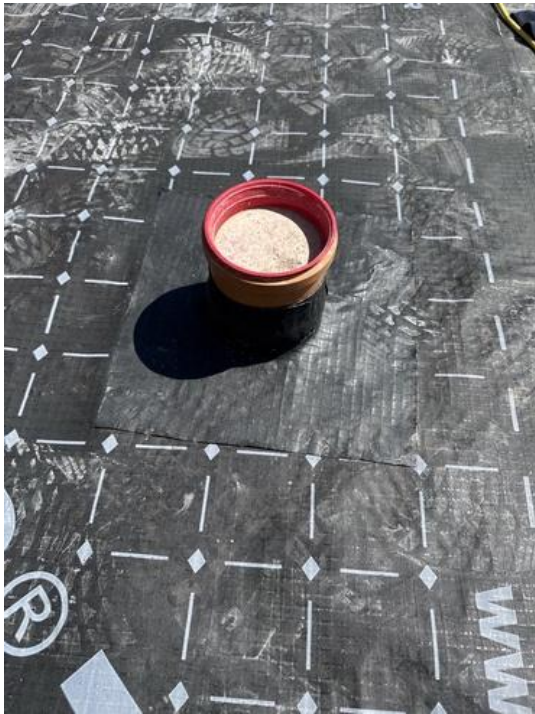
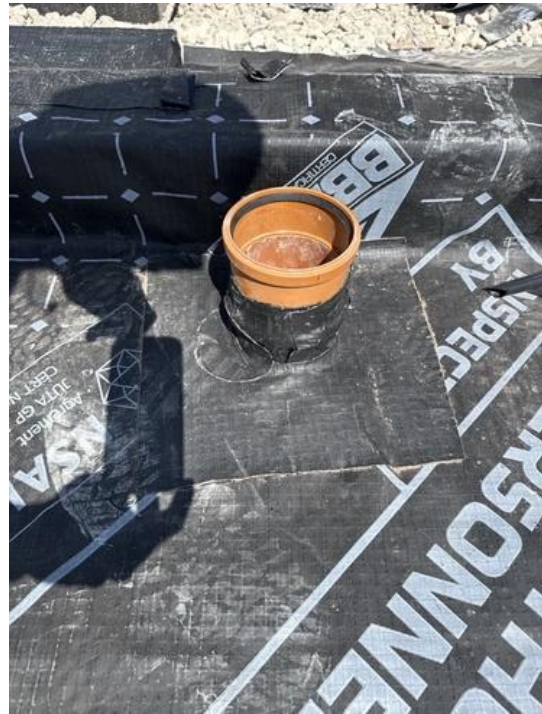
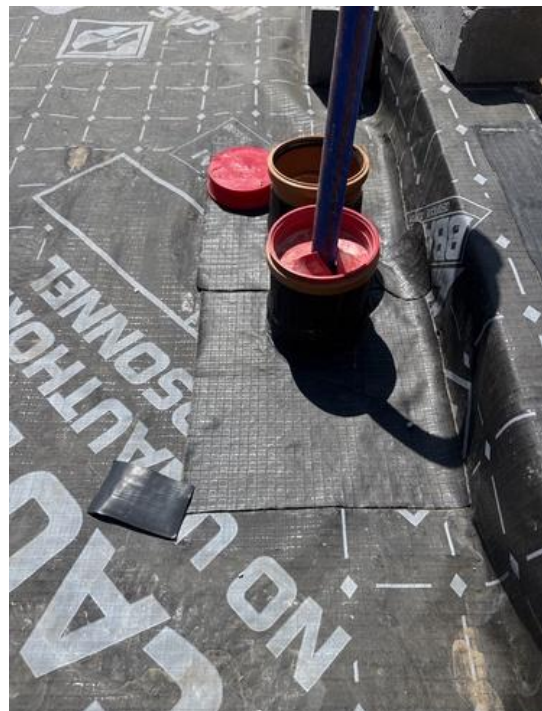
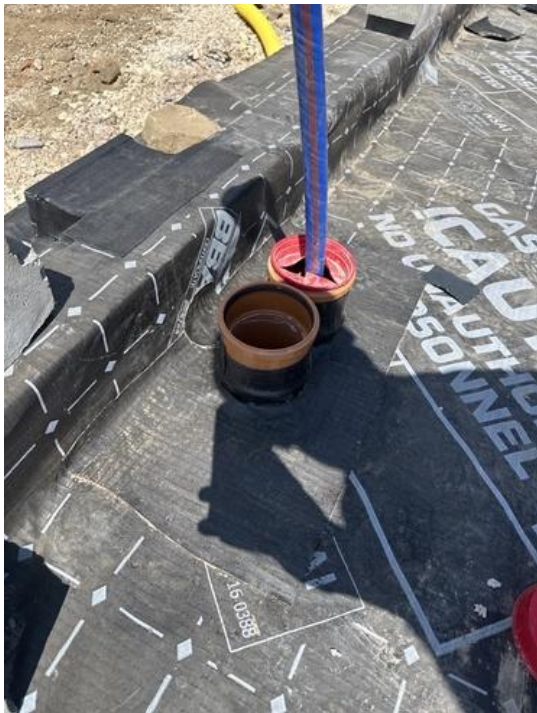
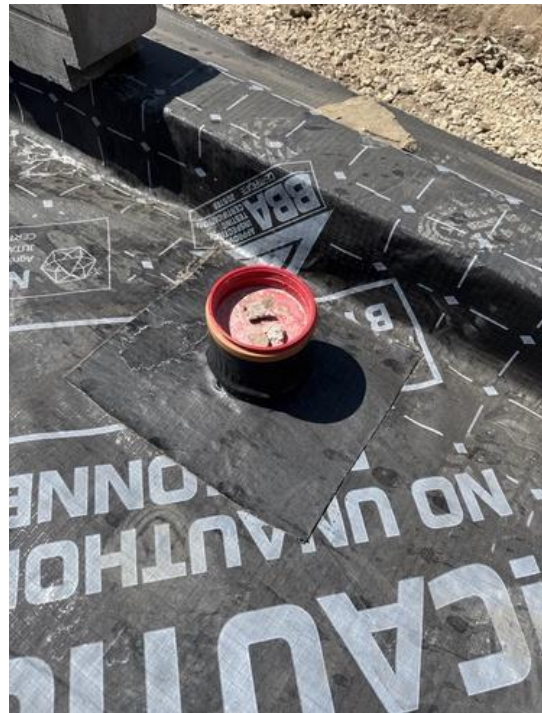
| <b>Service entries seals: Top hats seal arrangements fixed around service entries? Use of Jubilee clips or Bitumastic Sealant</b> | Pass |

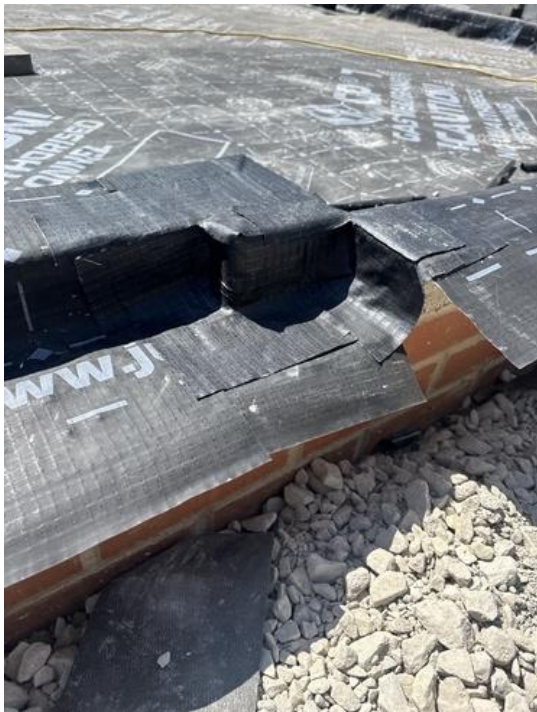
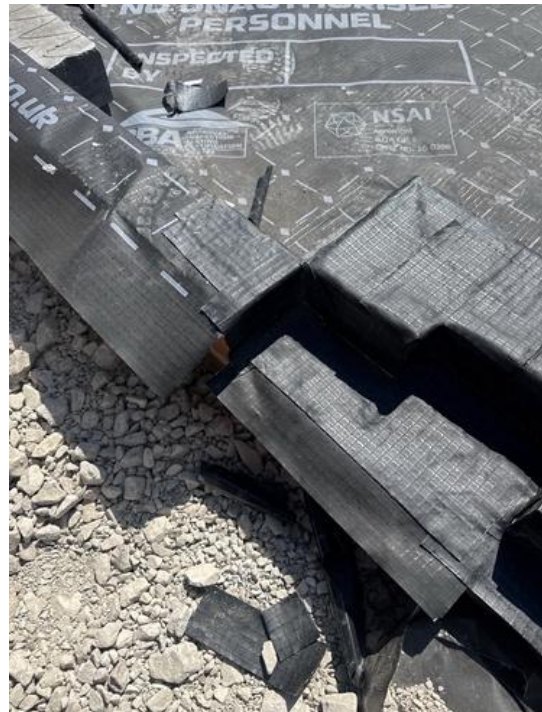
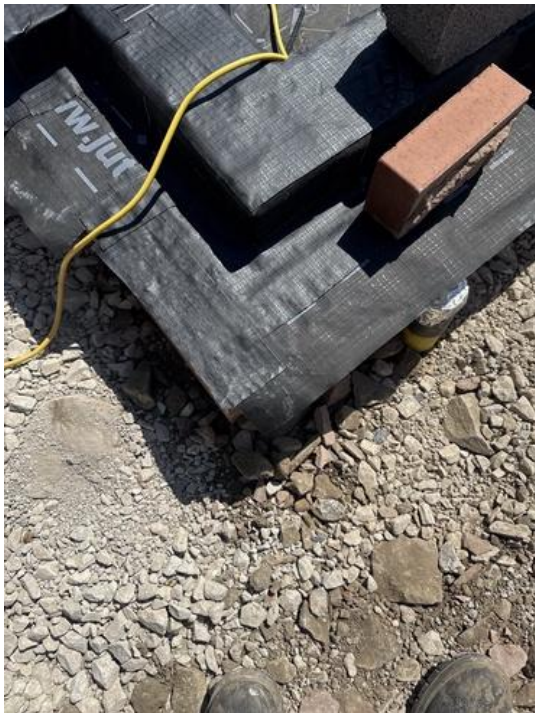
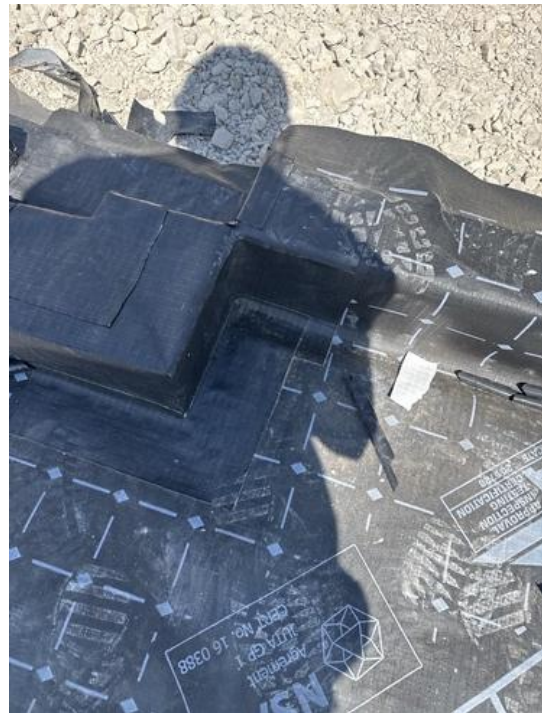
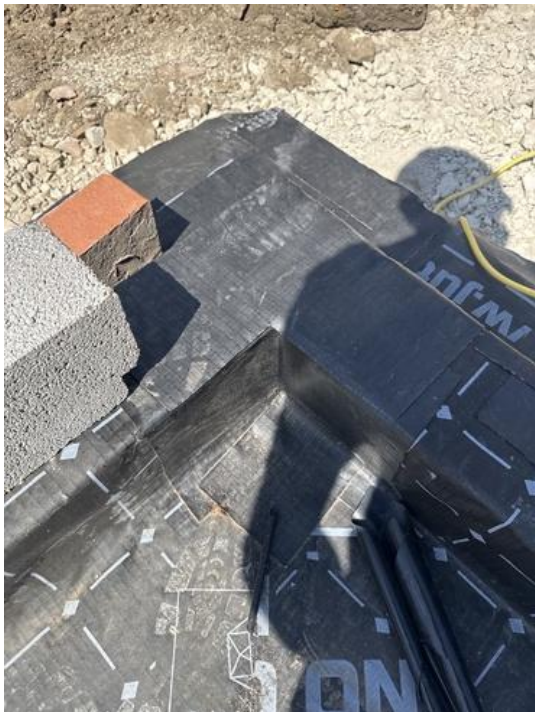
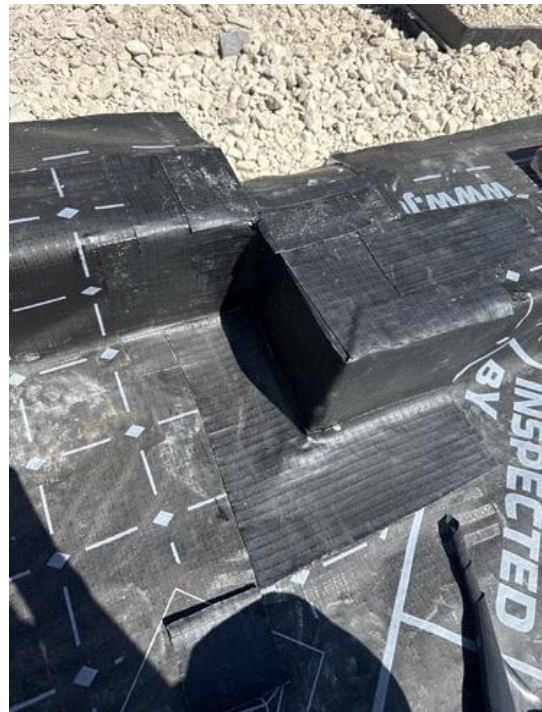
| <b>Corners / Internal joints: Check all corners are correctly formed or contractor has used preformed corners.</b> | Pass |

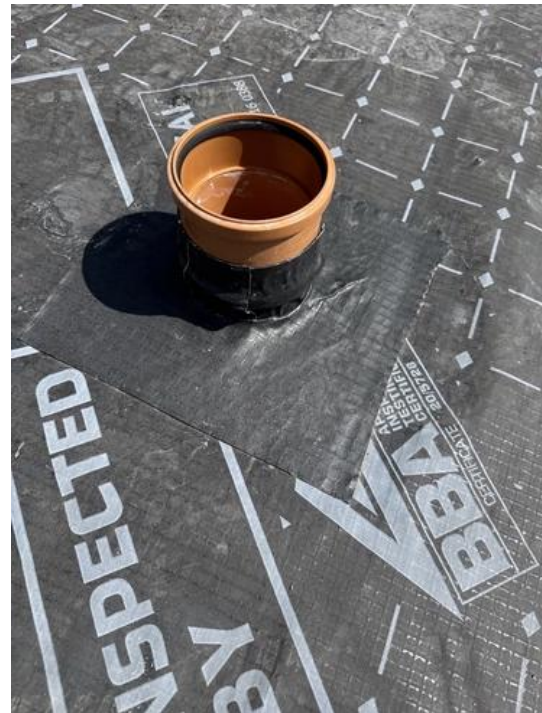
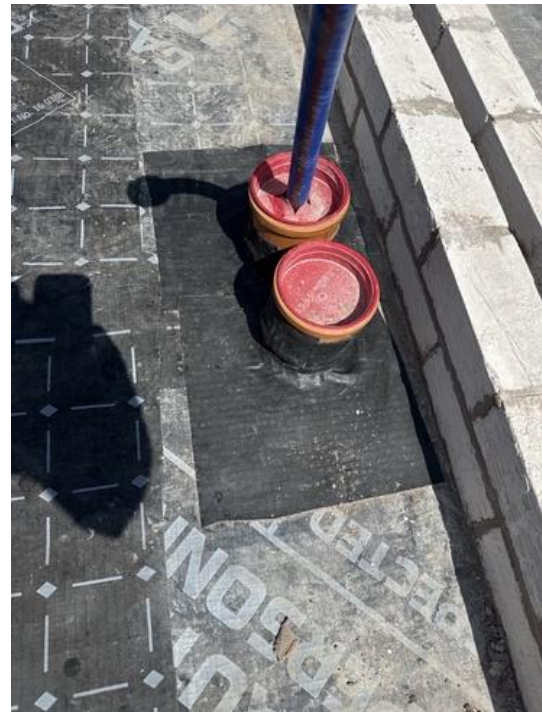
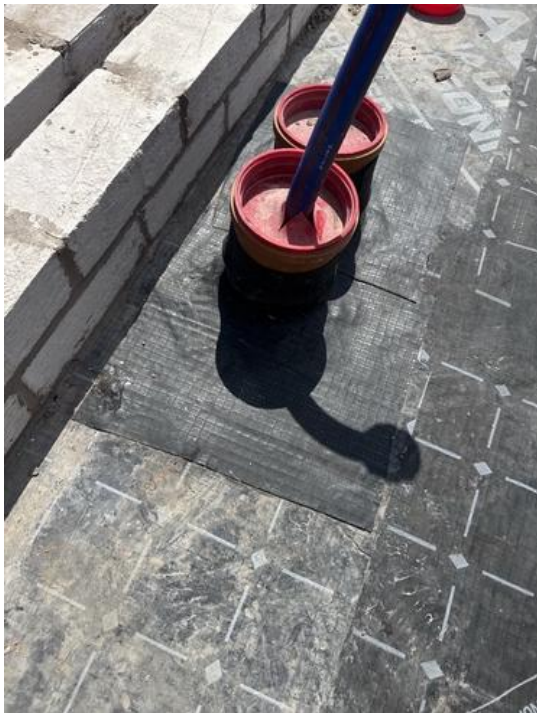
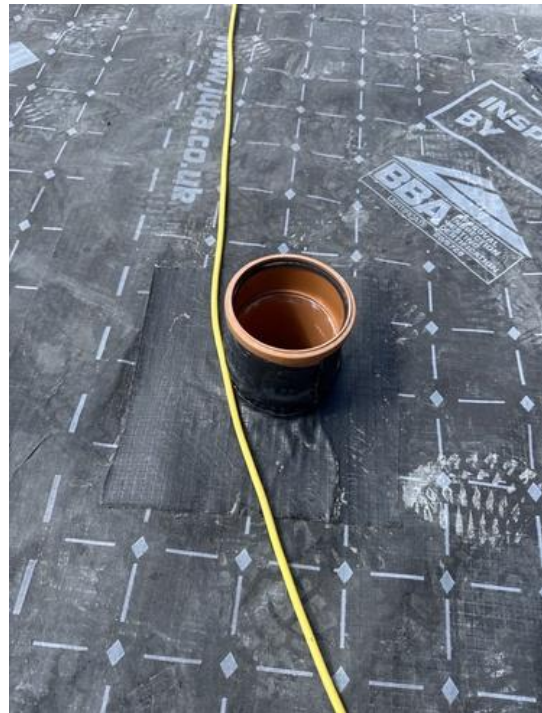
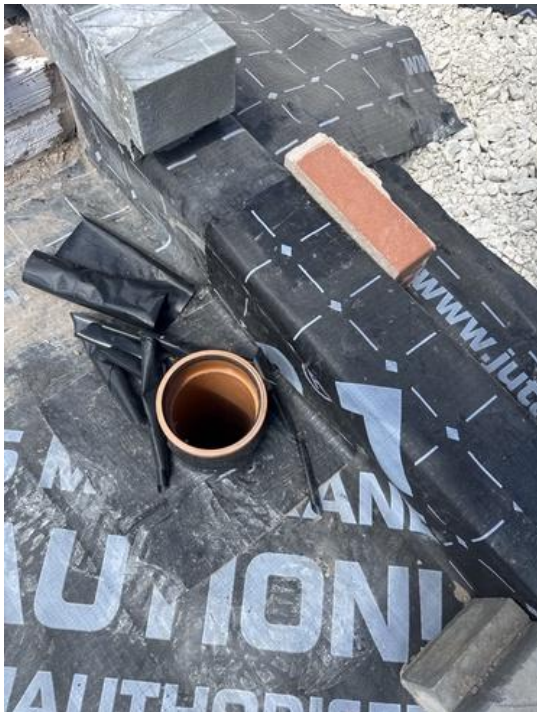
| Service entries seals: Top hats seal arrangements fixed around service entries? Use of Jubilee clips or Bitumastic Sealant | Pass | |

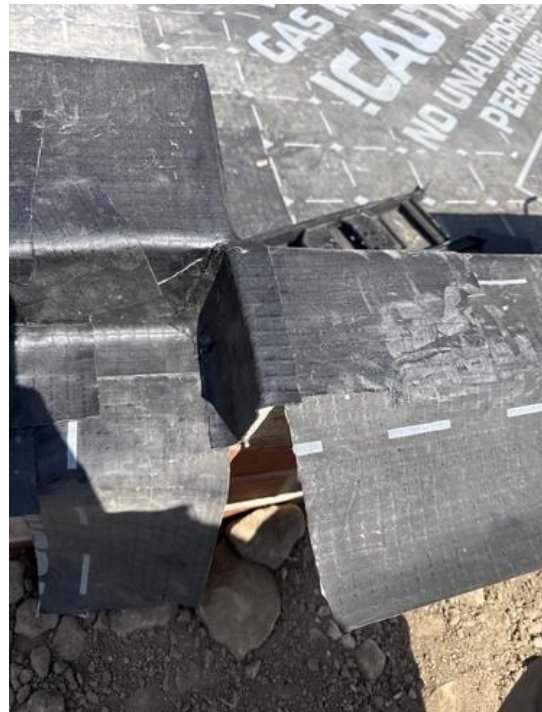
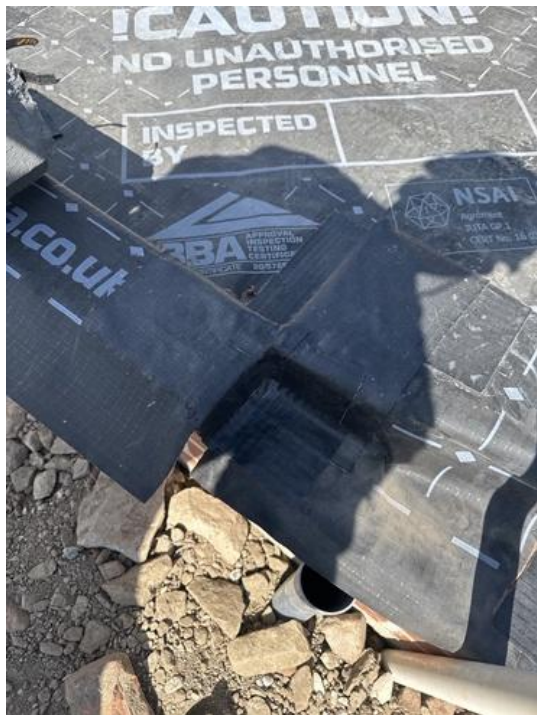
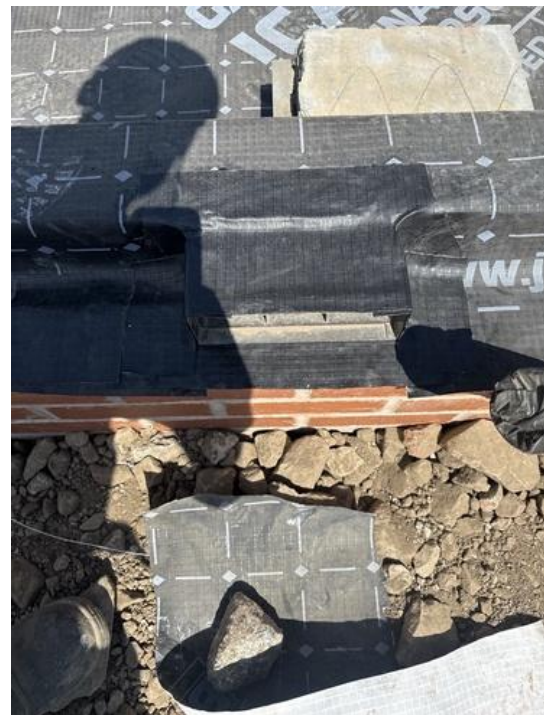
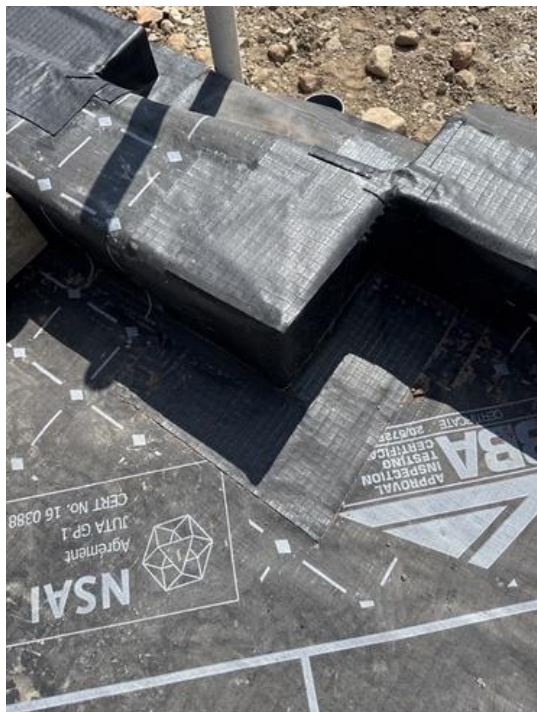
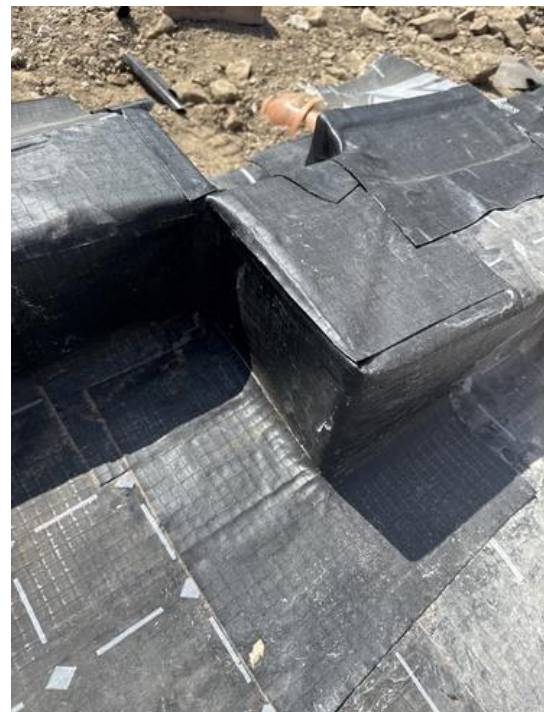
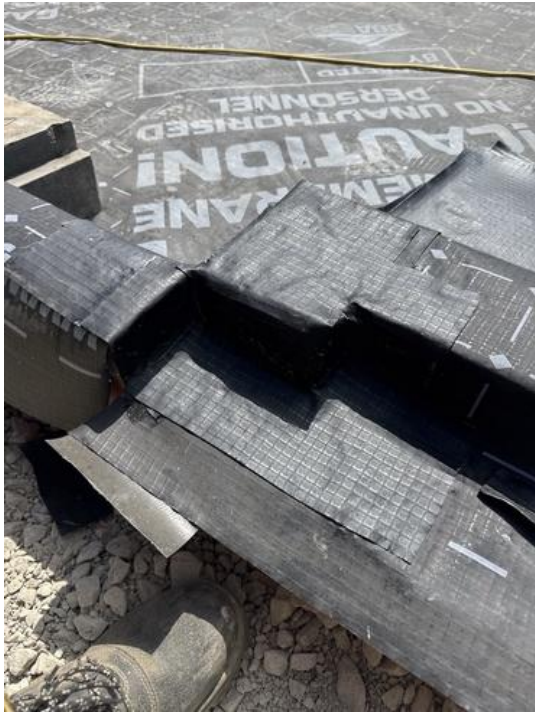
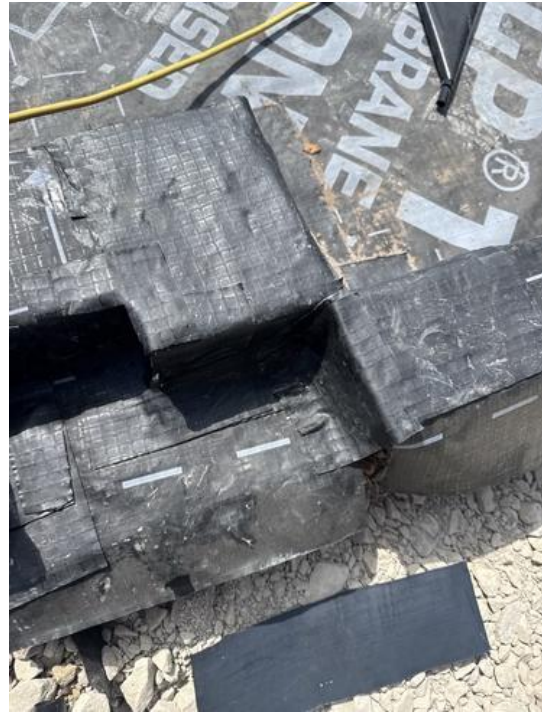
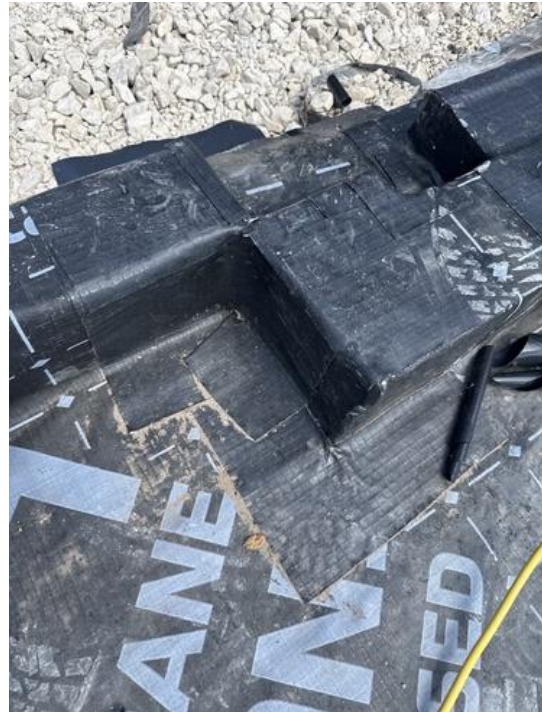
| Corners / Internal joints: Check all corners are correctly formed or contractor has used preformed corners. | Pass | |

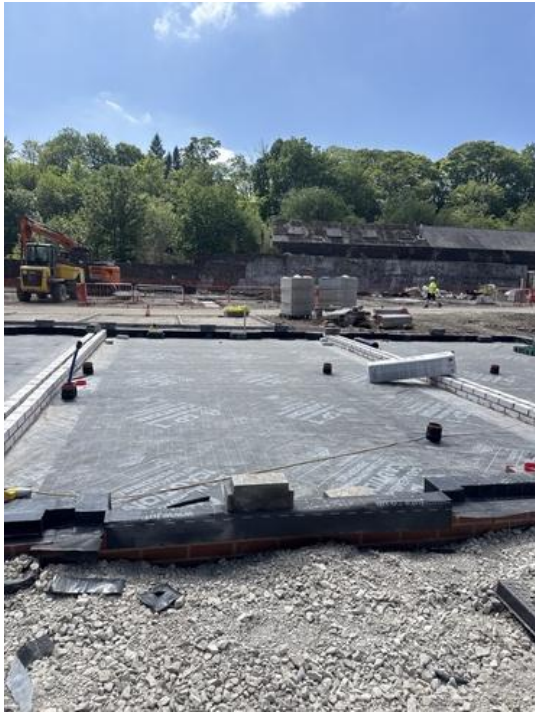
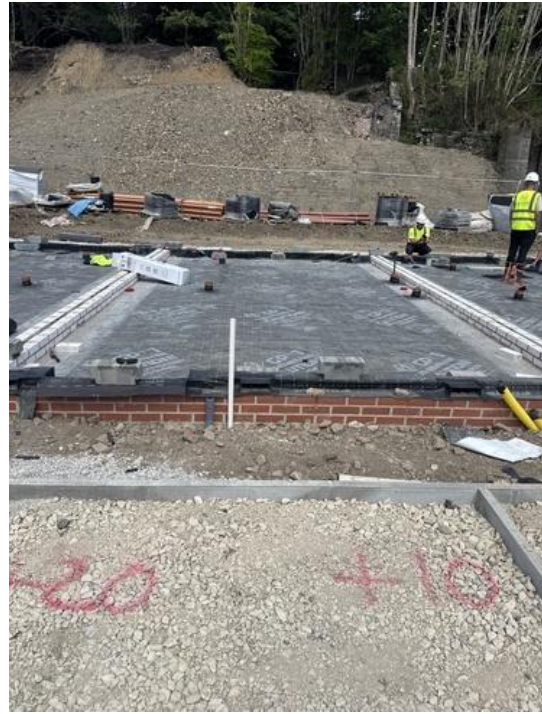
| Extent of Coverage: Is the membrane covering the entire plot? Does membrane span over outside walls? | Yes |

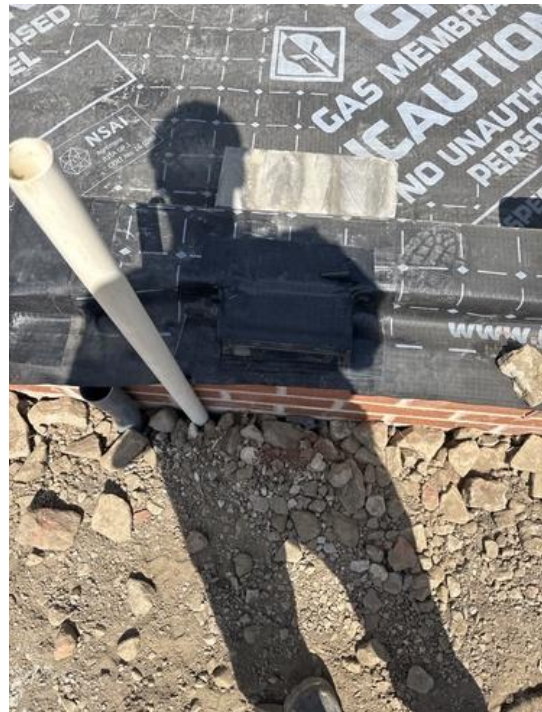
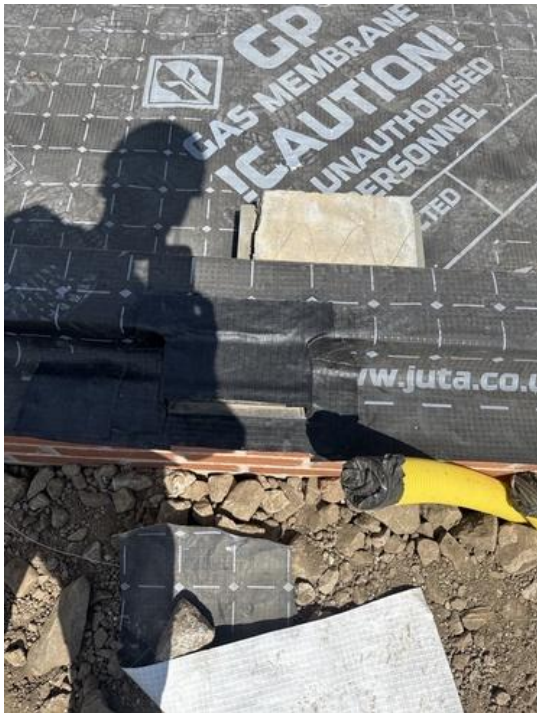
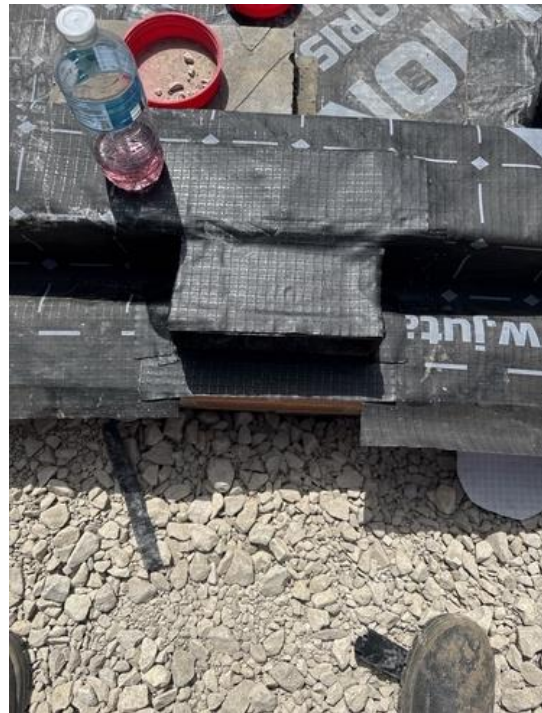
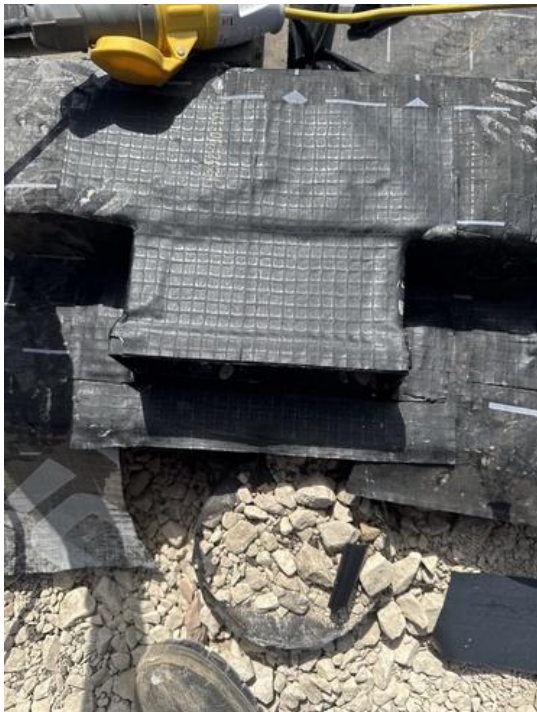
| External Wall Air bricks: Numbers, size. positions as design drawing? (Minimum of 3 walls) | Pass |

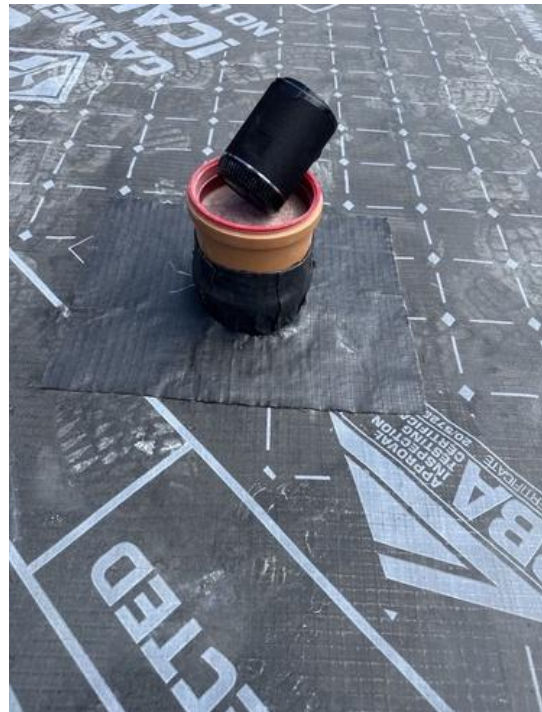
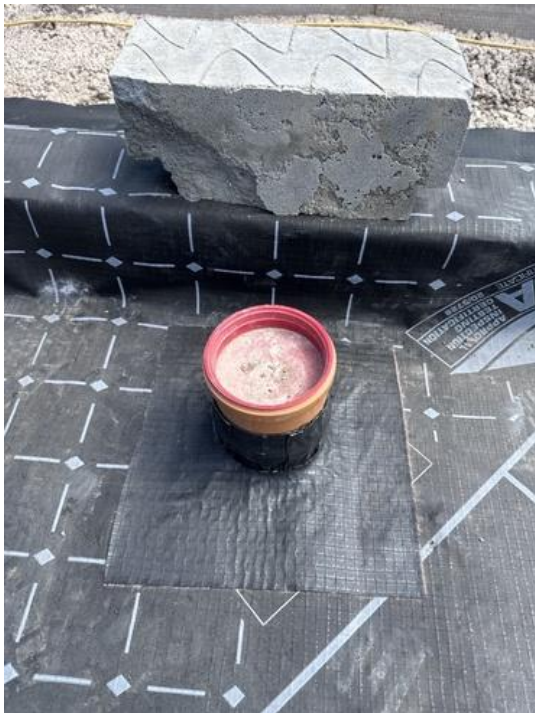
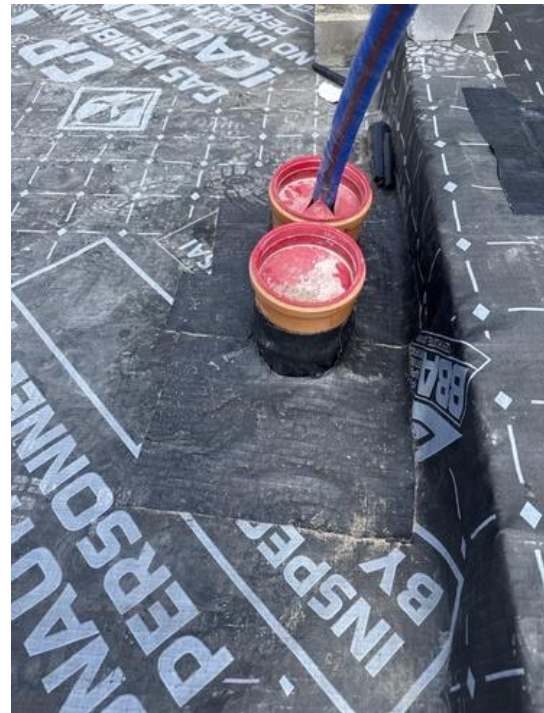
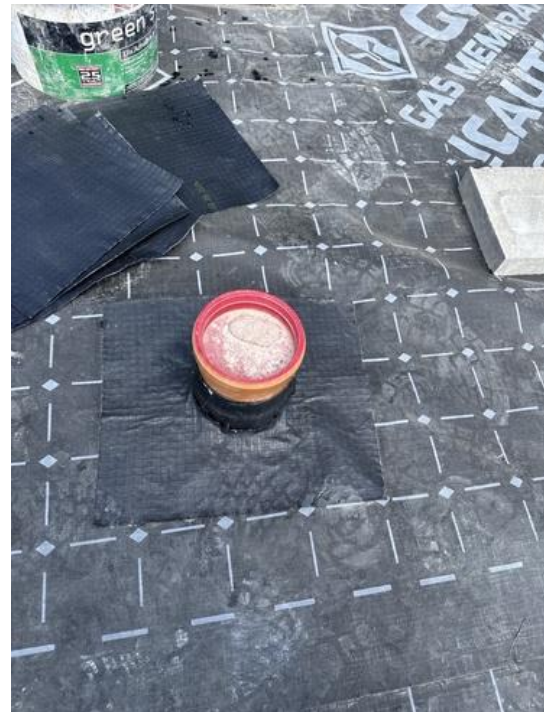
| Service entries seals: Top hats seal arrangements fixed around service entries? Use of Jubilee clips or Bitumastic Sealant | | Pass |

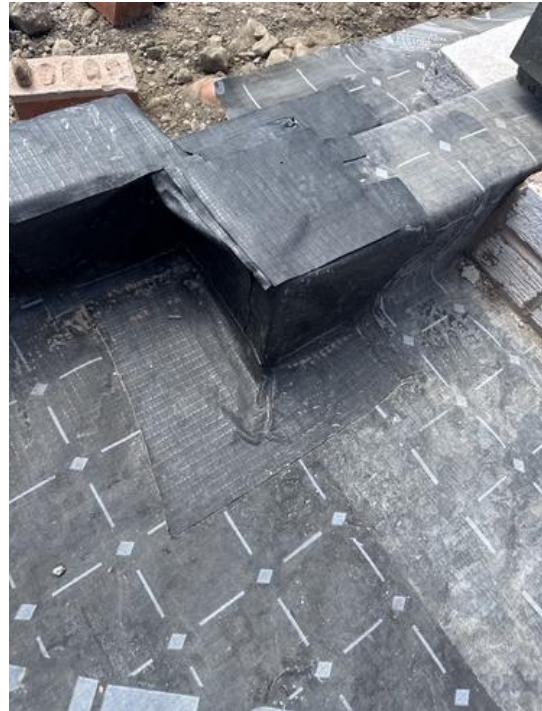
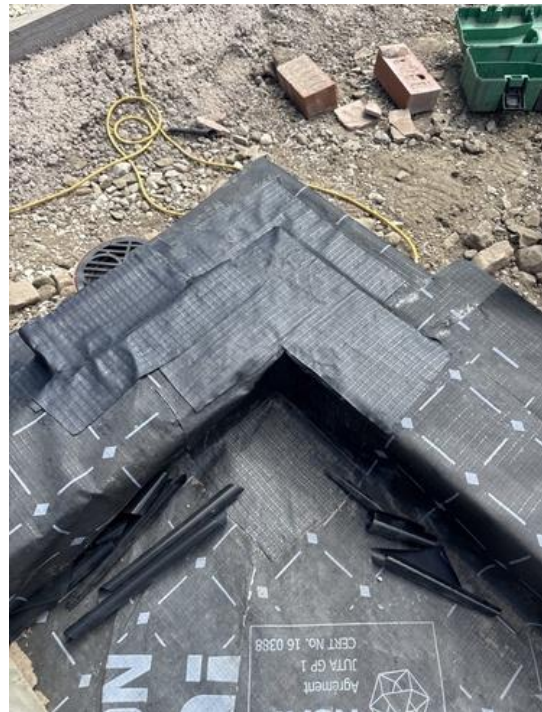
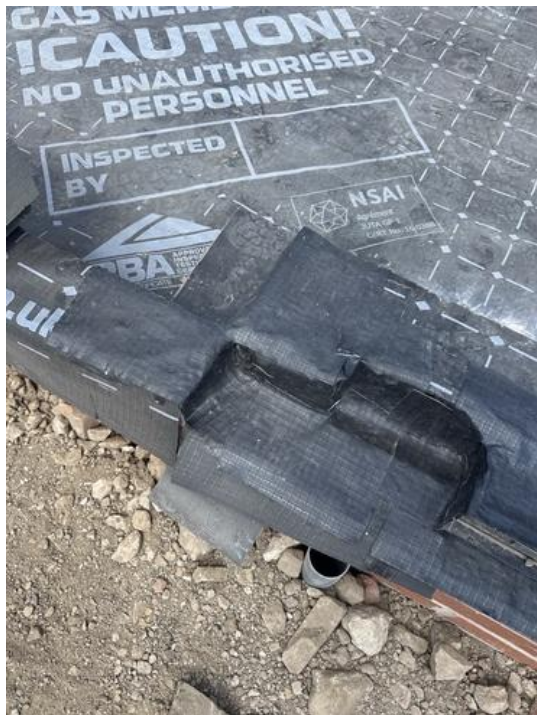
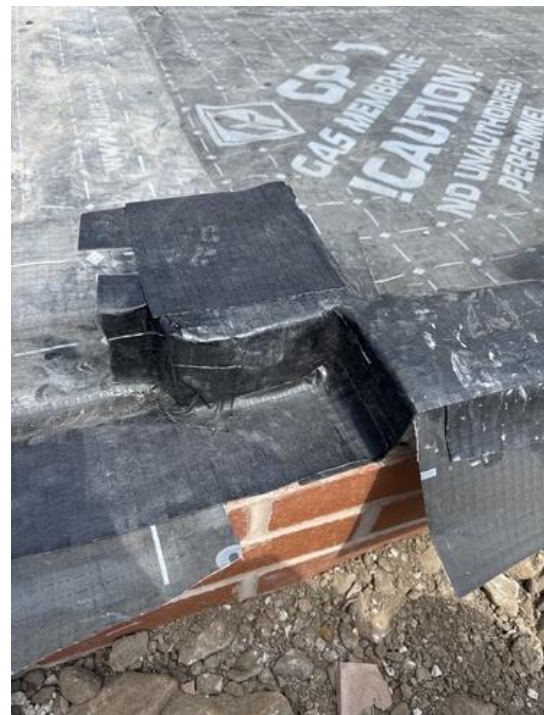
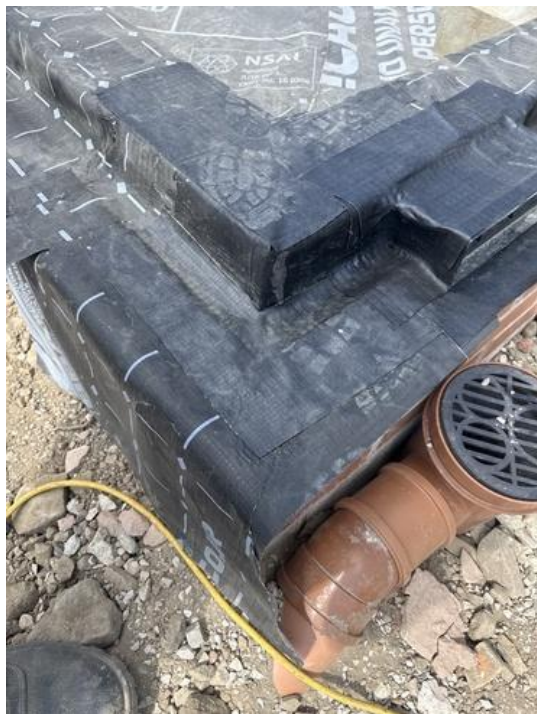
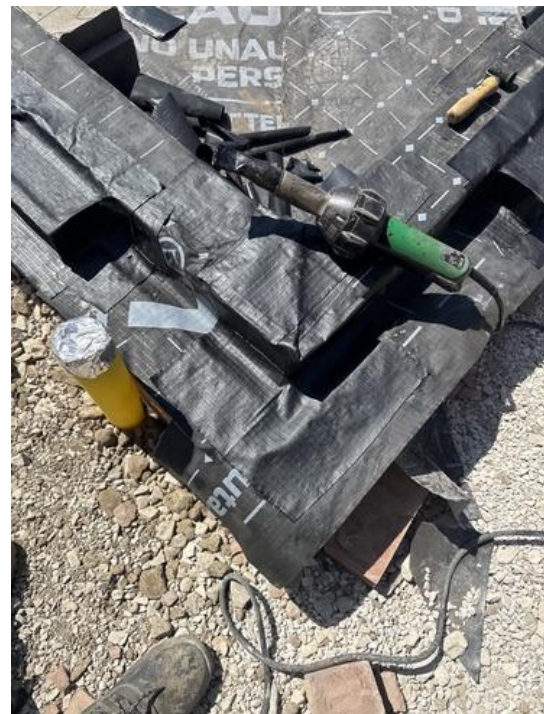
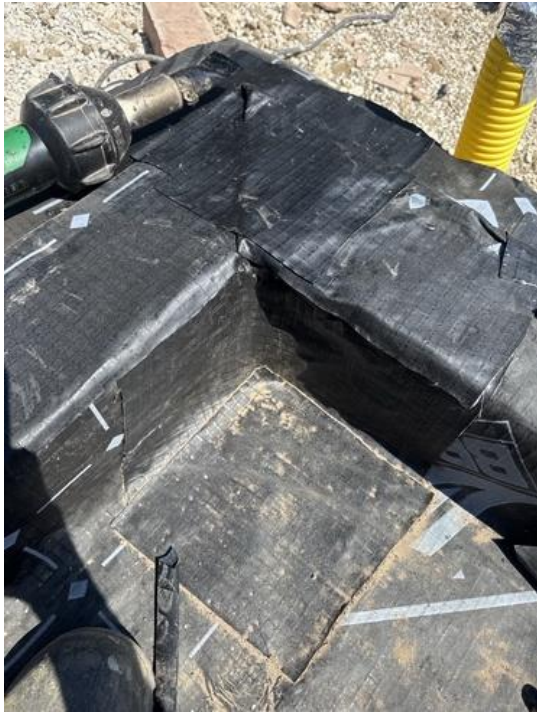
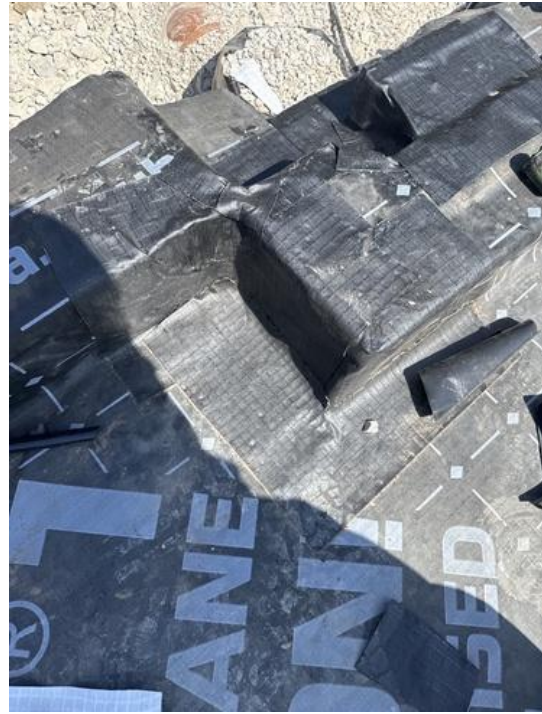
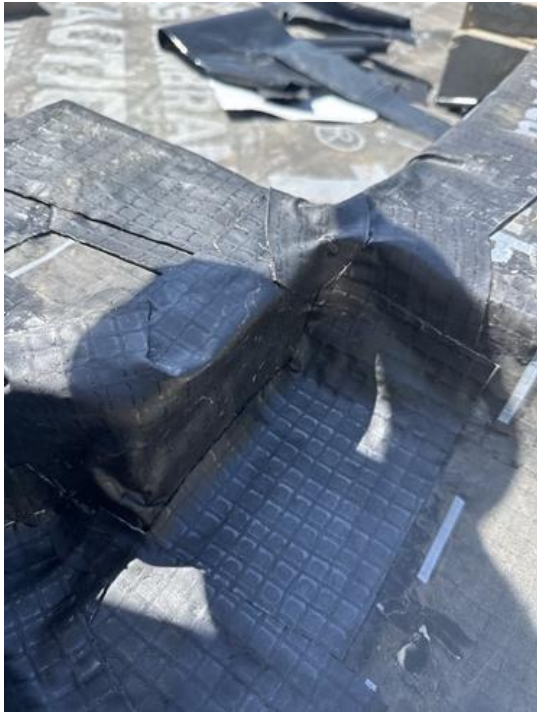
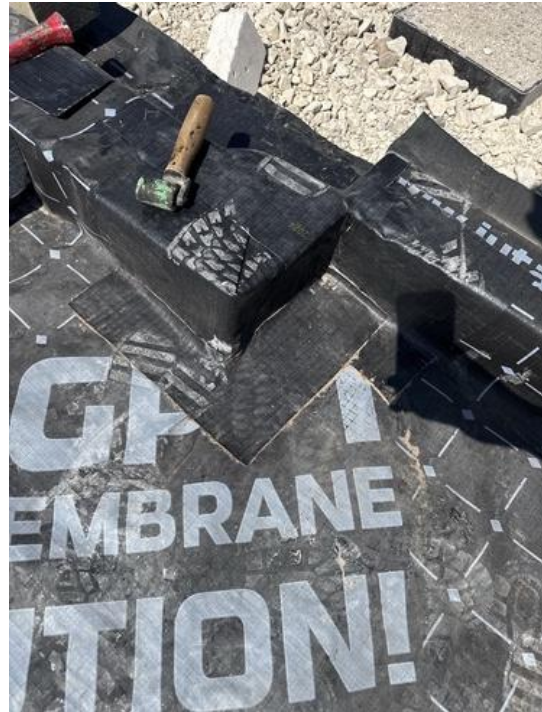
| Corners / Internal joints: Check all corners are correctly formed or contractor has used preformed corners. | | Pass |
