Touchstones Art Gallery, Rochdale

Roof Zone 1  
West Dormer and Chimney Details

| Project | RTAG.03 | No | 2011 |

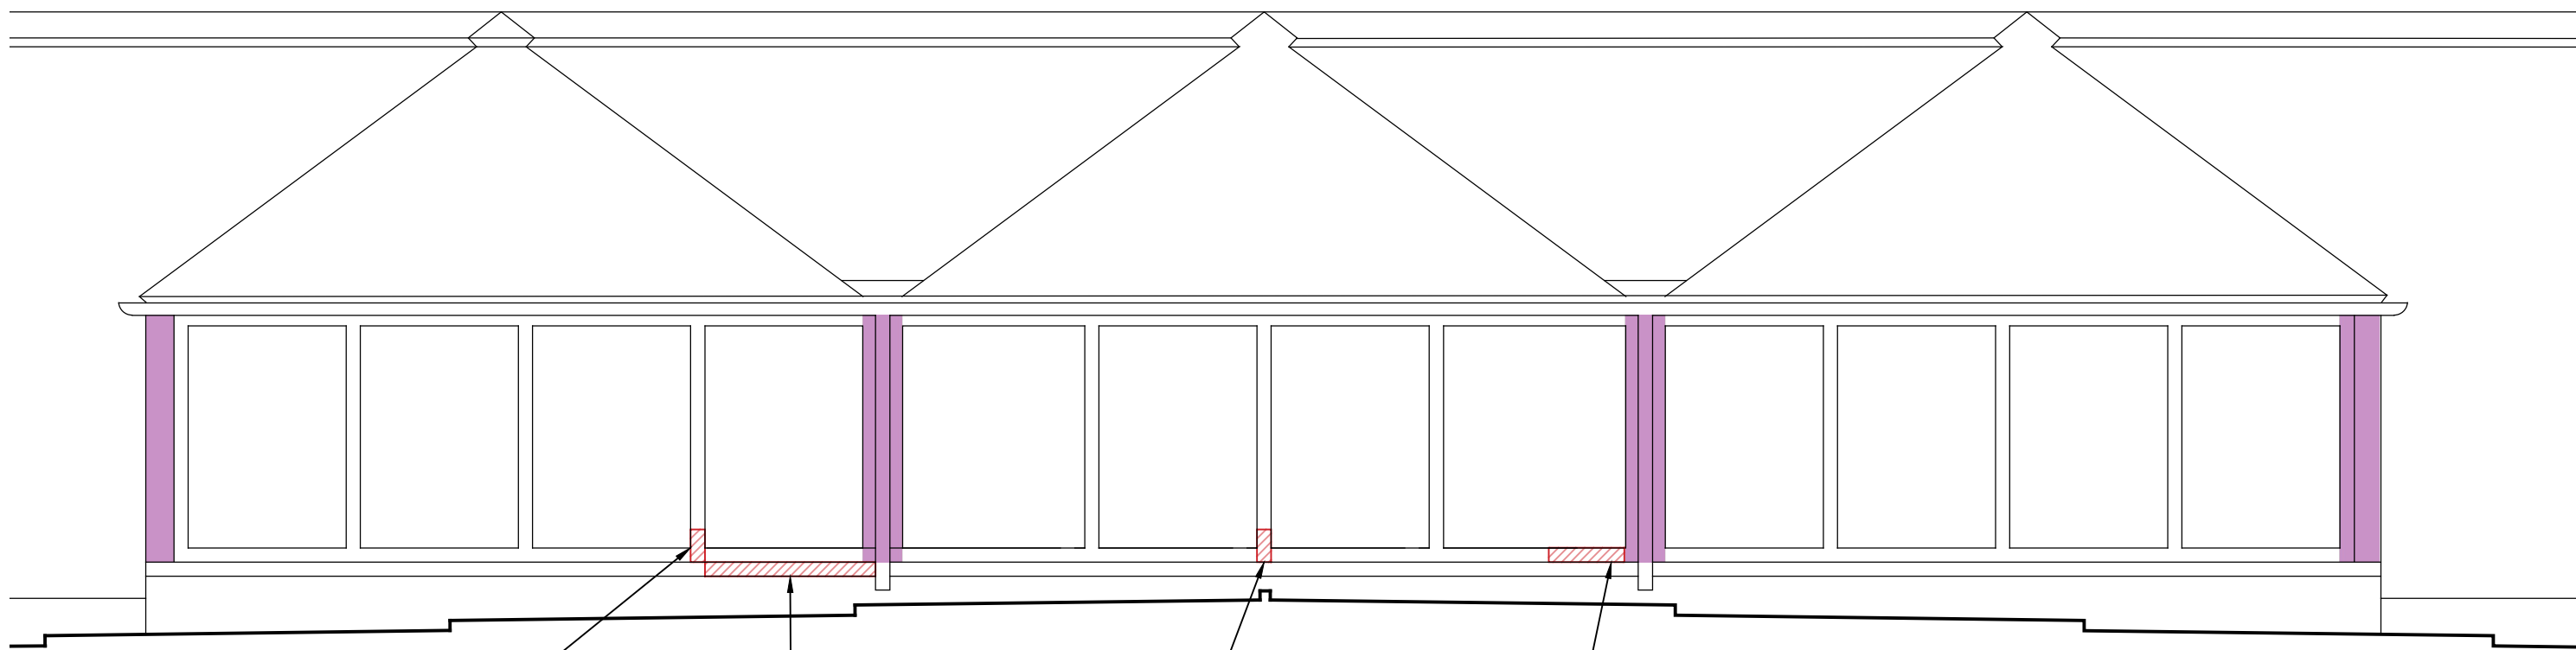
03  
2011  
West Dormer Elevation  
1:nts @ A1

Split at mullion needs to be filled as NBS P10 before re-decoration as NBS M60.

Split bead to be replaced to match existing profile as NBS C51.

Splice repairs at section of cill next to post as NBS C51.

Dormer windows over 3nos. bays. Each bay is split into 4nos. windows. Allow to replace bead underneath the cill as NBS G20 to match existing.

Allow to install new code 5 lead flashing as NBS H71 and LSA guidelines over timber frames separating dormer windows.
