## GAS MEMBRANE VALIDATION – EDENFIELD ROAD, NORDEN

| <b>Project Name:</b> | Edenfield Road, Norden |
| <b>Project Number:</b> | 16-465 |
| <b>Plots:</b> | 13-14 |

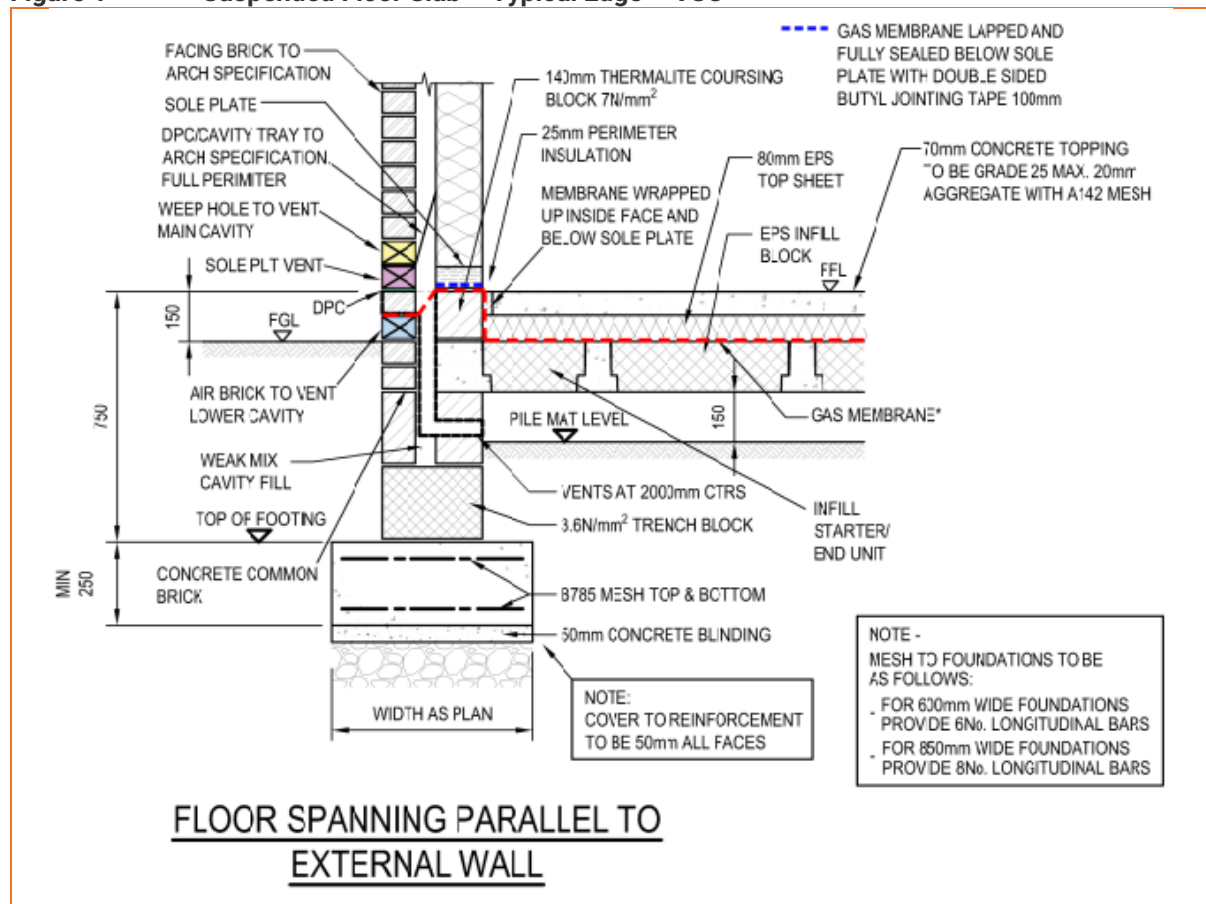
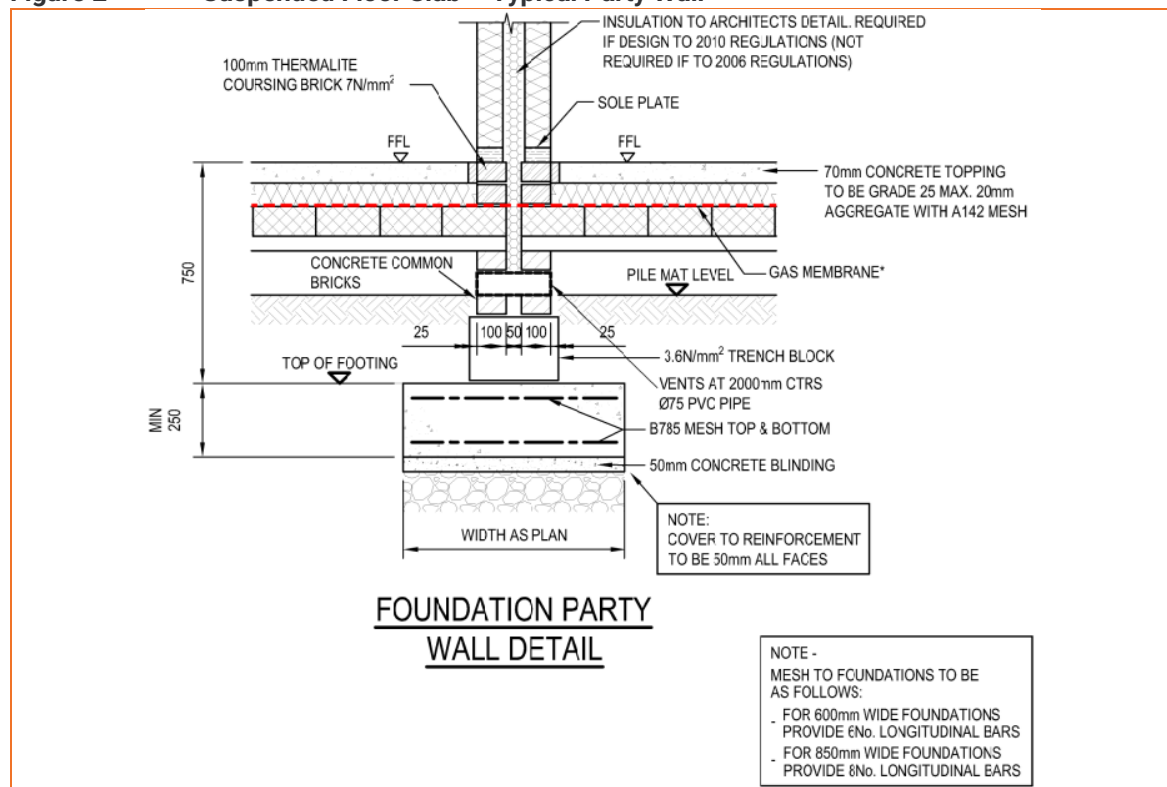
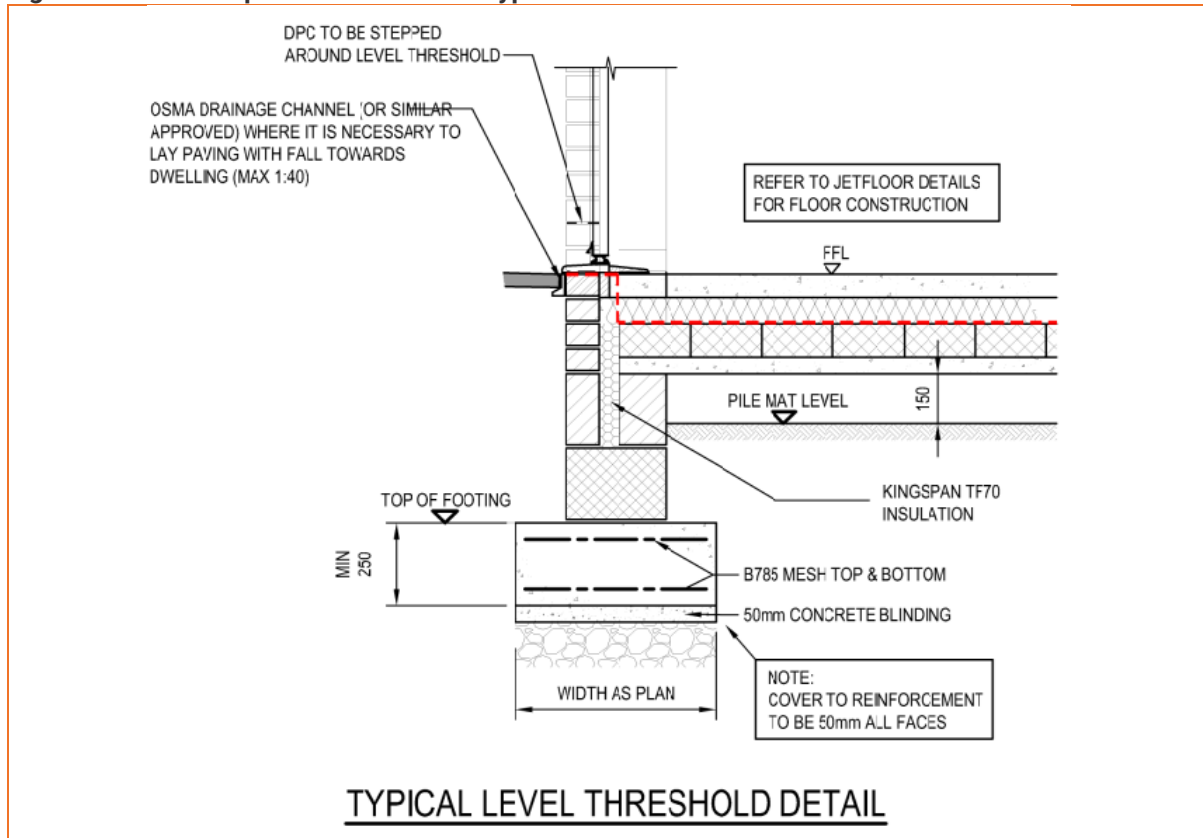
It has been confirmed as part of the validation that the membrane utilised in the plots discussed herein matches that of **Figures 1-4**.

The E3P Technician has inspected the installation of this membrane in line with the structural engineer's specifications in terms of placement and position (**Figures 1-4**), and the manufacturer's detail in terms of the workmanship.

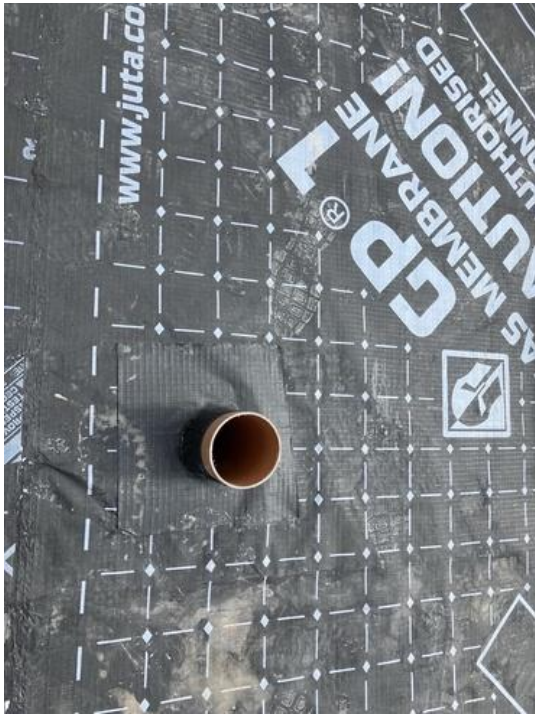
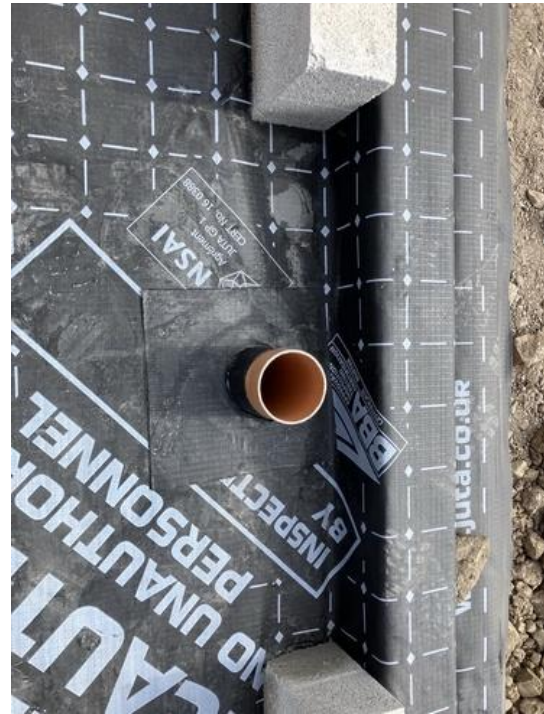
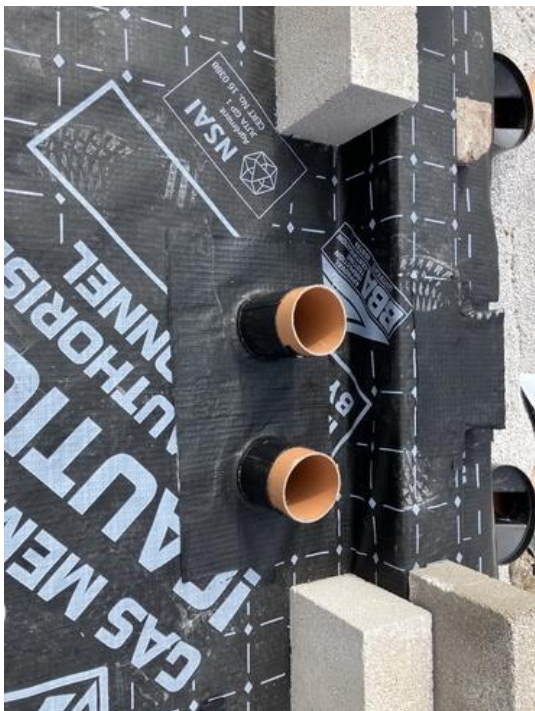
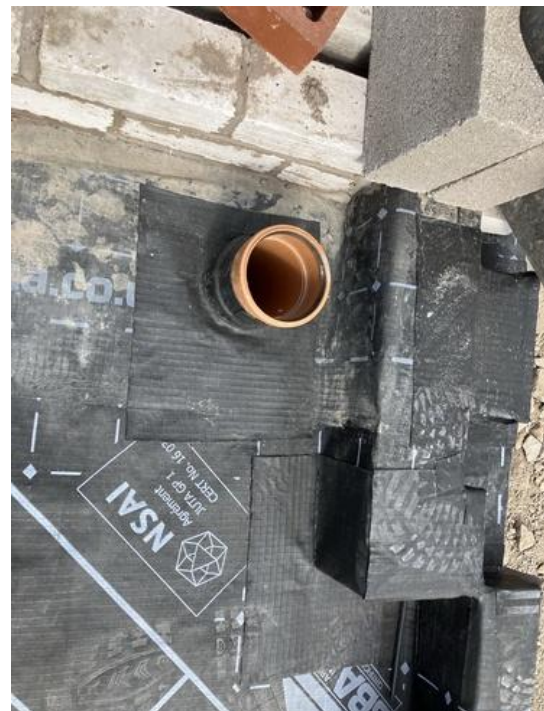
Where any penetration or service duct is present within the floor area, E3P inspected each one in turn and can confirm that rigid black polyethylene top hat units have been adequately sealed against the membrane with double-sided jointing tape at both the base and the protruding pipe as well as being secured against the pipe with a metal jubilee clip.

| <b>Service entries seals: Top hats seal arrangements fixed around service entries? Use of Jubilee clips or Bitumastic Sealant</b> | Pass |

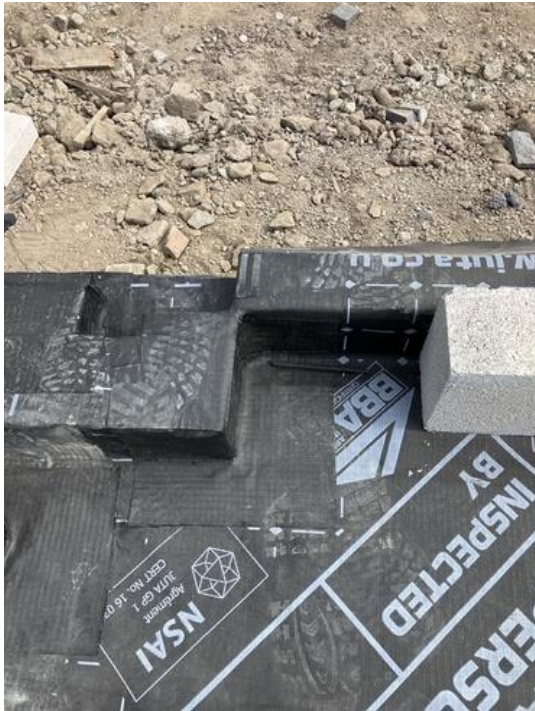
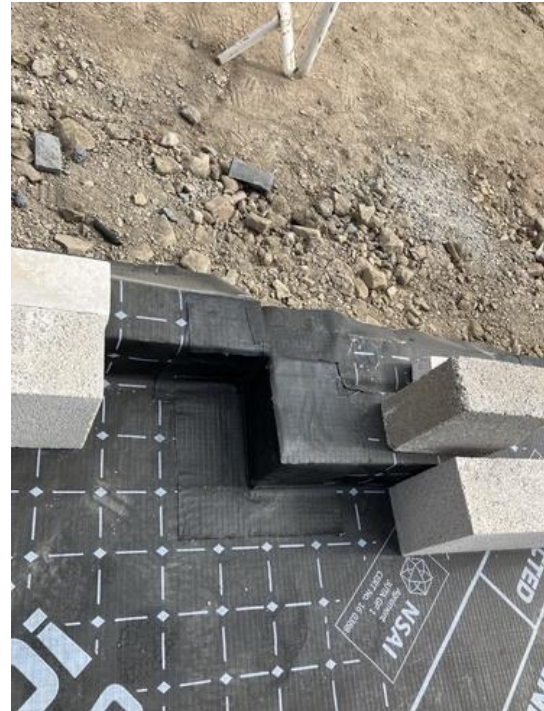
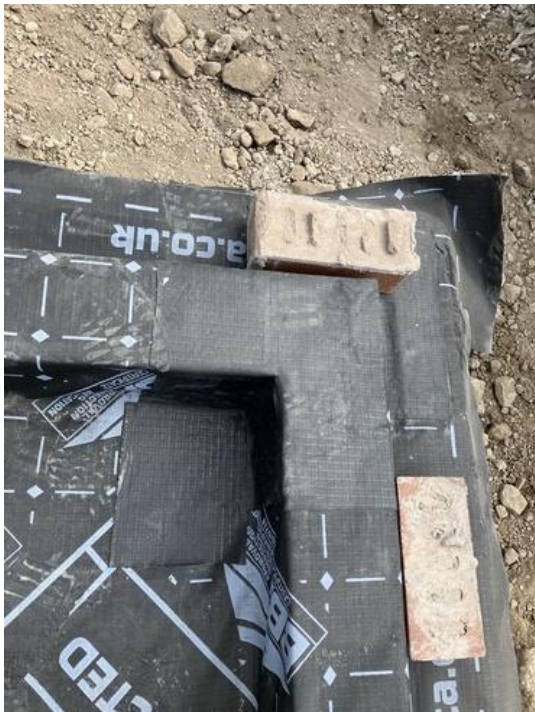
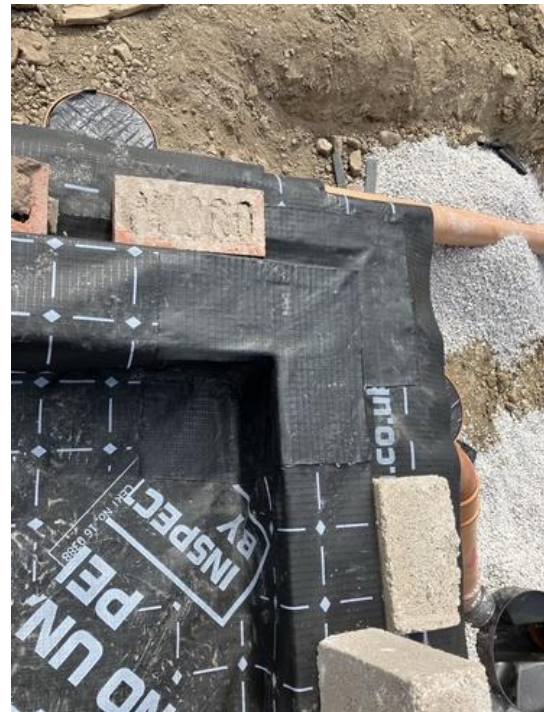
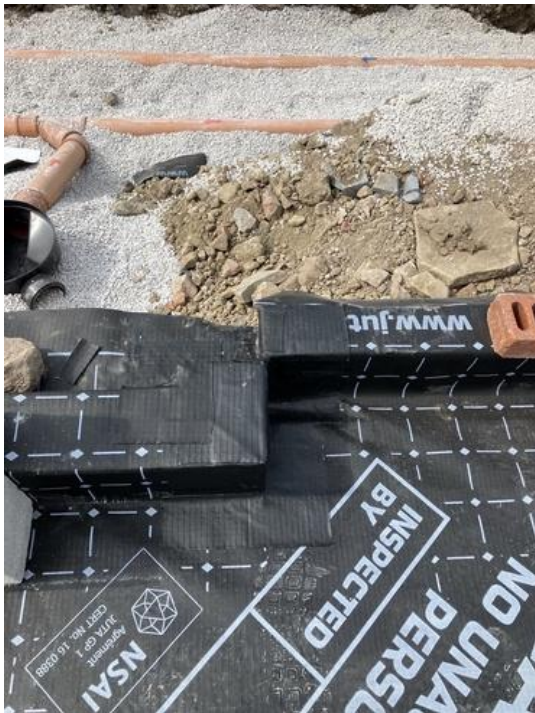
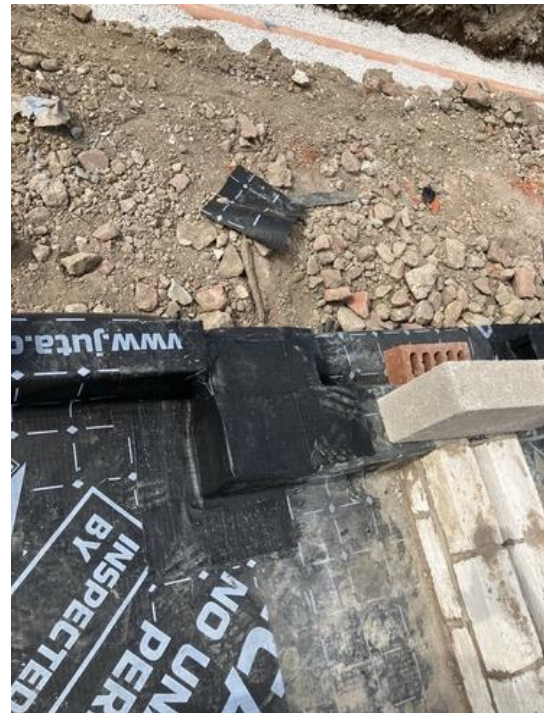
E3P inspected all joints including corner details, and can confirm that the membrane was overlapped in accordance with the manufacturer's specification and heat welded

| <b>Corners / Internal joints: Check all corners are correctly formed or contractor has used preformed corners.</b> | Pass |

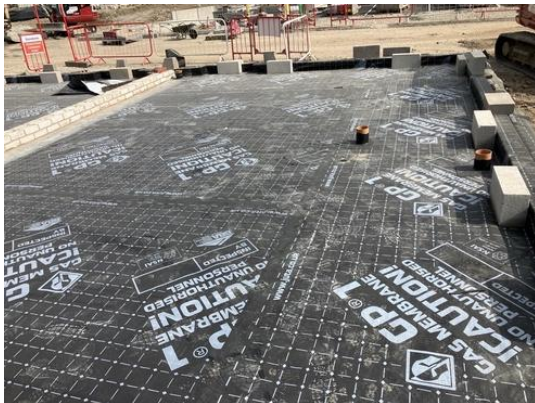
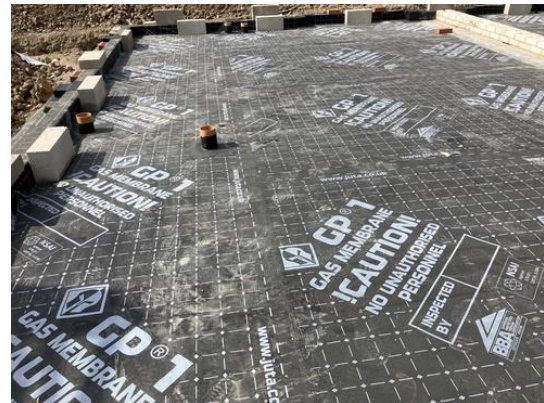
**Extent of Coverage: Is the membrane covering the entire plot? Does membrane span over outside walls?**

Yes

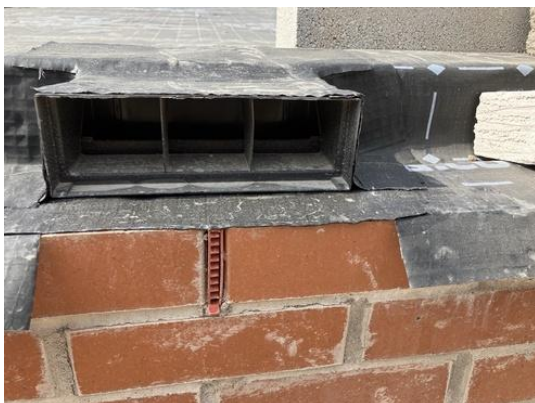
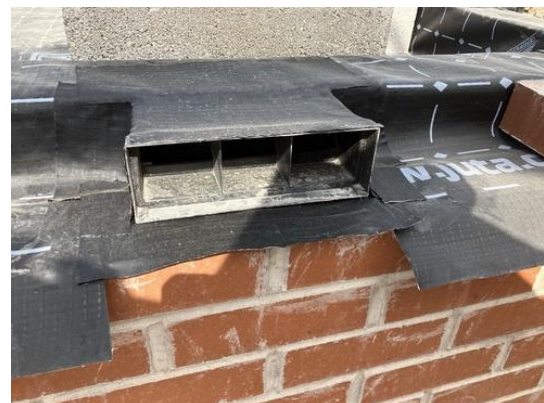
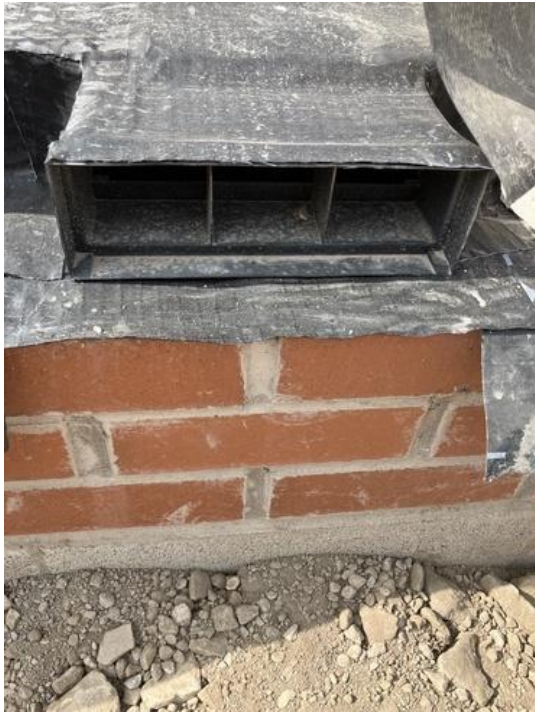
**External Wall Air bricks: Numbers, size. positions as design drawing? (Minimum of 3 walls)**

Pass

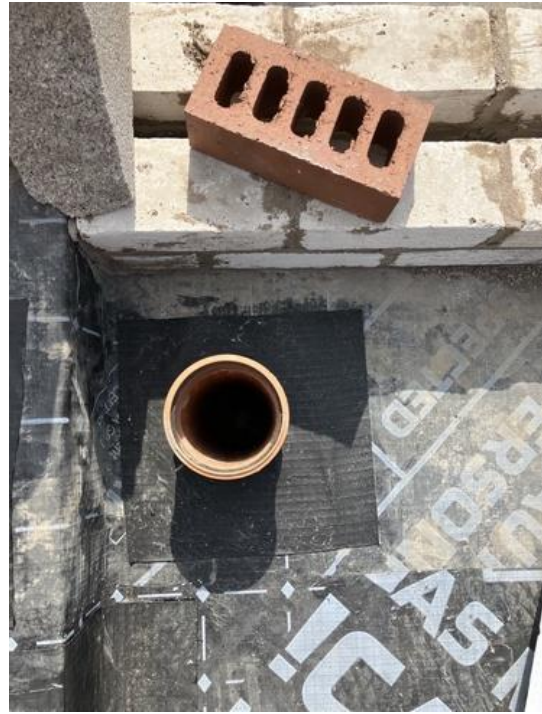
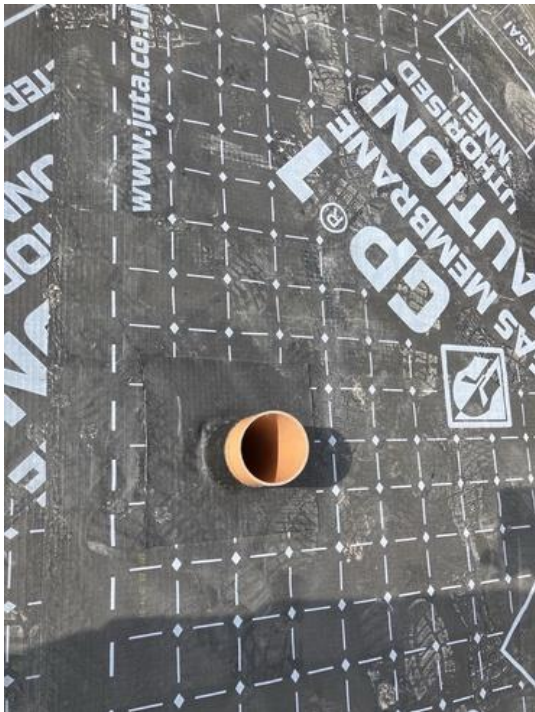
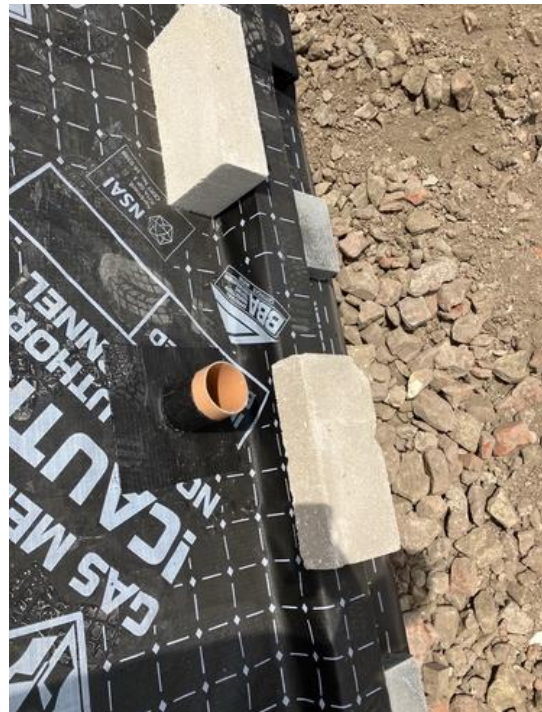
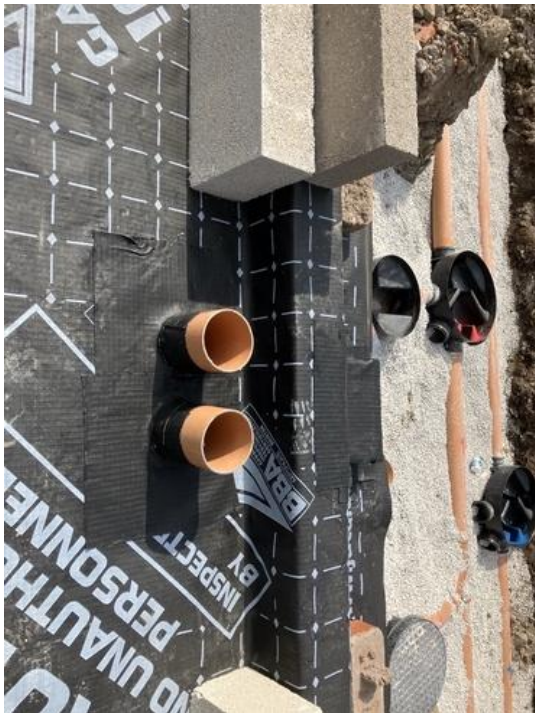
| <b>Service entries seals: Top hats seal arrangements fixed around service entries? Use of Jubilee clips or Bitumastic Sealant</b> | Pass | |

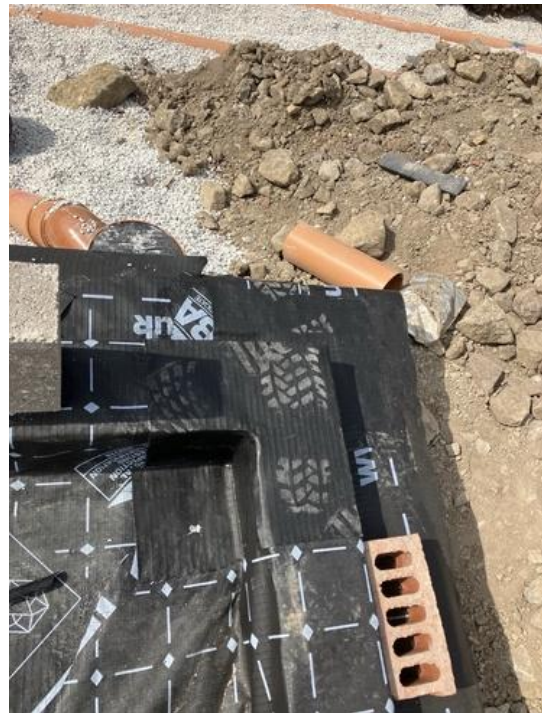
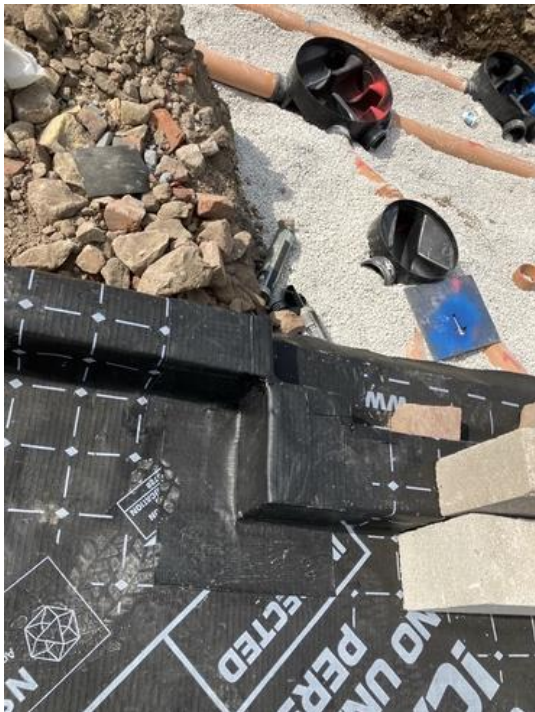
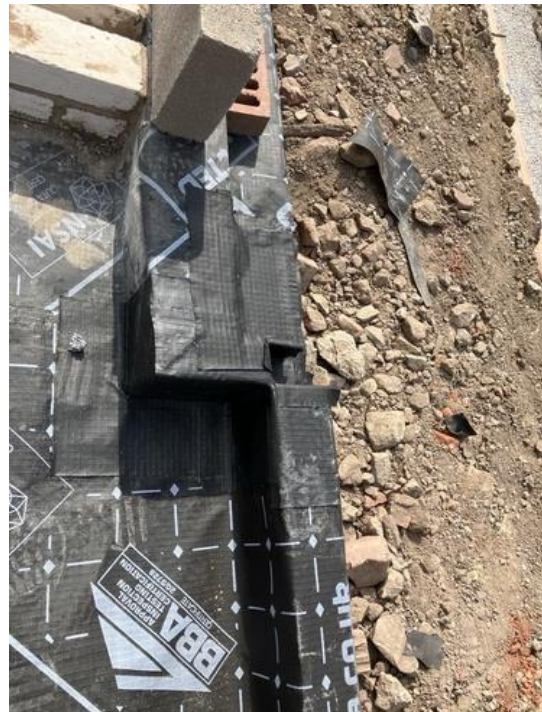
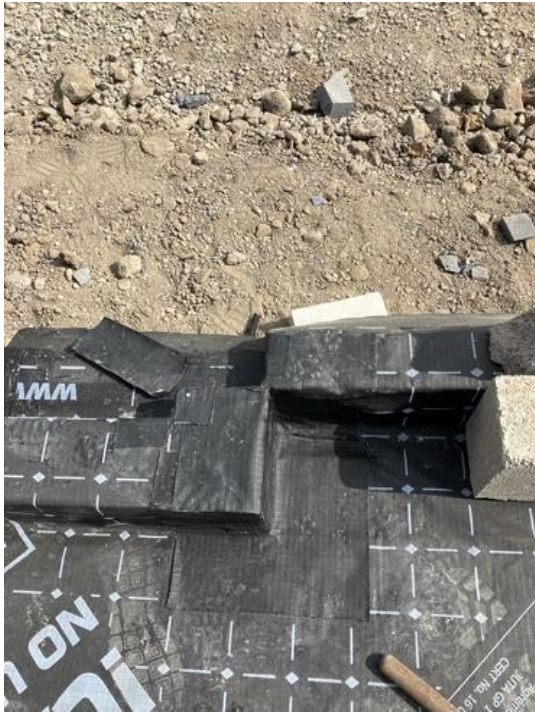
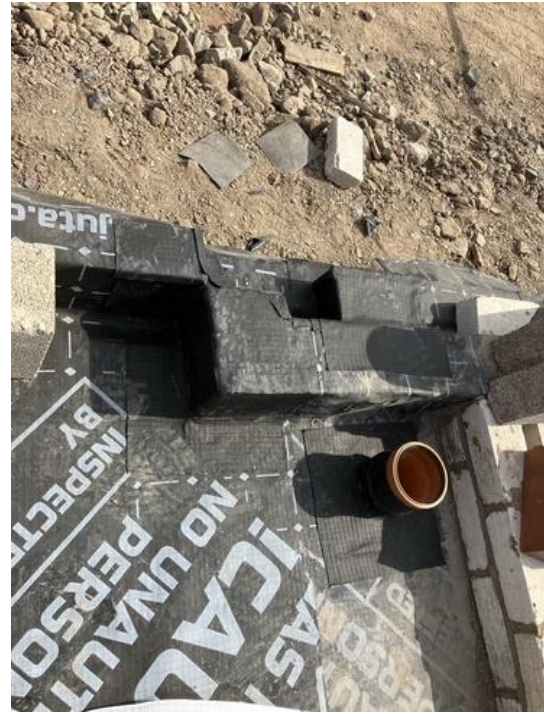
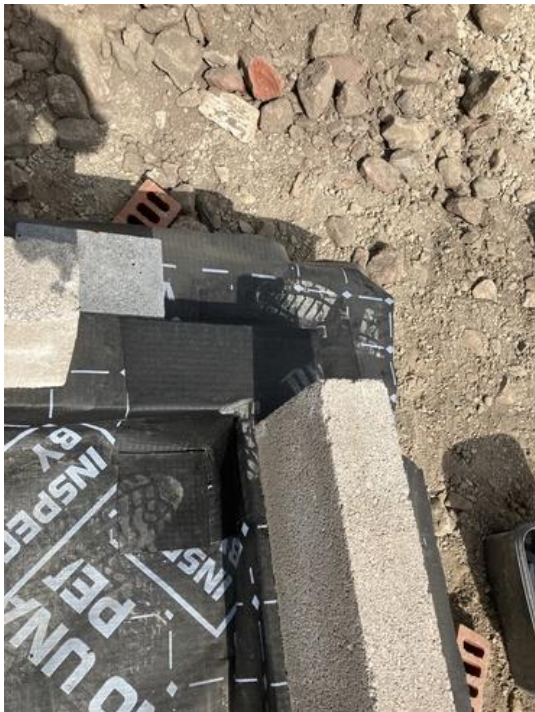
| <b>Corners / Internal joints: Check all corners are correctly formed or contractor has used preformed corners.</b> | Pass | |

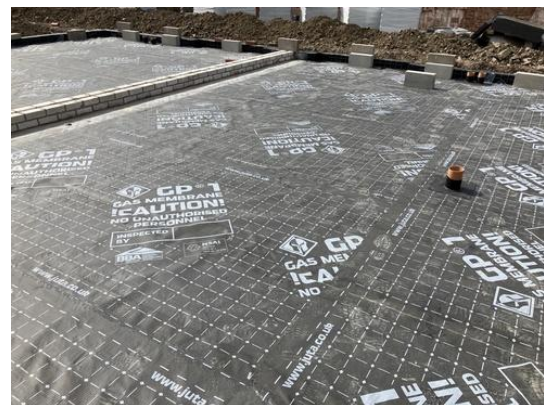
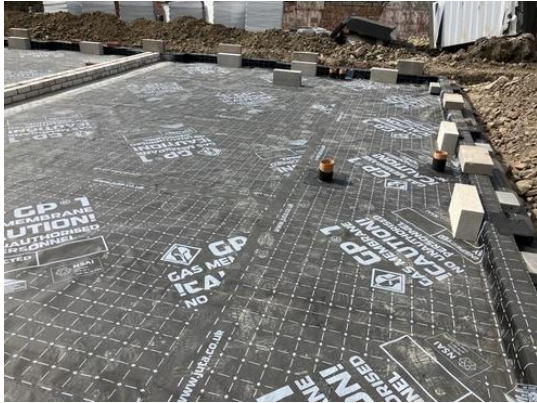
| <b>Extent of Coverage: Is the membrane covering the entire plot? Does membrane span over outside walls?</b> | Yes | |

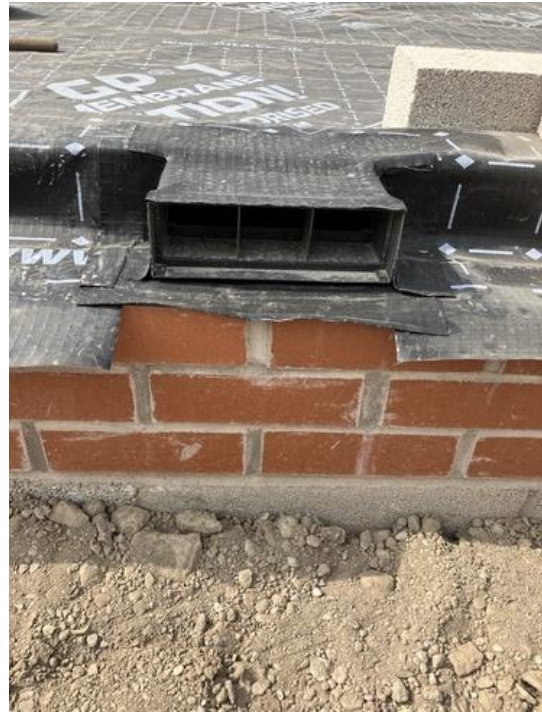
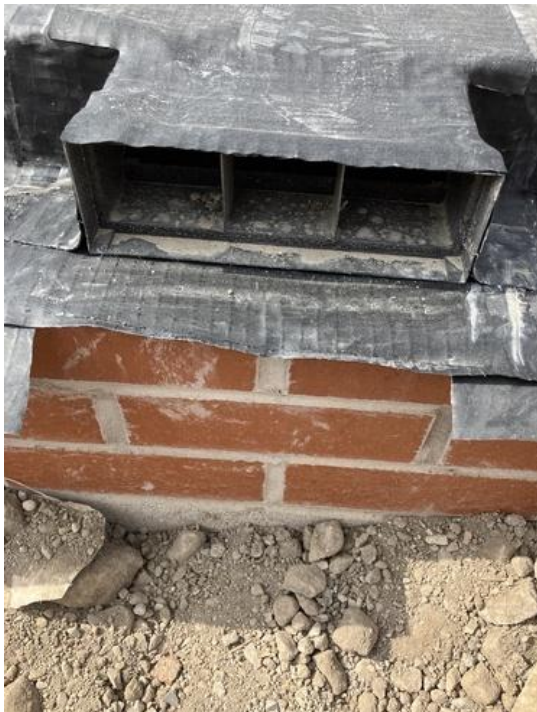
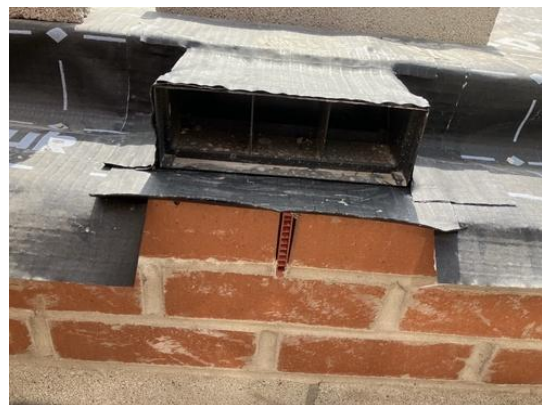
**External Wall Air bricks: Numbers, size. positions as design drawing? (Minimum of 3 walls)**

Pass
