Date: 4th June 2025  
Reference: 16465-V10

## GAS MEMBRANE VALIDATION – EDENFIELD ROAD, NORDEN

| <b>Project Name:</b> | Edenfield Road, Rochdale |
| <b>Plots:</b> | 36-39 & 49 |

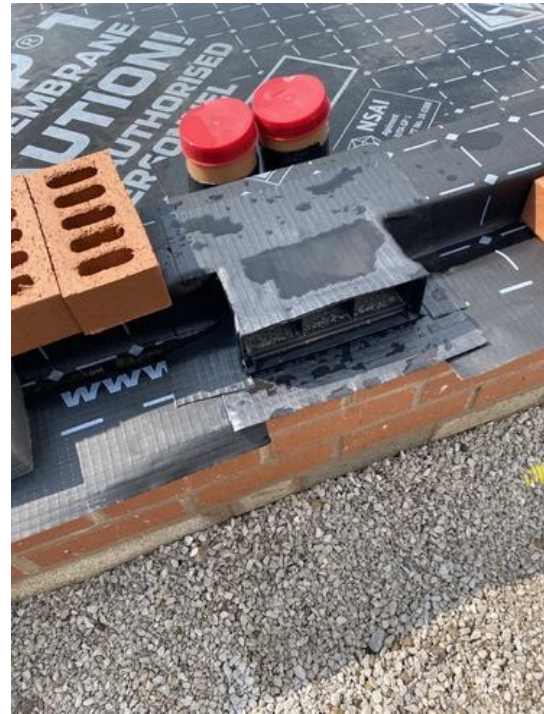
Photo 1

| <b>Are telescopic vents present?</b> | Yes | |

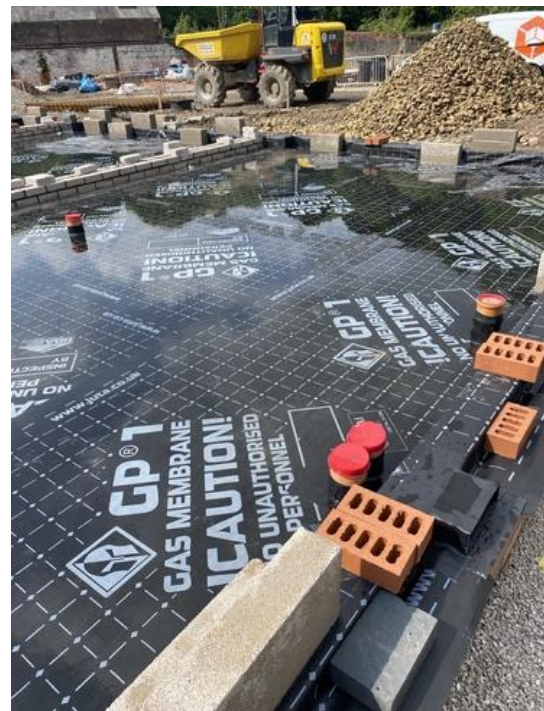
Photo 3

| <b>Gas Membrane Condition: Open punctures, tears, rips, stretching, Presence of debris, Repairs, Signs of weakness such as raised or sunken indentations, Protection plan in place to restrict access to lain gas membrane? IF FAIL DESCRIPTION IN ACTIONS AND PHOTOS REQUIRED</b> | | <div style="background-color: #2e8b57; color: white; text-align: center; padding: 20px;">Pass</div> |

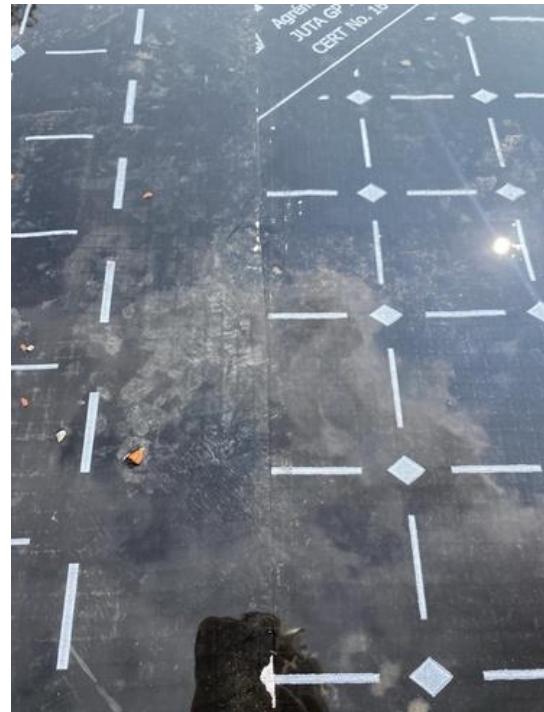
Photo 7

| <b>Are welds complete?</b> | | <div style="background-color: #2e8b57; color: white; text-align: center; padding: 20px;">Yes</div> |

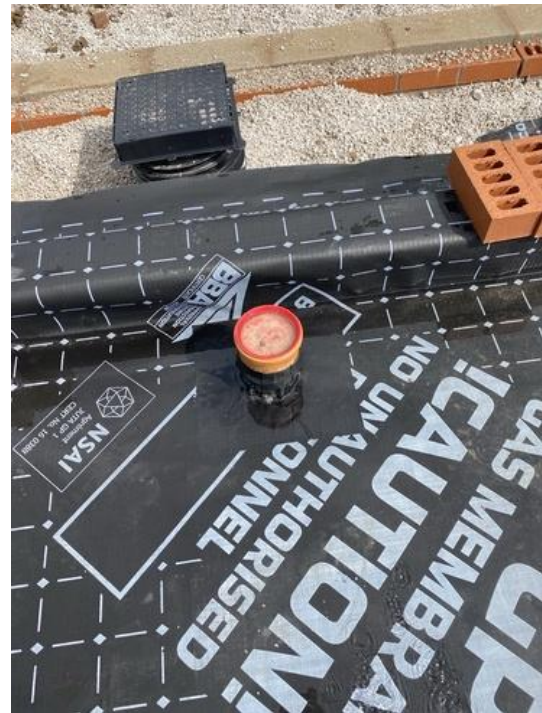
Photo 13

**Service entries seals: Top hats seal arrangements fixed around service entries? Use of Jubilee clips or Bitumastic Sealant**

Pass

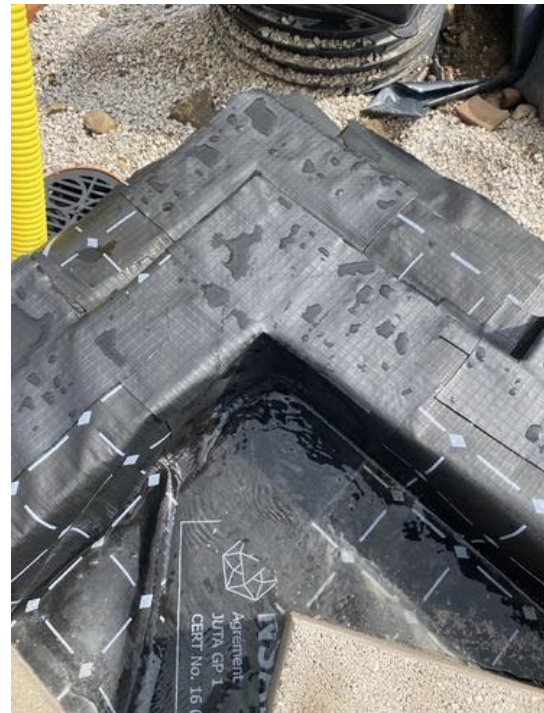
Photo 17

**Corners / Internal joints: Check all corners are correctly formed or contractor has used preformed corners.**

Pass

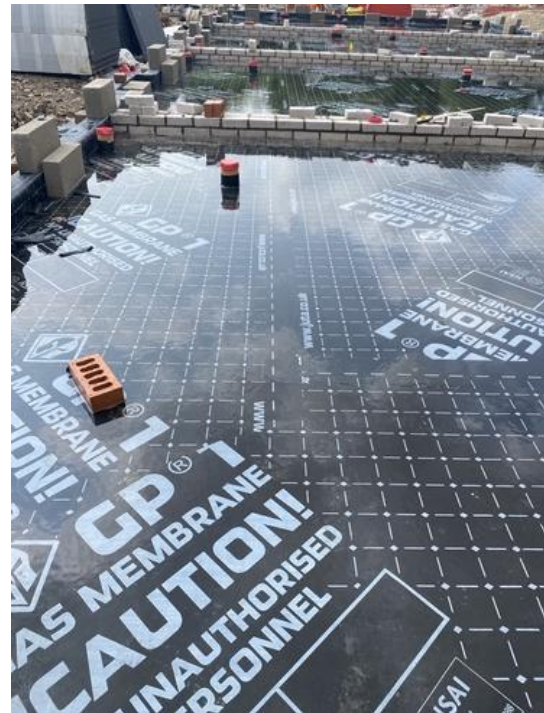
Photo 25

**Are folds running in line with joints? (no joints cutting across folds)**

Pass

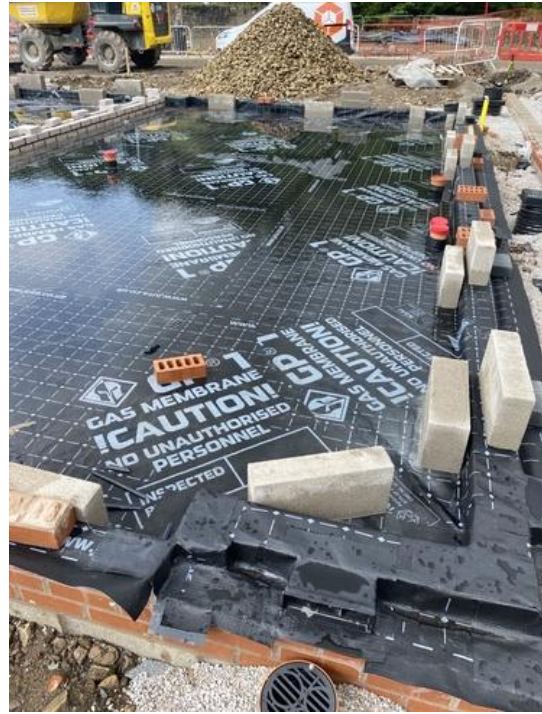
Photo 29

**Extent of Coverage: Is the membrane covering the entire plot? Does membrane span over outside walls?**

Yes
