Date: 16th June 2025  
Reference: 16465-V11

## GAS MEMBRANE VALIDATION – EDENFIELD ROAD, NORDEN

| <b>Project Name:</b> | Edenfield Road, Rochdale |
| <b>Plots:</b> | 46-48 |

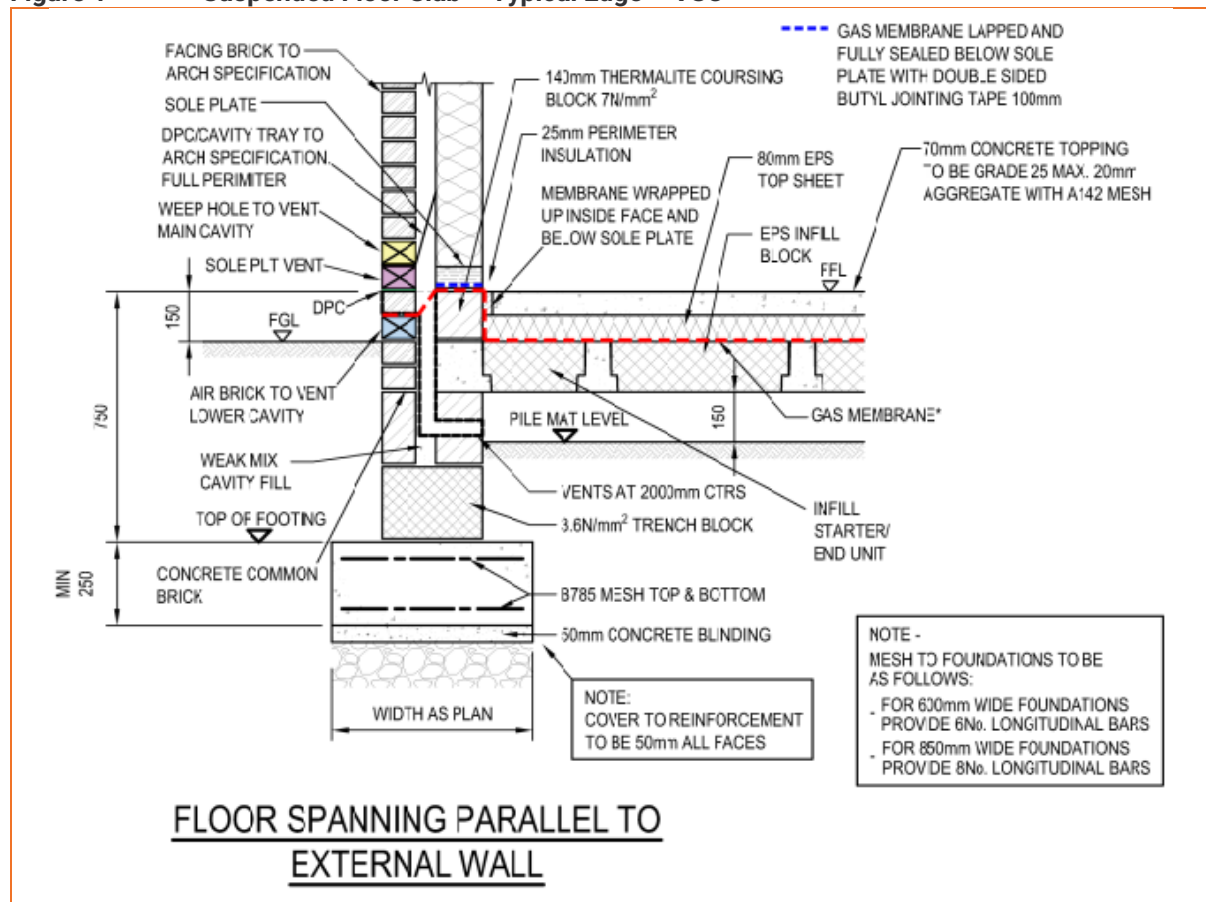
**Figure 1**      **Suspended Floor Slab – Typical Edge – VSC**

It has been confirmed as part of the validation that the membrane utilised in the plots discussed herein matches that of **Figures 1-4**.

The E3P Technician has inspected the installation of this membrane in line with the structural engineer's specifications in terms of placement and position (**Figures 1-4**), and the manufacturer's detail in terms of the workmanship.

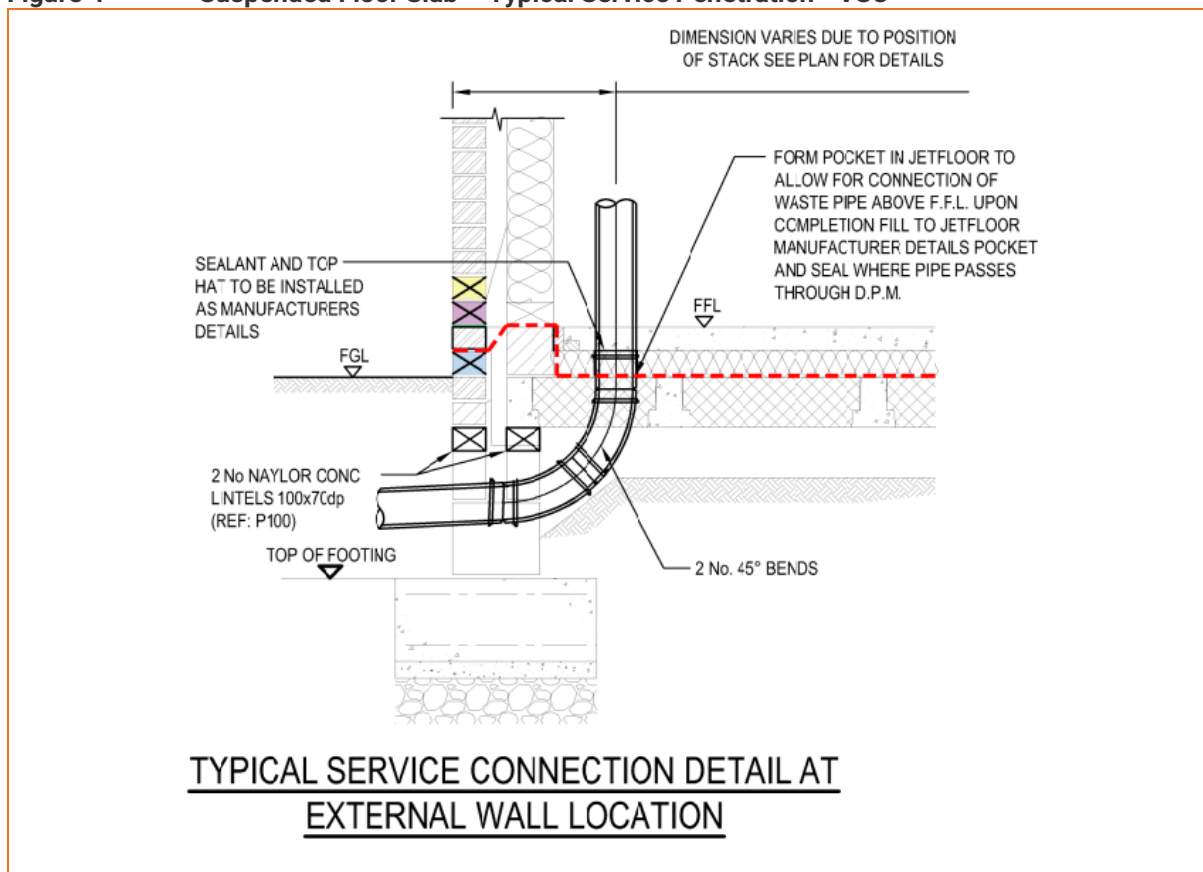
**Figure 4**      **Suspended Floor Slab – Typical Service Penetration - VSC**

Where any penetration or service duct is present within the floor area, E3P inspected each one in turn and can confirm that rigid black polyethylene top hat units have been adequately sealed against the membrane with double-sided jointing tape at both the base and the protruding pipe as well as being secured against the pipe with a metal jubilee clip.

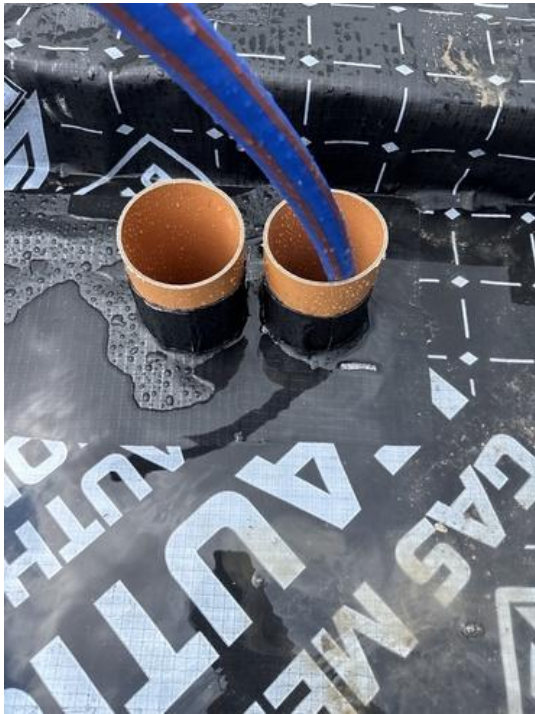
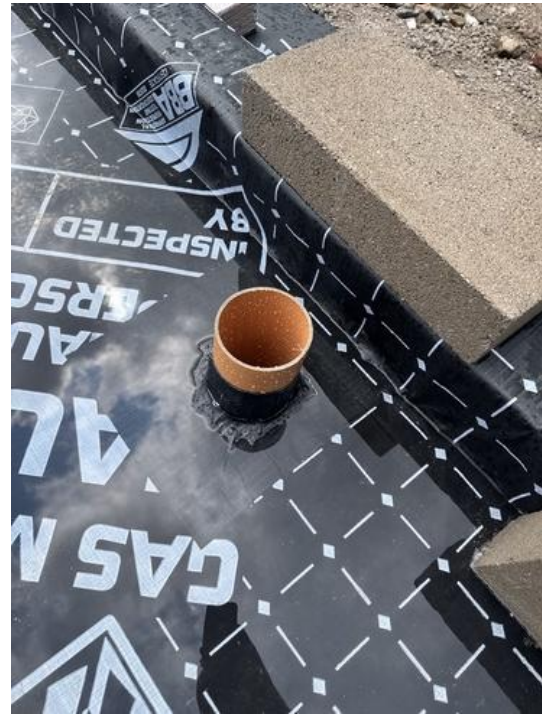
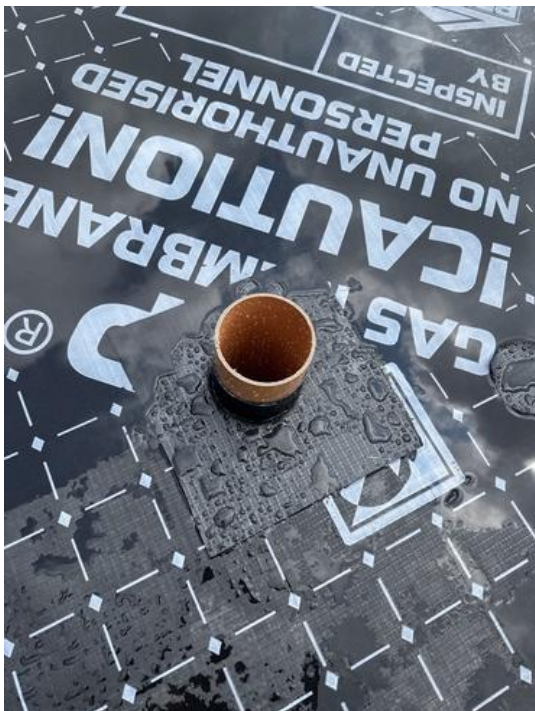
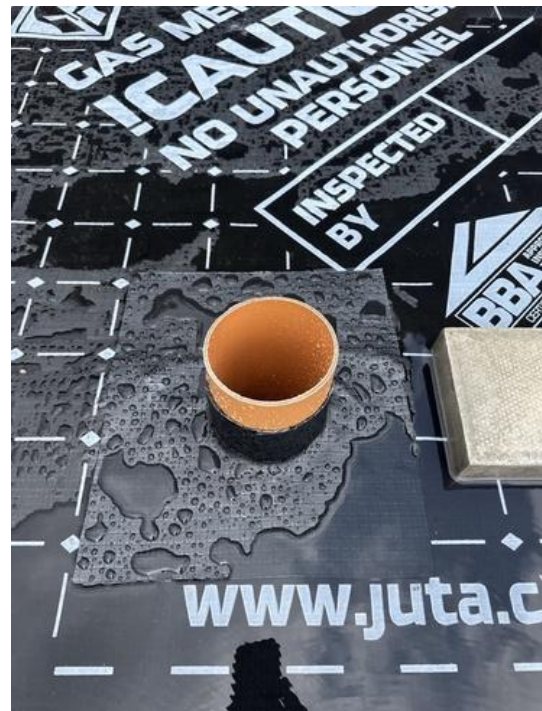
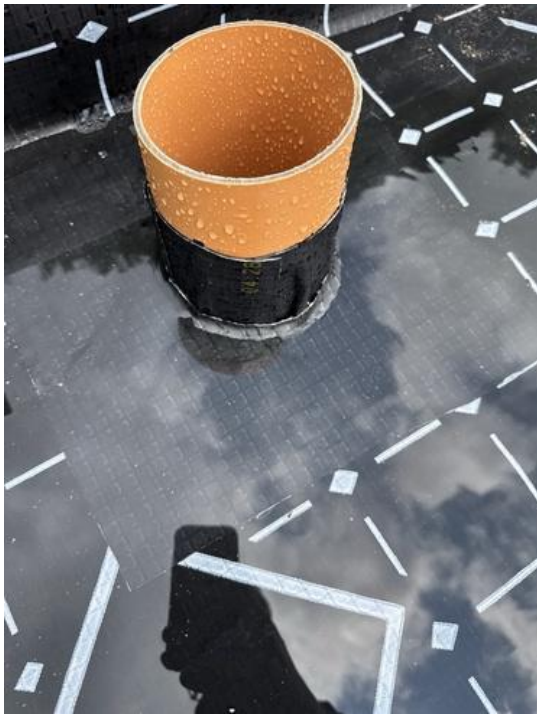
| <b>Service entries seals: Top hats seal arrangements fixed around service entries? Use of Jubilee clips or Bitumastic Sealant</b> | Pass |

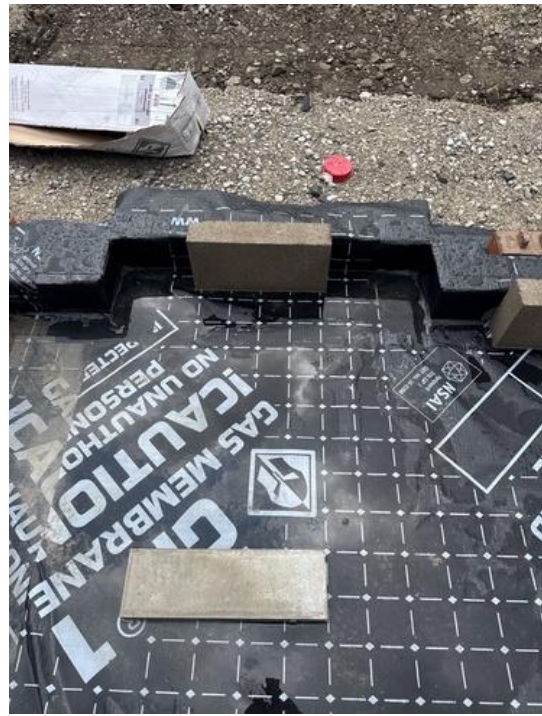
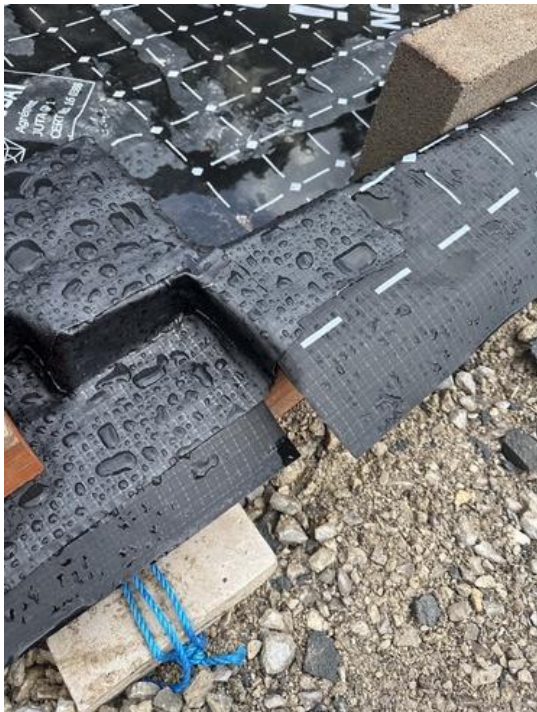
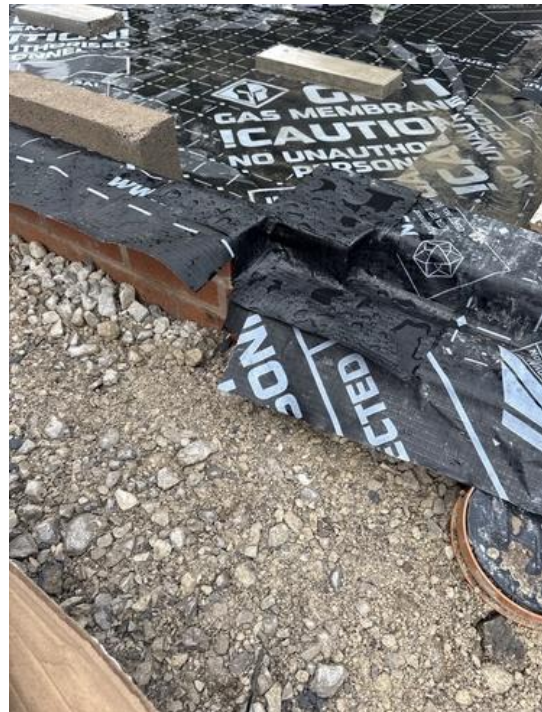
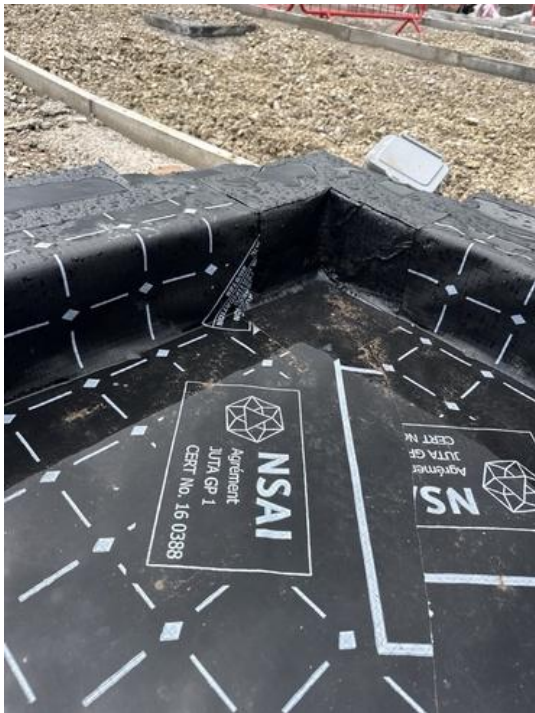
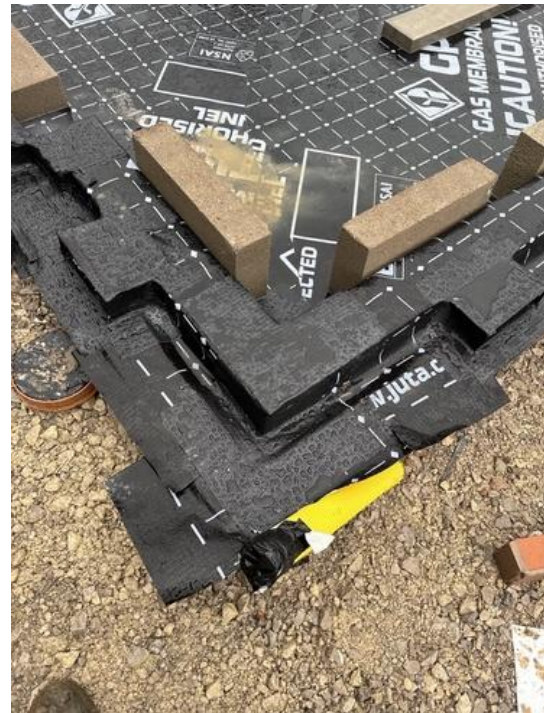
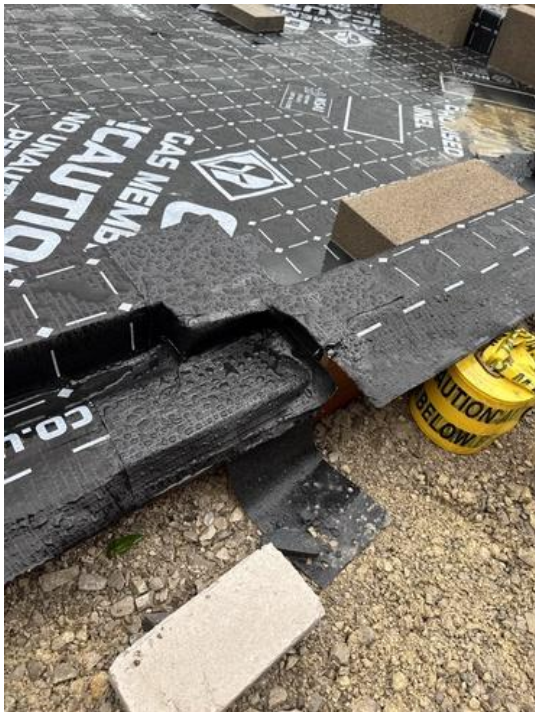
| <b>Corners / Internal joints: Check all corners are correctly formed or contractor has used preformed corners.</b> | Pass |

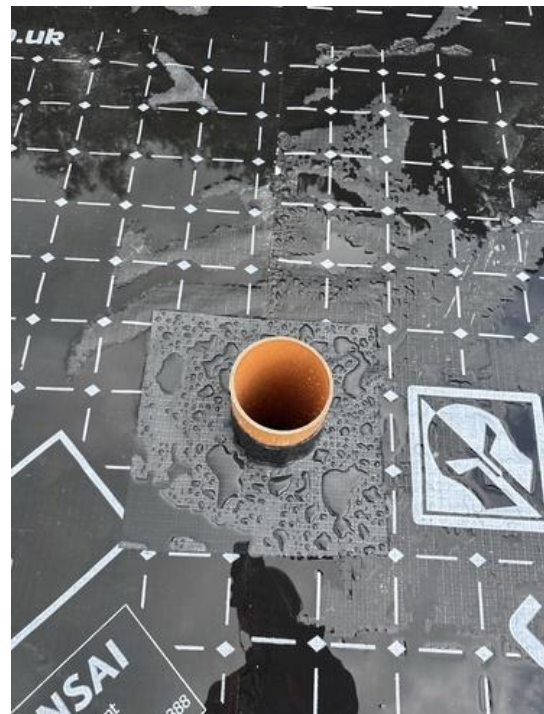
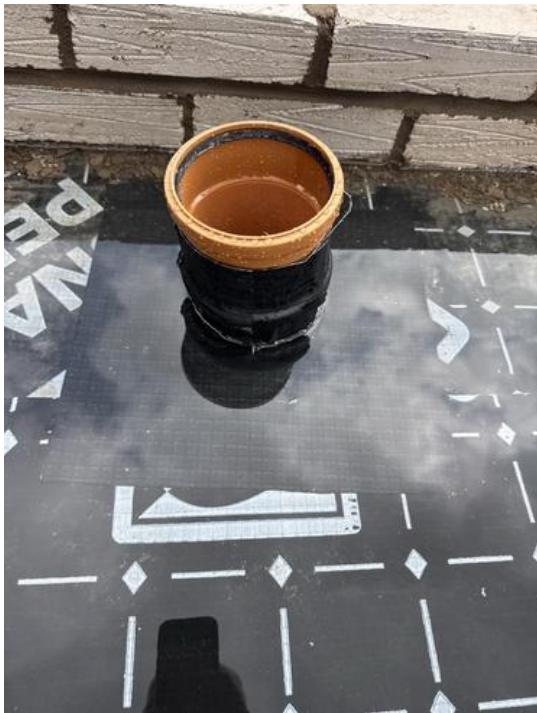
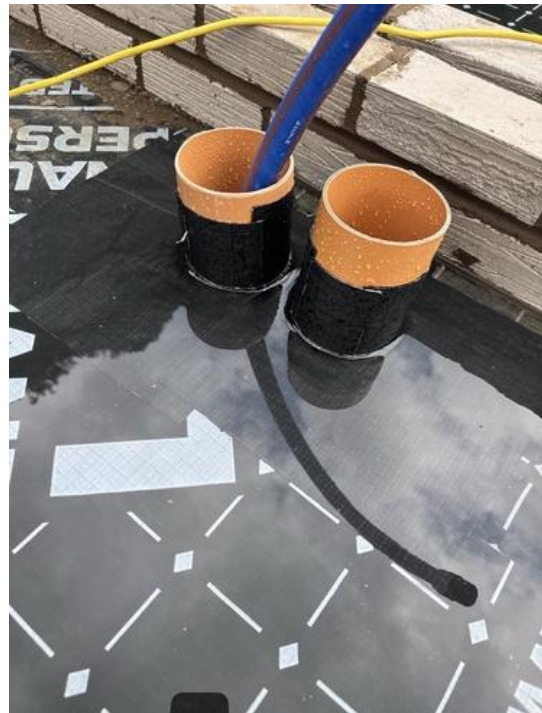
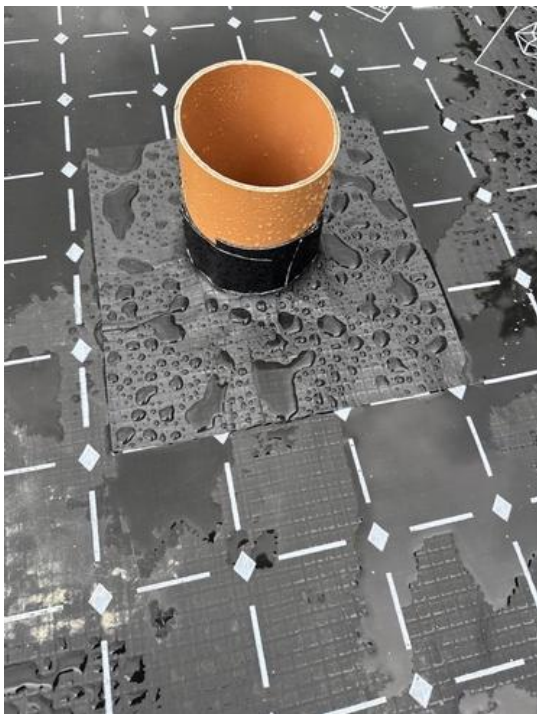
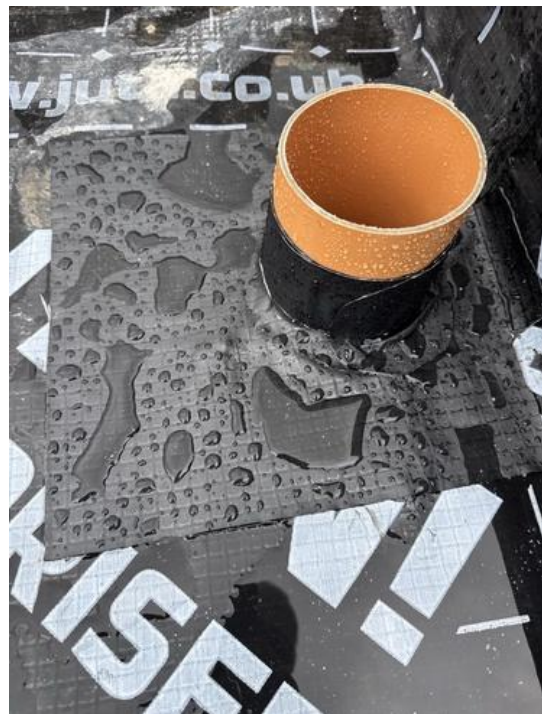
| <b>Service entries seals: Top hats seal arrangements fixed around service entries? Use of Jubilee clips or Bitumastic Sealant</b> | Pass | |

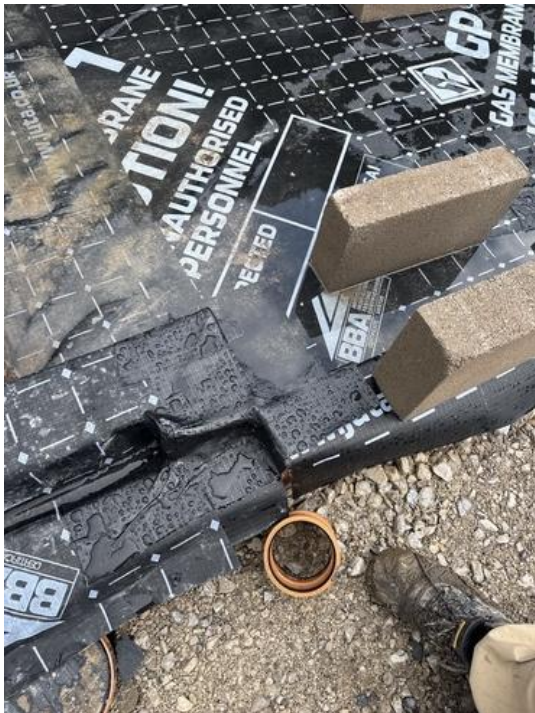
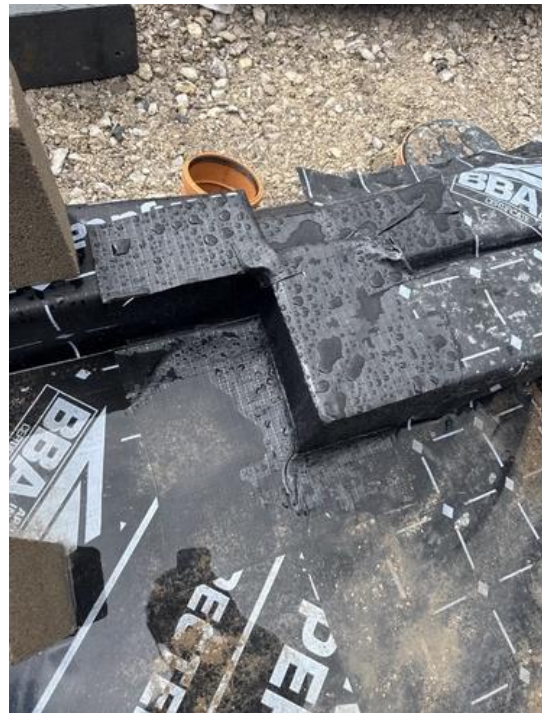
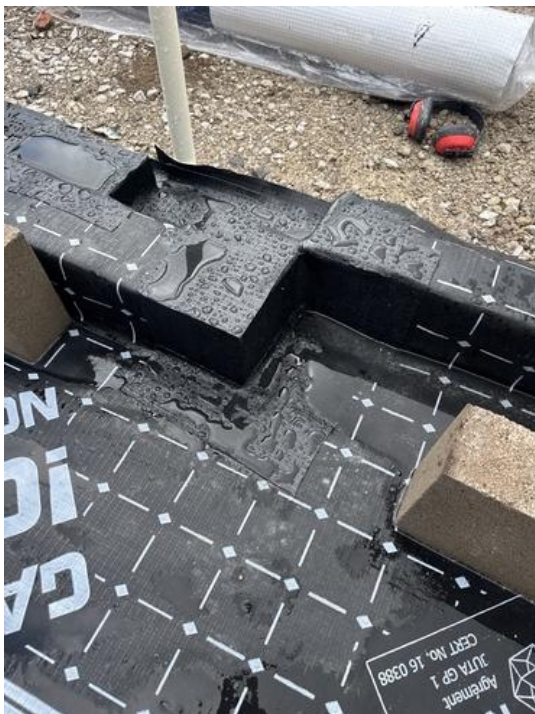
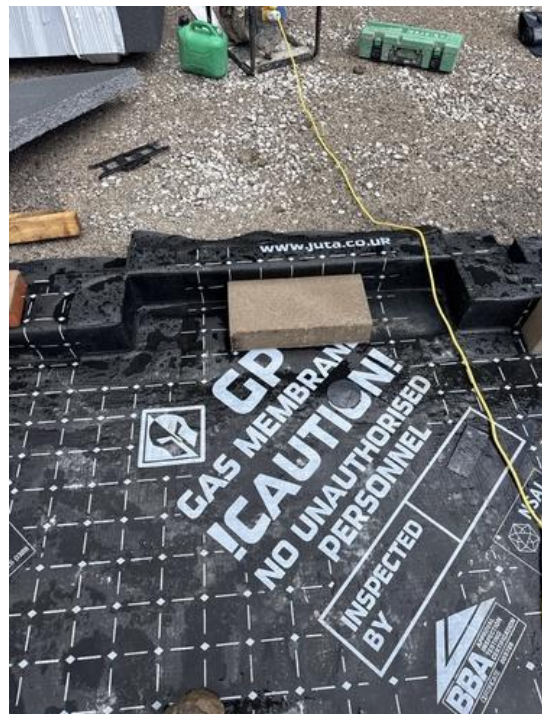
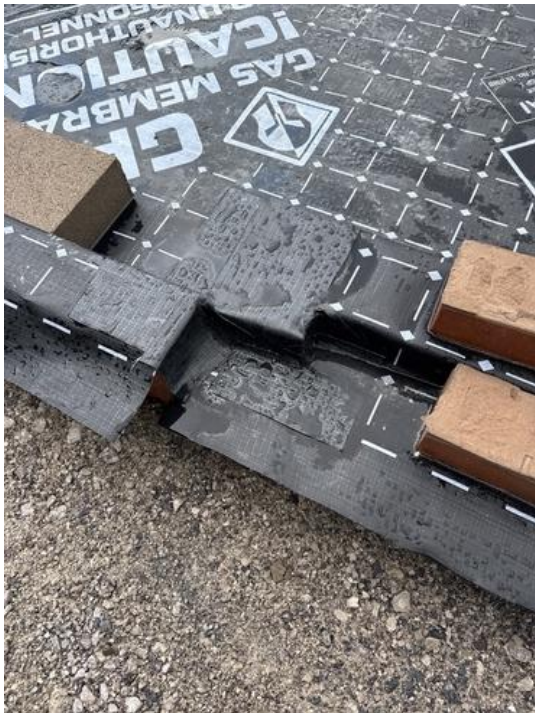
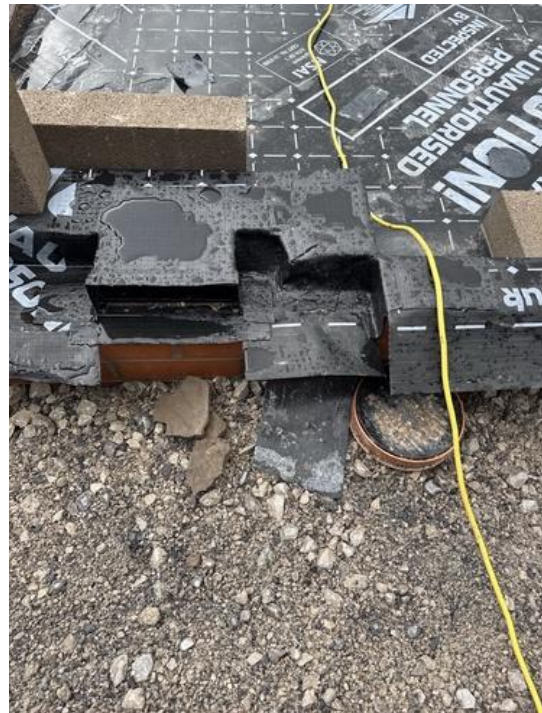
| <b>Corners / Internal joints: Check all corners are correctly formed or contractor has used preformed corners.</b> | Pass | |

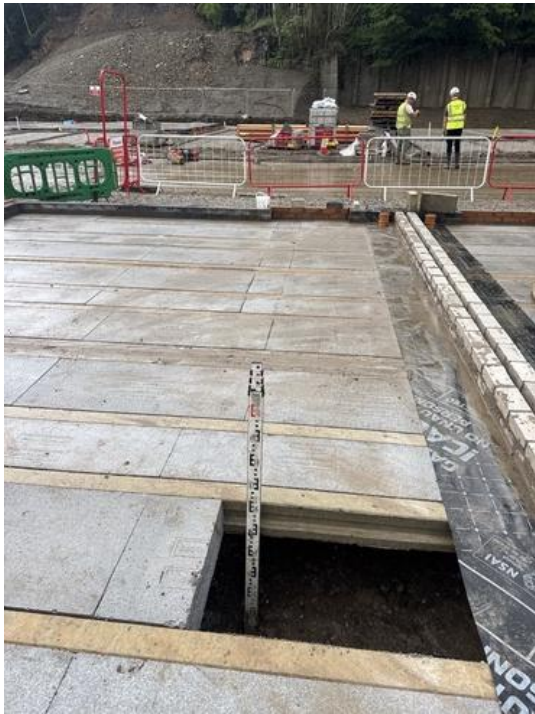
Photo 1

| Is the void clear? | Yes |
| Depth of Void | 500 |

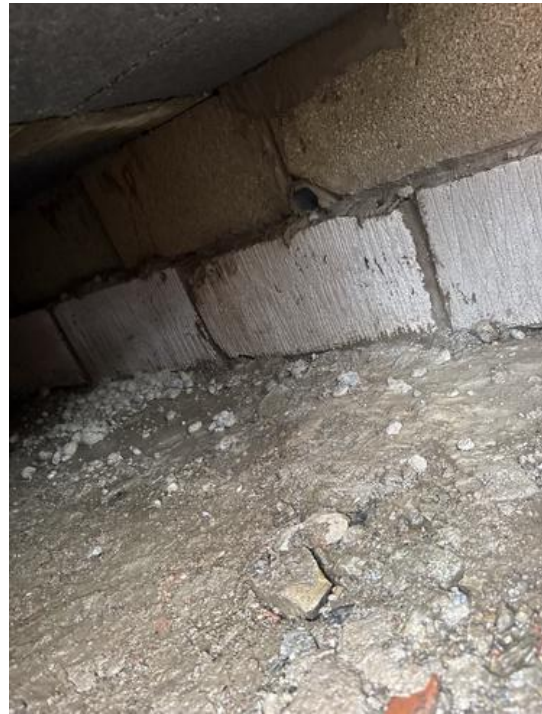
Photo 2

| Are Sleeper Walls present (if present take photos) | Yes |
| If sleeper walls are present are they vented? | Yes |

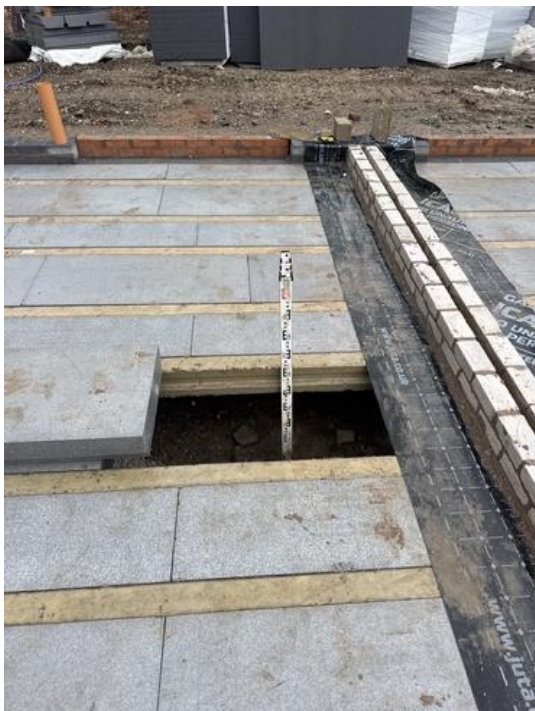
| Photo 3 | | |

| Is the void clear? | | Yes |
| Depth of Void | | 500 |

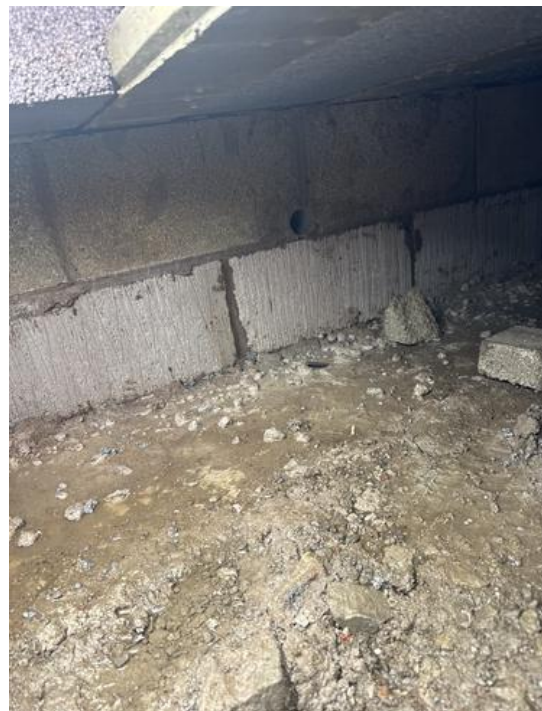
| Photo 4 | | |

| Are Sleeper Walls present (if present take photos) | | Yes |
| If sleeper walls are present are they vented? | | Yes |
