Date: 28<sup>th</sup> May 2025  
Reference: 16465-V9

## GAS MEMBRANE VALIDATION – EDENFIELD ROAD, NORDEN

| <b>Project Number:</b> | 16465 |
| <b>Plots:</b> | 24-25 |

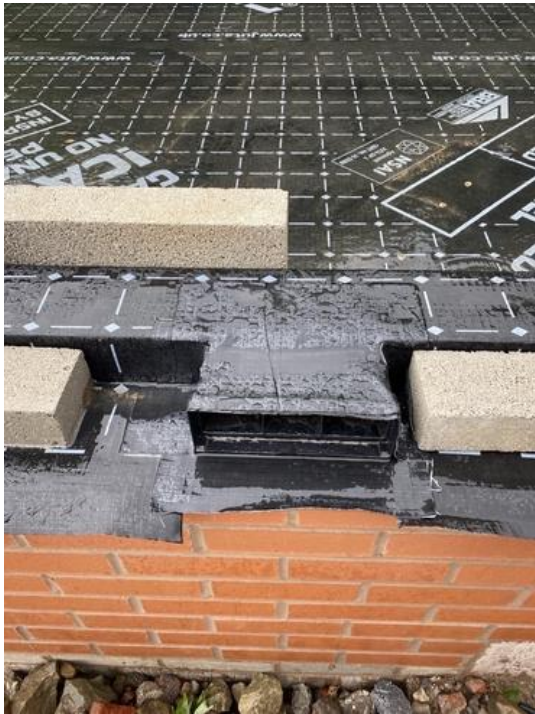
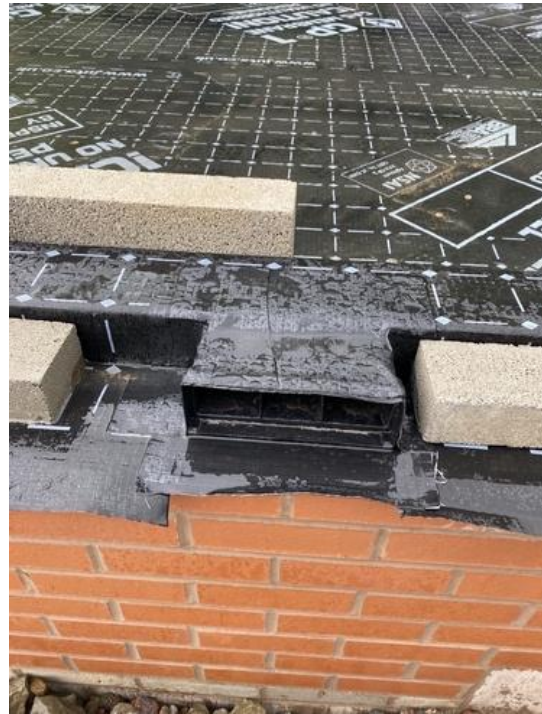
| <b>Are telescopic vents present?</b> | Yes |

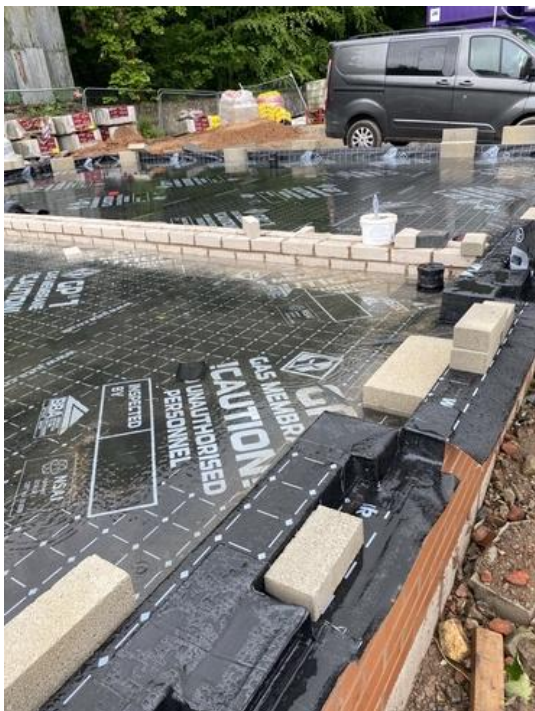
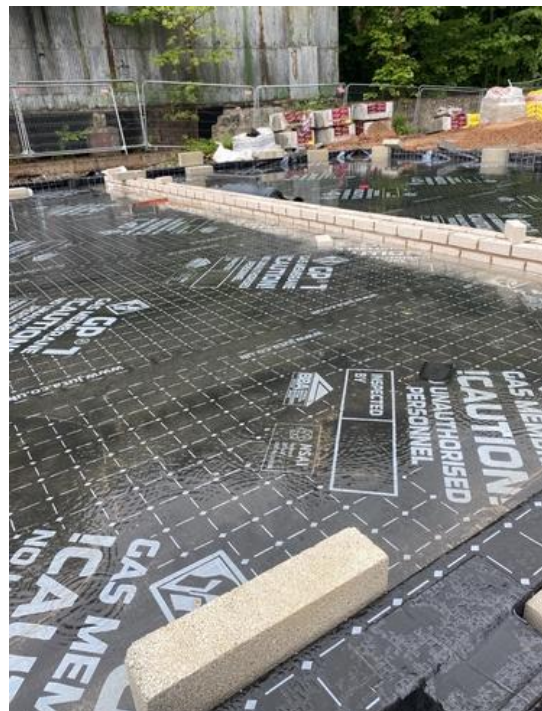
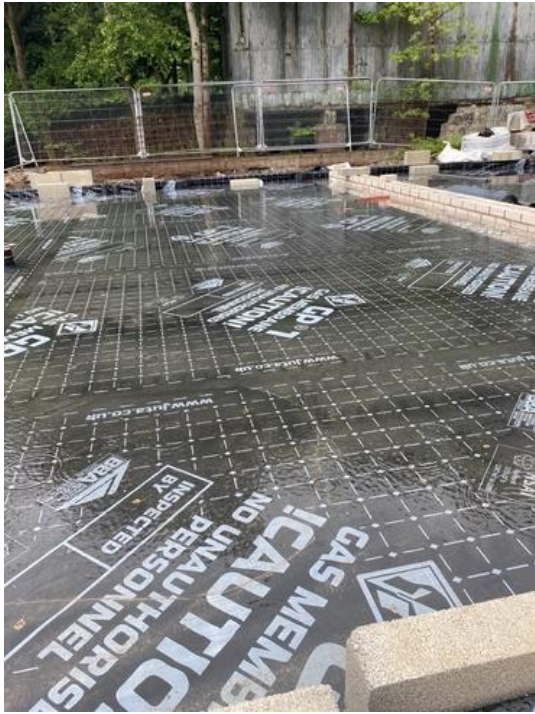
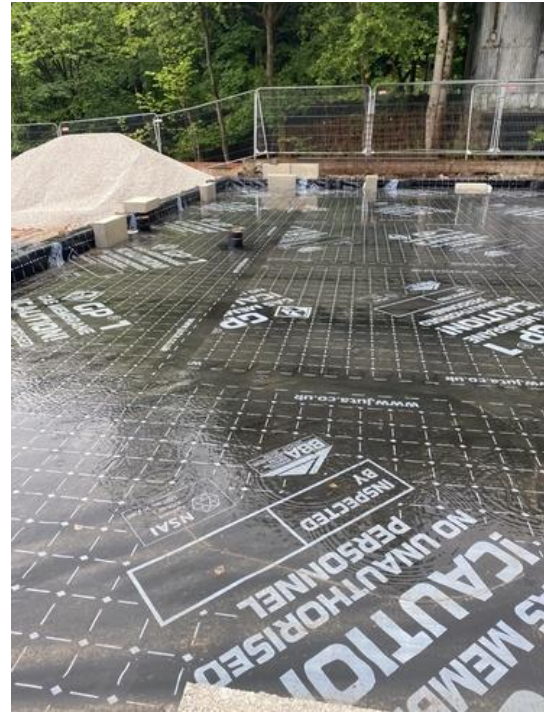
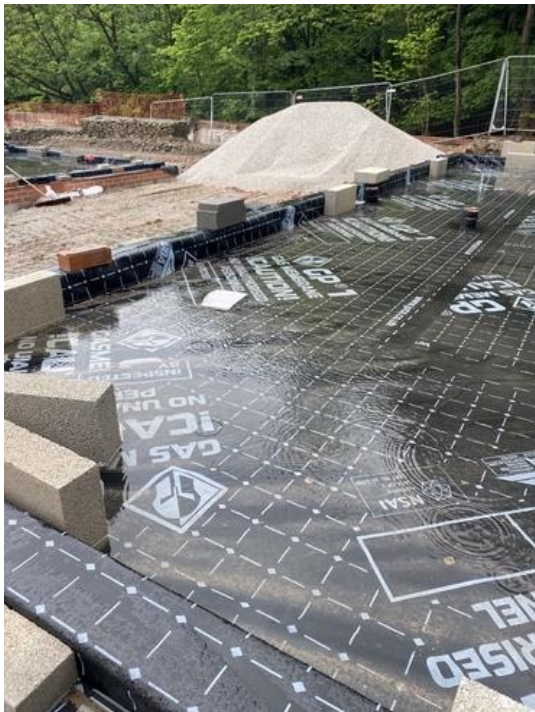
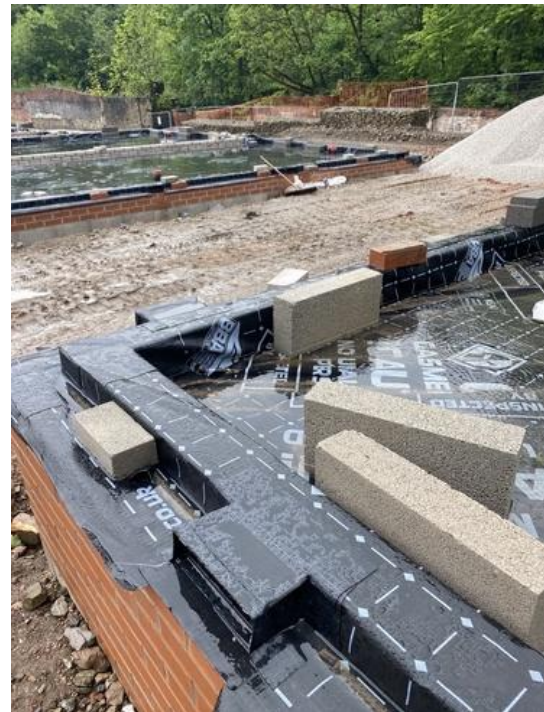
| <b>Gas Membrane Condition: Open punctures, tears, rips, stretching, Presence of debris, Repairs, Signs of weakness such as raised or sunken indentations, Protection plan in place to restrict access to lain gas membrane? IF FAIL DESCRIPTION IN ACTIONS AND PHOTOS REQUIRED</b> | <div style="background-color: #008000; color: white; padding: 20px; text-align: center;">Pass</div> |

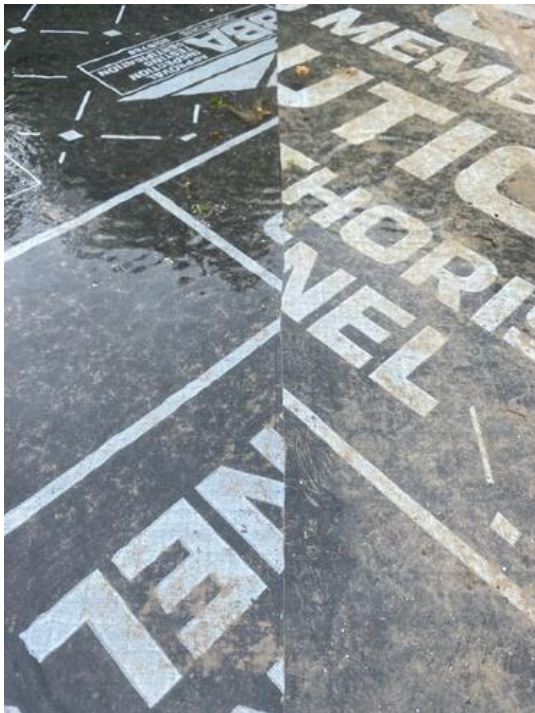
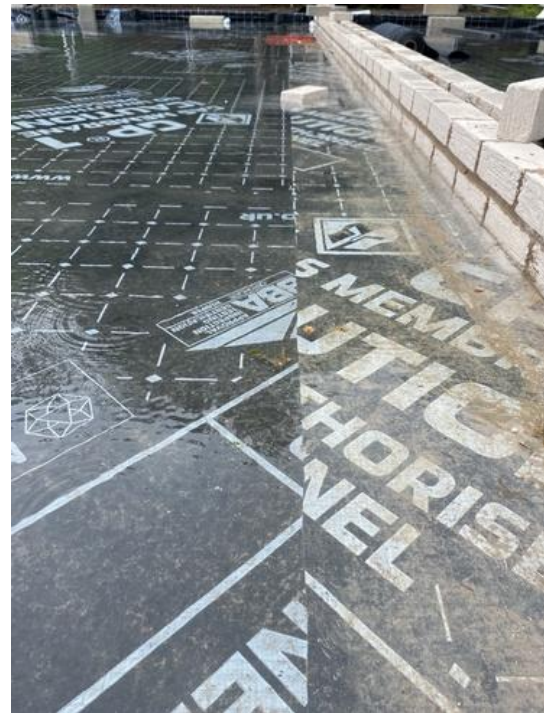
| <b>Are welds complete?</b> | Yes |

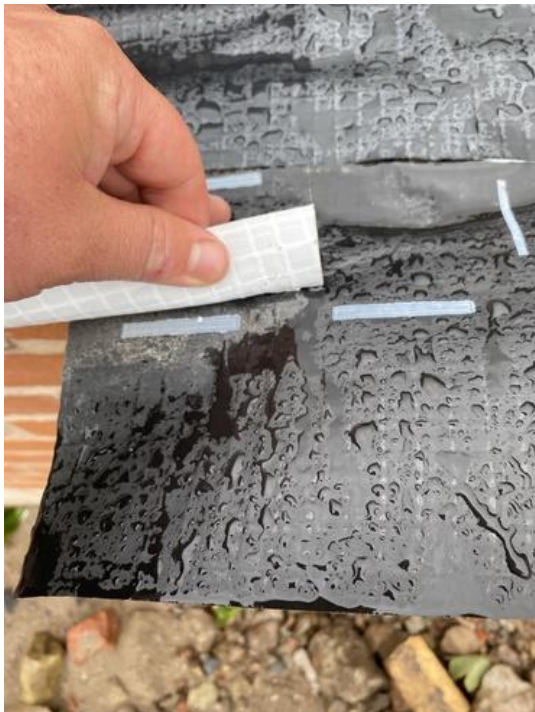
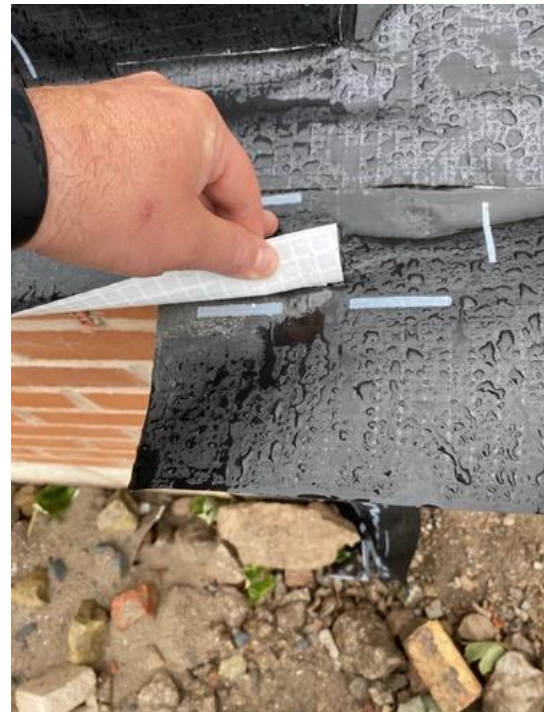
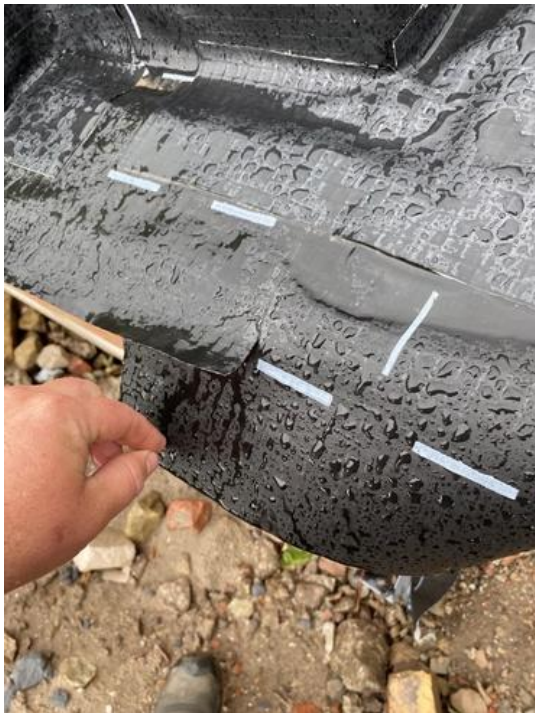
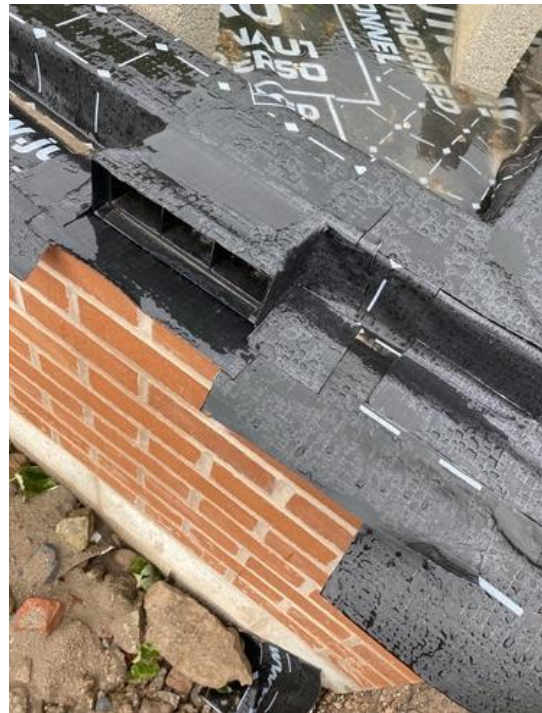
| <b>Are Joints lapped and sealed in accordance with manufacturer's requirements/ specification?</b> | Yes |

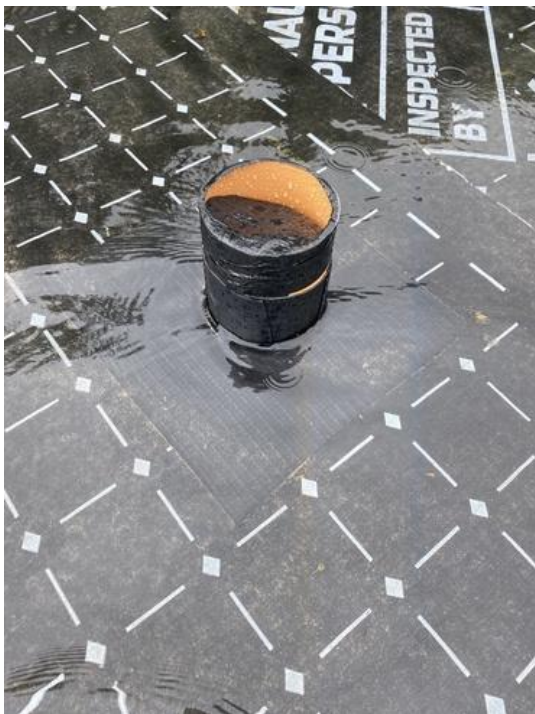
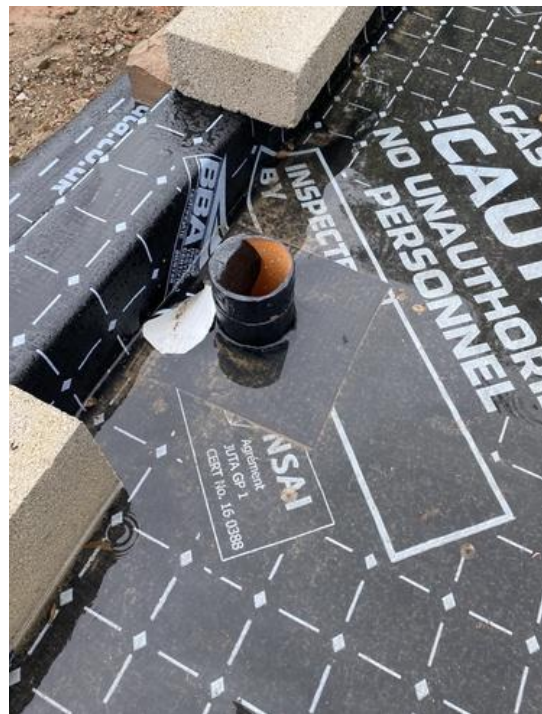
**Service entries seals: Top hats seal arrangements fixed around service entries? Use of Jubilee clips or Bitumastic Sealant**

Pass

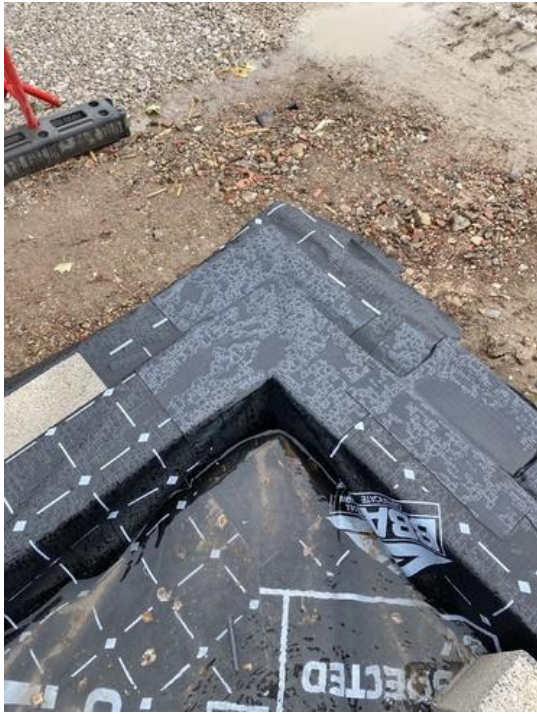
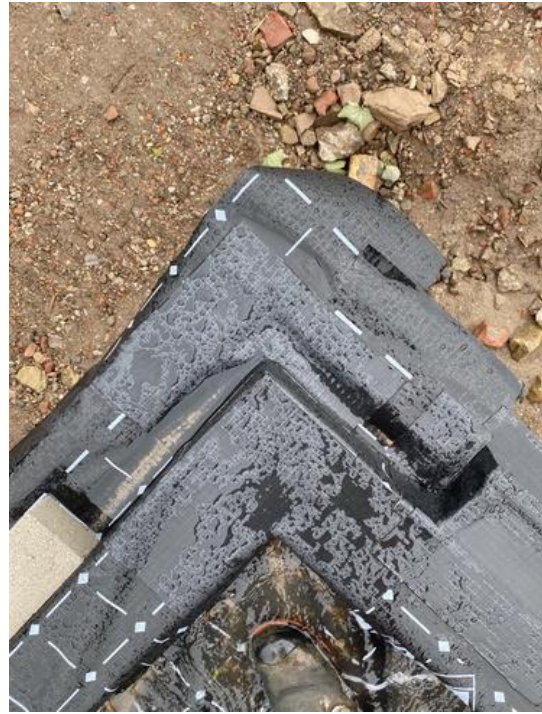
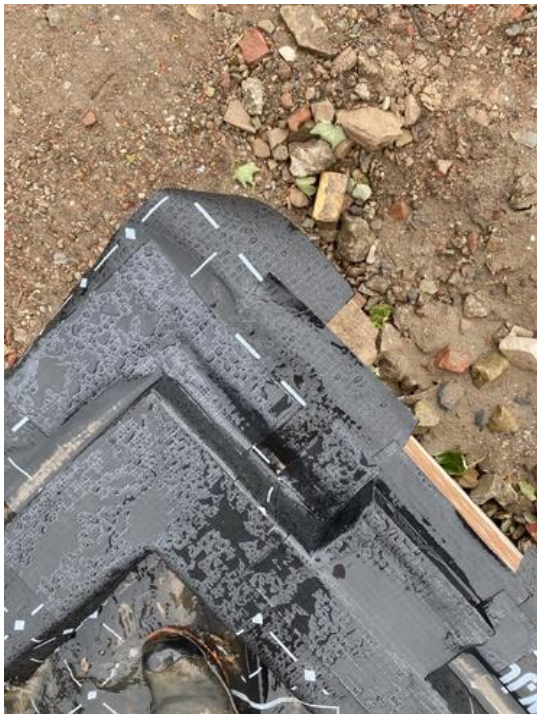
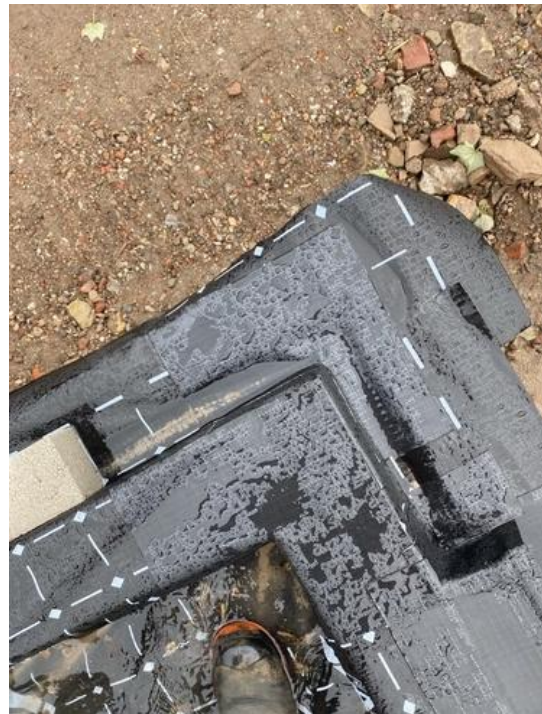
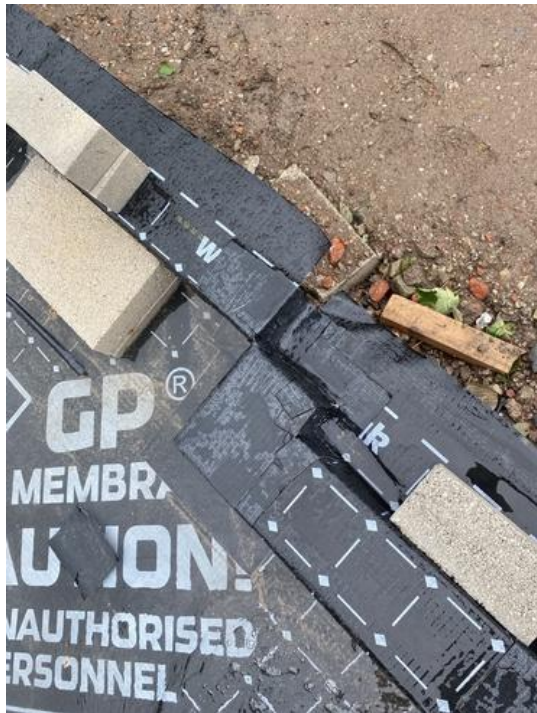
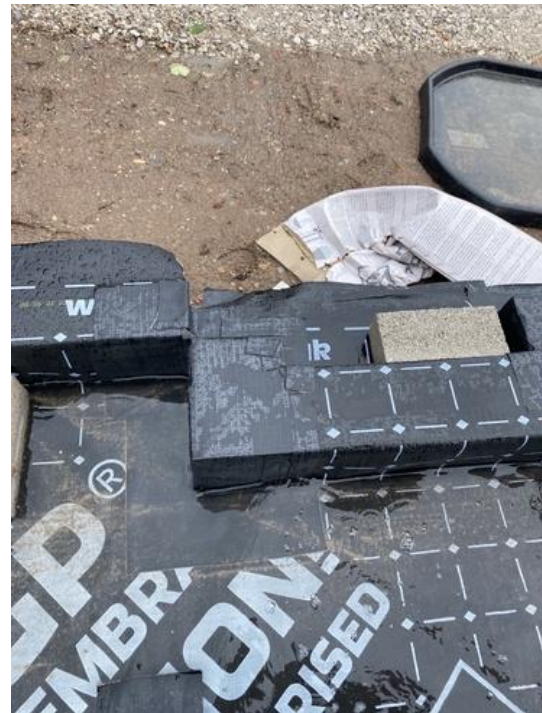
**Corners / Internal joints: Check all corners are correctly formed or contractor has used preformed corners.**

Pass

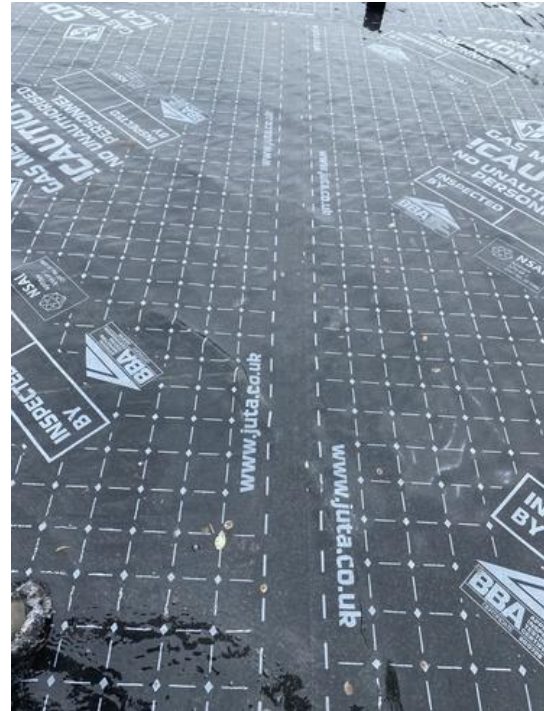
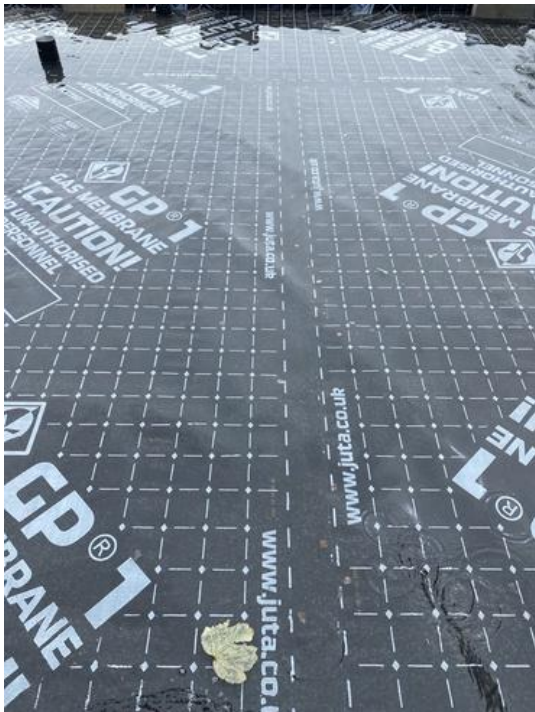
**Are folds running in line with joints? (no joints cutting across folds)**

Pass

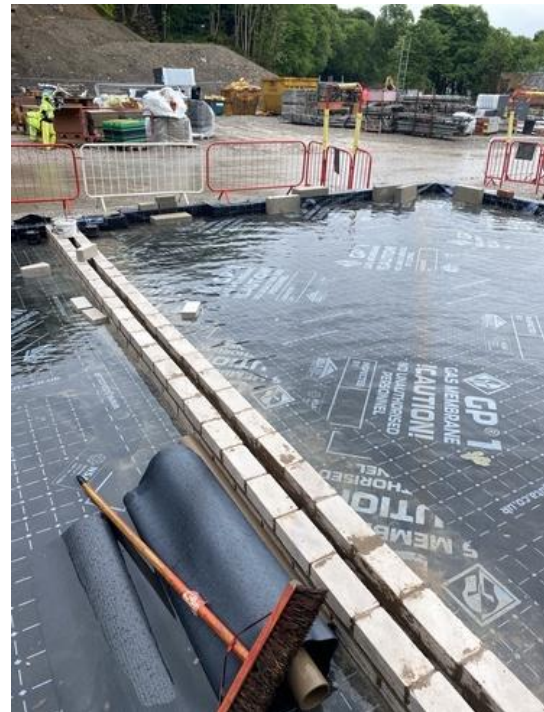
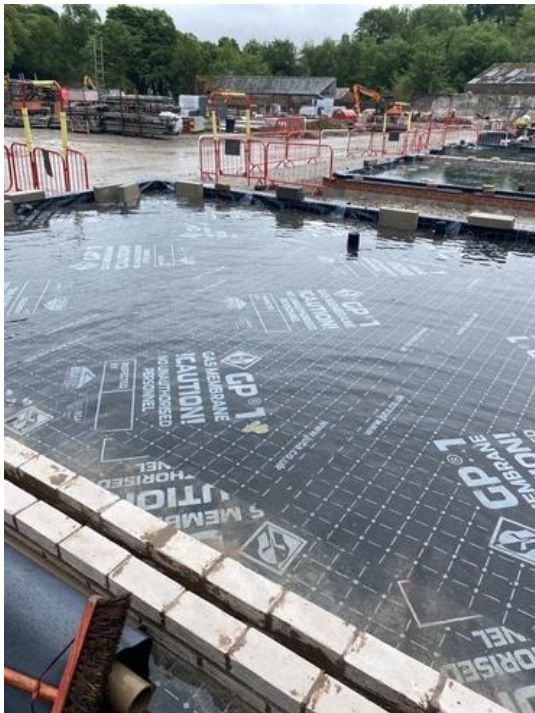
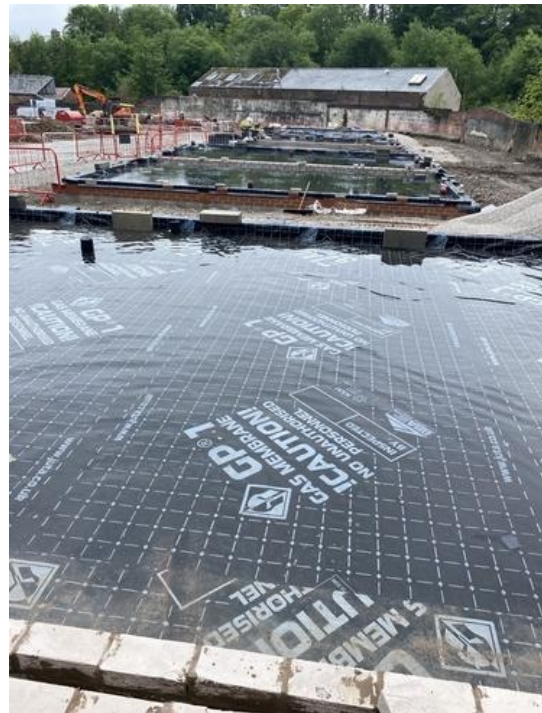
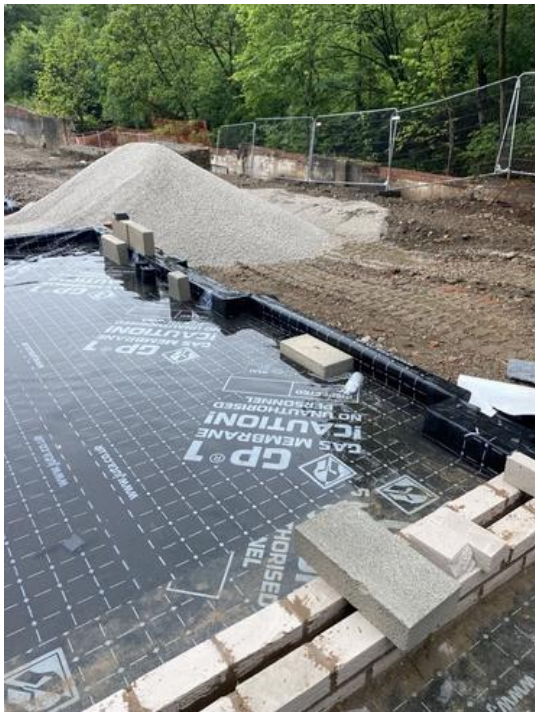
**Extent of Coverage: Is the membrane covering the entire plot? Does membrane span over outside walls?**

Yes

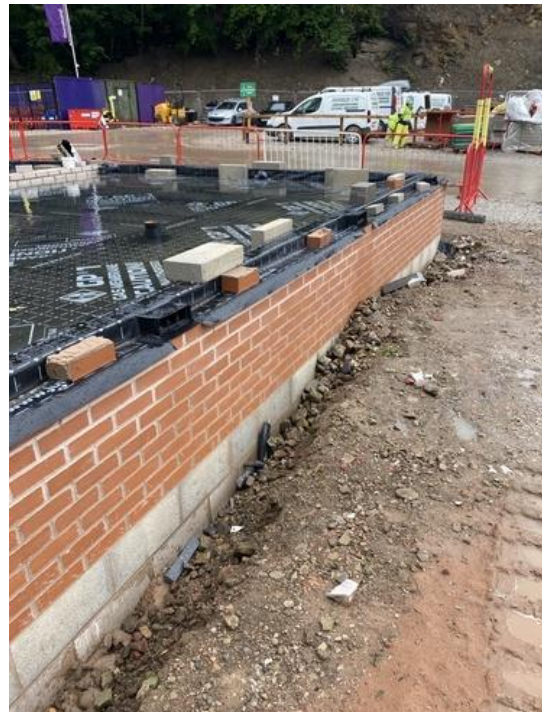
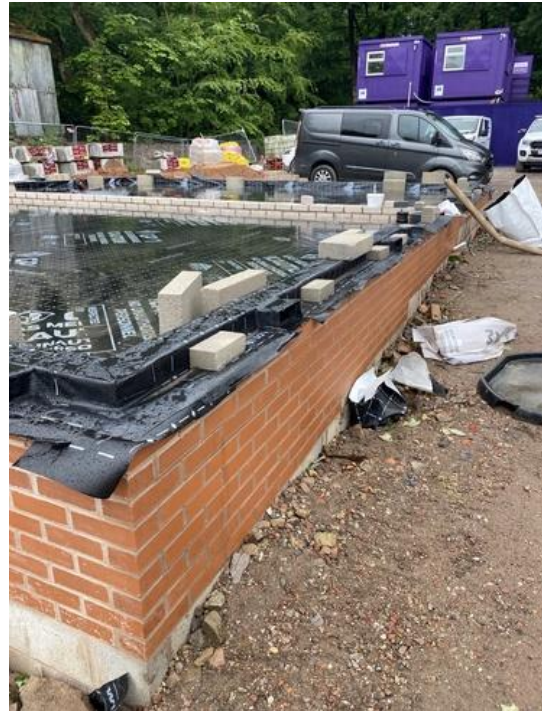
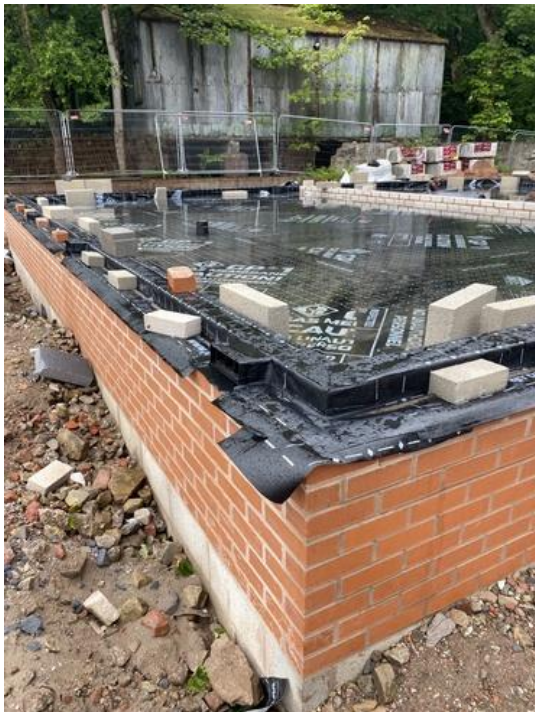
**External Wall Air bricks: Numbers, size. positions as design drawing? (Minimum of 3 walls)**

Pass

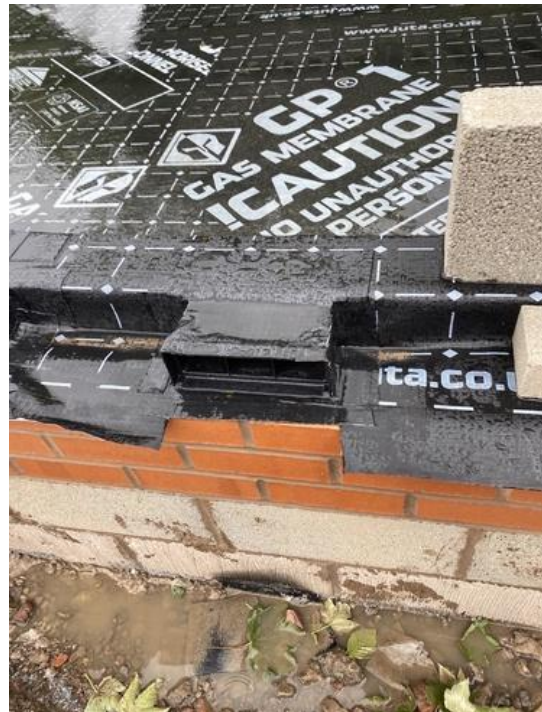
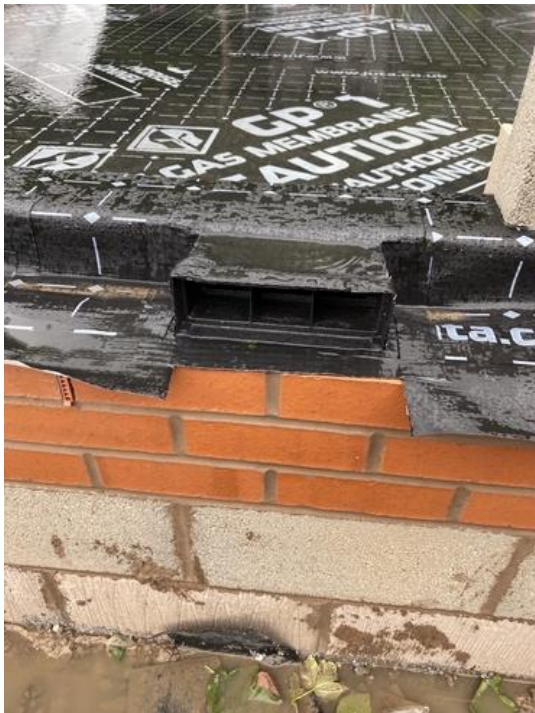
| Are telescopic vents present? | | Yes |

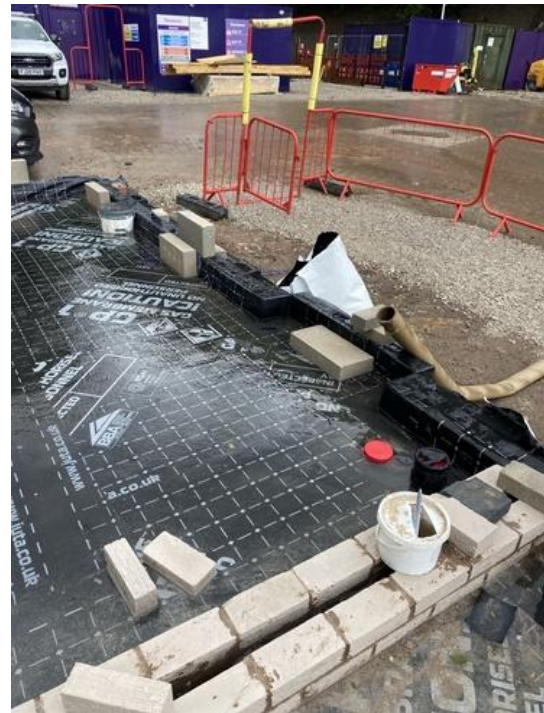
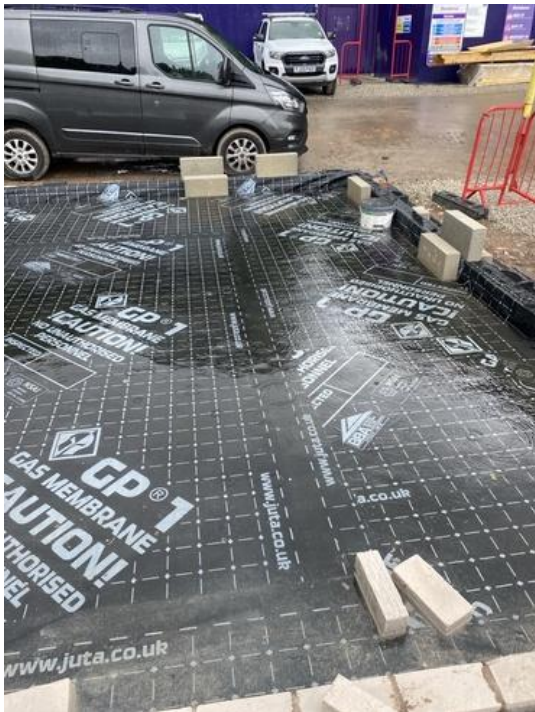
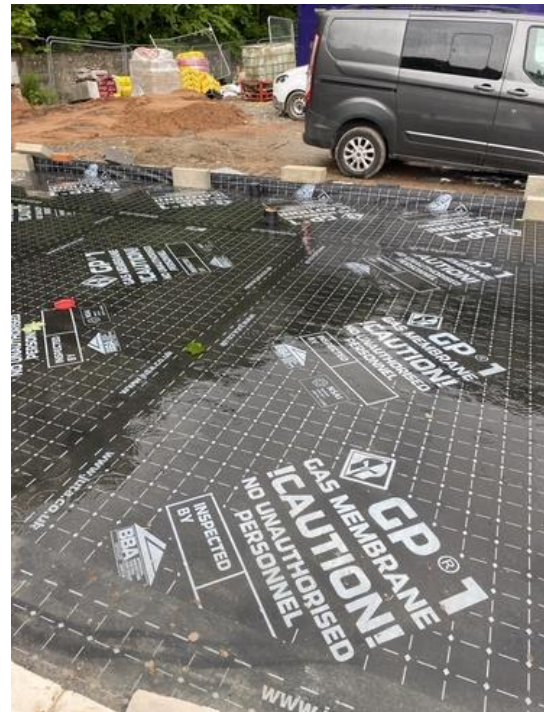
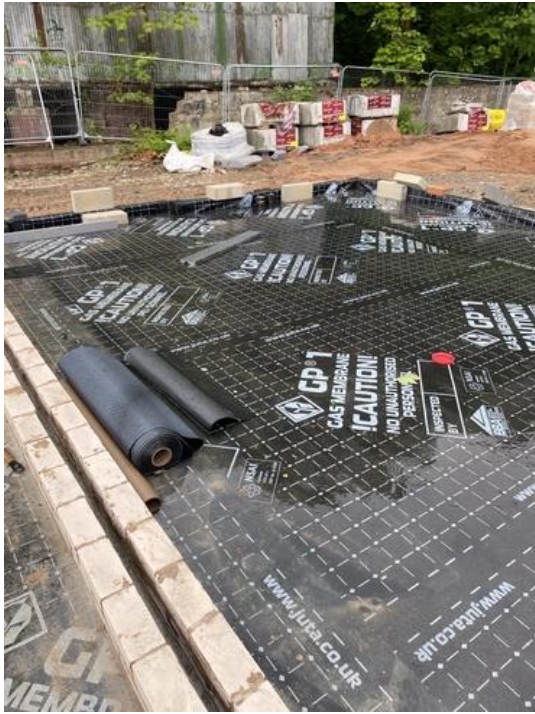
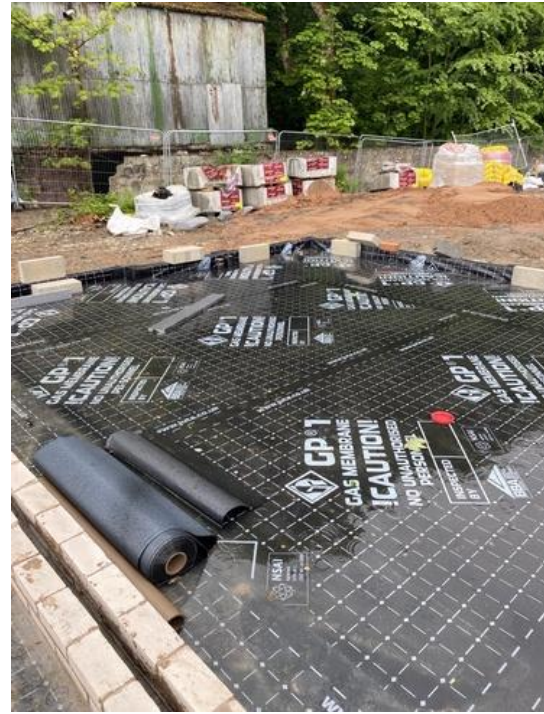
| Gas Membrane Condition: Open punctures, tears, rips, stretching, Presence of debris, Repairs, Signs of weakness such as raised or sunken indentations, Protection plan in place to restrict access to laid gas membrane? IF FAIL DESCRIPTION IN ACTIONS AND PHOTOS REQUIRED | | Pass |

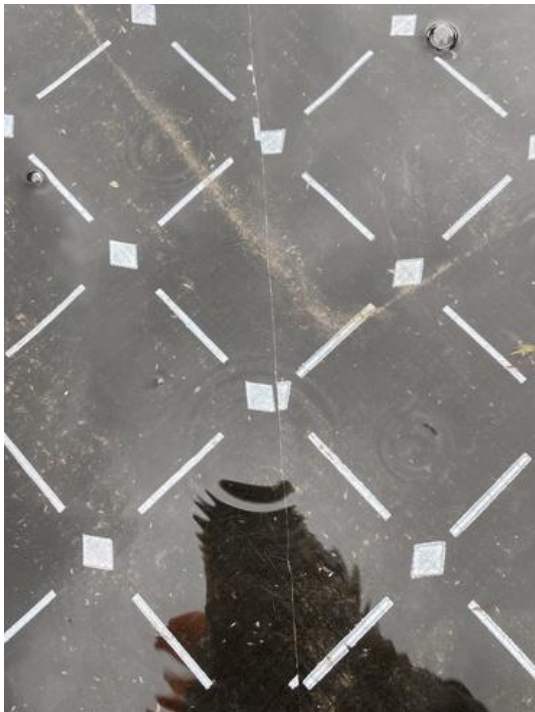
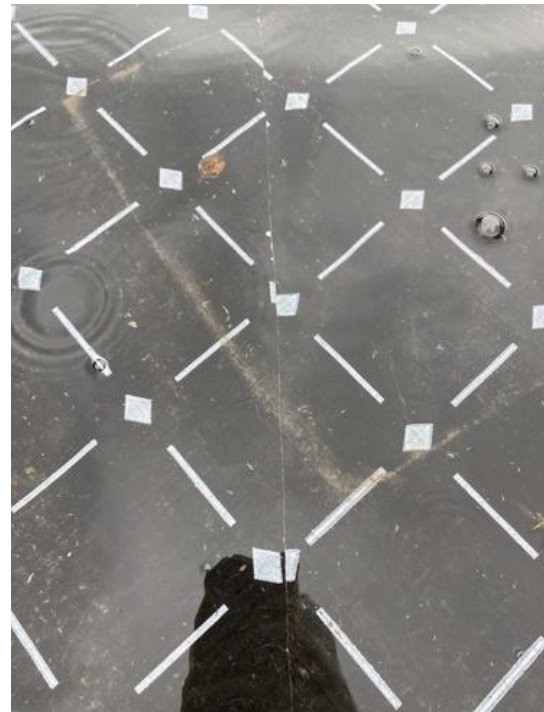
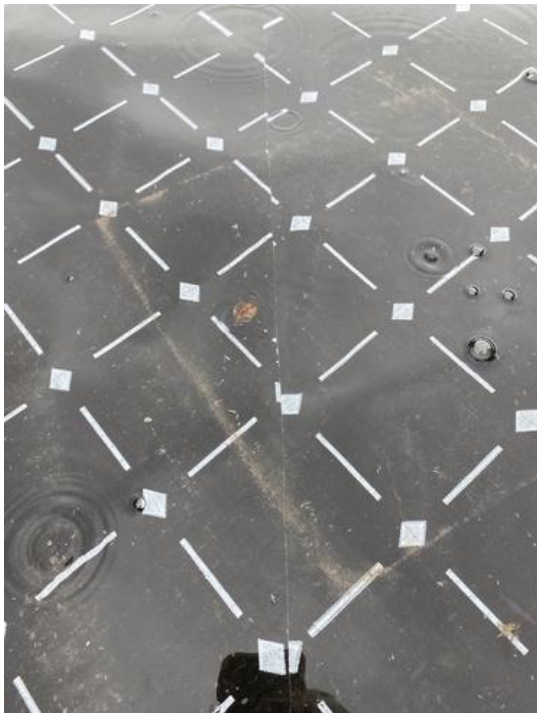
| Are welds complete? | | Yes |

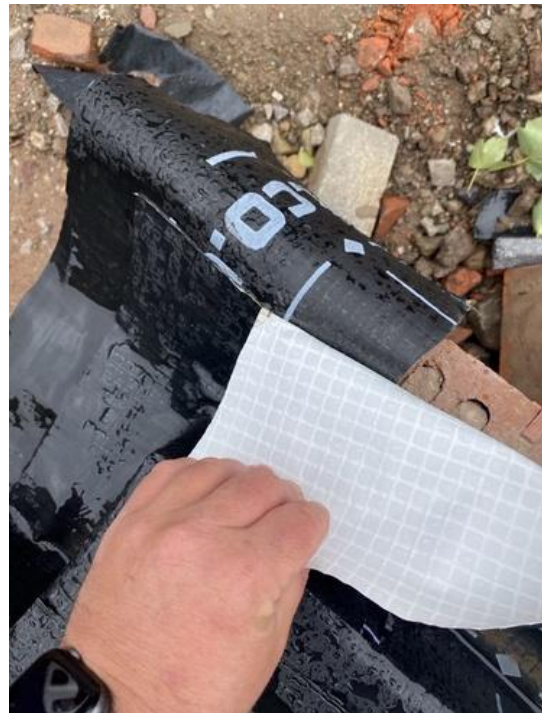
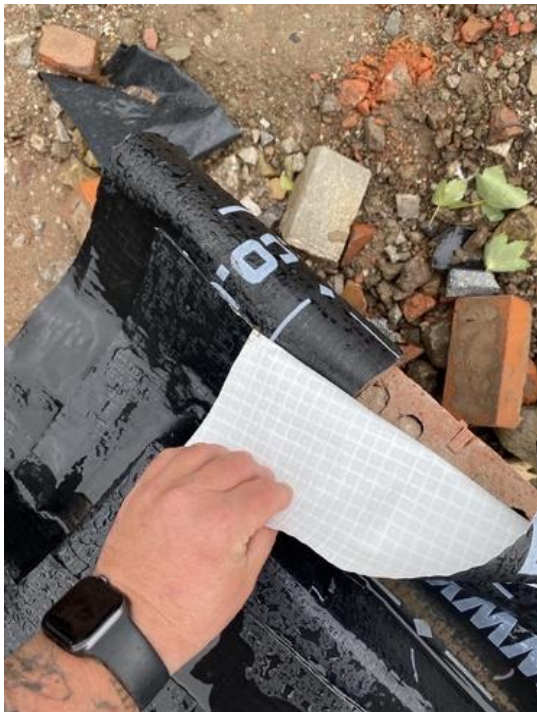
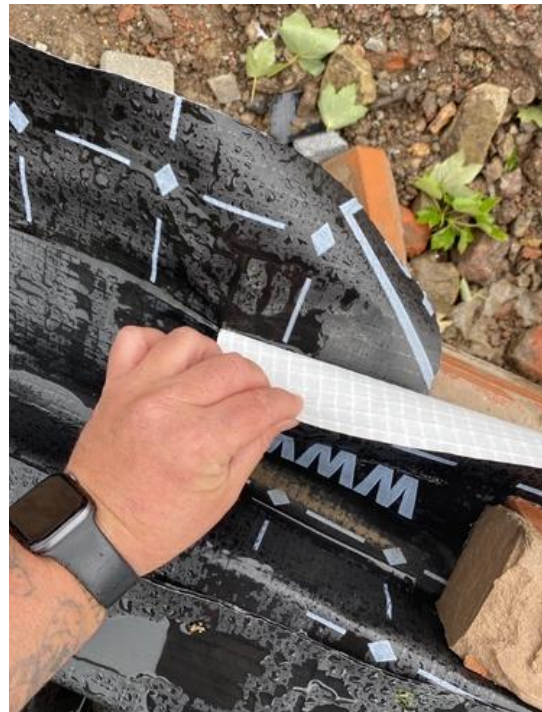
| Are Joints lapped and sealed in accordance with manufacturer's requirements/ specification? | | Yes |

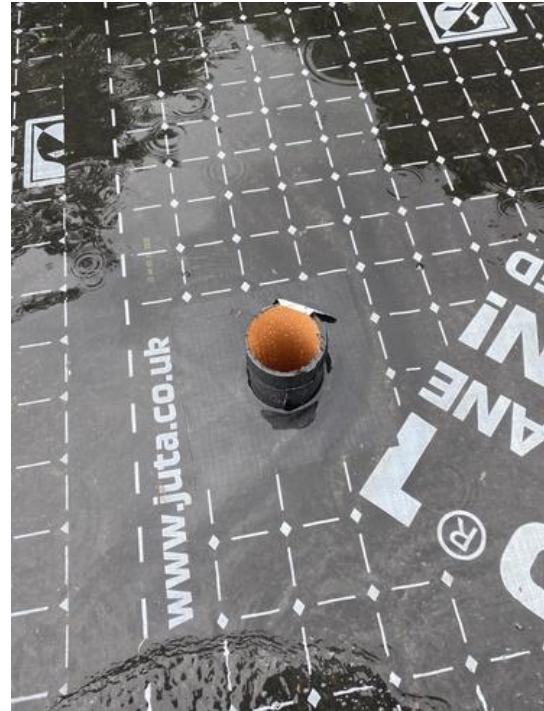
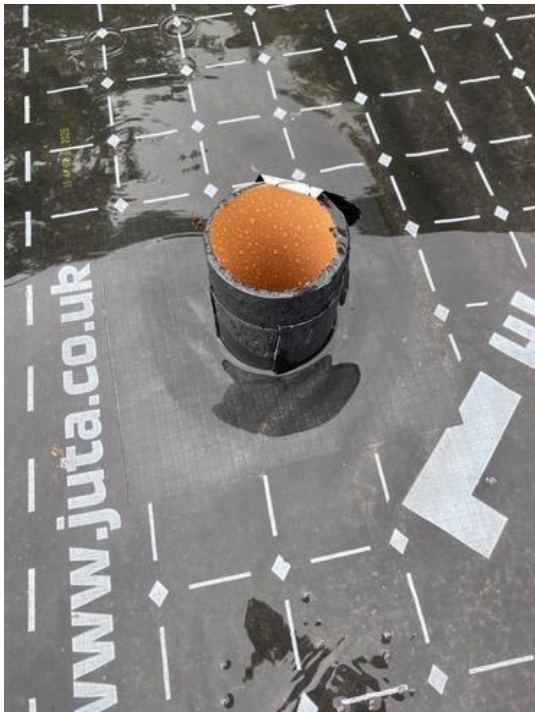
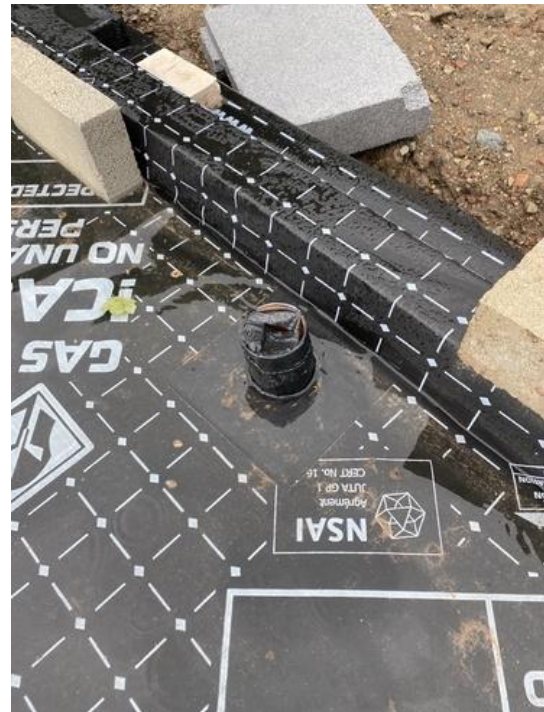
**Service entries seals: Top hats seal arrangements fixed around service entries? Use of Jubilee clips or Bitumastic Sealant**

Pass

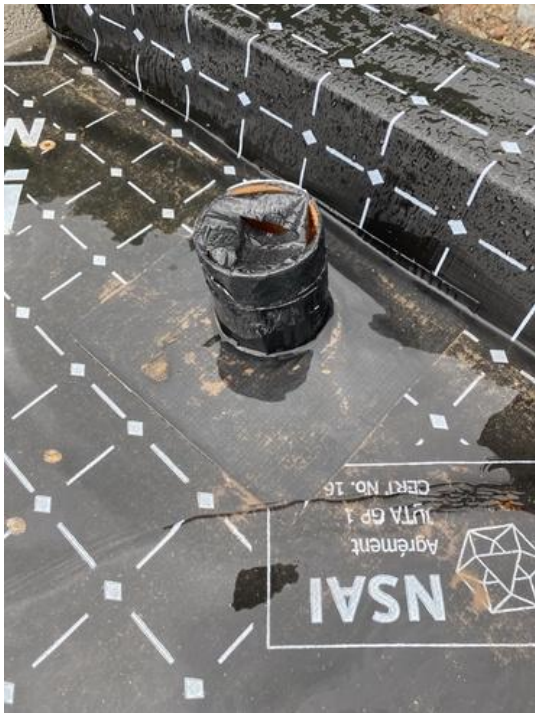
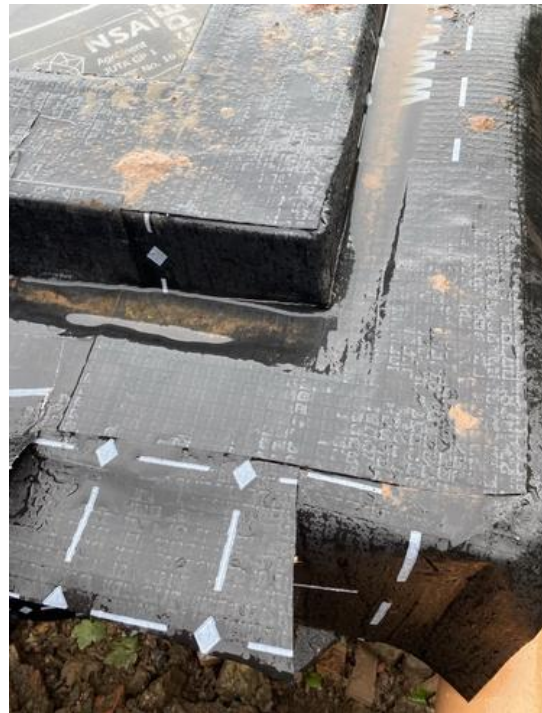
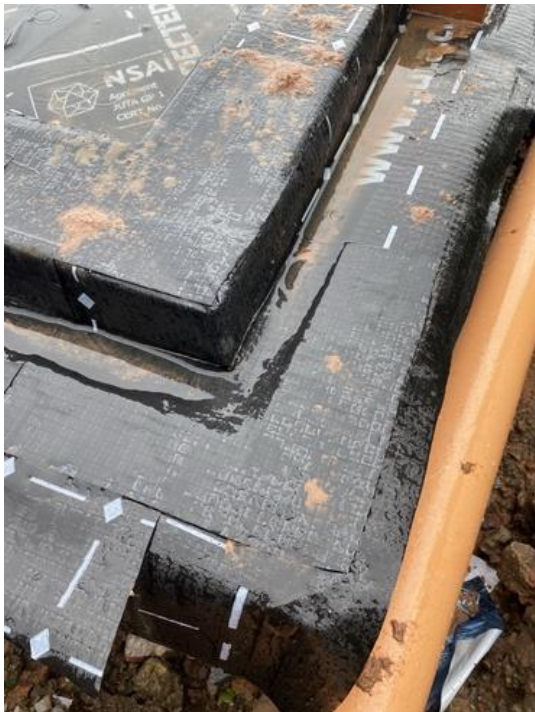
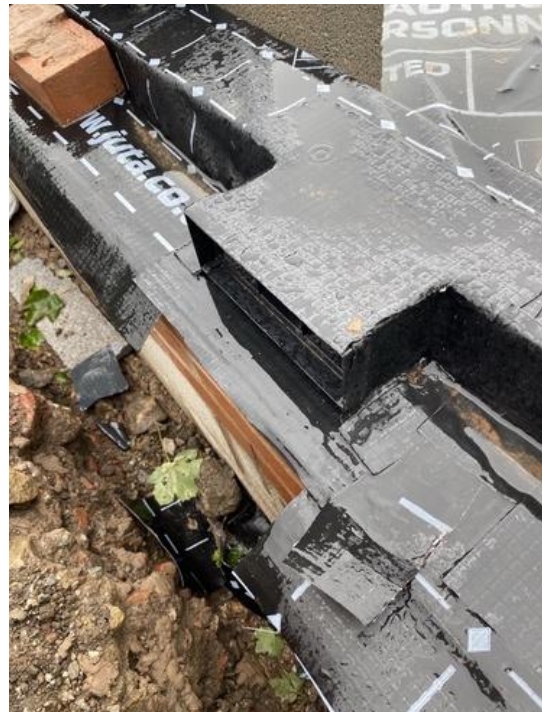
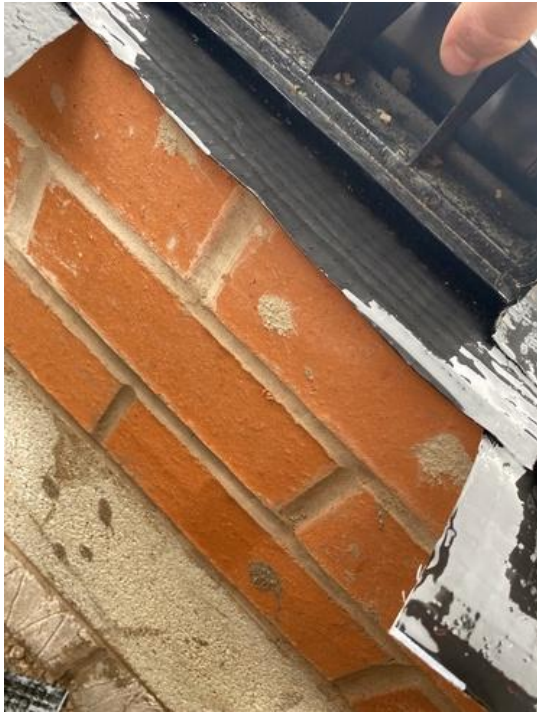
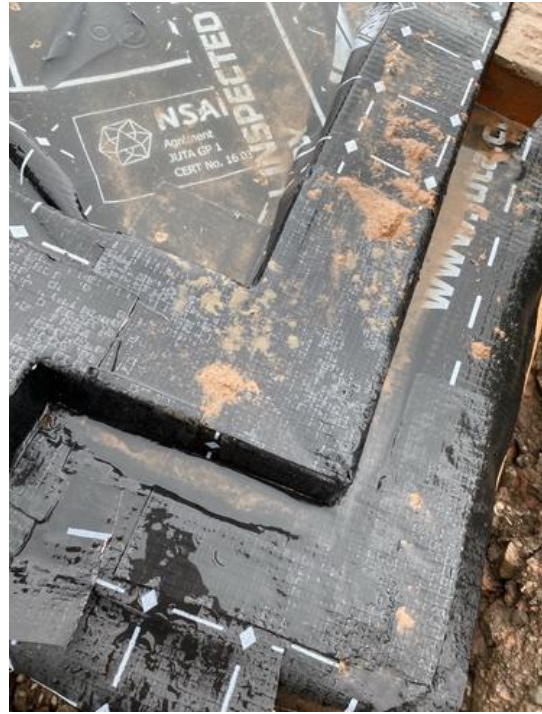
**Corners / Internal joints: Check all corners are correctly formed or contractor has used preformed corners.**

Pass

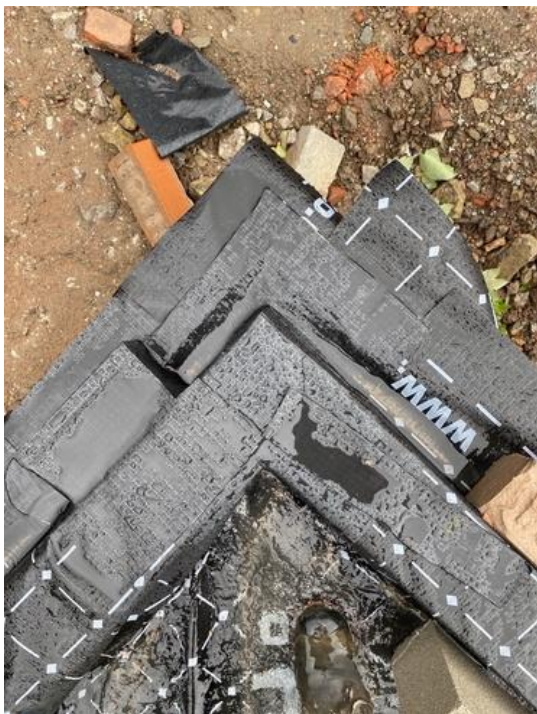
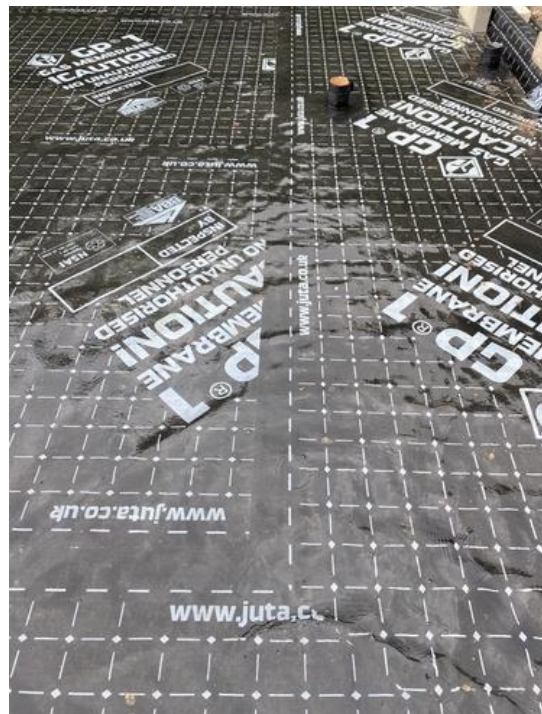
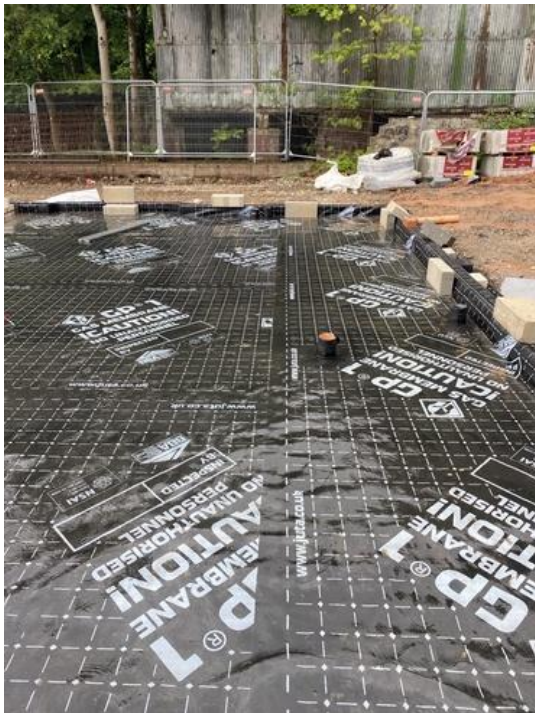
**Are folds running in line with joints? (no joints cutting across folds)**

Pass
