Date: 28<sup>th</sup> May 2025  
Reference: 16465-V9

## GAS MEMBRANE VALIDATION – EDENFIELD ROAD, NORDEN

| <b>Project Number:</b> | 16465 |
| <b>Plots:</b> | 24-25 |

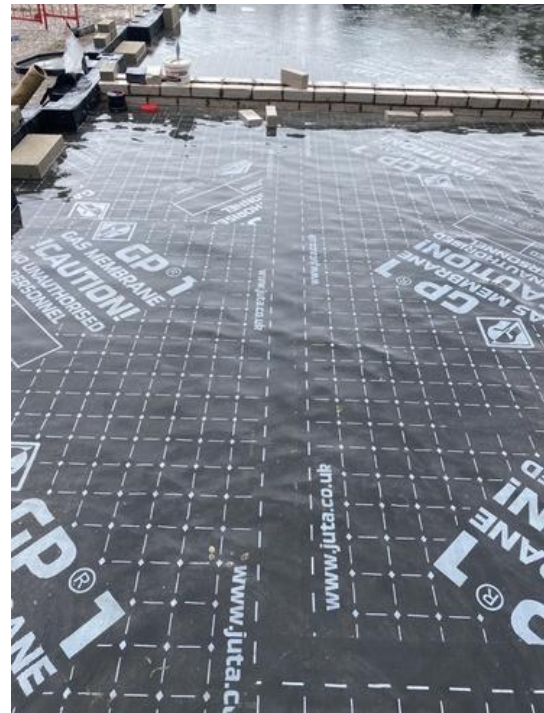
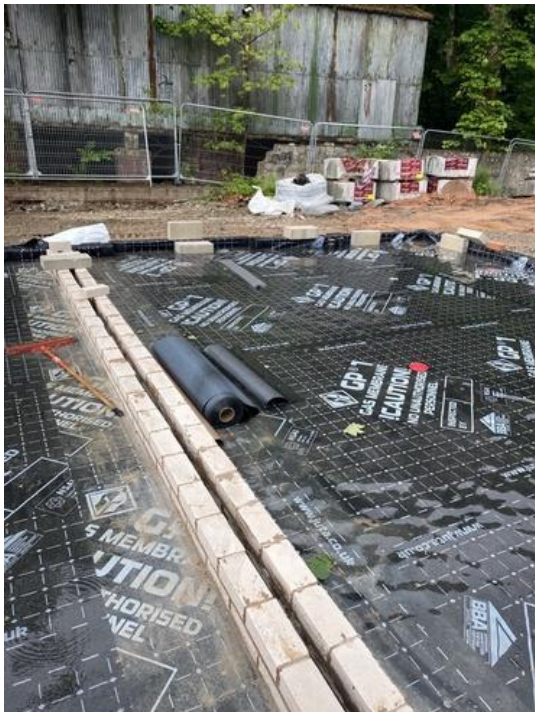
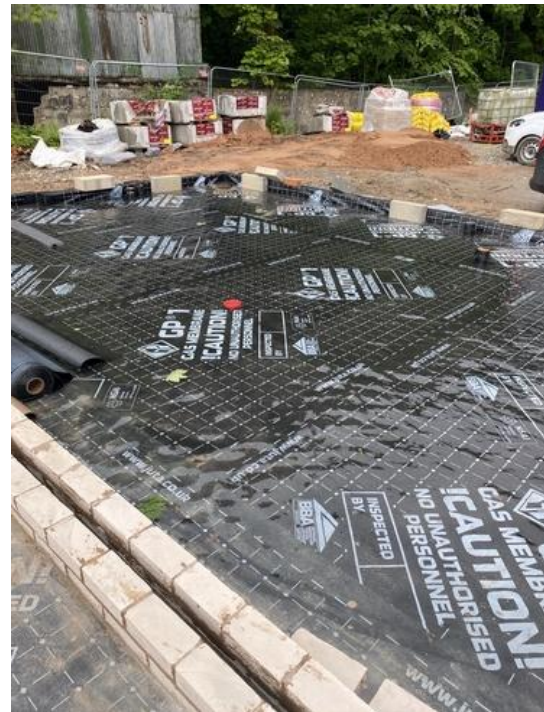
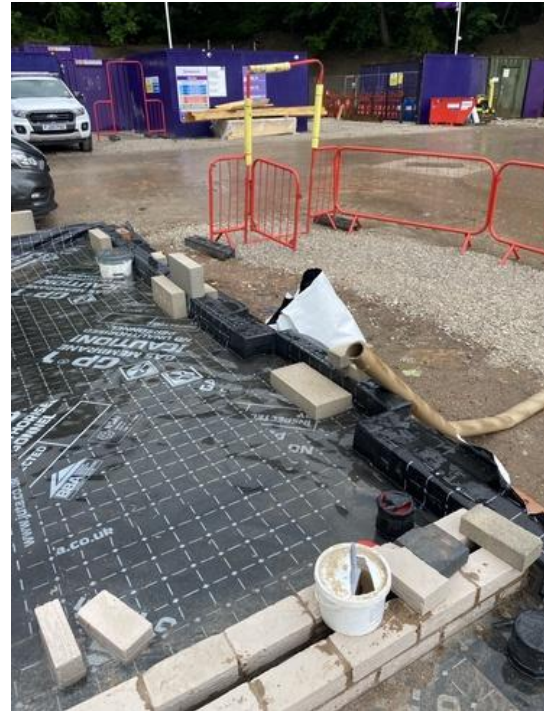
**Extent of Coverage: Is the membrane covering the entire plot? Does membrane span over outside walls?**

Yes
