Date: 28th May 2025  
Reference: 16465-V6

## GAS MEMBRANE VALIDATION – EDENFIELD ROAD, NORDEN

| <b>Project Name:</b> | Edenfield Road, Rochdale |
| <b>Plots:</b> | 43-45 |

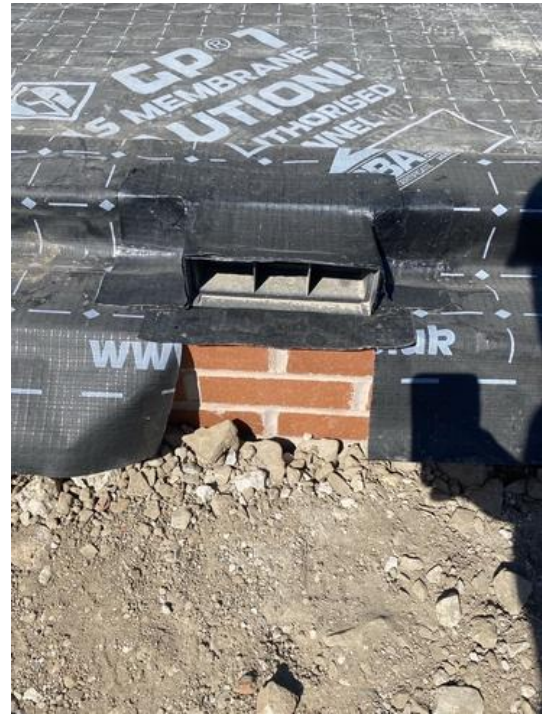
Photo 1

| <b>Are telescopic vents present?</b> | Yes |

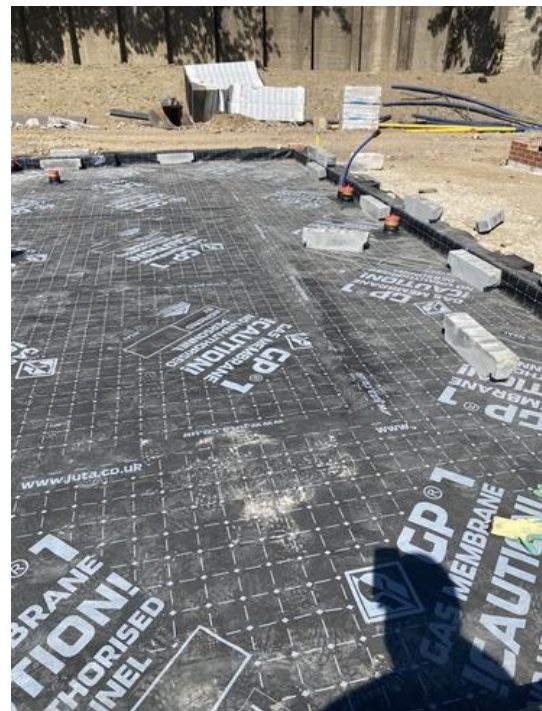
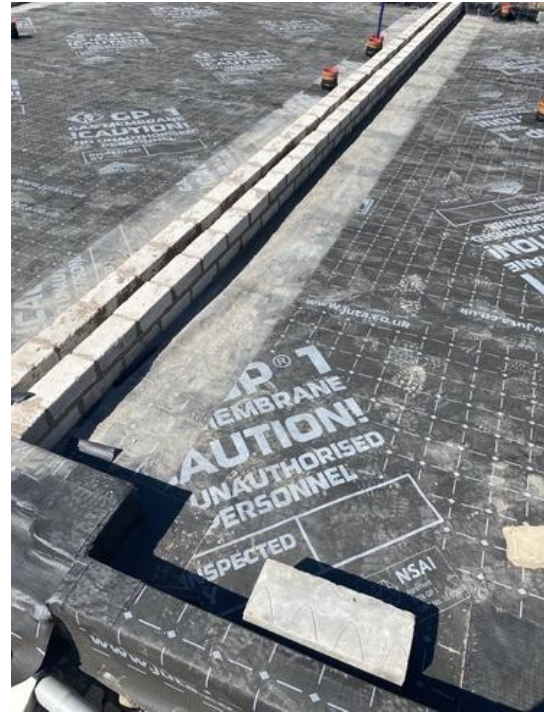
Photo 3

| <b>Gas Membrane Condition: Open punctures, tears, rips, stretching, Presence of debris, Repairs, Signs of weakness such as raised or sunken indentations, Protection plan in place to restrict access to laid gas membrane? IF FAIL DESCRIPTION IN ACTIONS AND PHOTOS REQUIRED</b> | Pass |

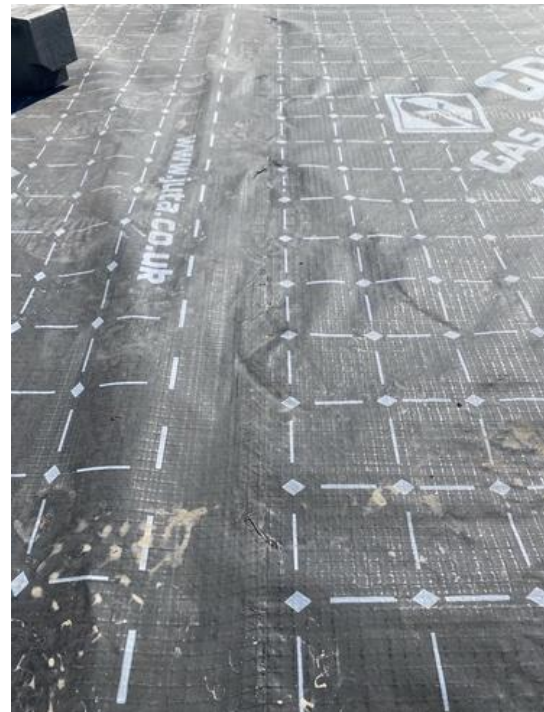
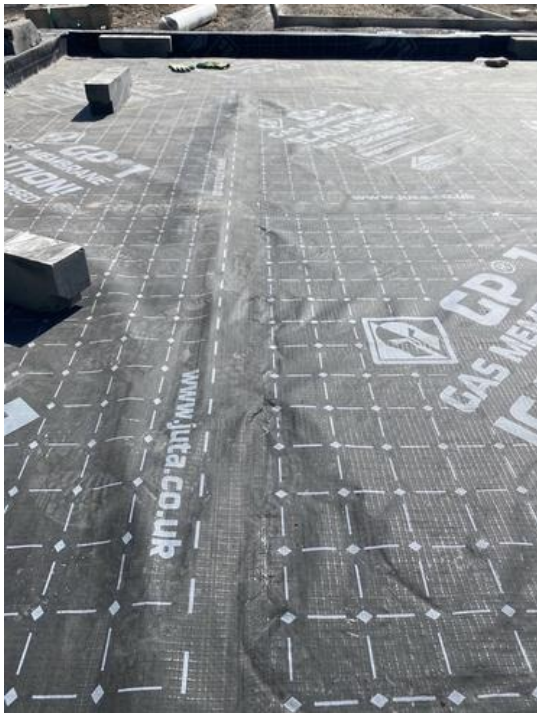
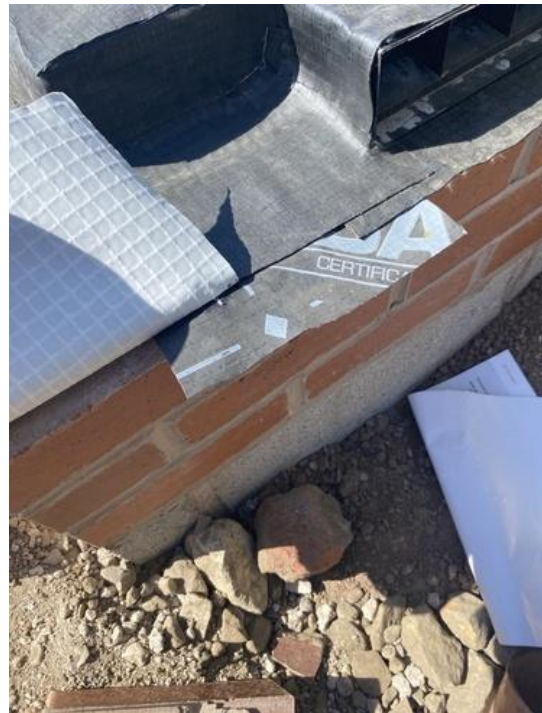
Photo 7

| <b>Are welds complete?</b> | Yes |

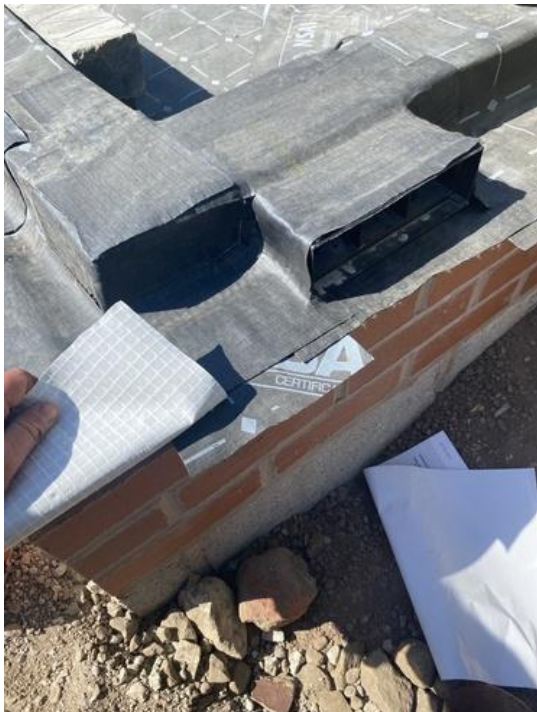
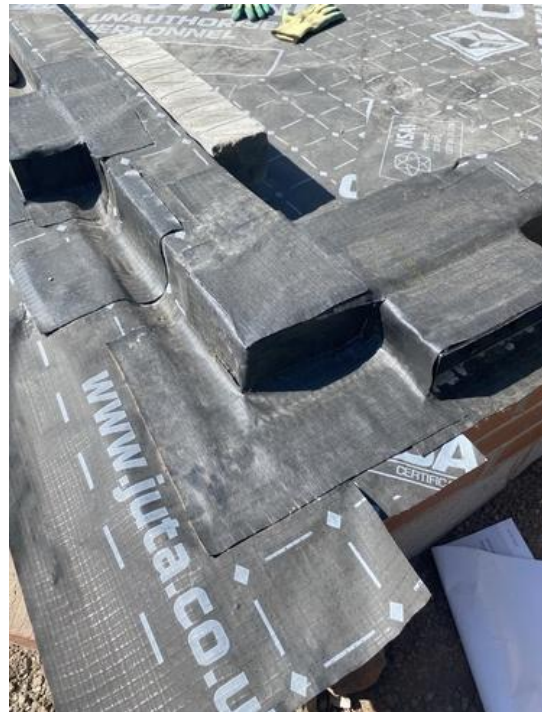
Photo 10

| <b>Are Joints lapped and sealed in accordance with manufacturer's requirements/ specification?</b> | Yes |

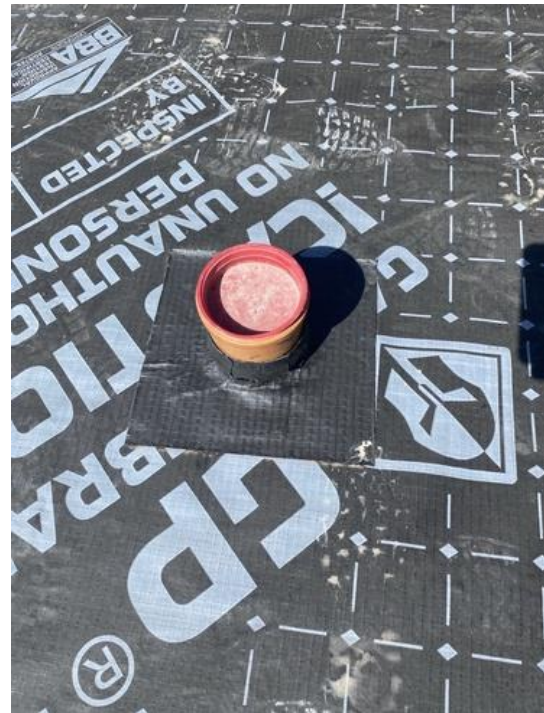
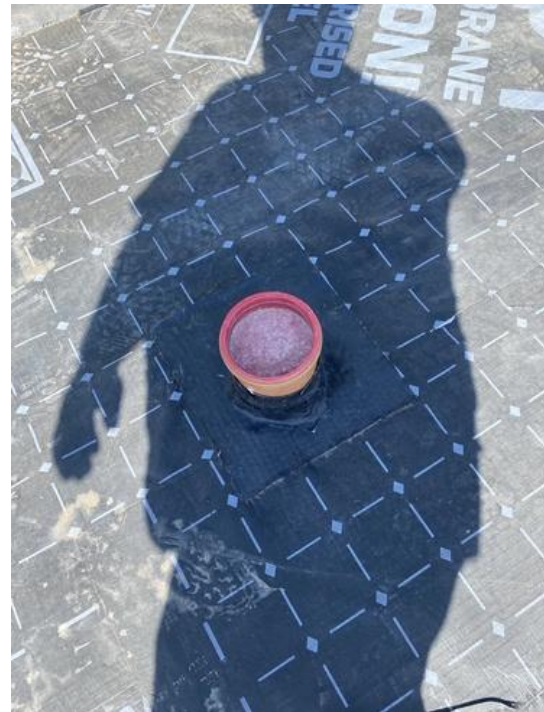
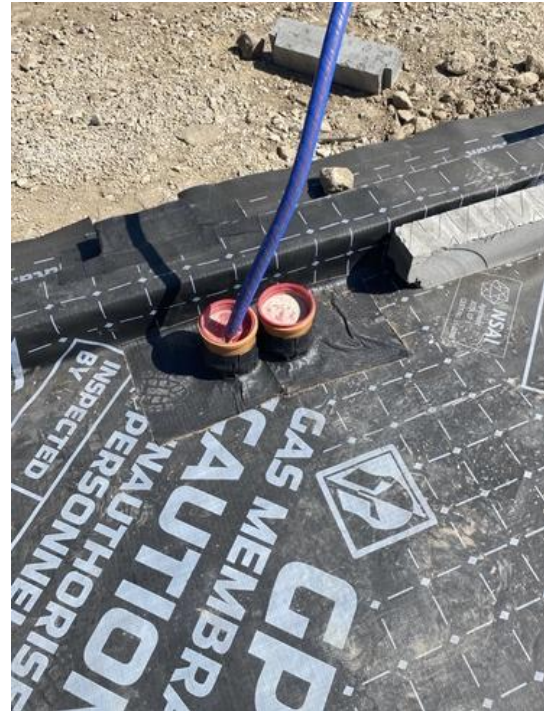
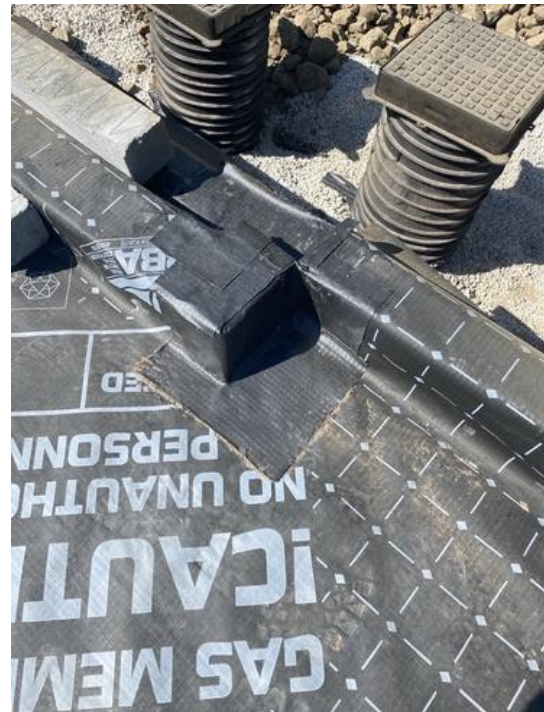
Photo 13

**Service entries seals: Top hats seal arrangements fixed around service entries? Use of Jubilee clips or Bitumastic Sealant**

Pass

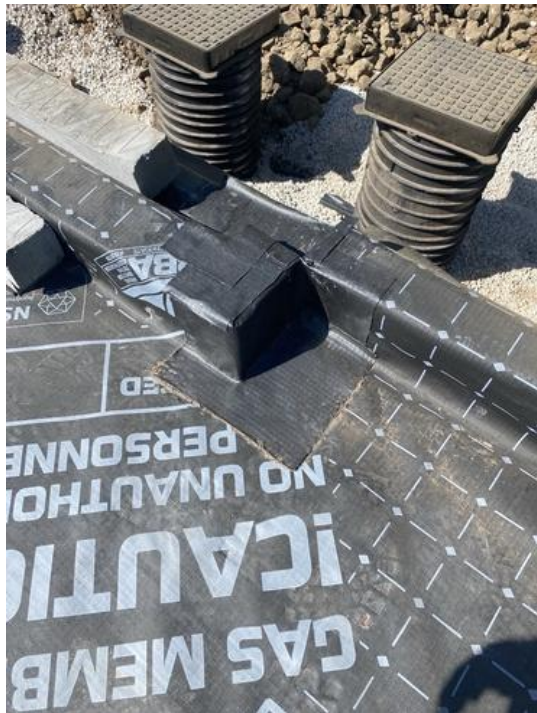
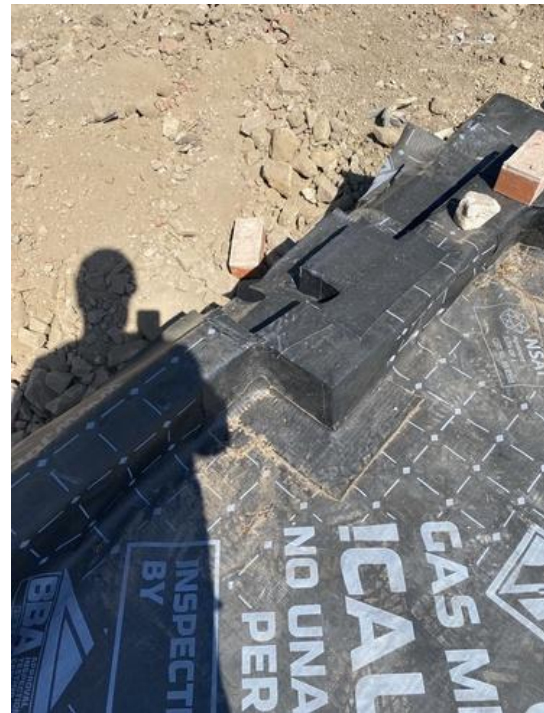
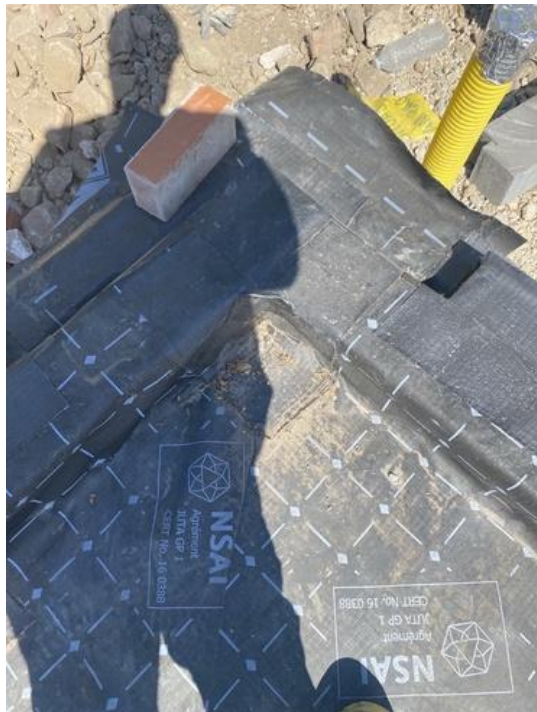
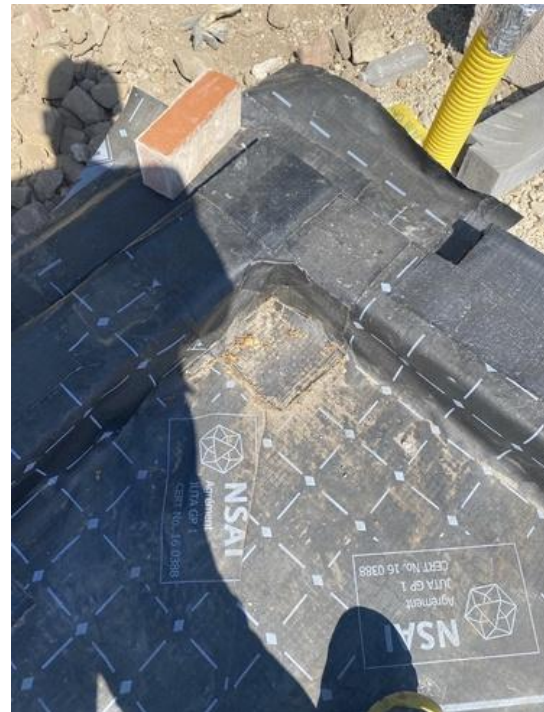
Photo 20

**Corners / Internal joints: Check all corners are correctly formed or contractor has used preformed corners.**

Pass

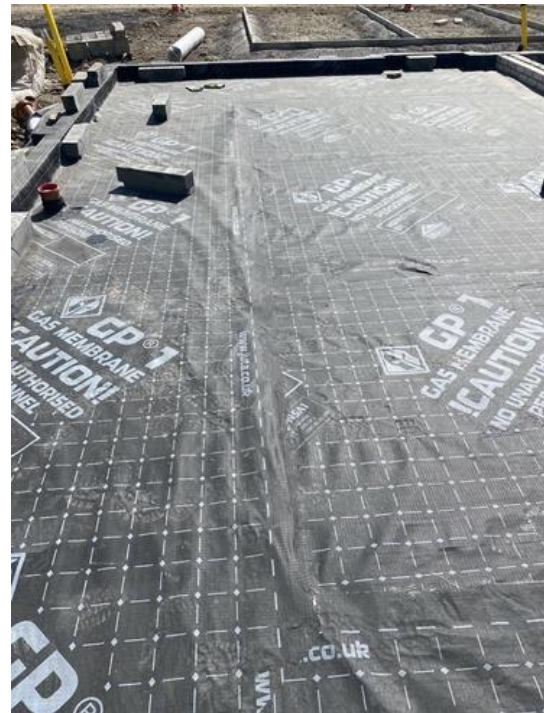
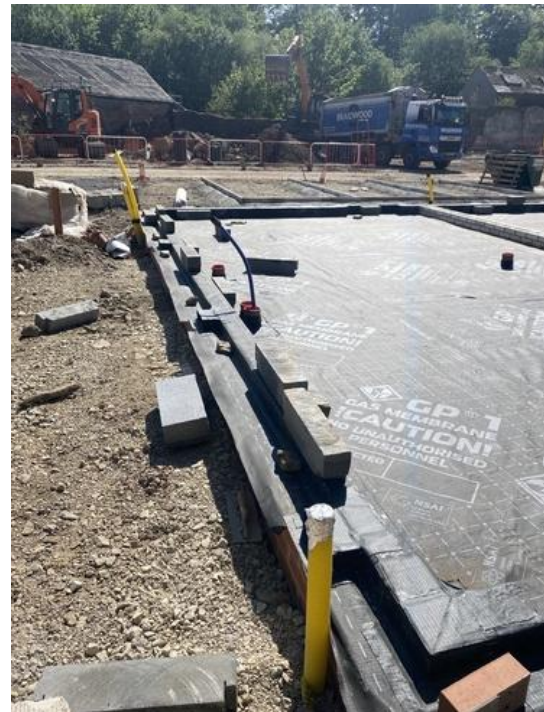
Photo 25

**Are folds running in line with joints? (no joints cutting across folds)**

Pass

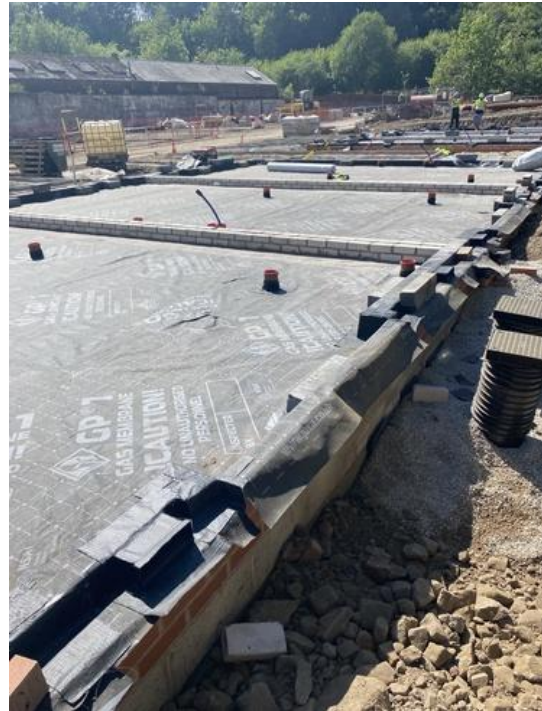
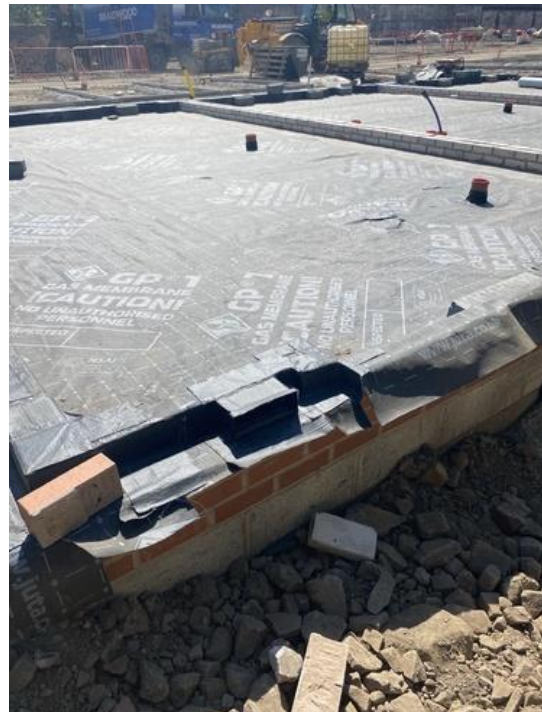
Photo 29

**Extent of Coverage: Is the membrane covering the entire plot? Does membrane span over outside walls?**

Yes

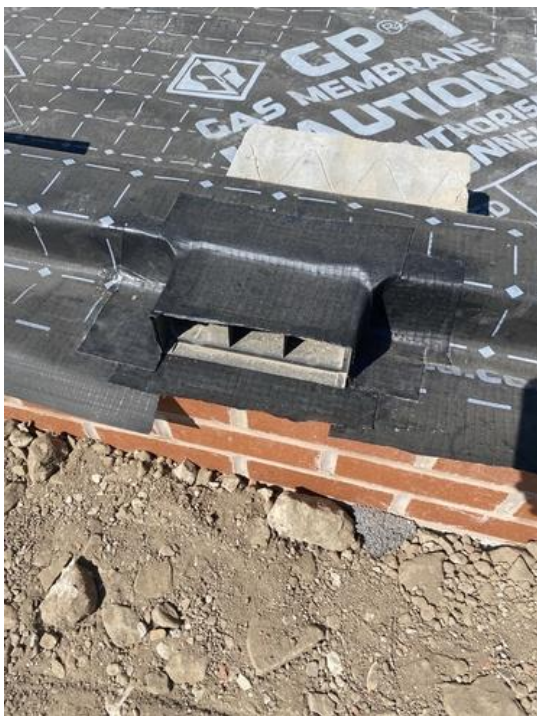
Photo 34

**External Wall Air bricks: Numbers, size. positions as design drawing? (Minimum of 3 walls)**

Pass

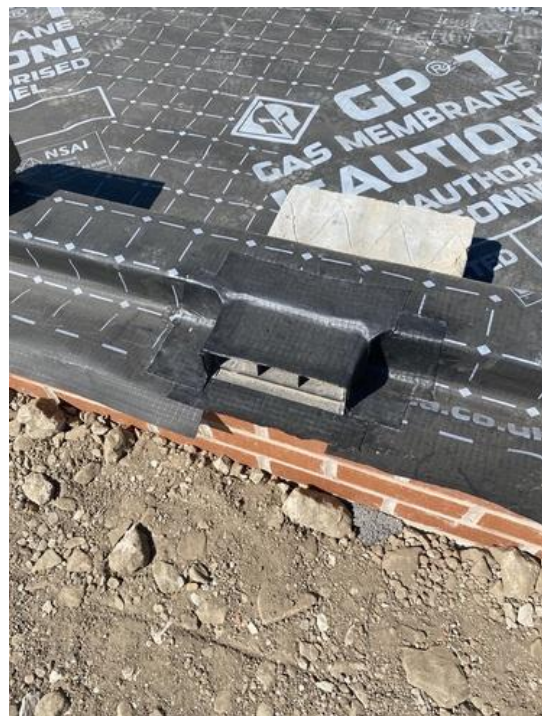
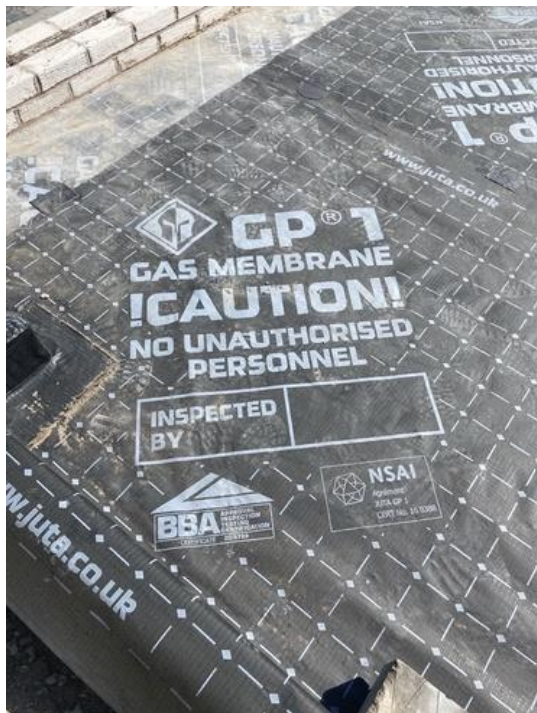
Photo 35

| Are telescopic vents present? | | Yes |

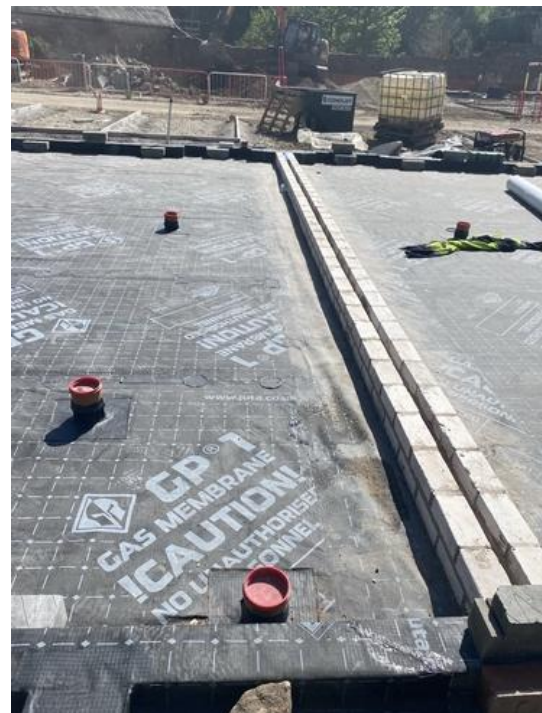
Photo 37

| Gas Membrane Type: Manufacturer, gauge, and colour.<br>(Take photos were possible showing Label) | | Juta - GP1 Gas Barrier |

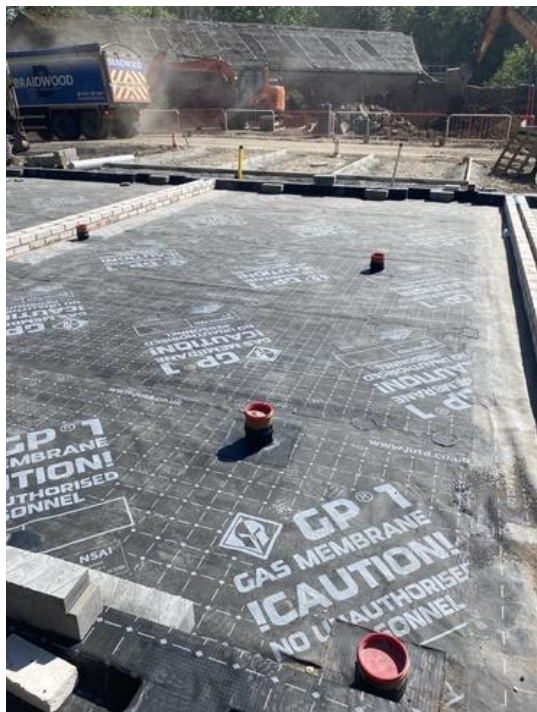
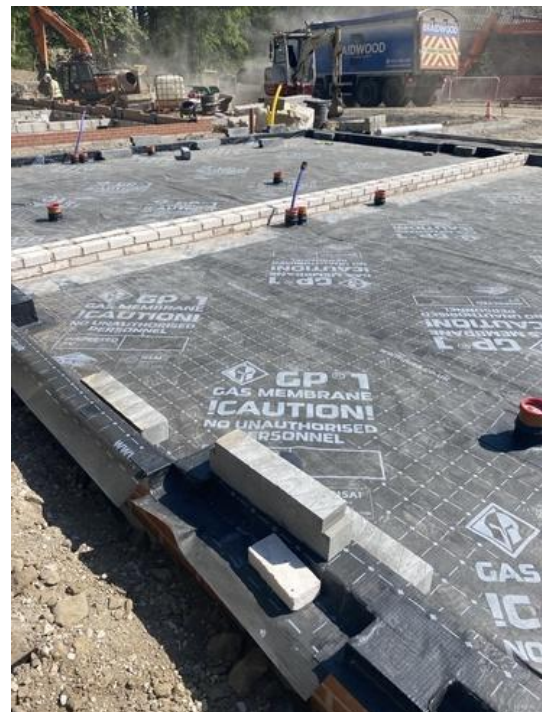
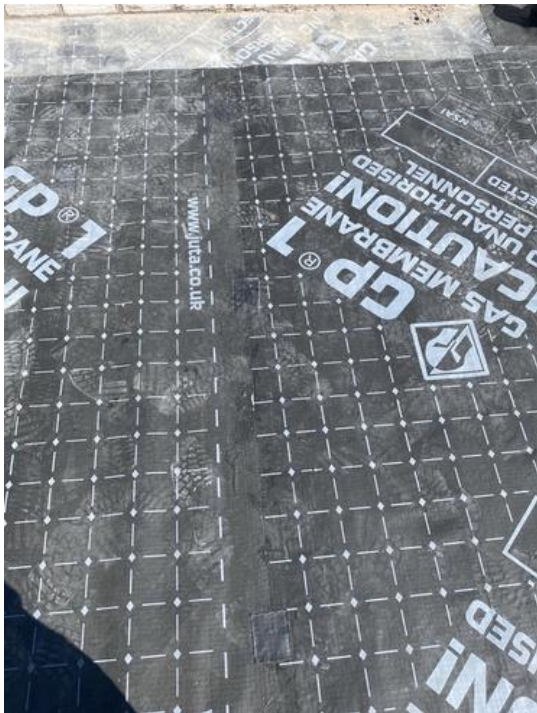
Photo 38

| Gas Membrane Condition: Open punctures, tears, rips, stretching, Presence of debris, Repairs, Signs of weakness such as raised or sunken indentations, Protection plan in place to restrict access to lain gas membrane? IF FAIL DESCRIPTION IN ACTIONS AND PHOTOS REQUIRED | | <div>Pass</div> |

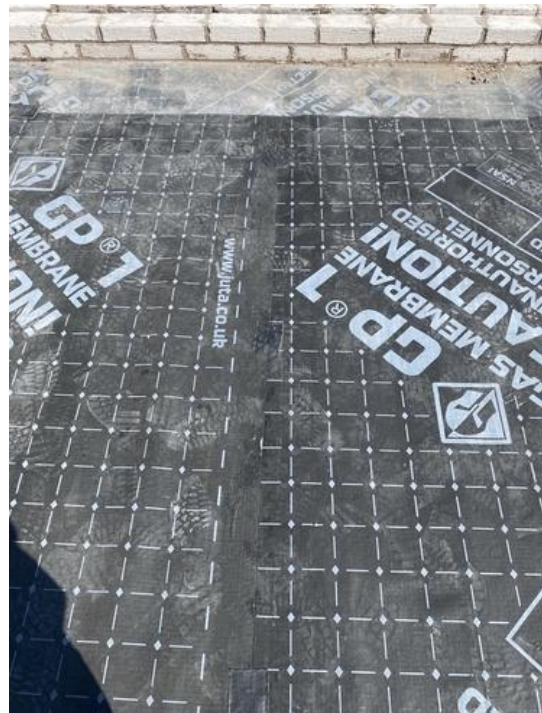
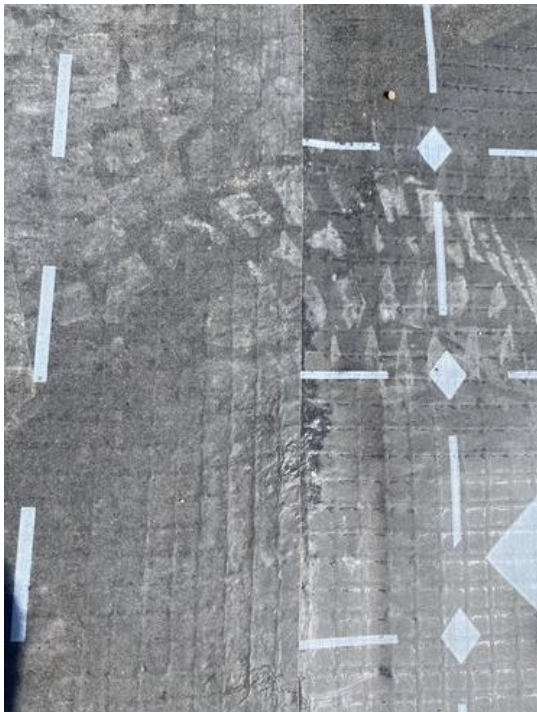
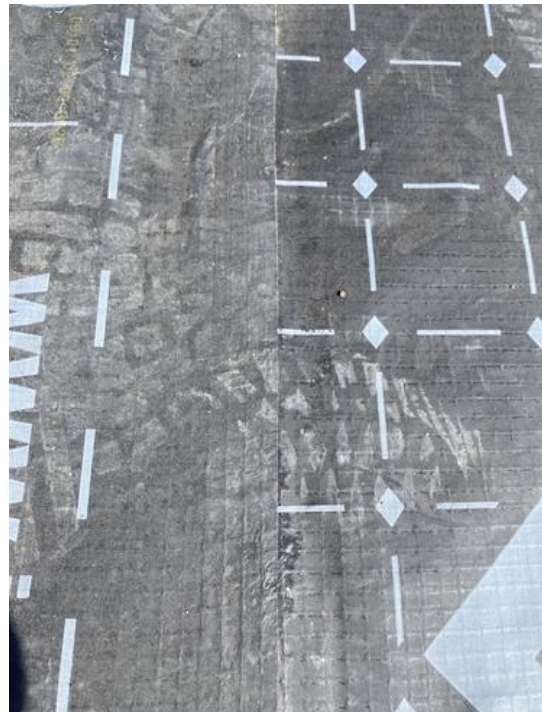
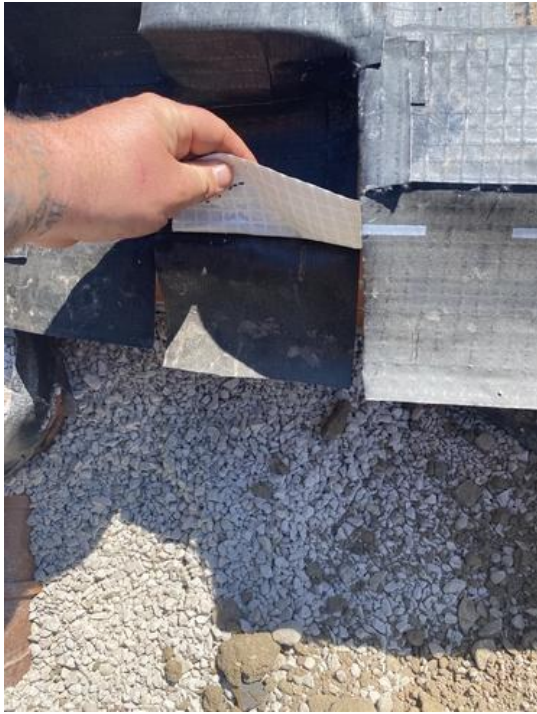
Photo 41

| Are welds complete? | | Yes |

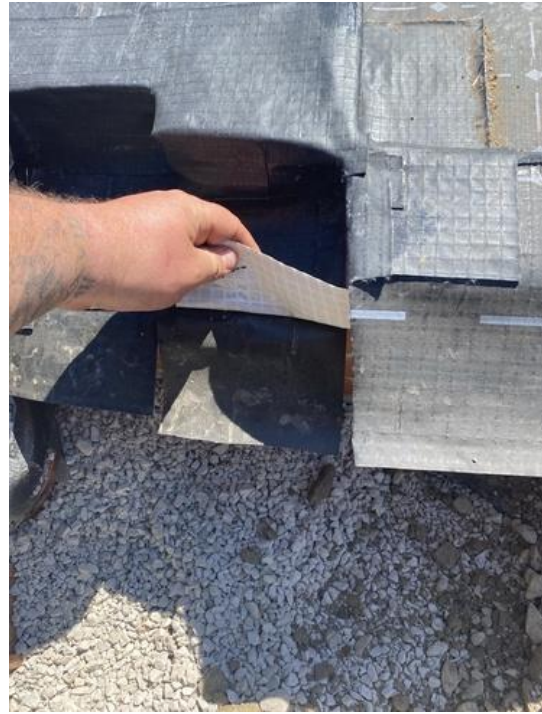
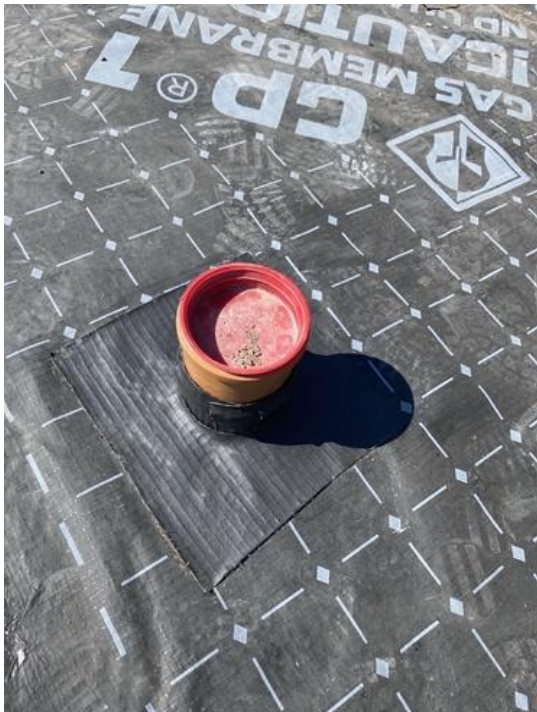
Photo 45

| Are Joints lapped and sealed in accordance with manufacturer's requirements/ specification? | | Yes |

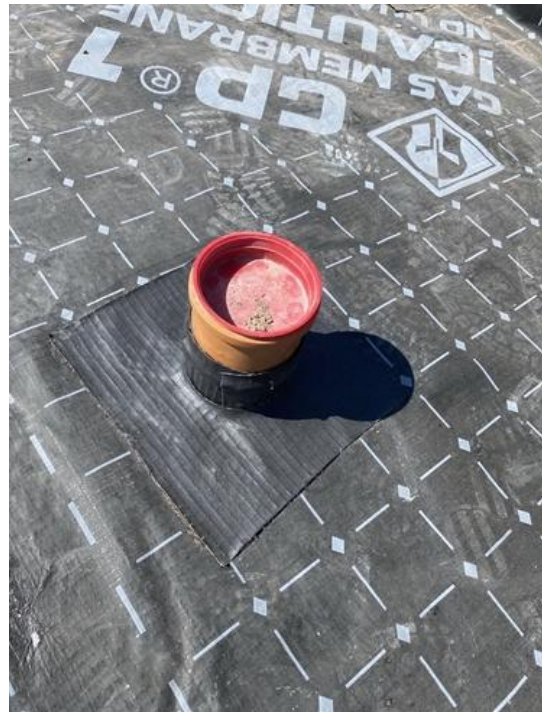
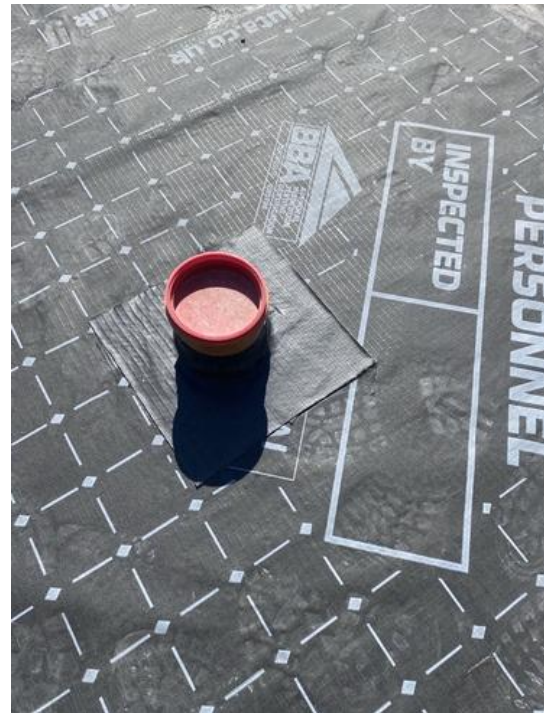
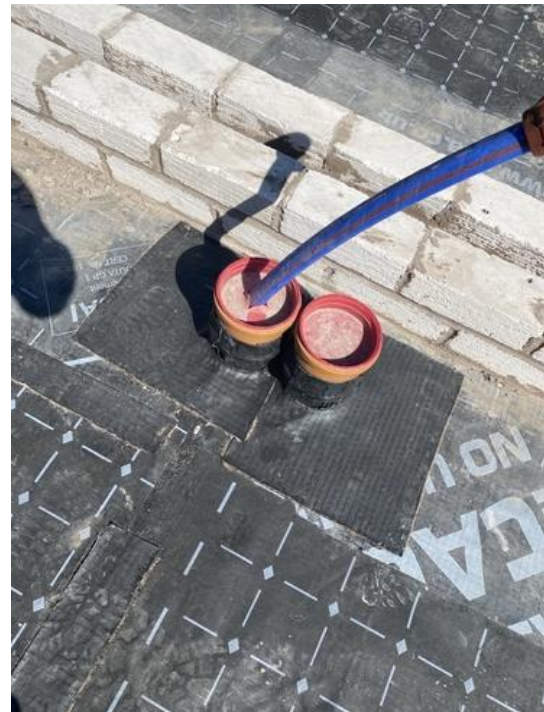
Photo 47

**Service entries seals: Top hats seal arrangements fixed around service entries? Use of Jubilee clips or Bitumastic Sealant**

Pass

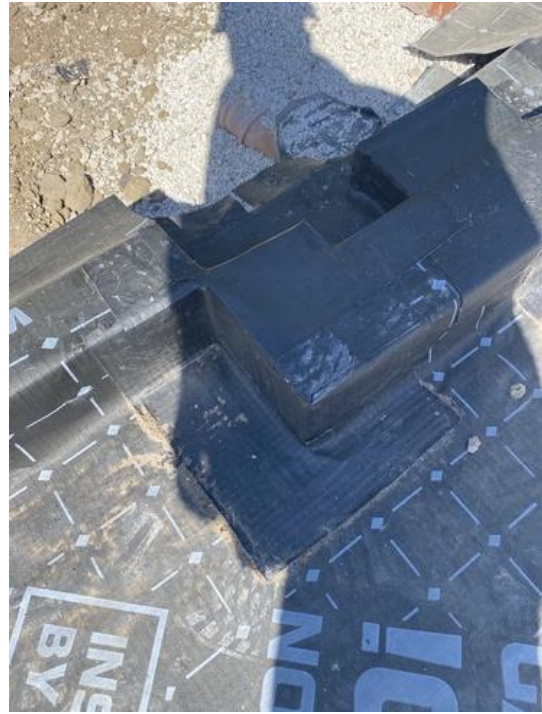
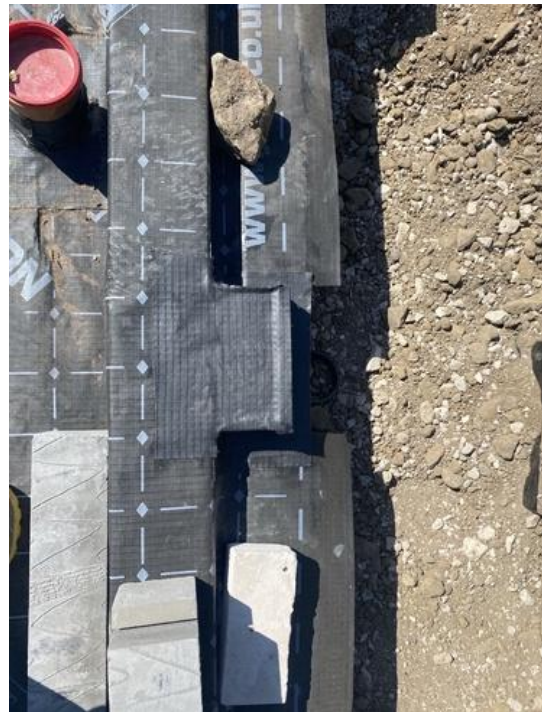
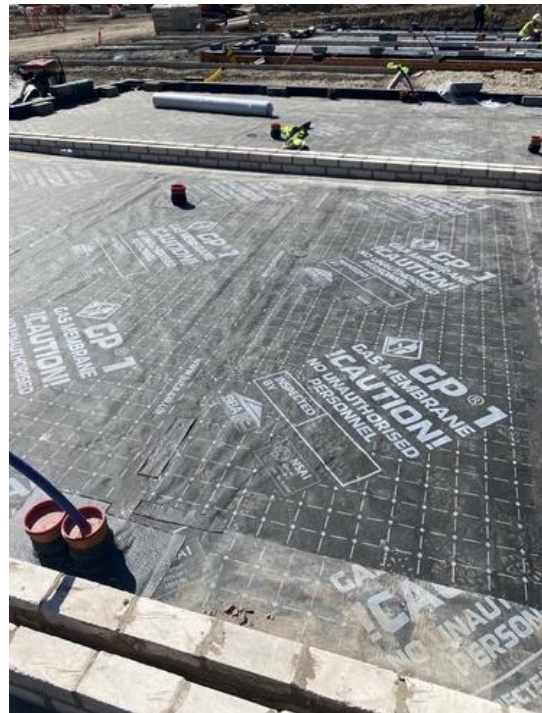
Photo 53

**Corners / Internal joints: Check all corners are correctly formed or contractor has used preformed corners.**

Pass

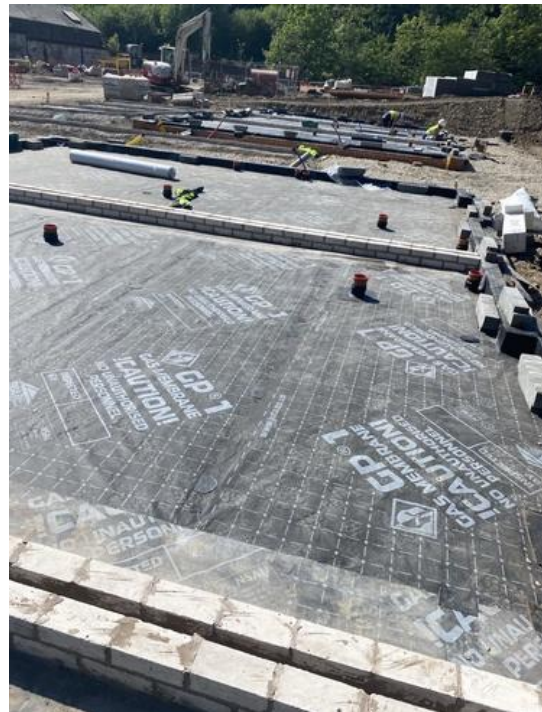
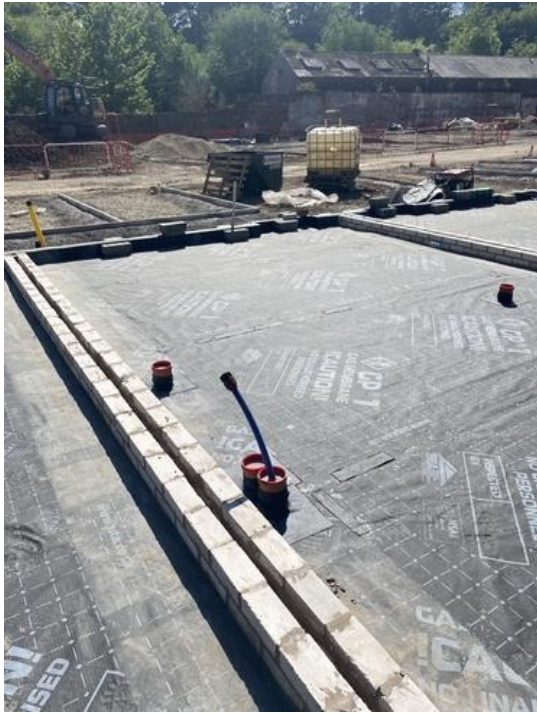
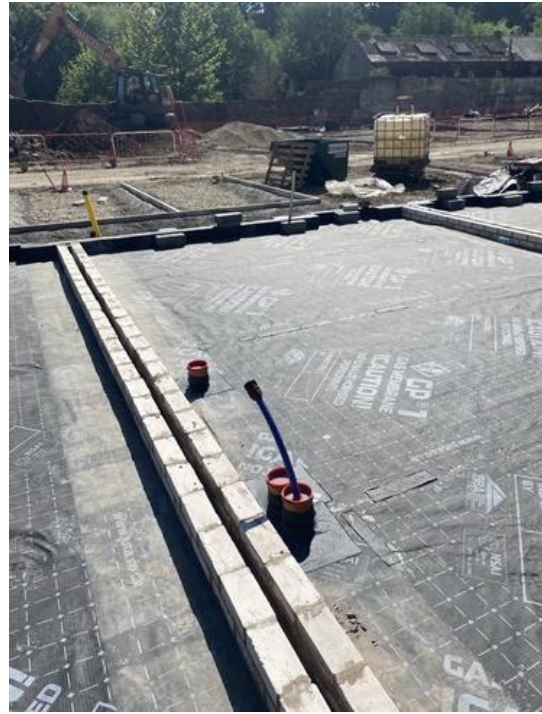
Photo 59

**Extent of Coverage: Is the membrane covering the entire plot? Does membrane span over outside walls?**

Yes

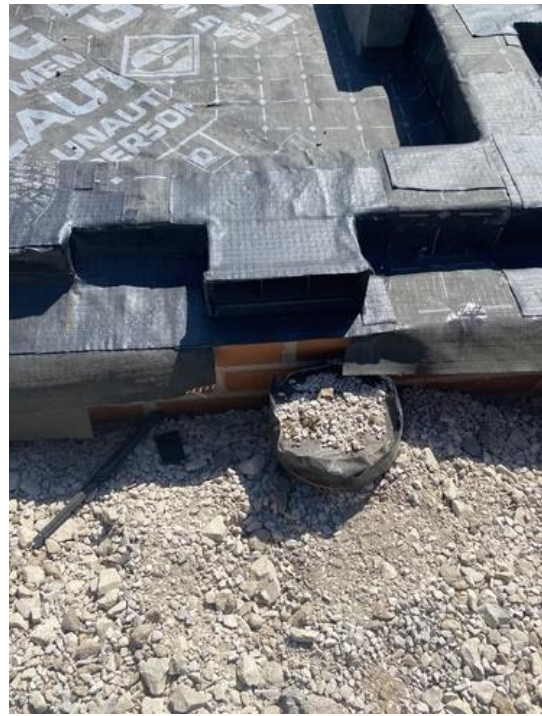
Photo 67

**External Wall Air bricks: Numbers, size. positions as design drawing? (Minimum of 3 walls)**

Pass

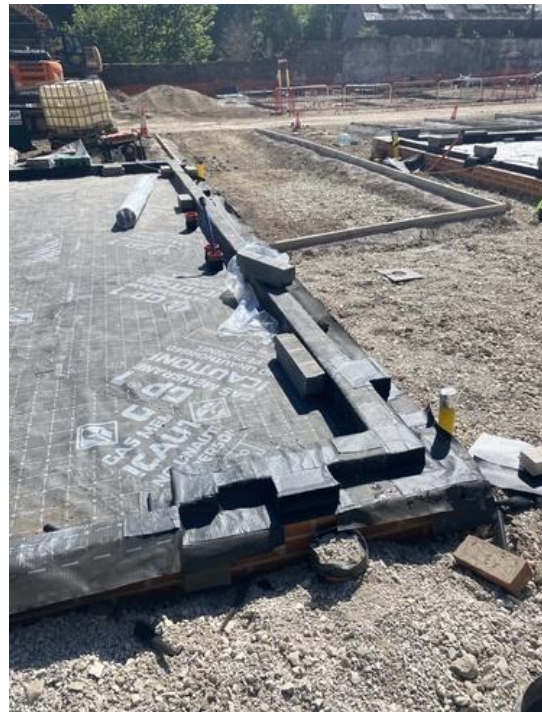
Photo 69

| Are telescopic vents present? | | Yes |

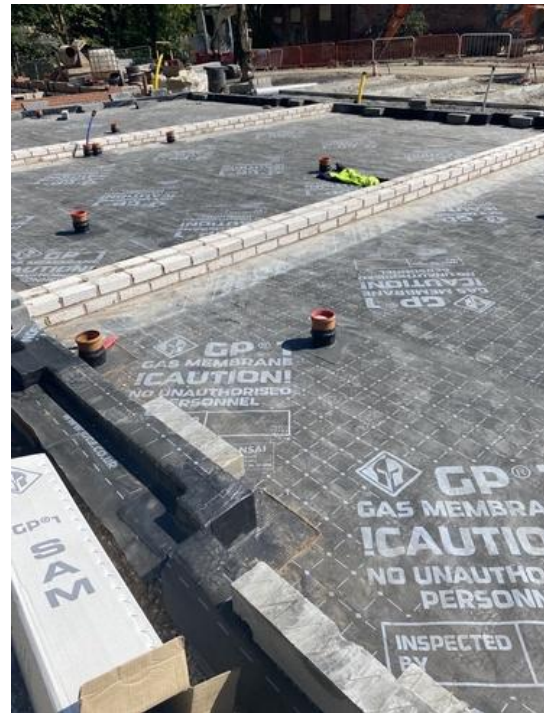
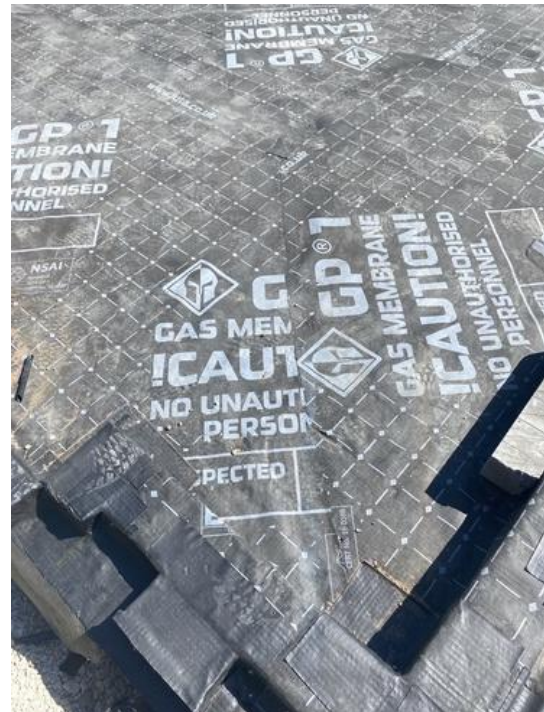
Photo 71

| <b>Gas Membrane Condition: Open punctures, tears, rips, stretching, Presence of debris, Repairs, Signs of weakness such as raised or sunken indentations, Protection plan in place to restrict access to laid gas membrane? IF FAIL DESCRIPTION IN ACTIONS AND PHOTOS REQUIRED</b> | | Pass |

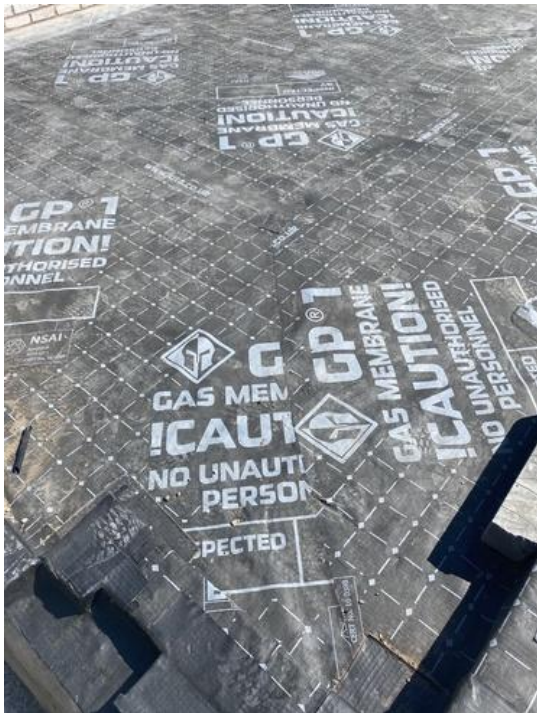
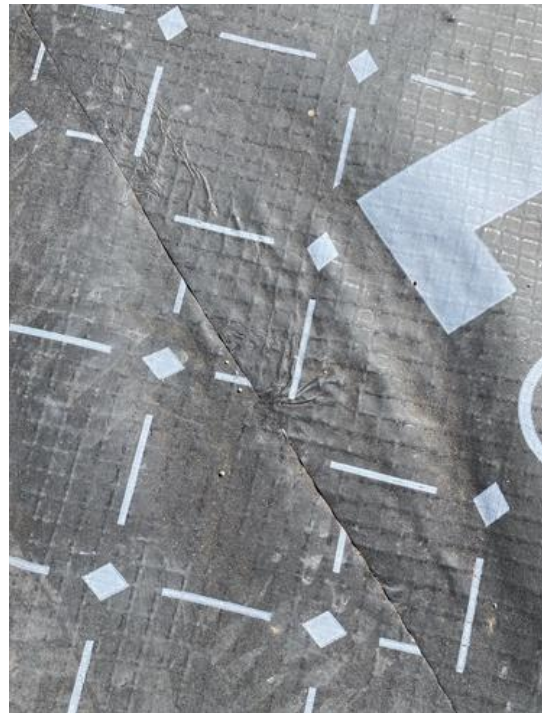
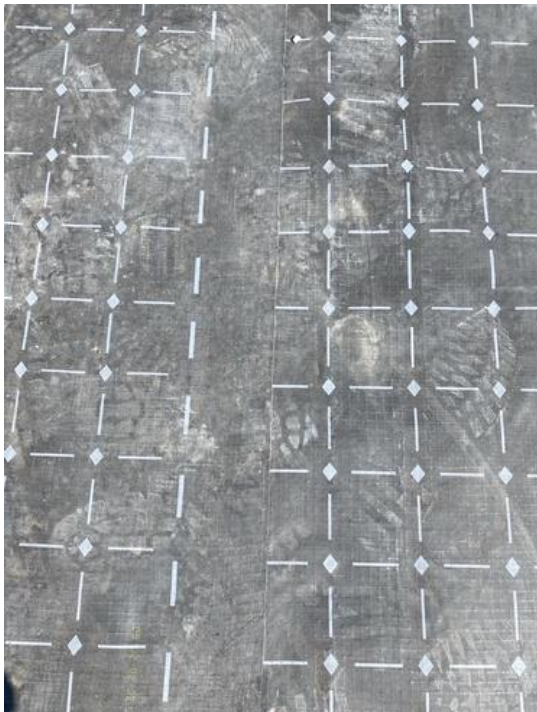
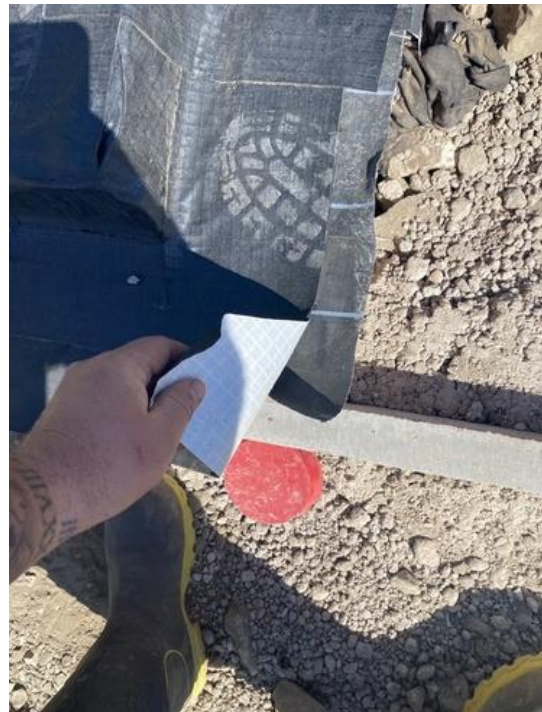
Photo 74

| Are welds complete? | | Yes |

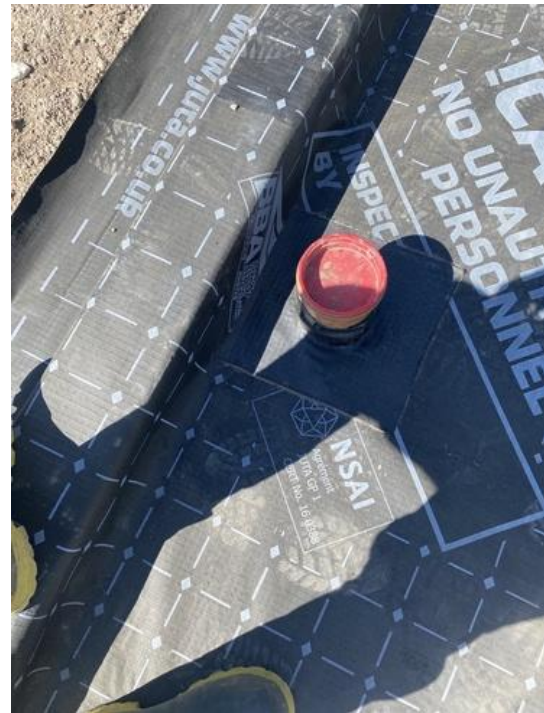
Photo 79

| Are Joints lapped and sealed in accordance with manufacturer's requirements/ specification? | | Yes |

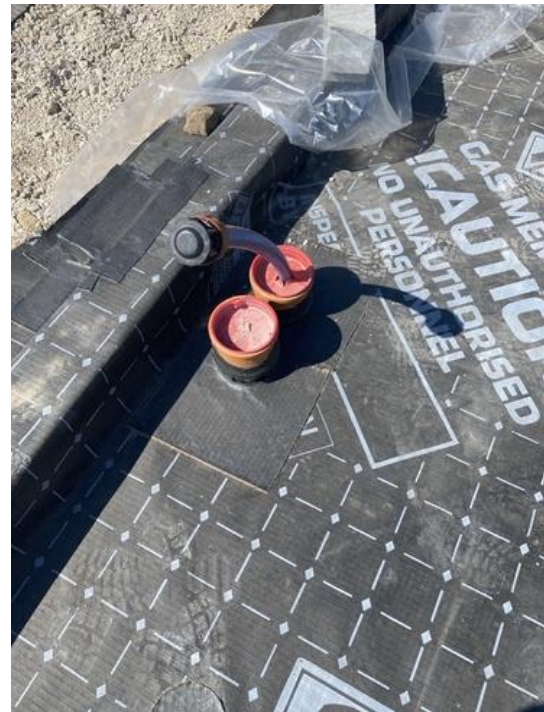
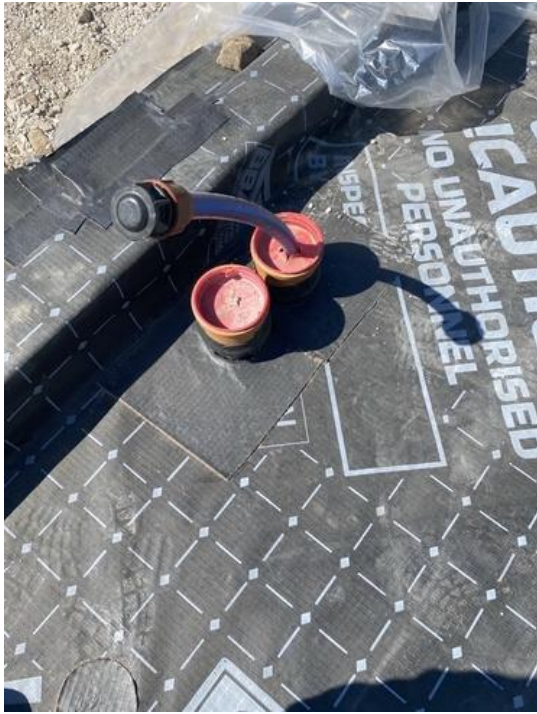
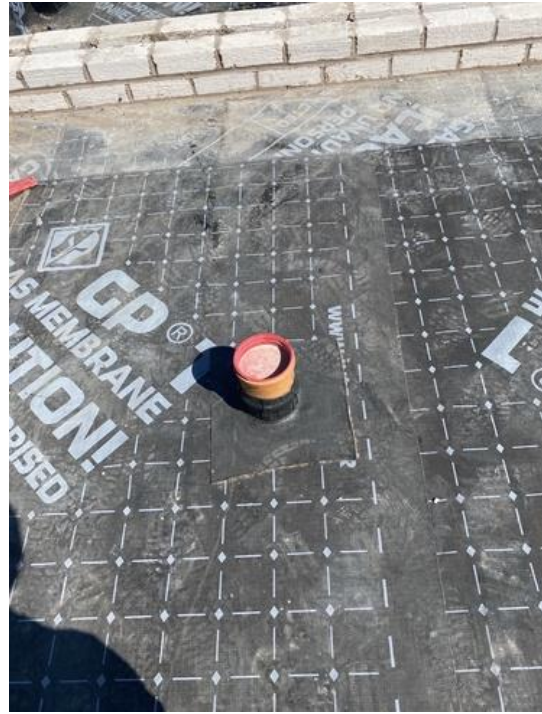
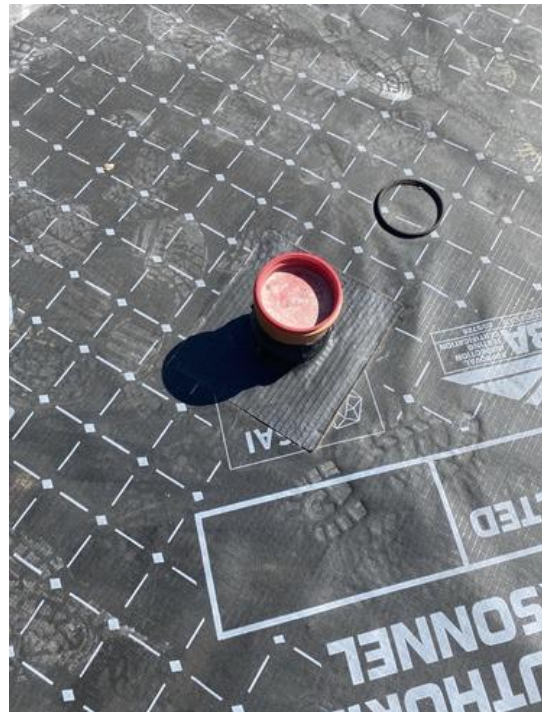
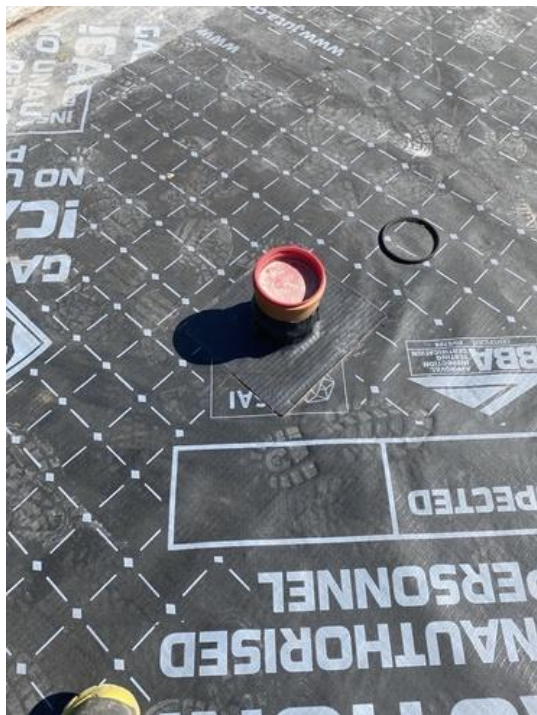
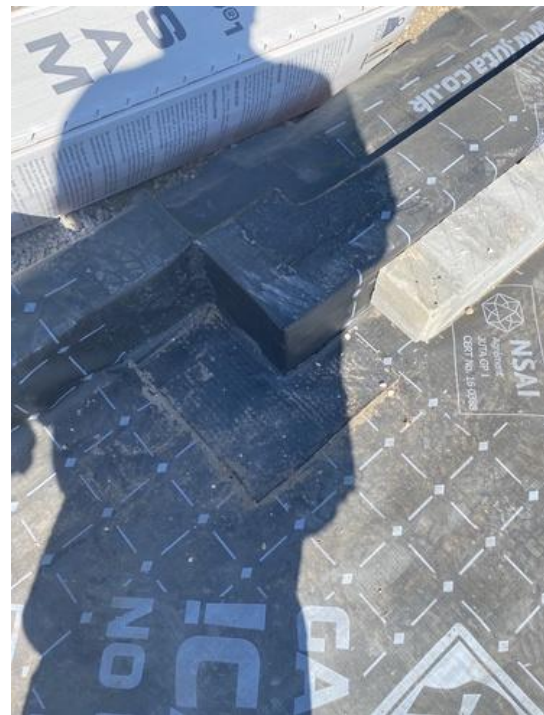
Photo 81

**Service entries seals: Top hats seal arrangements fixed around service entries? Use of Jubilee clips or Bitumastic Sealant**

Pass
