Date: 28th May 2025  
Reference: 16465-V6

## GAS MEMBRANE VALIDATION – EDENFIELD ROAD, NORDEN

| <b>Project Name:</b> | Edenfield Road, Rochdale |
| <b>Plots:</b> | 43-45 |

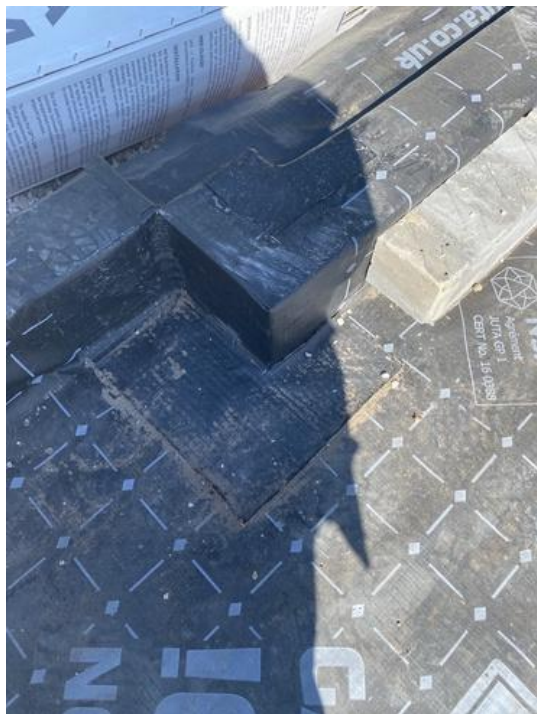
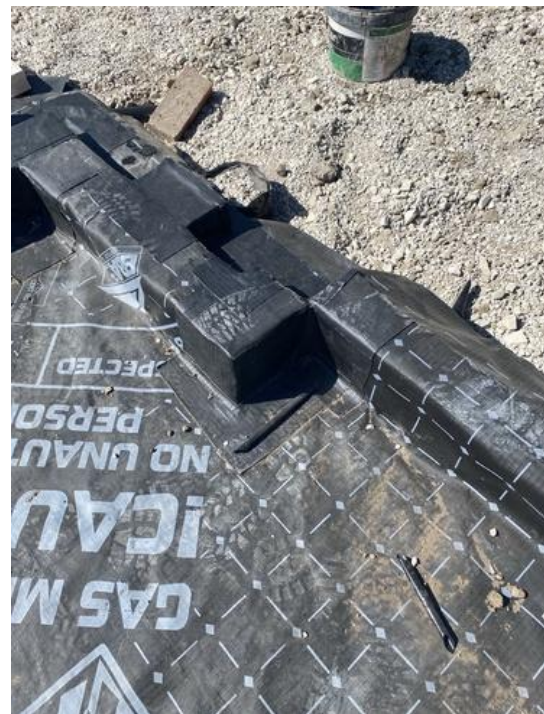
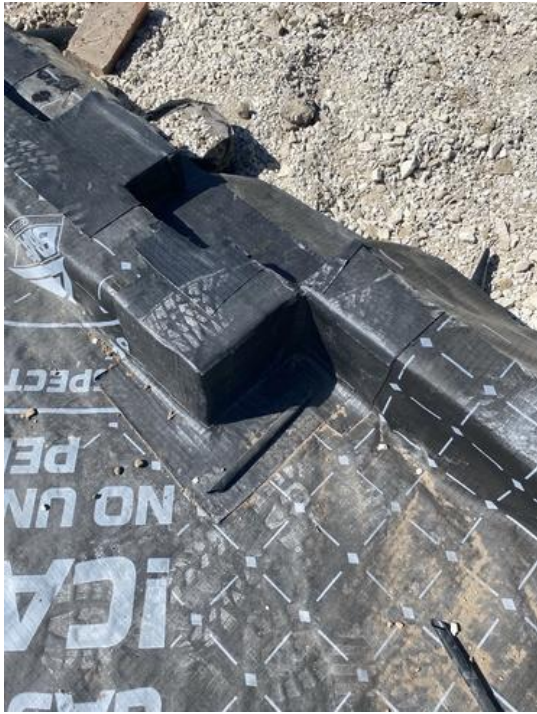
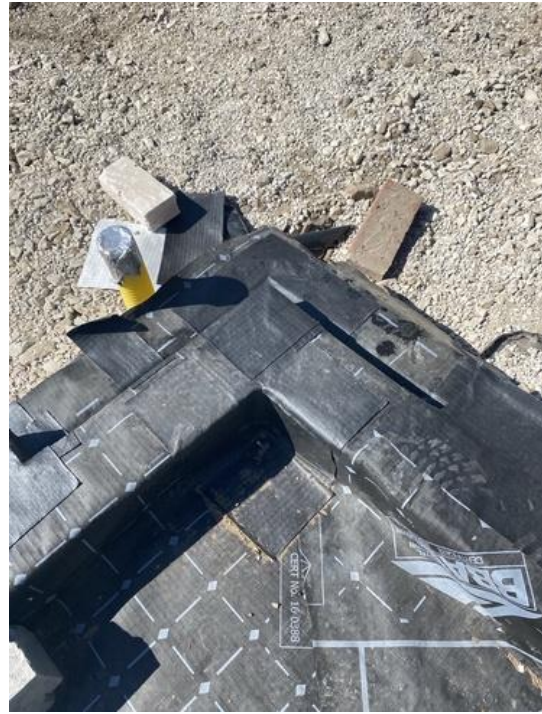
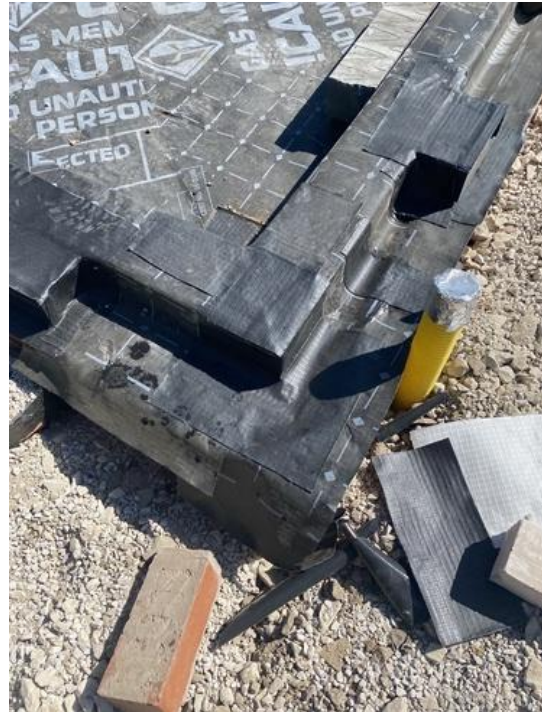
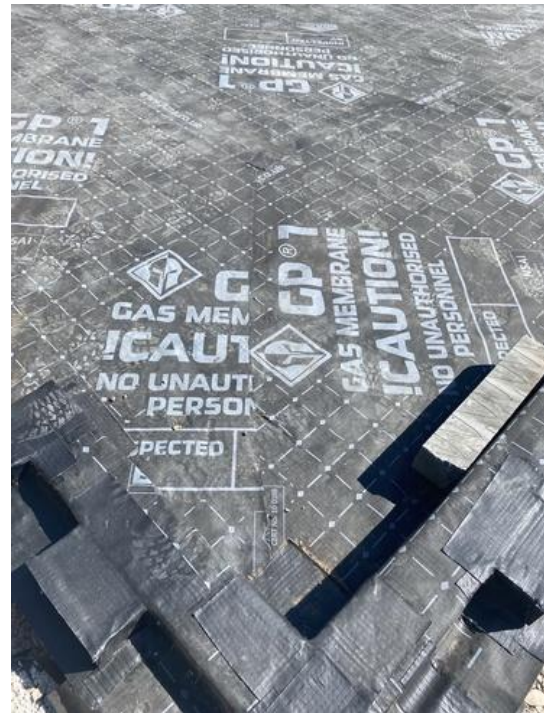
Photo 88

**Corners / Internal joints: Check all corners are correctly formed or contractor has used preformed corners.**

Pass

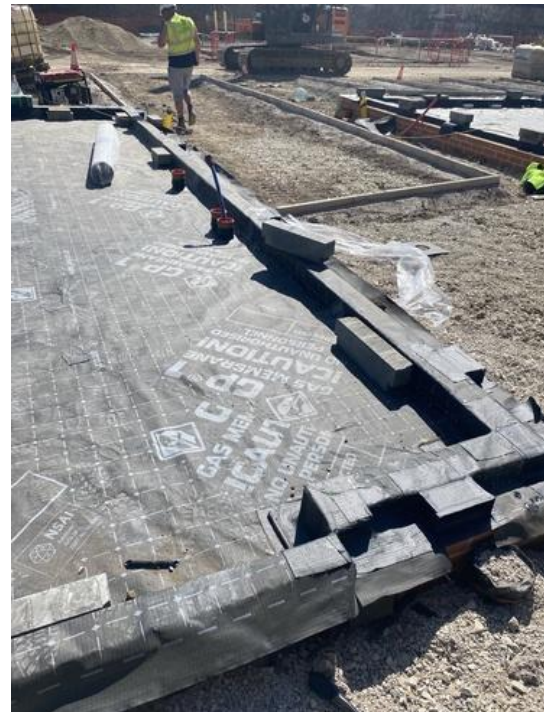
Photo 97

**Are folds running in line with joints? (no joints cutting across folds)**

Pass

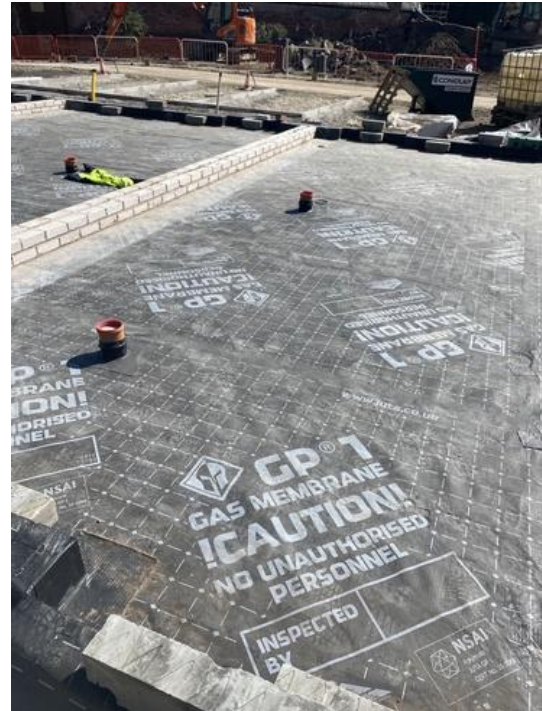
Photo 99

**Extent of Coverage: Is the membrane covering the entire plot? Does membrane span over outside walls?**

Yes

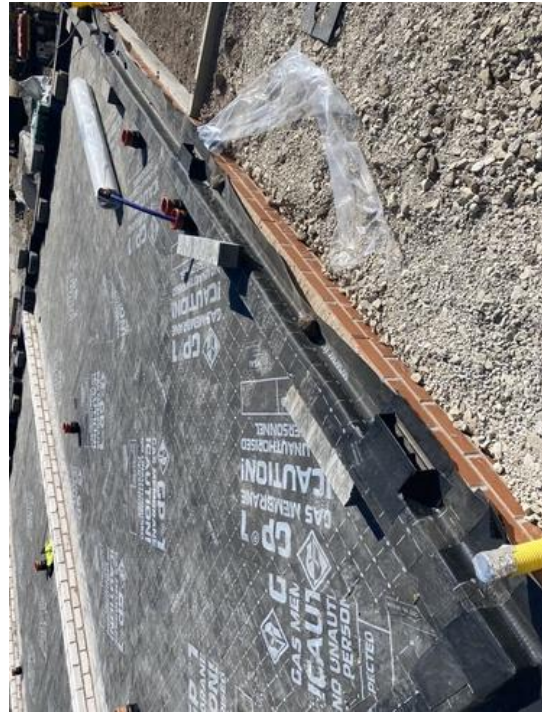
Photo 103

**External Wall Air bricks: Numbers, size. positions as design drawing? (Minimum of 3 walls)**

Pass
