**Broadfield Park Slopes ('The Slopes'), Rochdale**

Design & Access Statement Appendix: Volume II

For Rochdale Development Agency

**RE: BROADFIELD PARK SLOPES, ROCHDALE – SURFACE WATER SAMPLING**

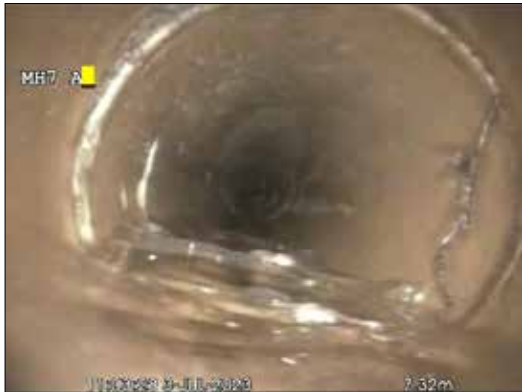
Photo: 3\_4a, 00:00:00  
2.3m, Open joint medium

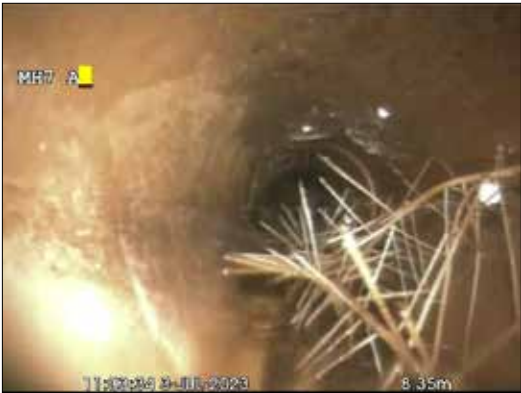
Photo: 3\_5a, 00:00:00  
7.4m, Circumferential Crack, from 05 to 02 o'clock

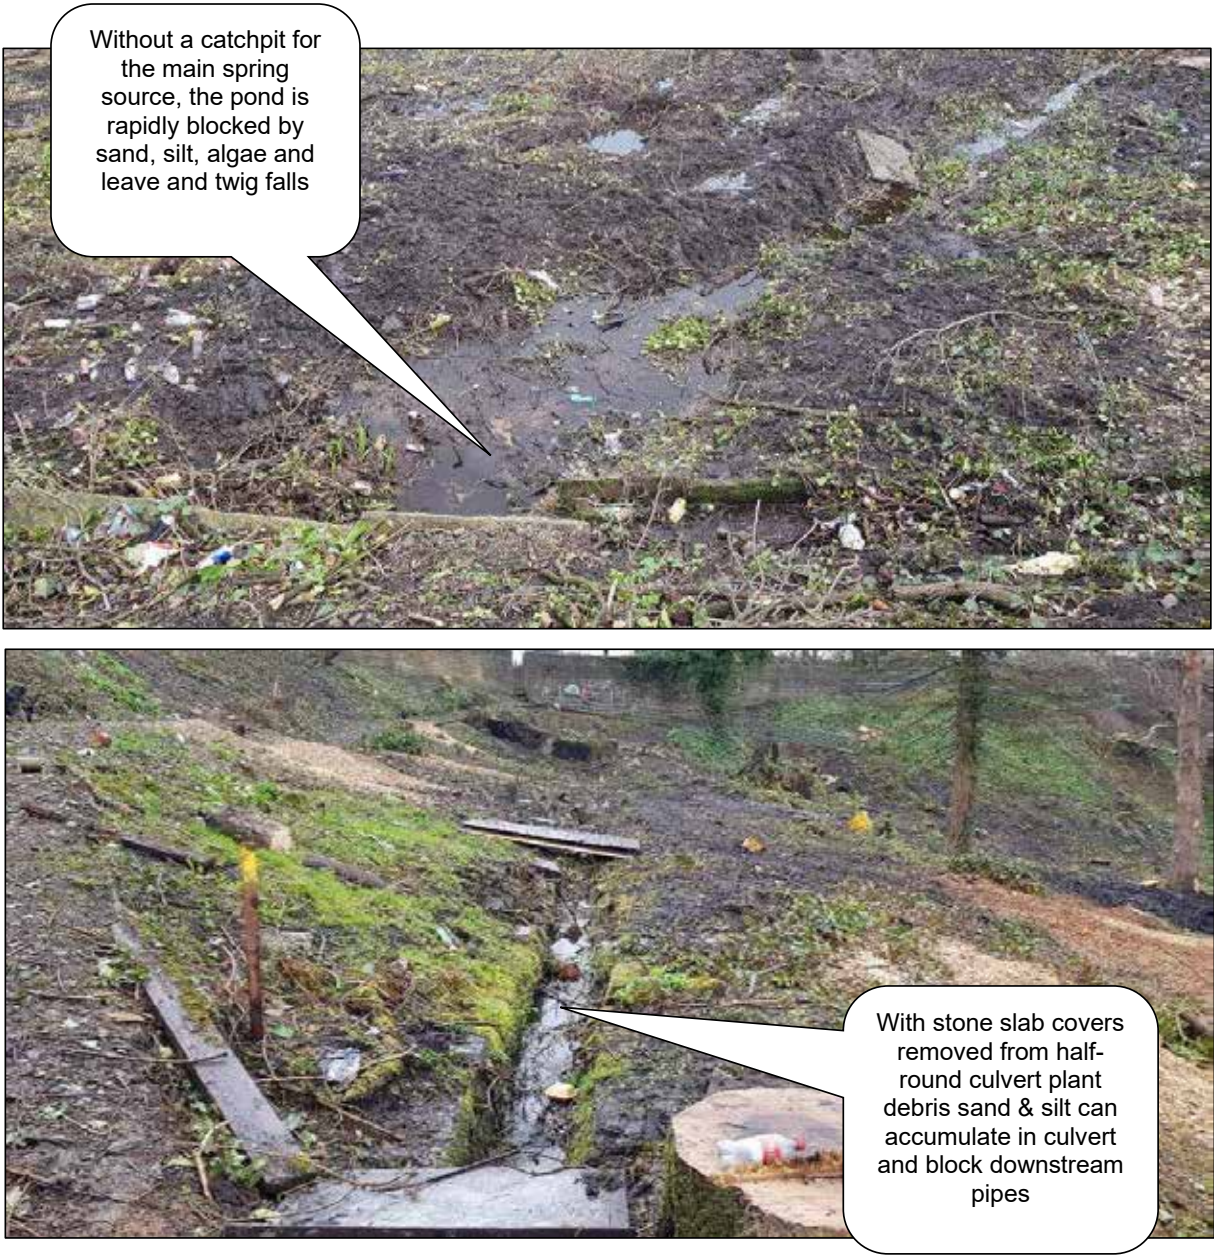
Fig. 6.3  
At Main Spring Source for Packer Spout the Spring Catchpit was Removed  
and Pond Created - Stone Slab Covers Removed from Half-Round Culverts

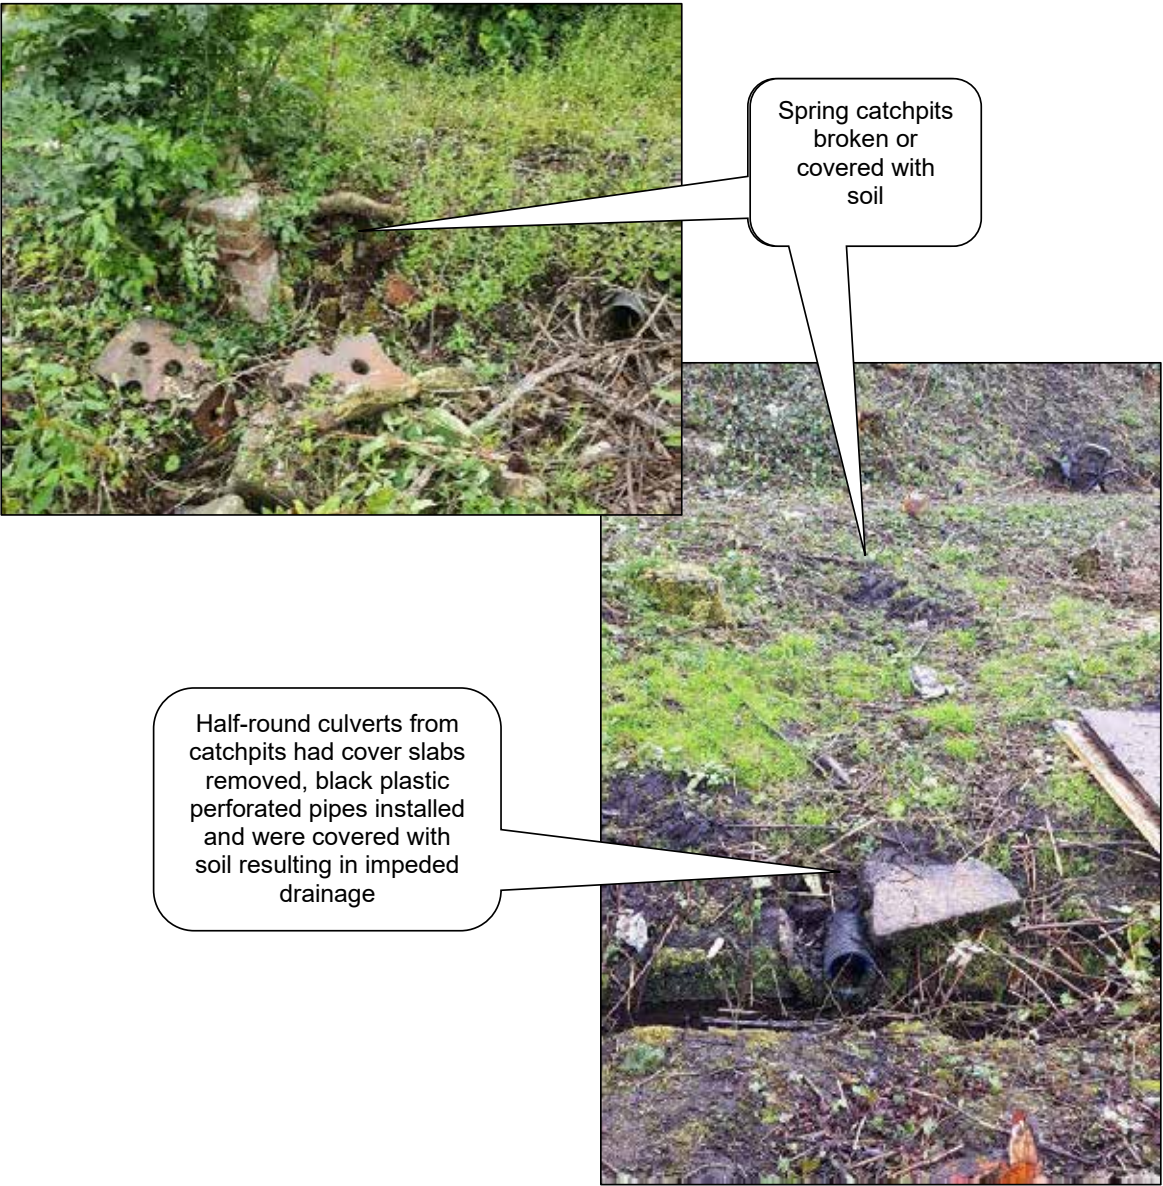
Figure 6.4  
Packer Spout Top Spring Line Catchpits Broken or Covered With Soil –  
Half-Round Culverts from Catchpits Have Cover Slabs Removed, Black Plastic  
Perforated Pipes installed and Are Covered with Soil Resulting In Impeded Drainage

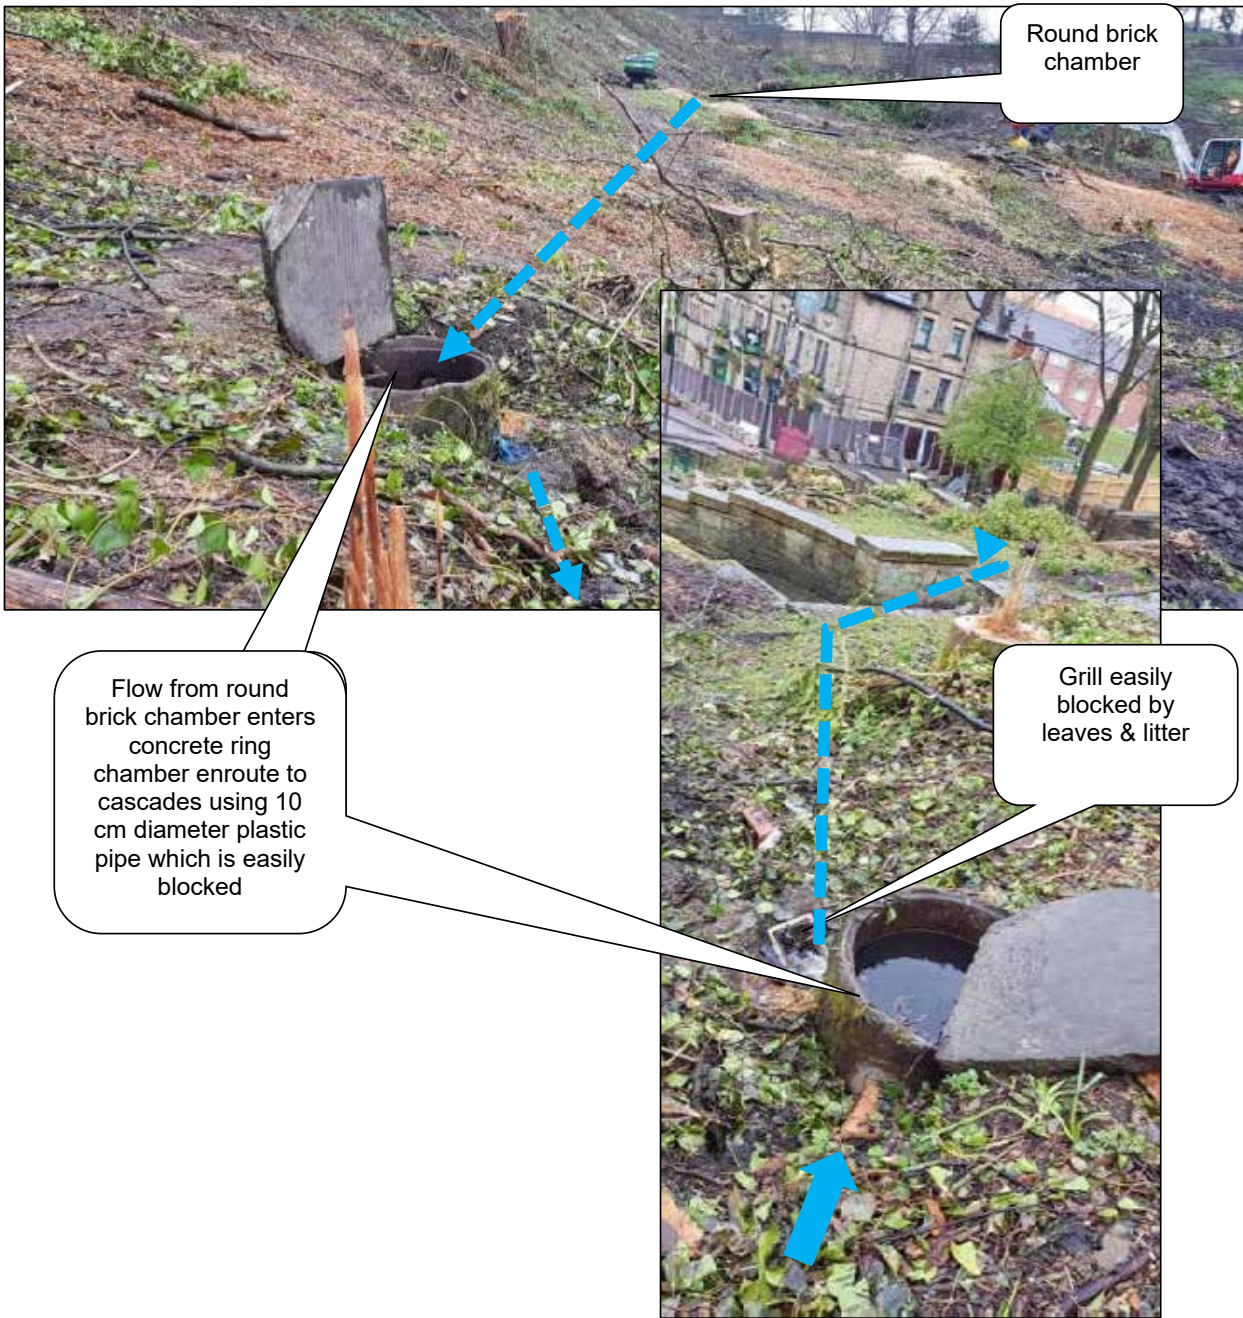
Fig. 6.6  
Water Flow Diverted to East of Packer Spout Reservoir  
Flow from Round Brick Chamber enters Concrete Ring Chamber Silt Trap Enroute to  
Cascades Using 10 cm Diameter Plastic Pipe Which is Easily Blocked

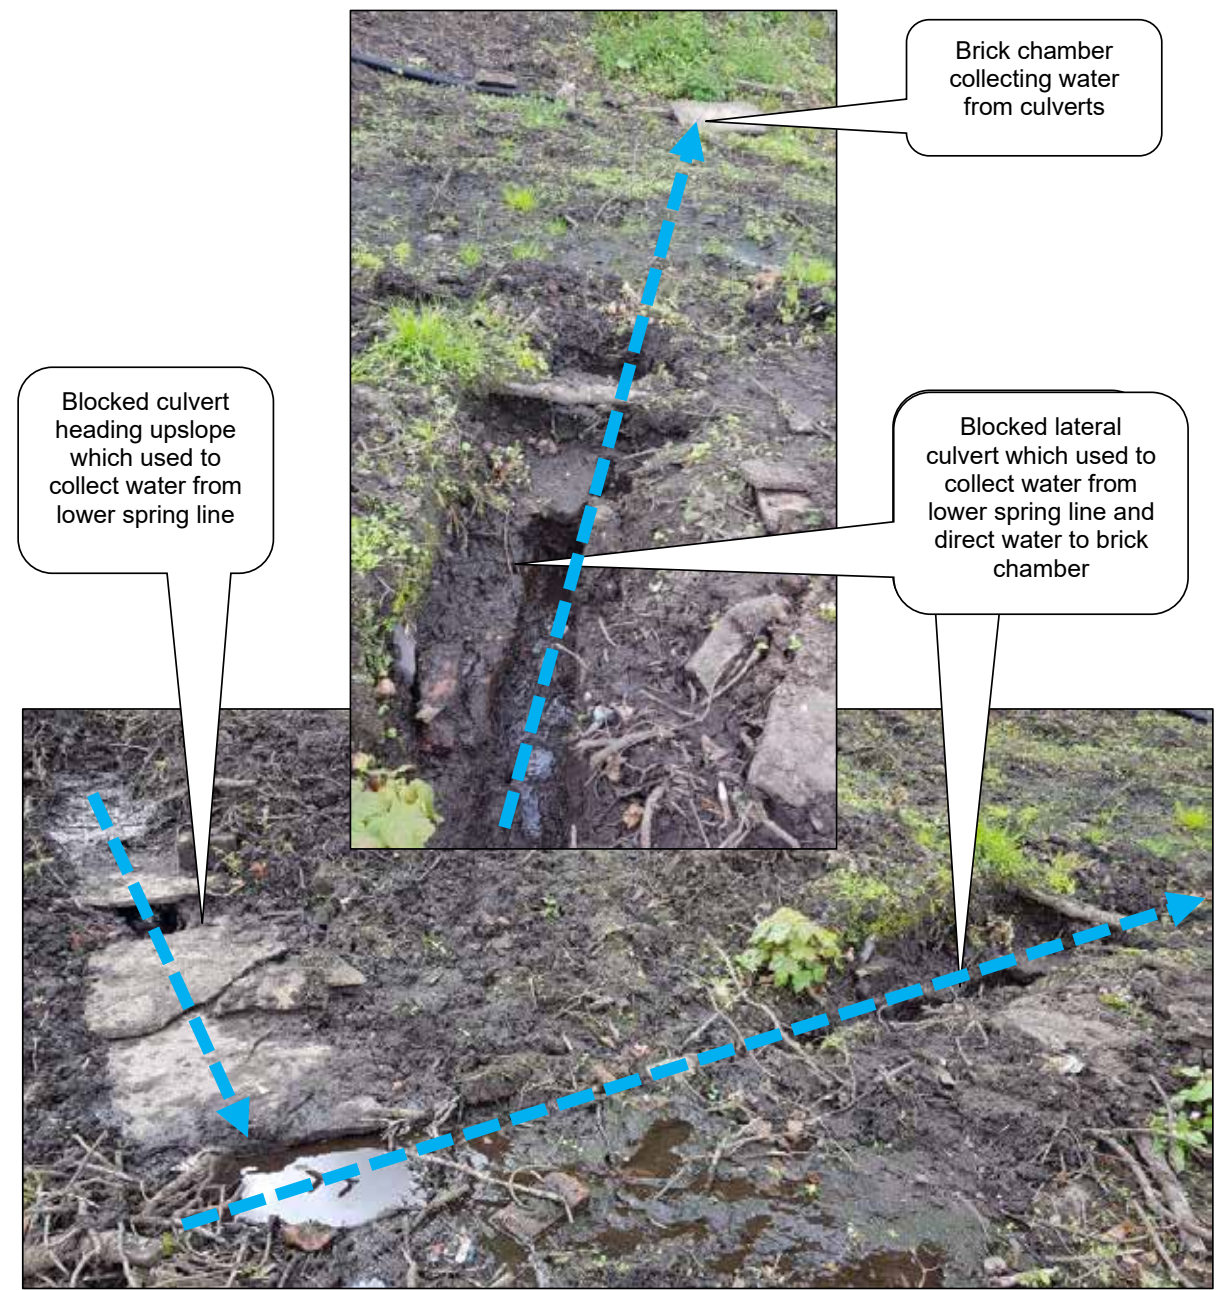
Fig. 6.9.  
Culverts Collecting Water from Lower Spring Line and Channelling it to Underground  
Brick Chamber Covered with Soil and Blocked

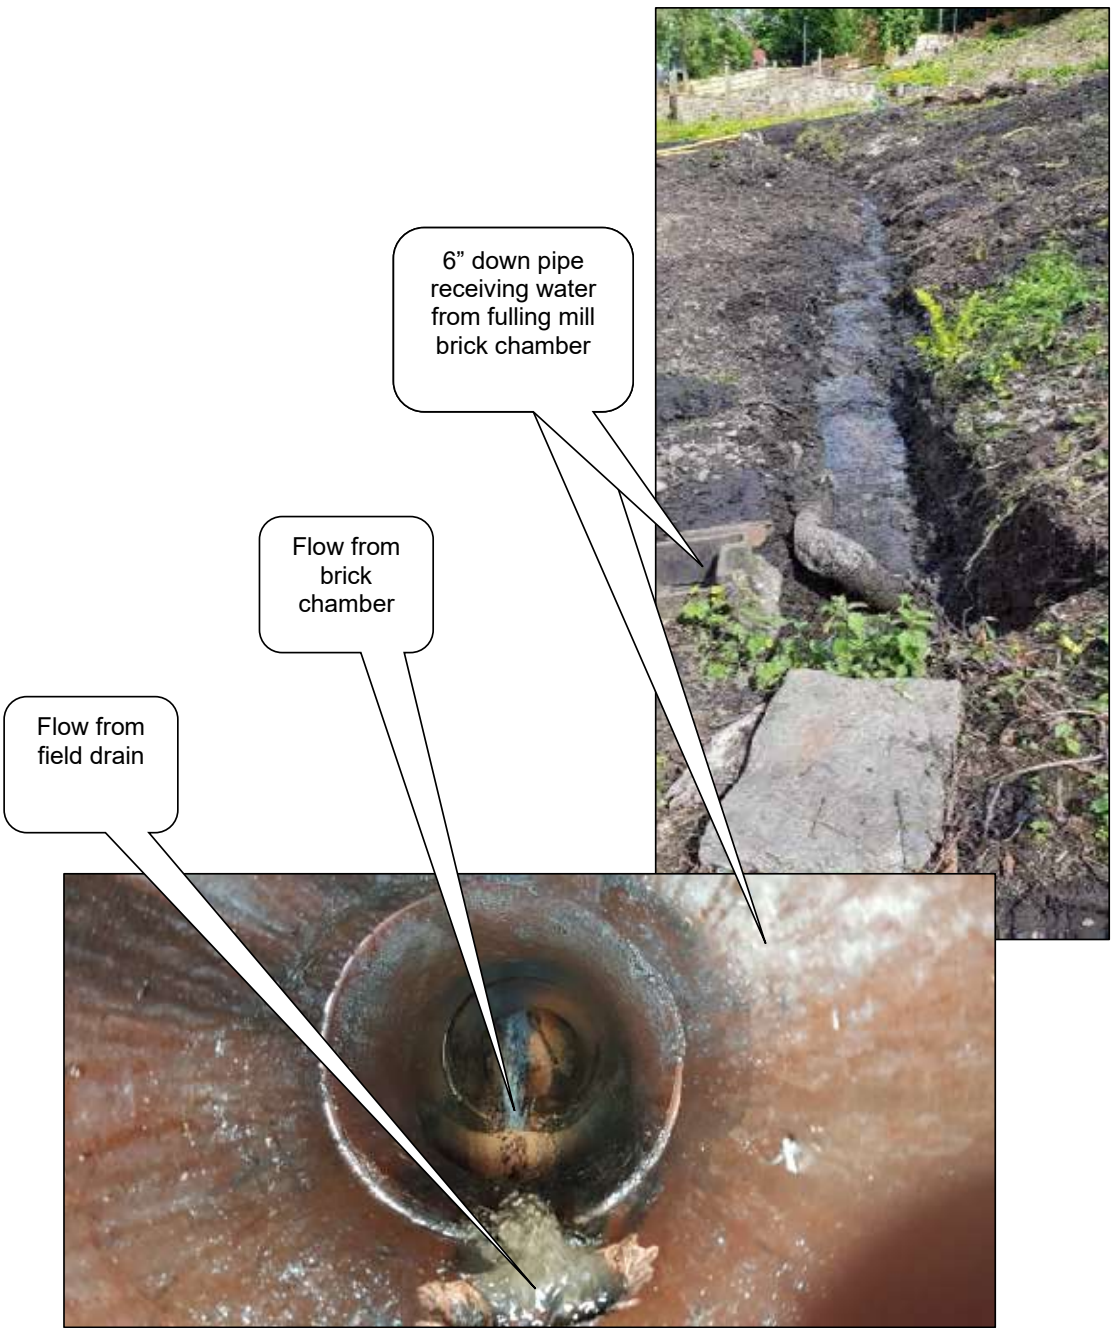
Fig. 6.10  
Field Drain Installed at Base of Slope to West of Packer Spout Reservoir to Collect  
Runoff – Field Drain Enters top of Down Pipe which Receives Water From  
Underground Brick Chamber

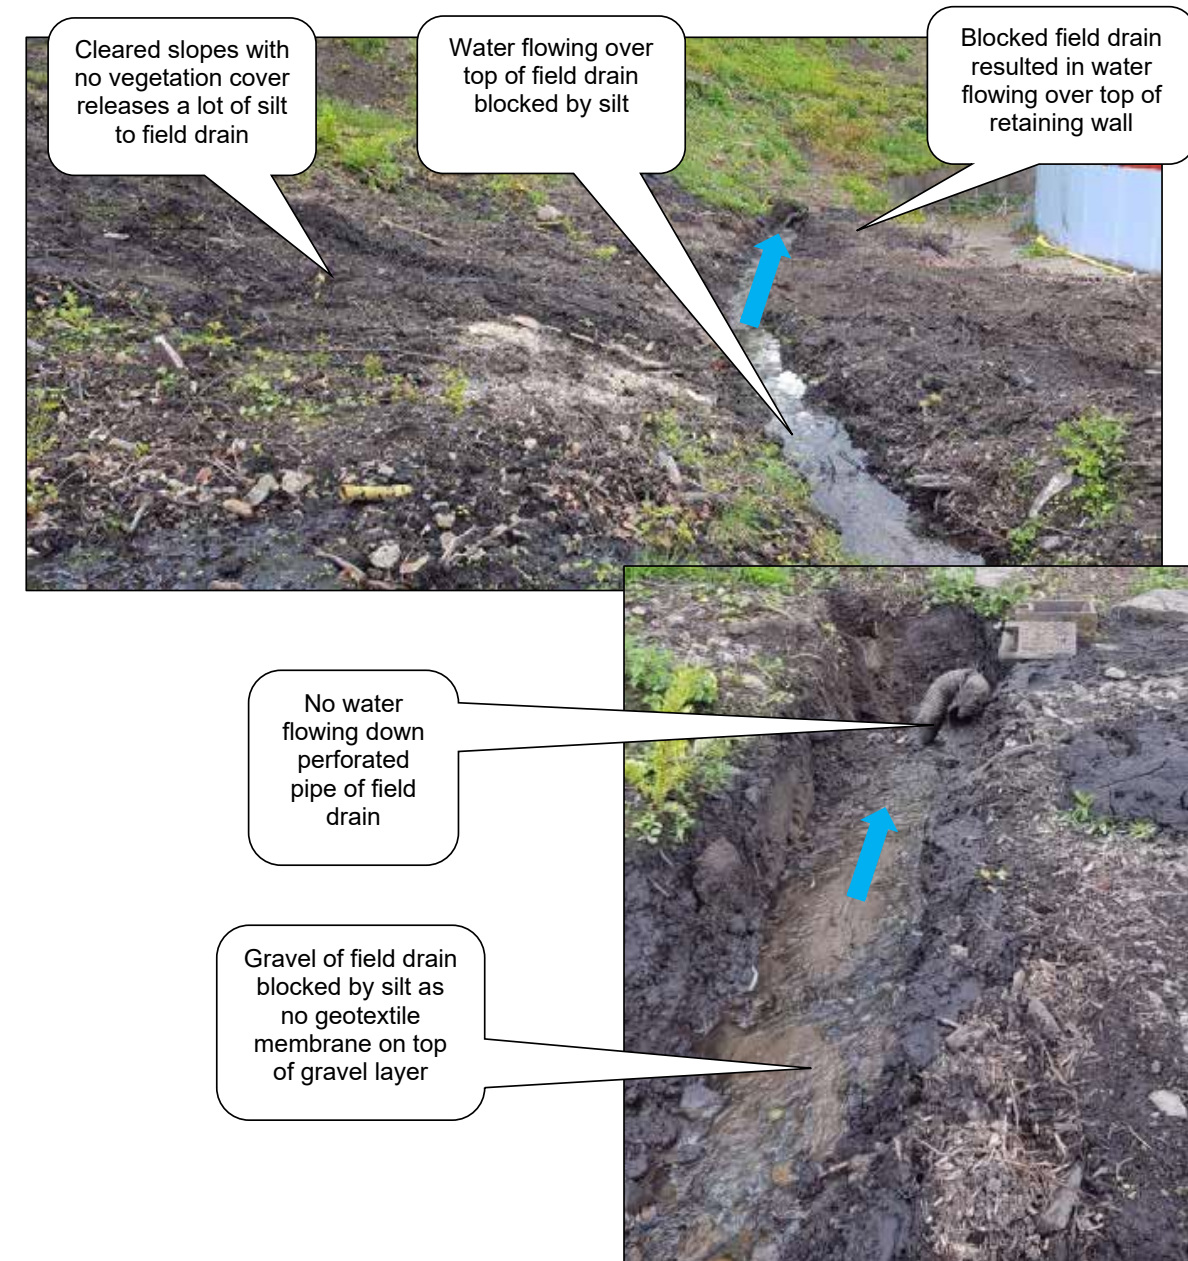
Fig. 7.1  
Blocked Field Drain at Base of Slope –  
(Due to Silt Generated by Slope Clearance & Absence of Geotextile Membrane at  
Top of Field Drain)

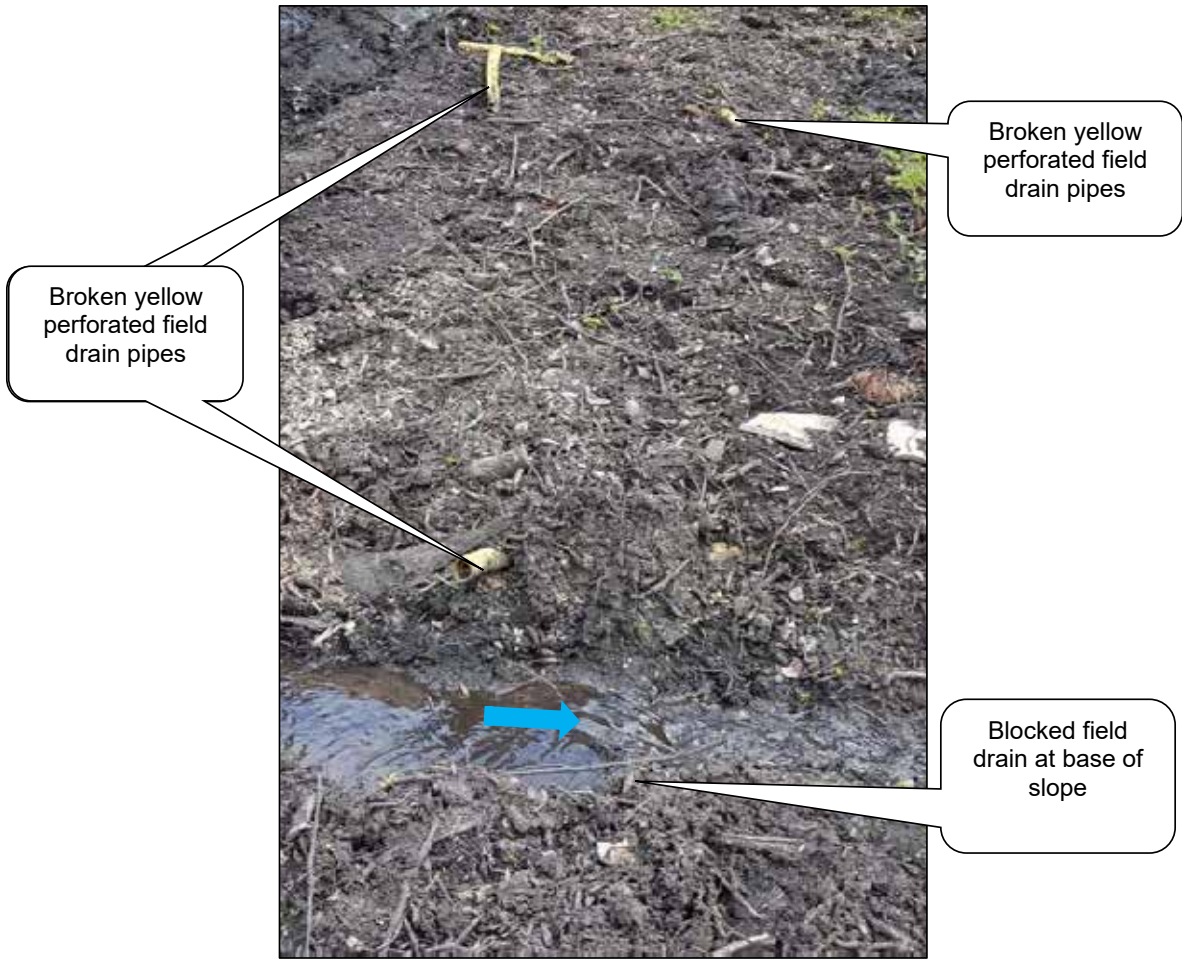
Fig. 7.2  
Broken Yellow Field Drain Pipes above Field Drain at Base of Slope

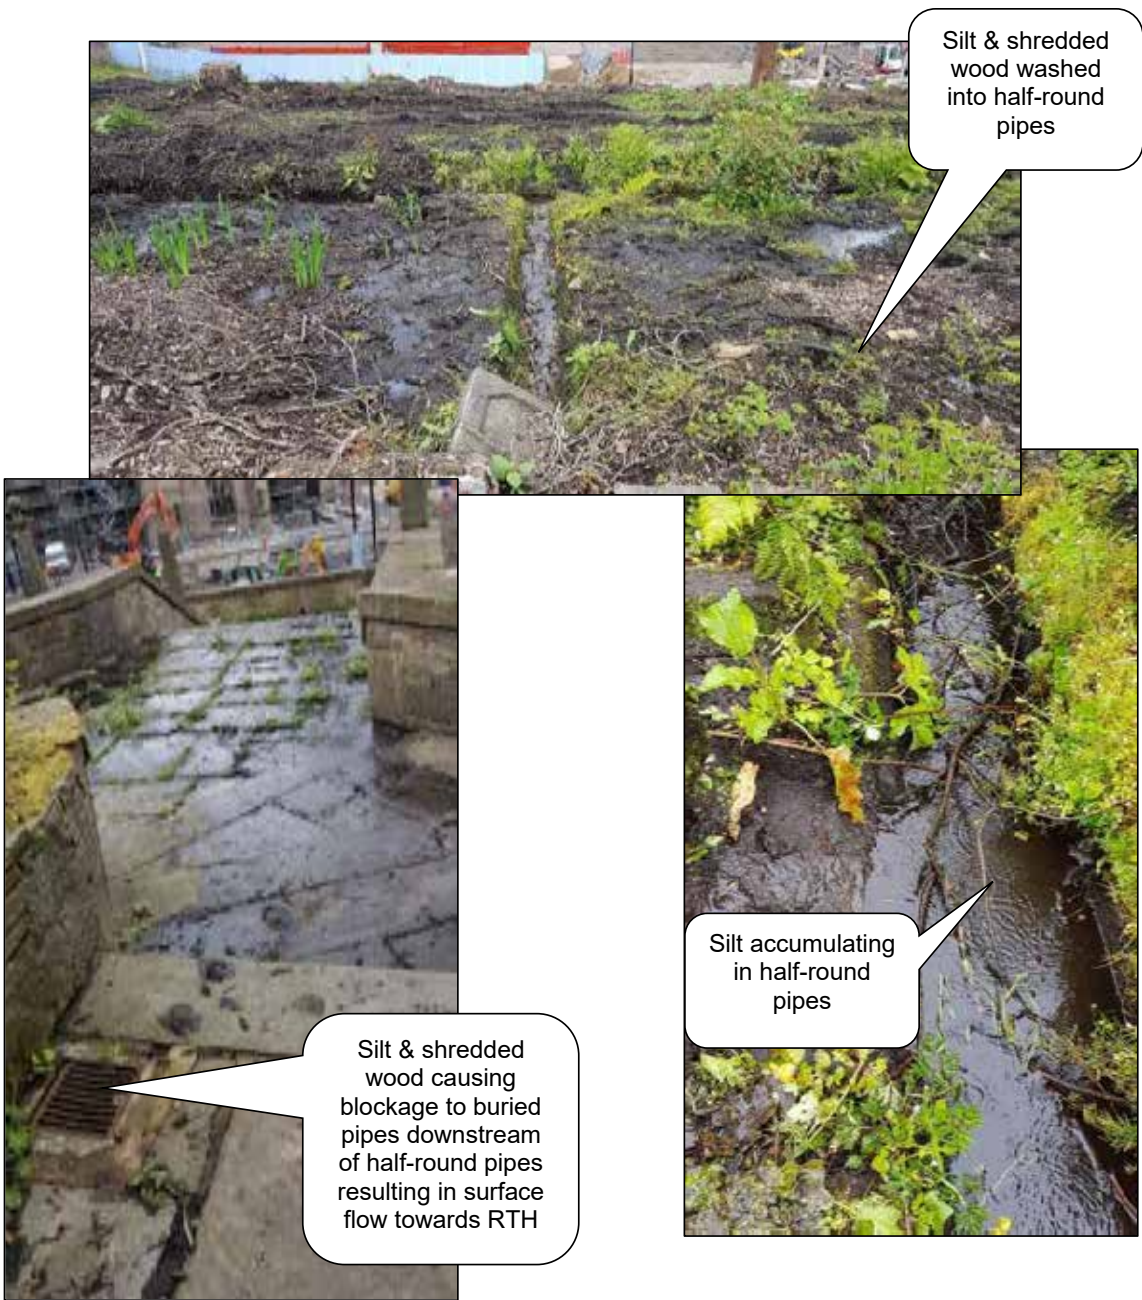
Fig. 7.3  
Silt and Shredded Wood Washed into Top Slope Half Round Pipes Causing Blockage of Downstream Buried Pipes Resulting in Surface Flow Towards RTH
