## **SYKE HOUSE BARN**

## **Archaeological Building Recording**

**North Star Archaeology**

**February 2024**

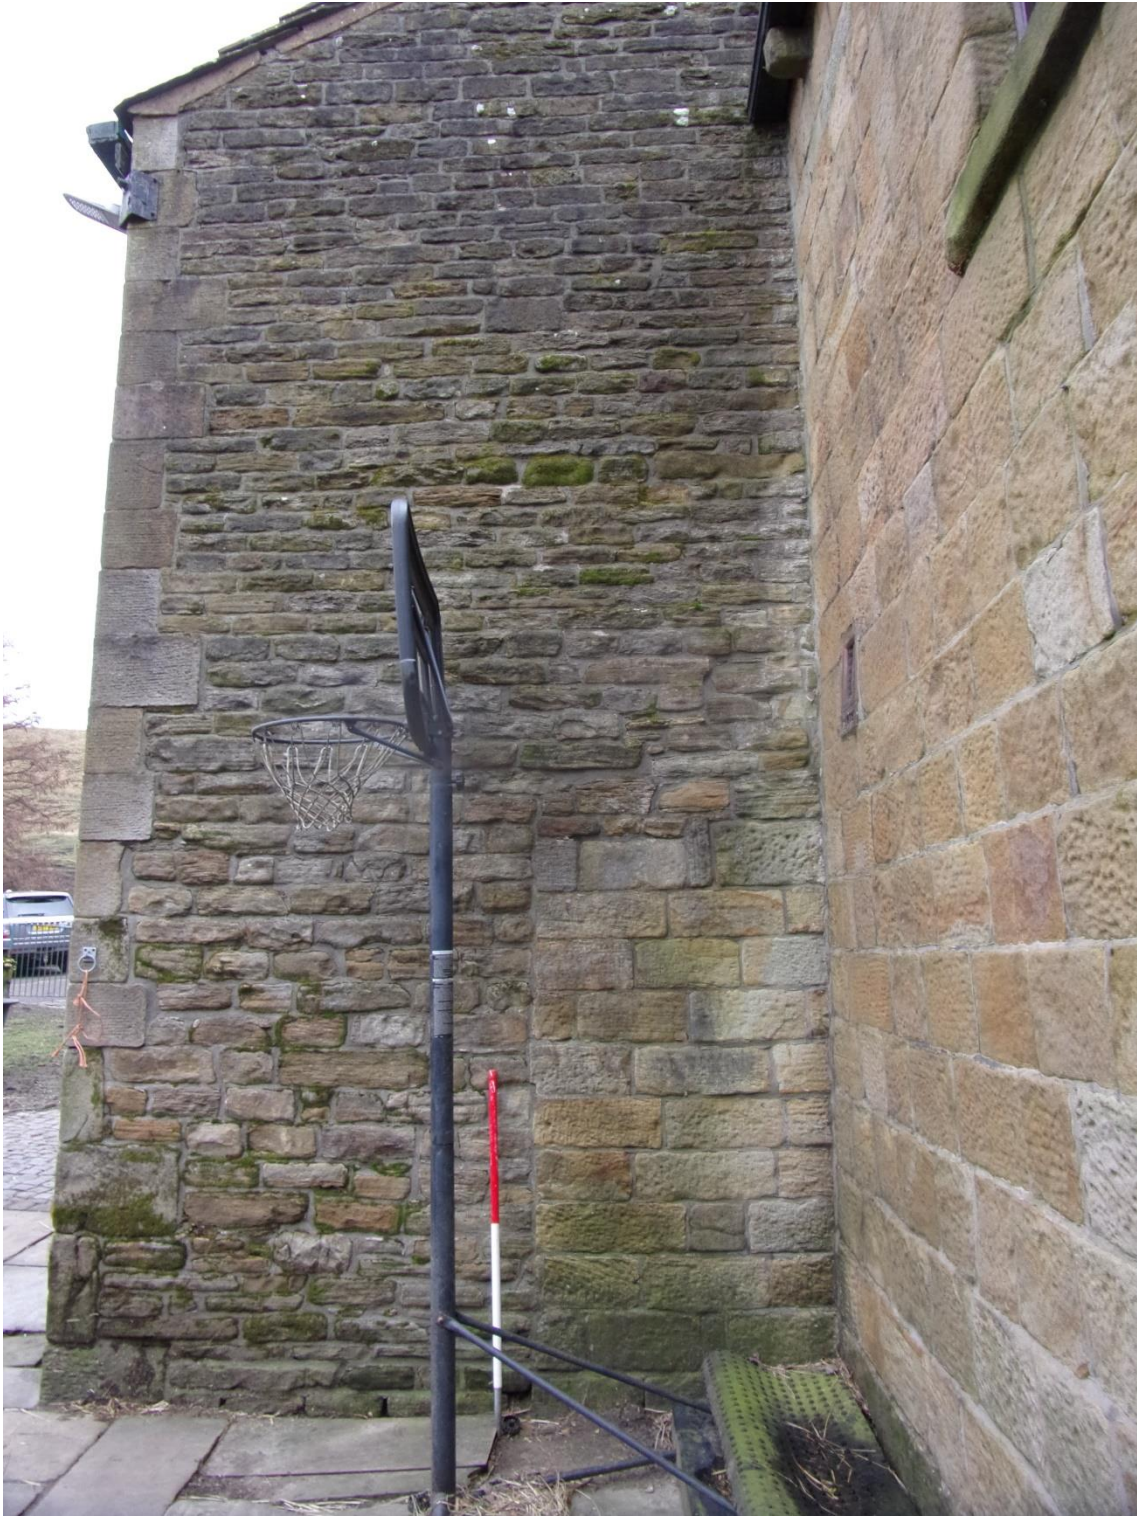
*Plate 5 Blocked aperture in the east elevation of the barn*

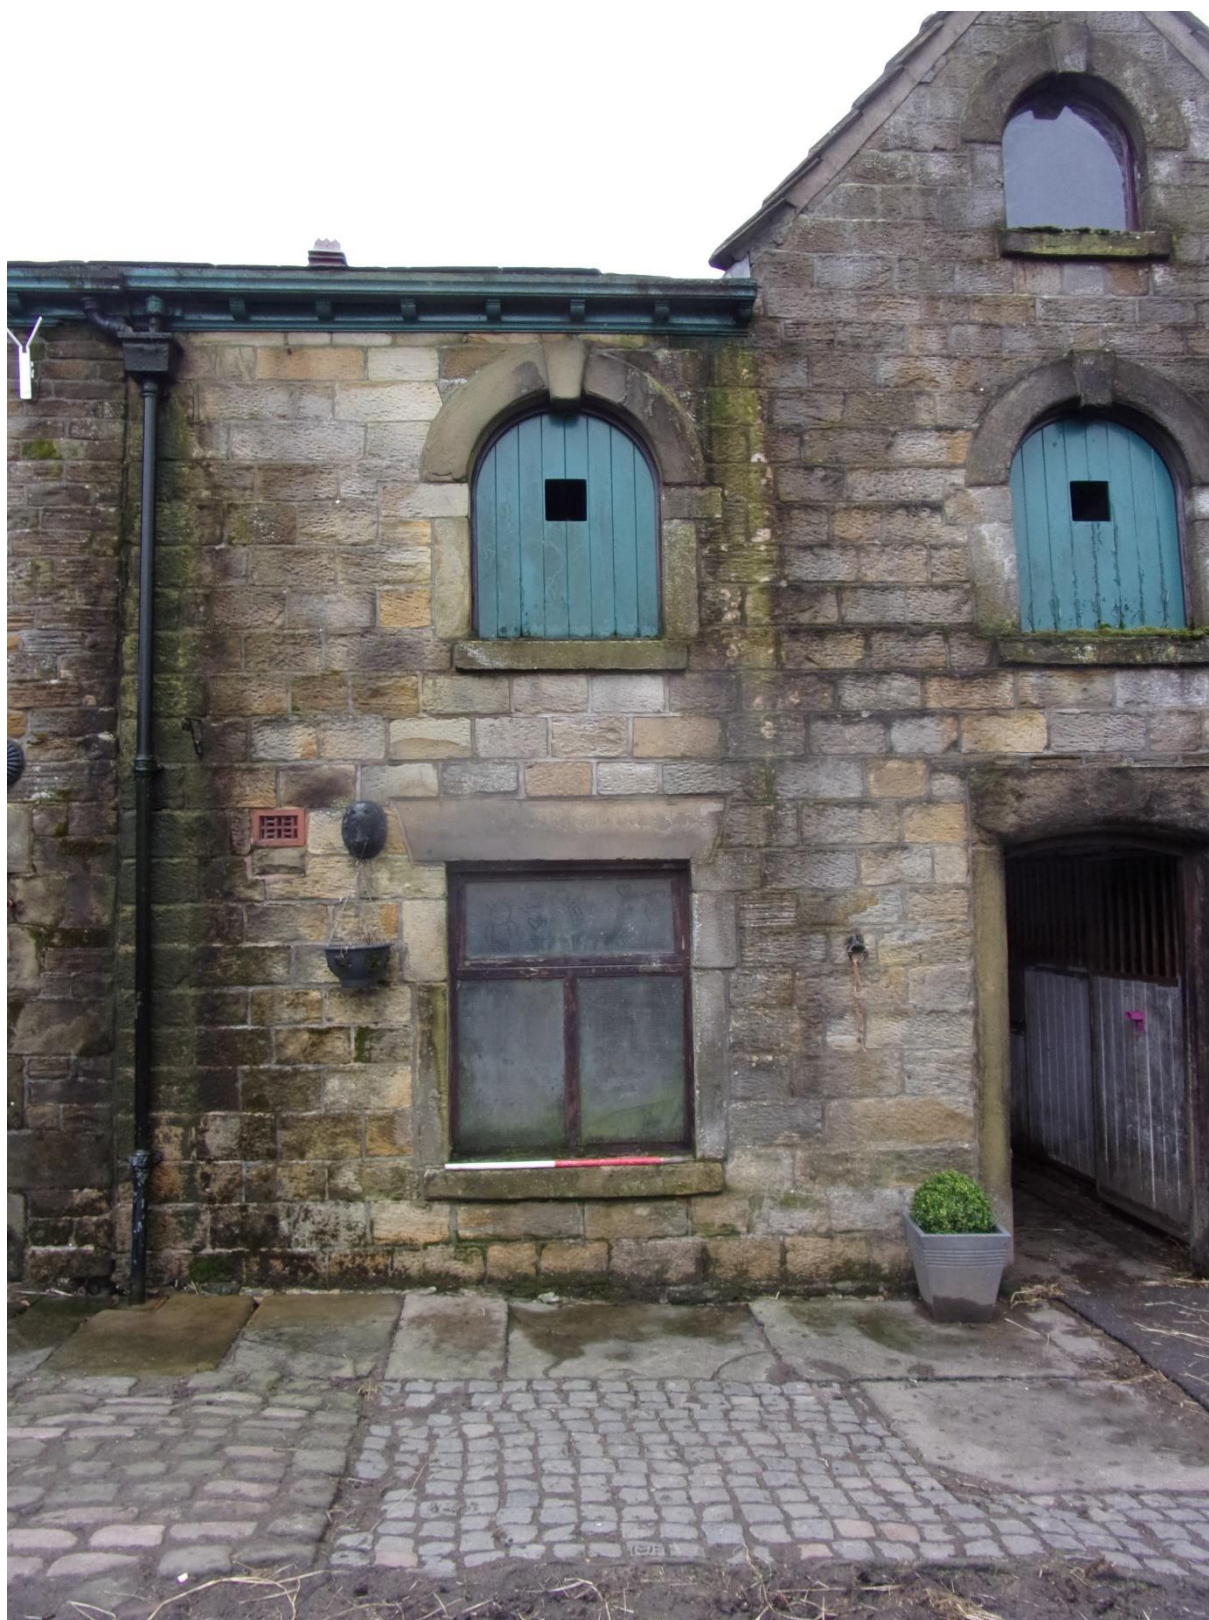
*Plate 7 Remodelled central part of the north elevation, facing south*

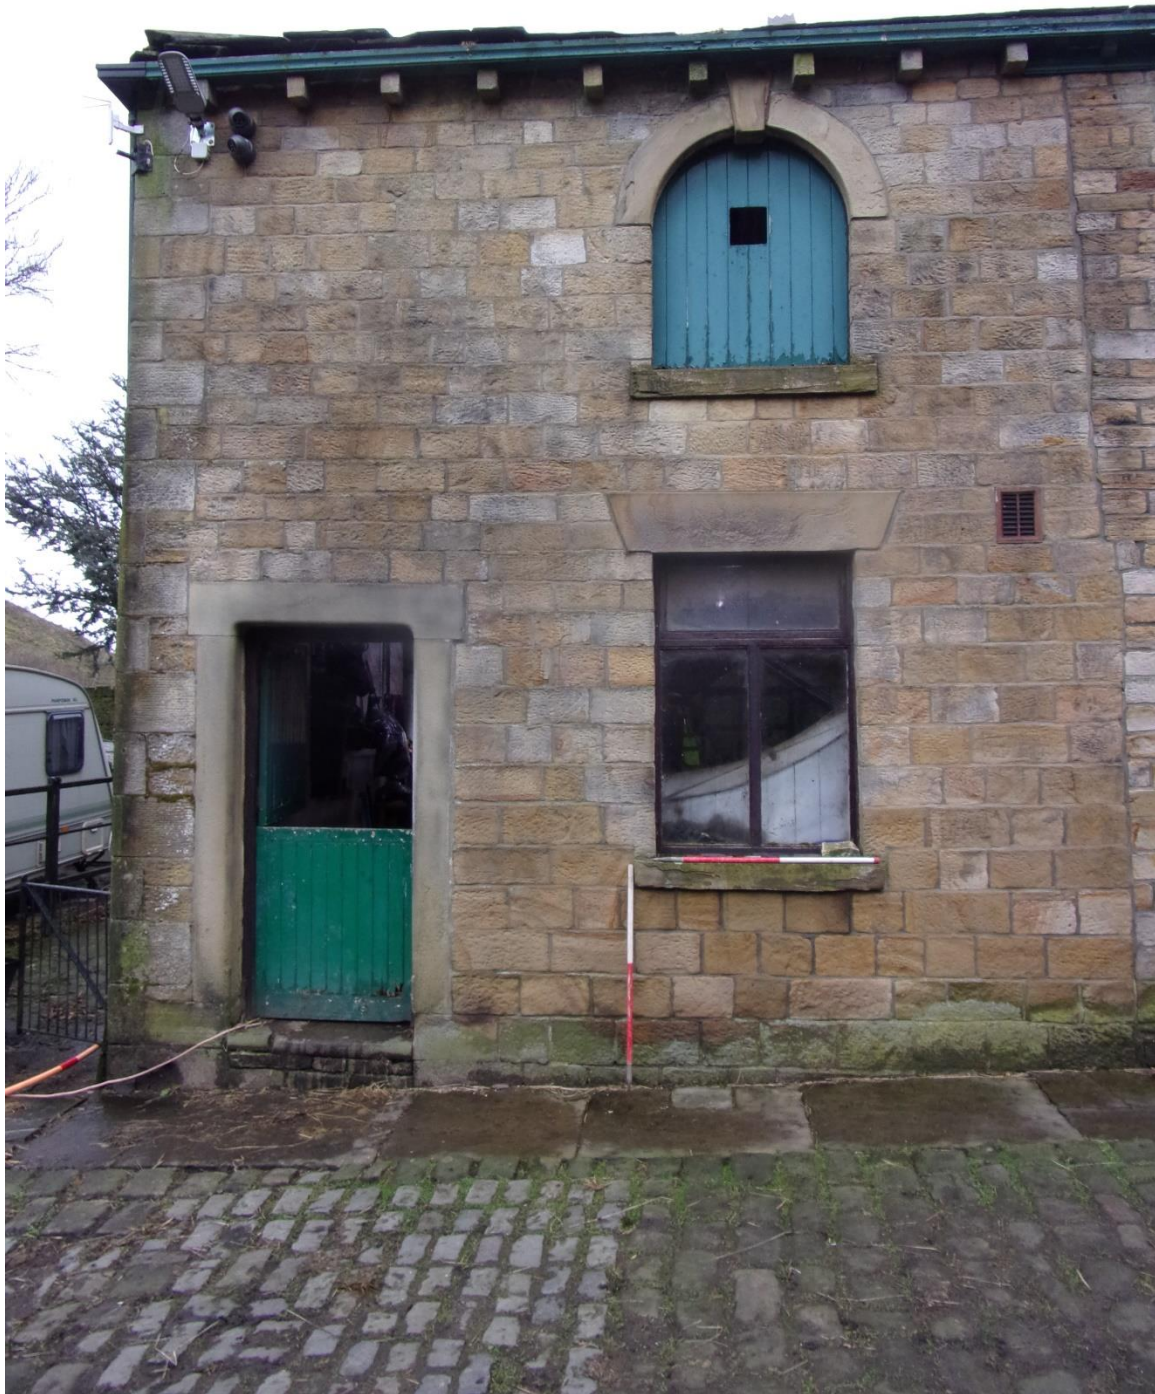
*Plate 12 South elevation of the west stable, facing north. Clear join in the stonework can be observed.*

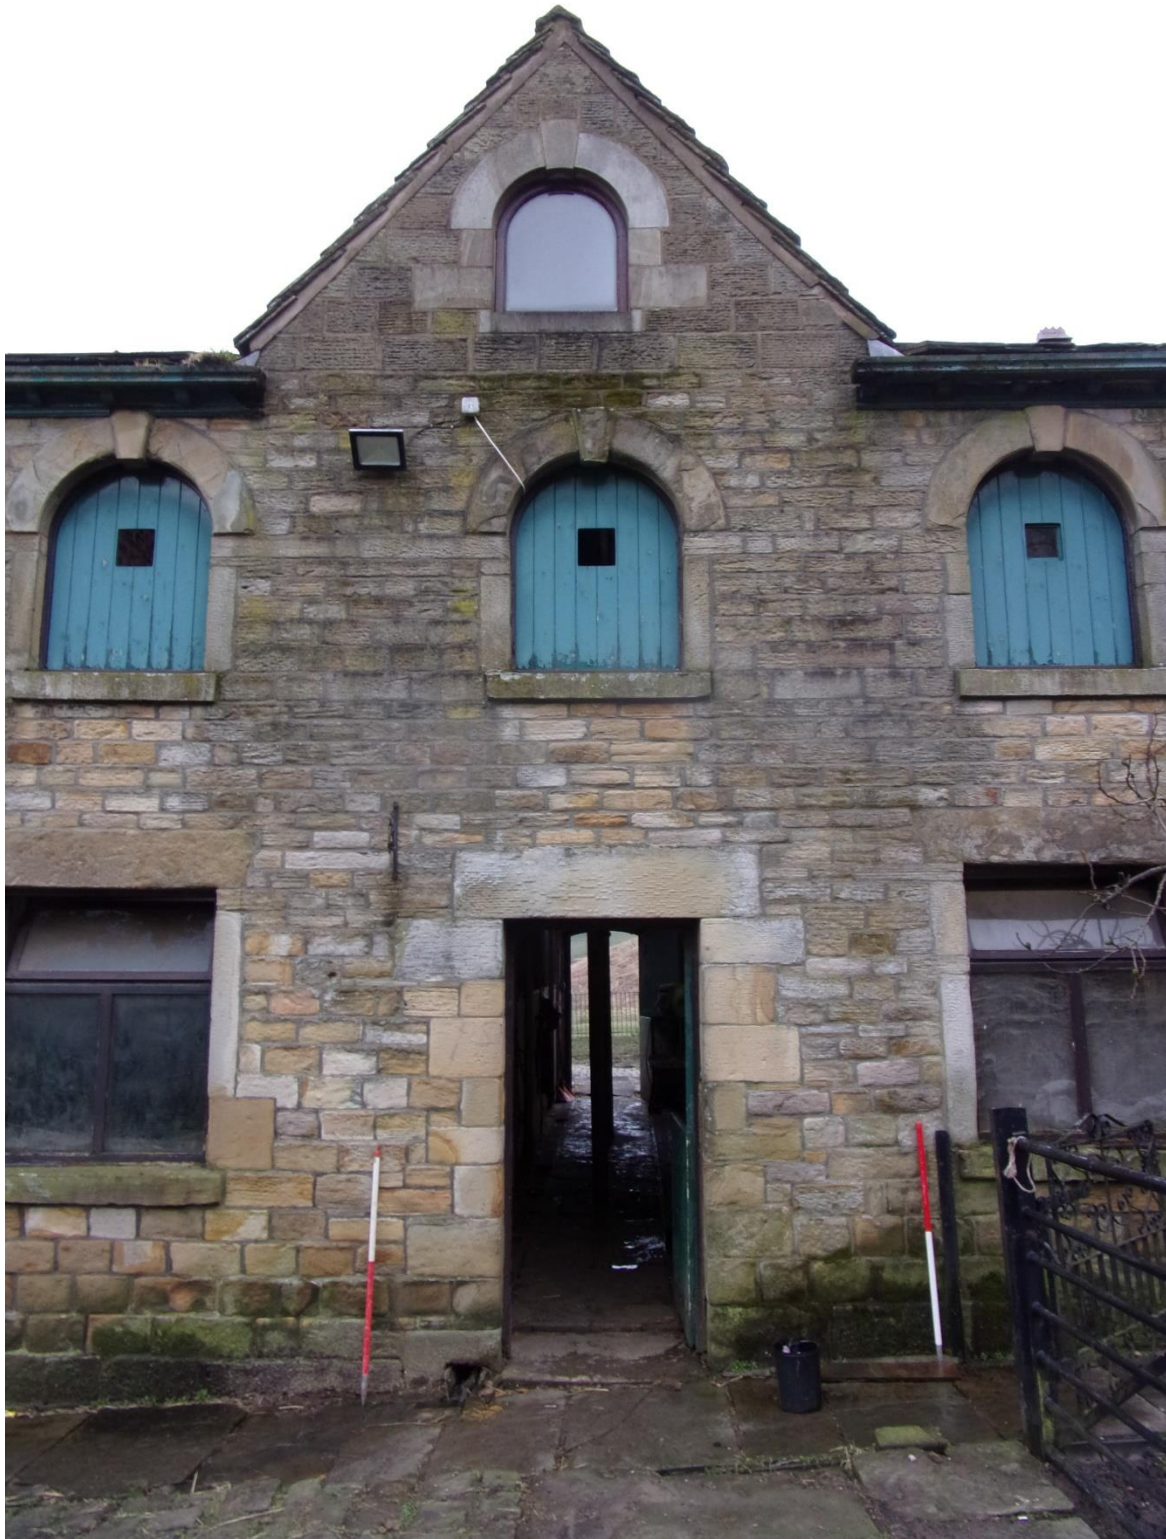
*Plate 14 Central remodelled part of the south elevation facing north. The gable is a later, probably 1980s addition.*

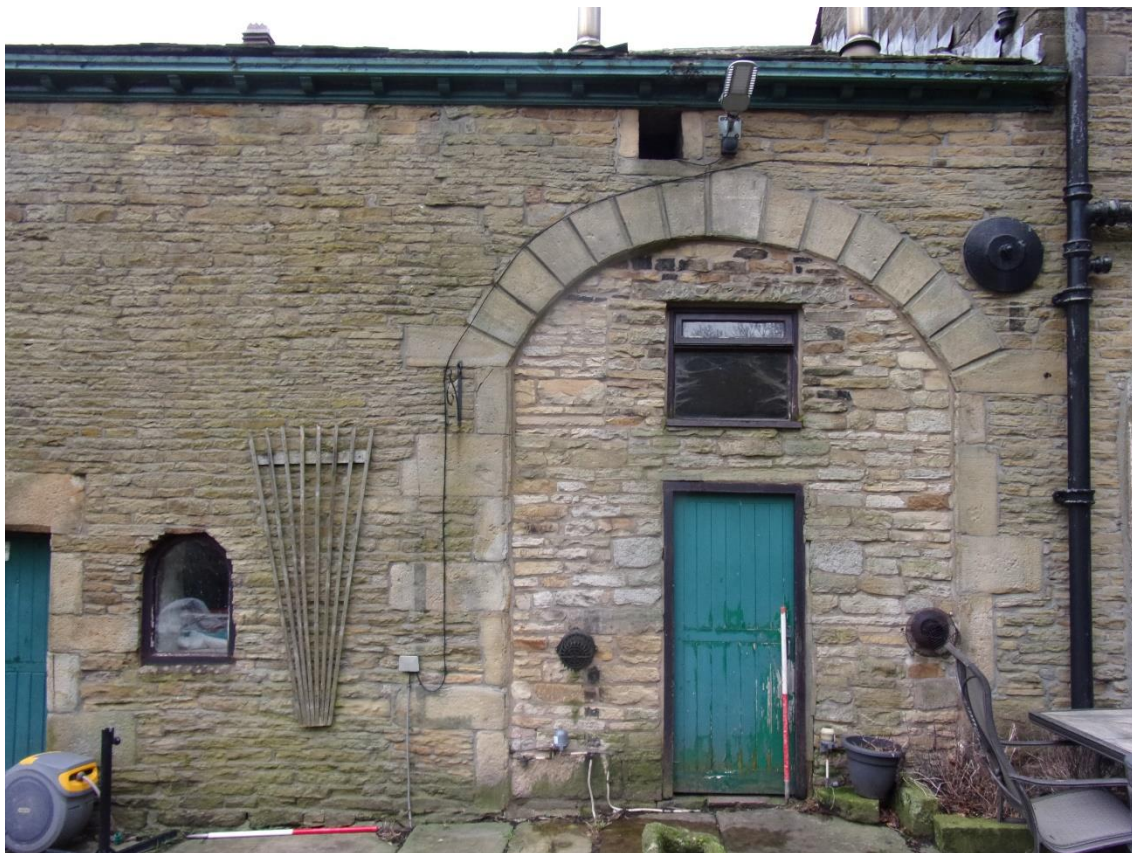
*Plate 16 Blocked cart door in the south elevation facing north*

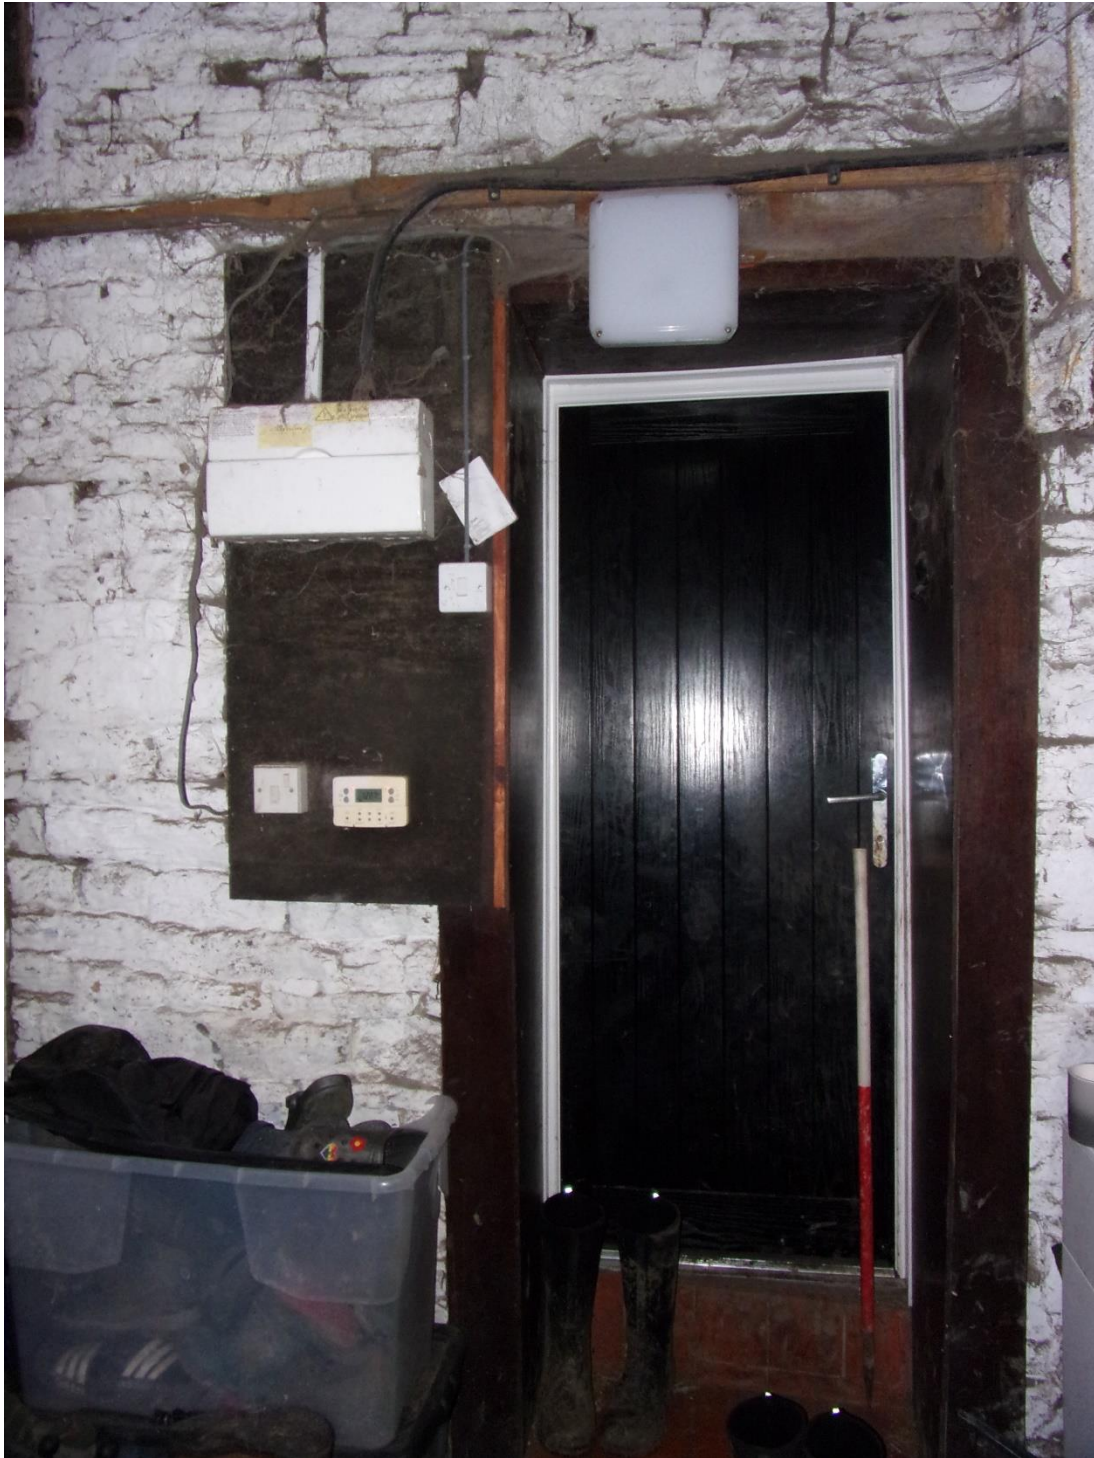
*Plate 27 Modern doorway to the farmhouse in the east elevation*

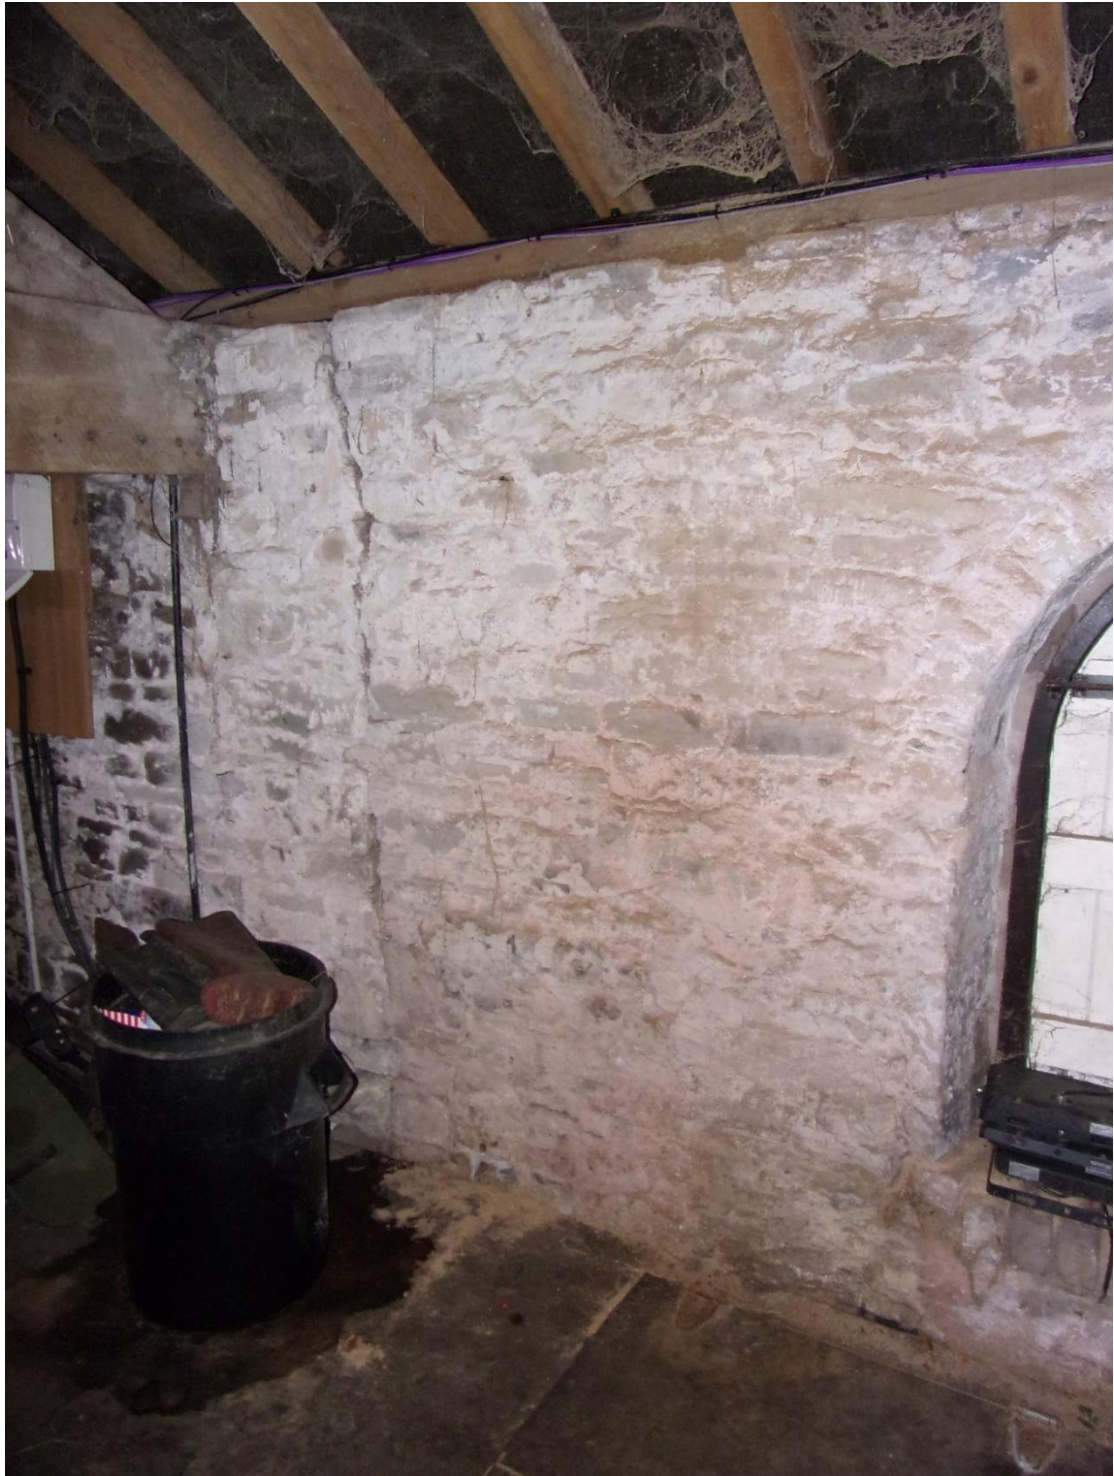
*Plate 68 Wall crack in the south elevation of Room 13*

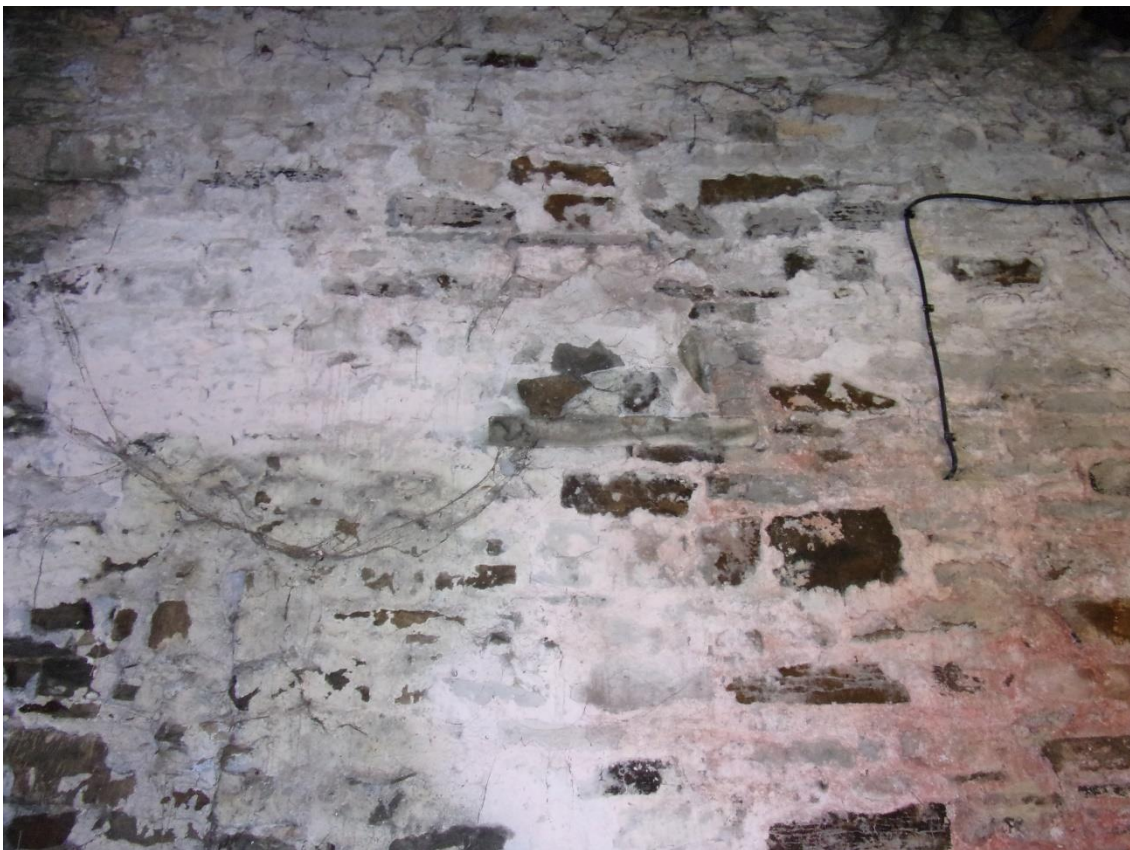
*Plate 74 Possible blocked aperture in the west elevation of Room 13, facing west*

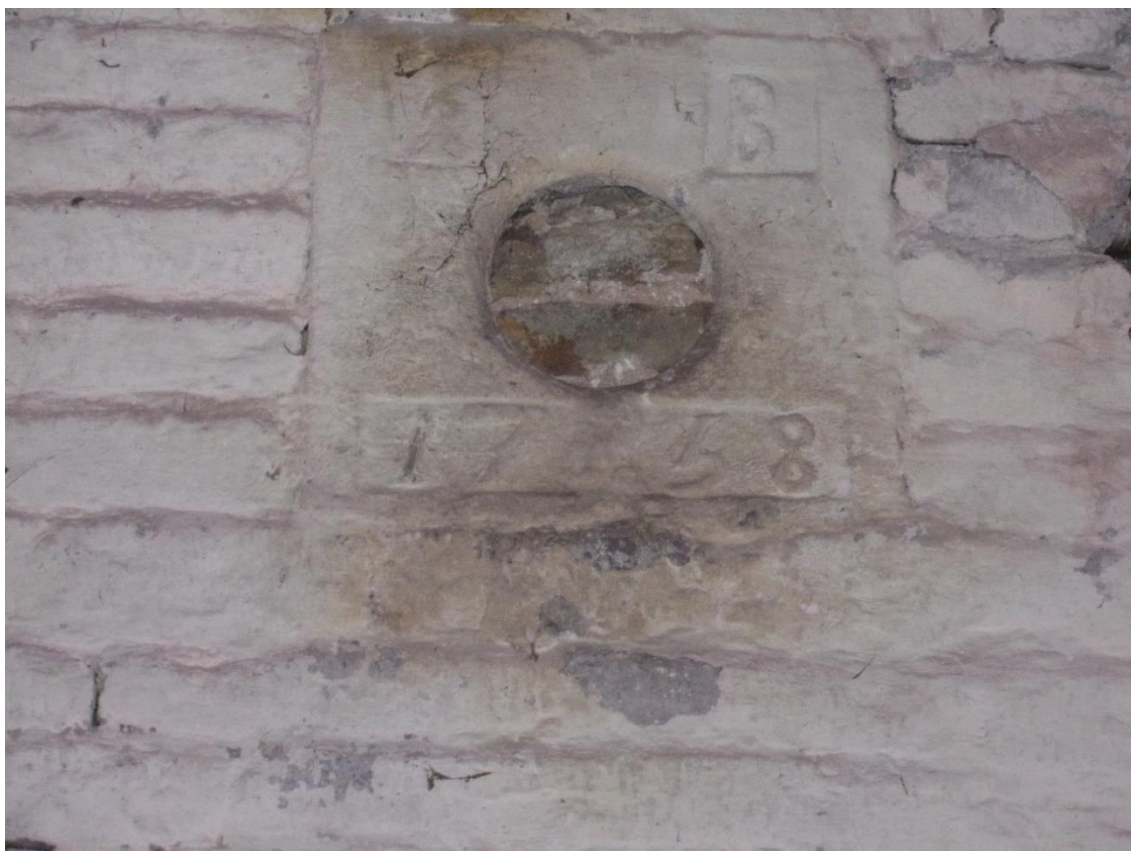
**Room 14:** All four elevations were of stone and white plaster with one window with rounded arched head in both the north and south elevations and two in the west elevation. An owl hole with the 1758 date can be observed at the apex of the gable in the east elevation (Plate 76) which originally was an external wall of the barn. The roof has exposed purlins and rafters and is supported by a half queen post truss running from the east elevation to the west.

*Plate 76 Blocked owl hole with a datestone of 1758 in east-facing elevation of Room 14*
