Elevation DD

Rochdale Borough Council  
SMP - St Mary's CE Primary School  
Elevation DD - Demolition & Repairs  
SMP-SEV-XX-XX-DR-A-03013

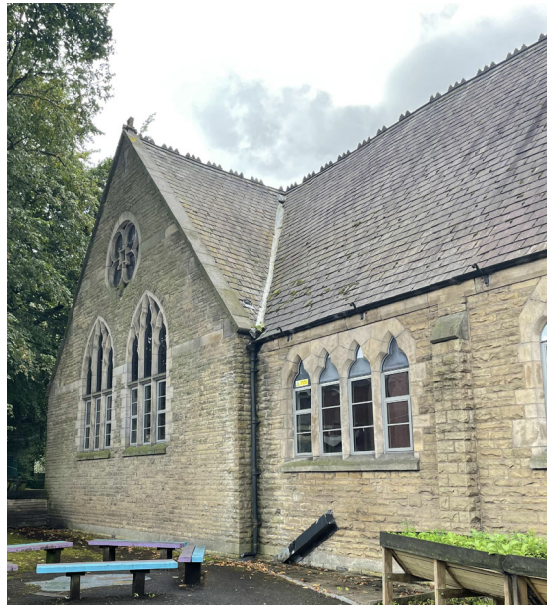
Multiple damaged Ridge Tiles

- Decorative Ridge Tiles: 105 Lm  
Ridge tiles to be removed and set aside with salvaged tiles for re-use. Replace damaged tiles as per the existing style. Ridge ventilation provided with new linear vent. Ridge venting per detail F-F in drawing SMP-SEV-XX-XX-DR-A-03105 (Typical Dormer Window)

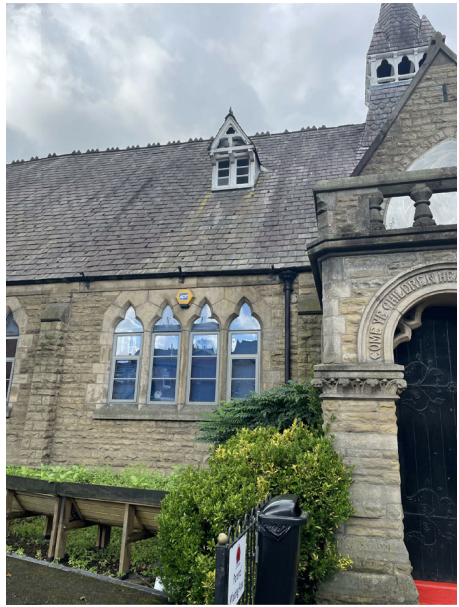
Ridge Tiles damaged near Cupola

Significant Ridge tile damage in this area

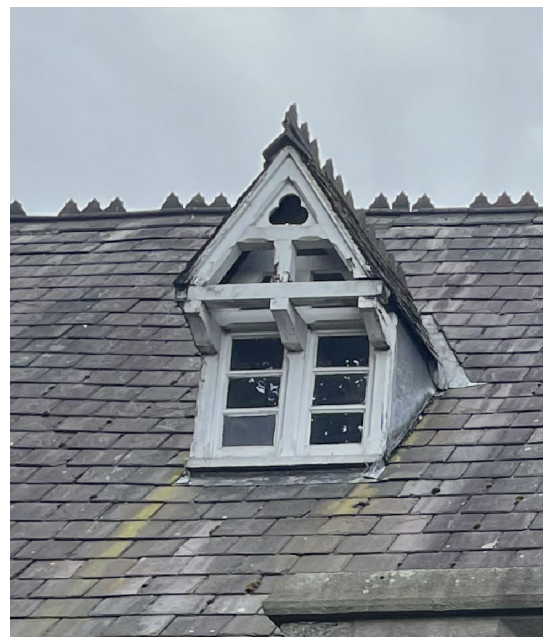
C3 Dormer woodwork damaged; requires further inspection

- Dormer Window: 09 no.  
Splice in new timbers where appropriate. Access to be provided for detailed inspection and methodology agreed. Carefully sand down and repaint in appropriate materials as per the specification. Roofing section per detail F-F in drawing SMP-SEV-XX-XX-DR-A-03105 (Typical Dormer Window)

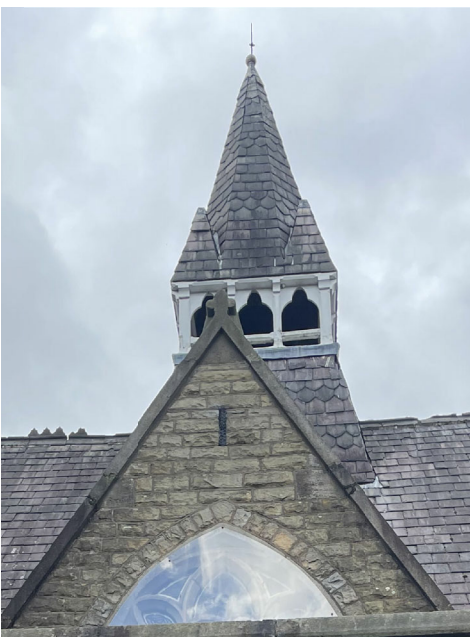
Cupola woodwork undamaged; requires further inspection

- Cupola: 01 no.  
Splice in new timbers where appropriate. Access to be provided for detailed inspection and methodology agreed. Carefully sand down and repaint in appropriate materials as per the specification. Cupola roofing is as per the building's other slate roof eaves, but is at a steeper gradient (assume larger area than in plan).
