| PROJECT | SMP - St Mary's CE Primary School |
| TITLE | Elevation CC - Demolition & Repairs |
| NUMBER | SMP-SEV-XX-XX-DR-A-03012 |

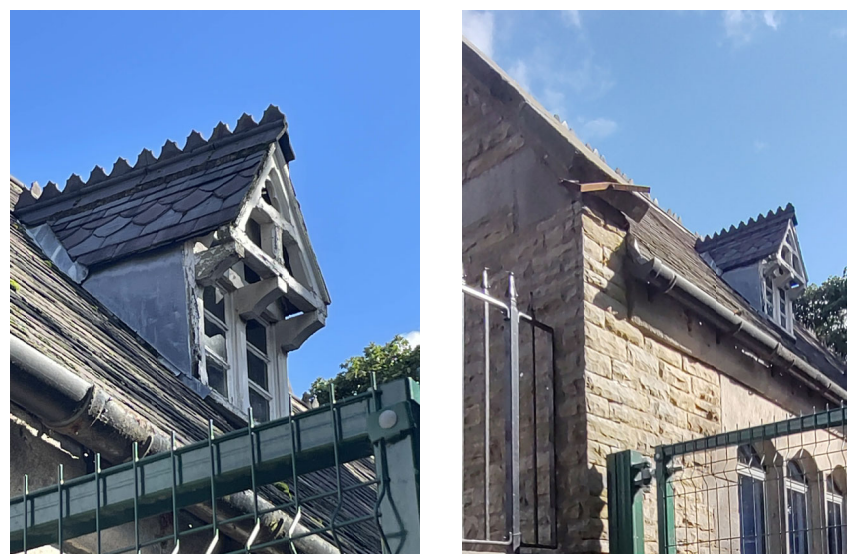
D3 Dormer damaged; requires replacement sections spliced into remaining framework

Rusted metal clamping at base of stone capping

- Dormer Window: 09 no.  
Splice in new timbers where appropriate. Access to be provided for detailed inspection and methodology agreed. Carefully sand down and repaint in appropriate materials as per the specification. Roofing section per detail F-F in drawing SMP-SEV-XX-XX-DR-A-03105 (Typical Dormer Window)

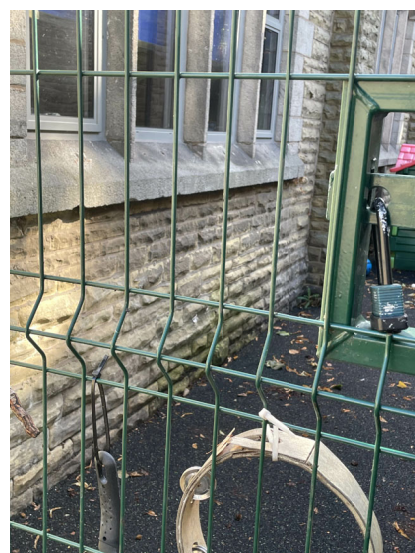
Mould at ground level - investigate if moisture trapped by adjacent Nursery rubberised hard-standing
