| PROJECT | SMP - St Mary's CE Primary School |
| TITLE | Elevation AA - Demolition & Repairs |
| NUMBER | SMP-SEV-XX-XX-DR-A-03010 |

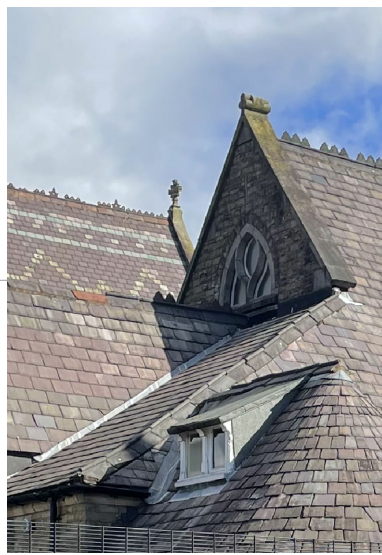
Significant Ridge tile damage in this area

- Decorative Ridge Tiles: 105 Lm  
Ridge tiles to be removed and set aside with salvaged tiles for re-use. Replace damaged tiles as per the existing style. Ridge ventilation provided with new linear vent. Ridge venting per detail F-F in drawing SMP-SEV-XX-XX-DR-A-03105 (Typical Dormer Window)

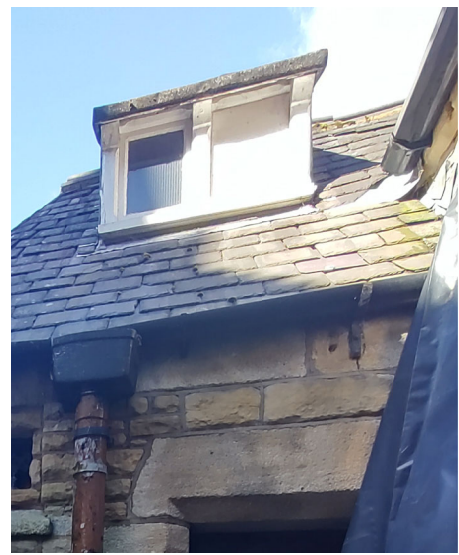
G1 Non-Gabled 'Shed' Dormer Windows require re-felting

- Dormer Window: 09 no.  
Splice in new timbers where appropriate. Access to be provided for detailed inspection and methodology agreed. Carefully sand down and repaint in appropriate materials as per the specification. Roofing section per detail F-F in drawing SMP-SEV-XX-XX-DR-A-03105 (Typical Dormer Window)

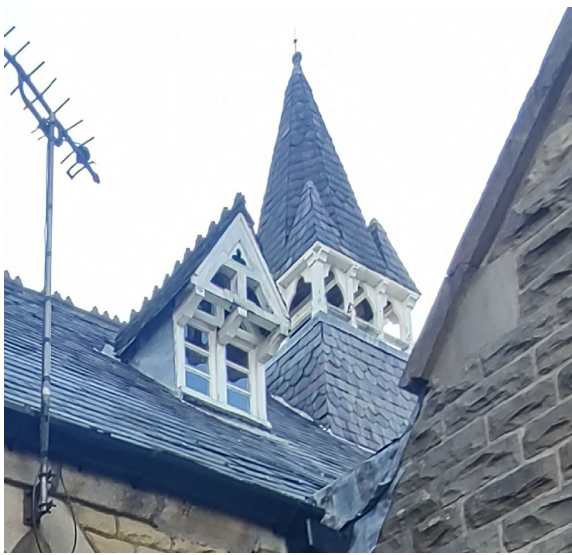
C3 Dormer window woodwork requires repainting

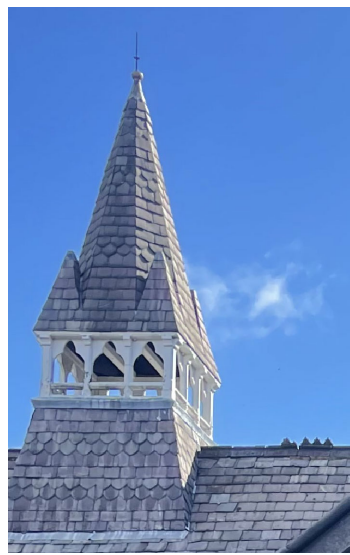
Cupola tiling intact

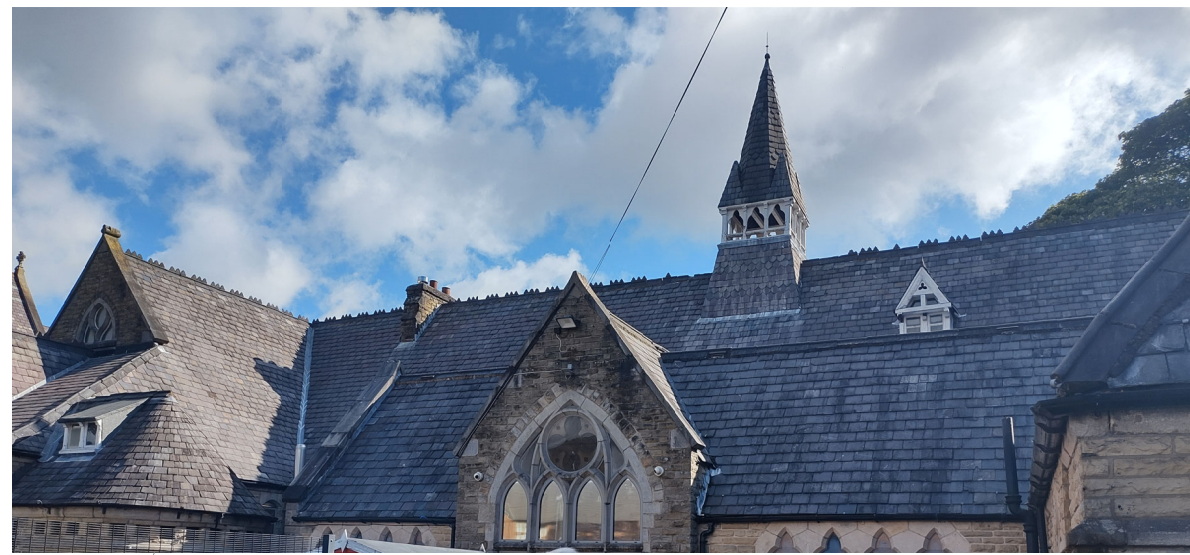
Broken Ridge Tiles mainly around Cupola

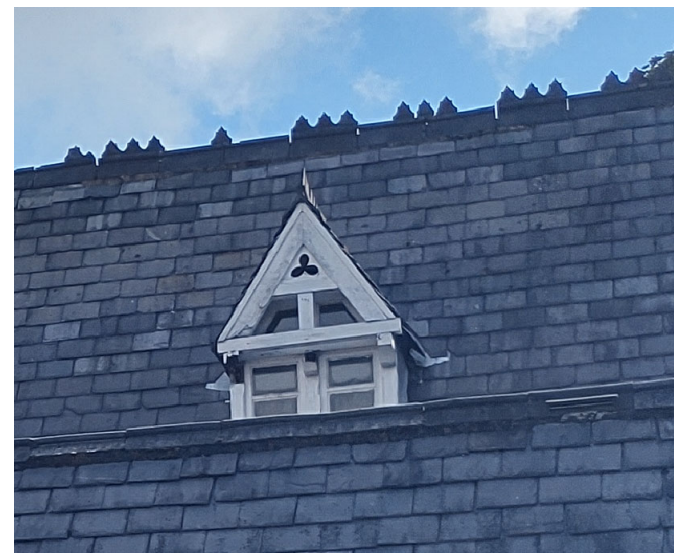
C4 Dormer window woodwork requires repainting

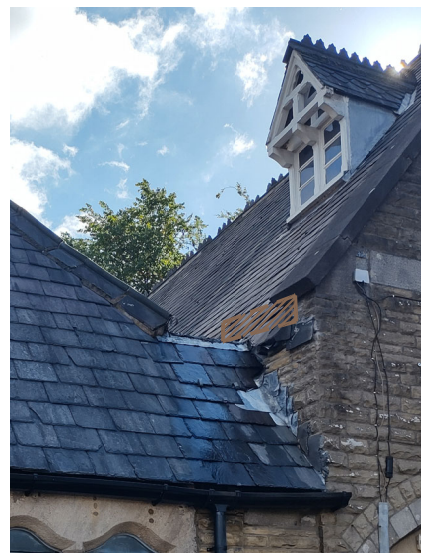
Additional guttering required in this area

- Rainwater Goods: 18 no.  
Down-pipe to be removed and replaced with cast-iron rainwater goods allowing for increased diameter (6 inch) to mitigate increased rainfall. Existing cast-iron hoppers to be retained & refurbished where possible. Guttering per detail B-B in drawing SMP-SEV-XX-XX-DR-A-03100 (Typical External Gutter)
