| PROJECT | SMP - St Mary's CE Primary School |
| TITLE | Elevation EE - Demolition & Repairs |
| NUMBER | SMP-SEV-XX-XX-DR-A-03014 |

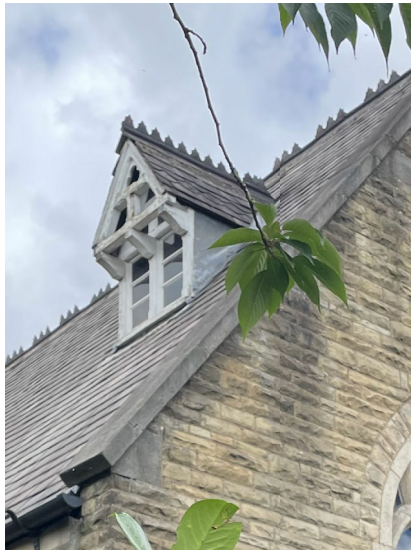
A2 Dormer wood paintwork worn; requires further inspection

- Dormer Window: 09 no.  
Splice in new timbers where appropriate. Access to be provided for detailed inspection and methodology agreed. Carefully sand down and repaint in appropriate materials as per the specification. Roofing section per detail F-F in drawing SMP-SEV-XX-XX-DR-A-03105 (Typical Dormer Window)

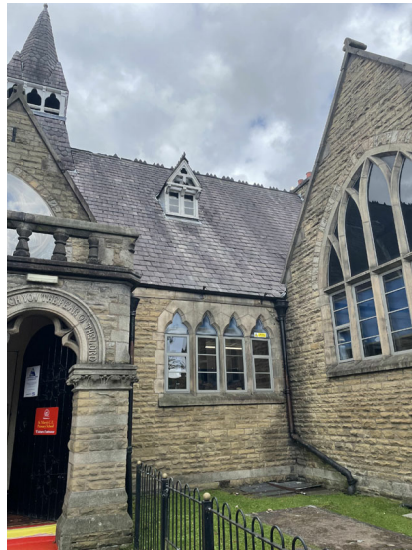
Downpipe rusted; requires sanding down & repainting

- Rainwater Goods: 18 no.  
Down-pipe to be removed and replaced with cast-iron rainwater goods allowing for increased diameter (8 inch) to mitigate increased rainfall. Existing cast-iron hoppers to be retained & refurbished where possible. Guttering per detail B-B in drawing SMP-SEV-XX-XX-DR-A-03100 (Typical External Gutter)
