| PROJECT | SMP - St Mary's CE Primary School |
| TITLE | Elevation AA - Demolition & Repairs |
| NUMBER | SMP-SEV-XX-XX-DR-A-03010 |

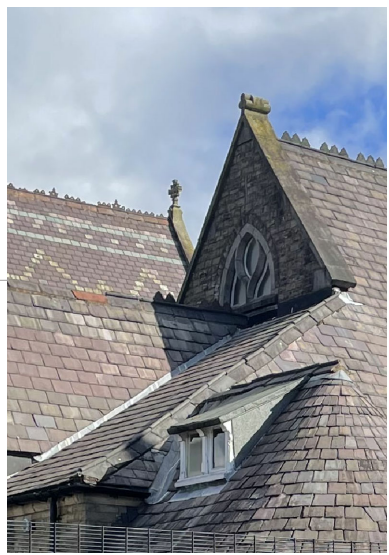
Significant Ridge tile damage in this area

- Ridge Tiles: 50 Lm  
Ridge tiles to be removed and set aside with salvaged tiles for re-use.  
Replace damaged tiles like-for-like.
- Bat Slate: [Dashed Hatch Approx. Location, Solid Hatch Exact Location]  
Integrated Bat access slate: metal vent to allow access for bats into roof void, with sufficient gap cut into roof structure underneath. Fitted within a hole cut to slate which is placed over the vent to reduce visual impact. 1no. Bat Slate located in area of observed bat emergence (west wing of the building, facing north, adjacent to Dormer D2) and then 3no. supplementary 'enhancement slates' along remaining wings (north, east, south).

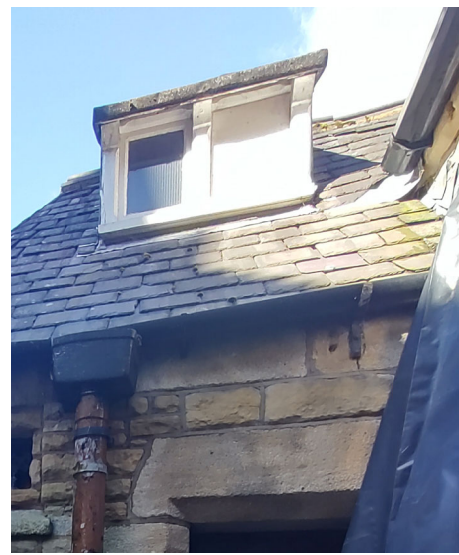
G1 Non-Gabled 'Shed' Dormer Windows require re-felting

- Dormer Window: 09 no.  
Splice in new timbers where appropriate. Access to be provided for detailed inspection and methodology agreed. Carefully sand down and repaint in appropriate materials as per the specification. Roofing section per detail F-F in drawing SMP-SEV-XX-XX-DR-A-03105 (Typical Dormer Window)

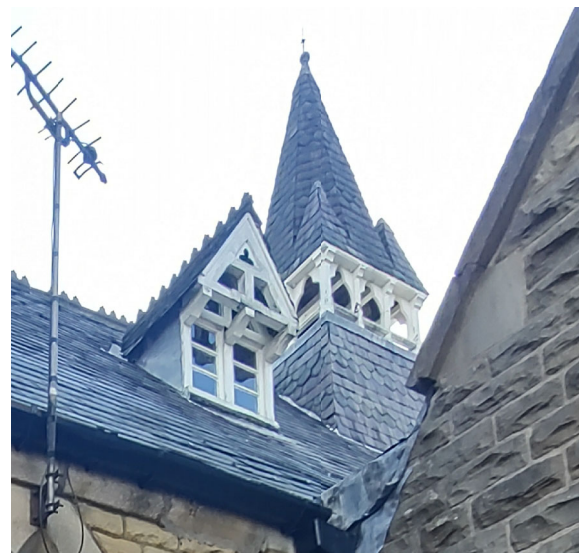
C3 Dormer window woodwork requires repainting

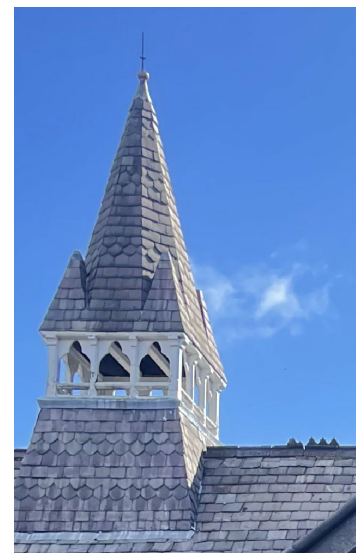
Cupola tiling intact

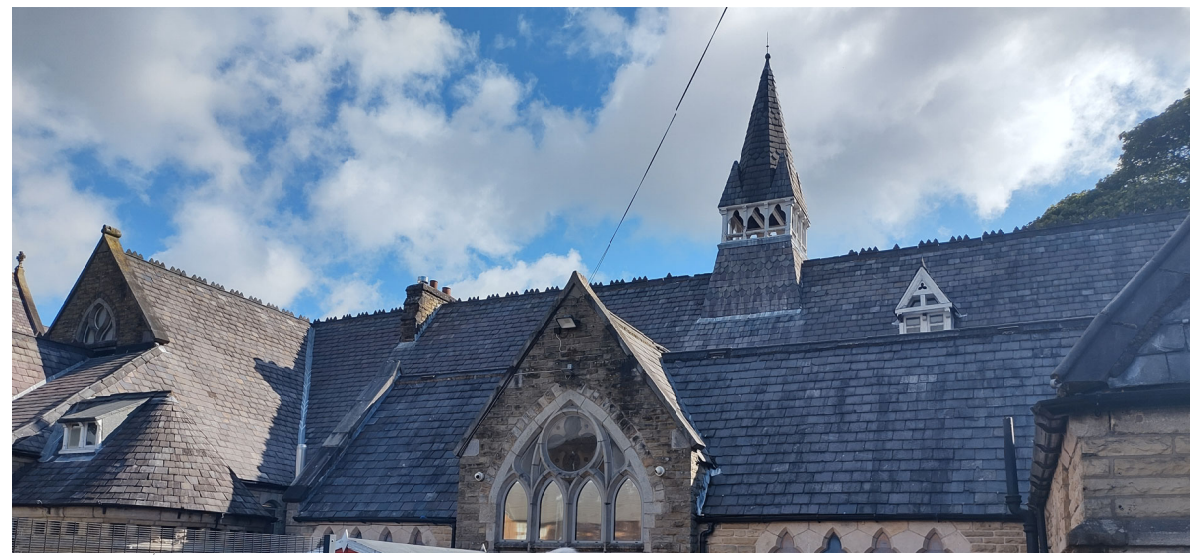
Broken Ridge Tiles mainly around Cupola

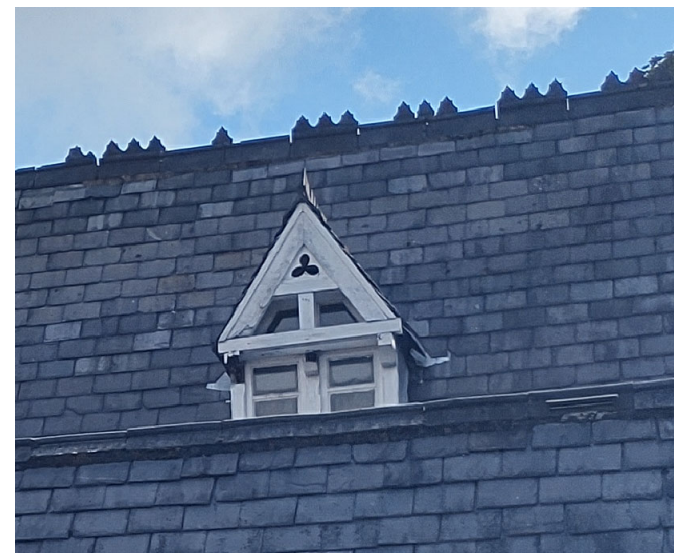
C4 Dormer window woodwork requires repainting

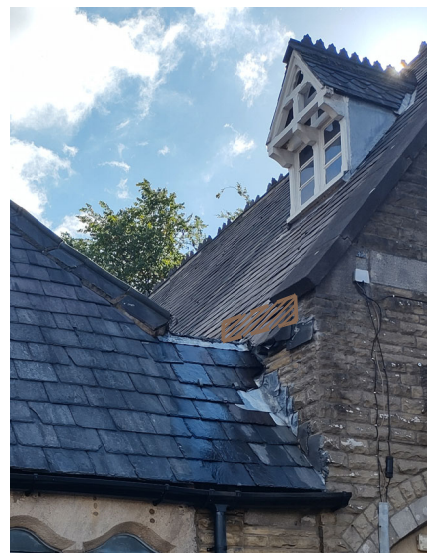
Additional guttering required in this area

- Rainwater Goods: 18 no.  
Down-pipe to be removed and replaced with cast-iron rainwater goods allowing for increased diameter (6 inch) to mitigate increased rainfall.  
Guttering per detail B-B in drawing SMP-SEV-XX-XX-DR-A-03100 (Typical External Gutter)

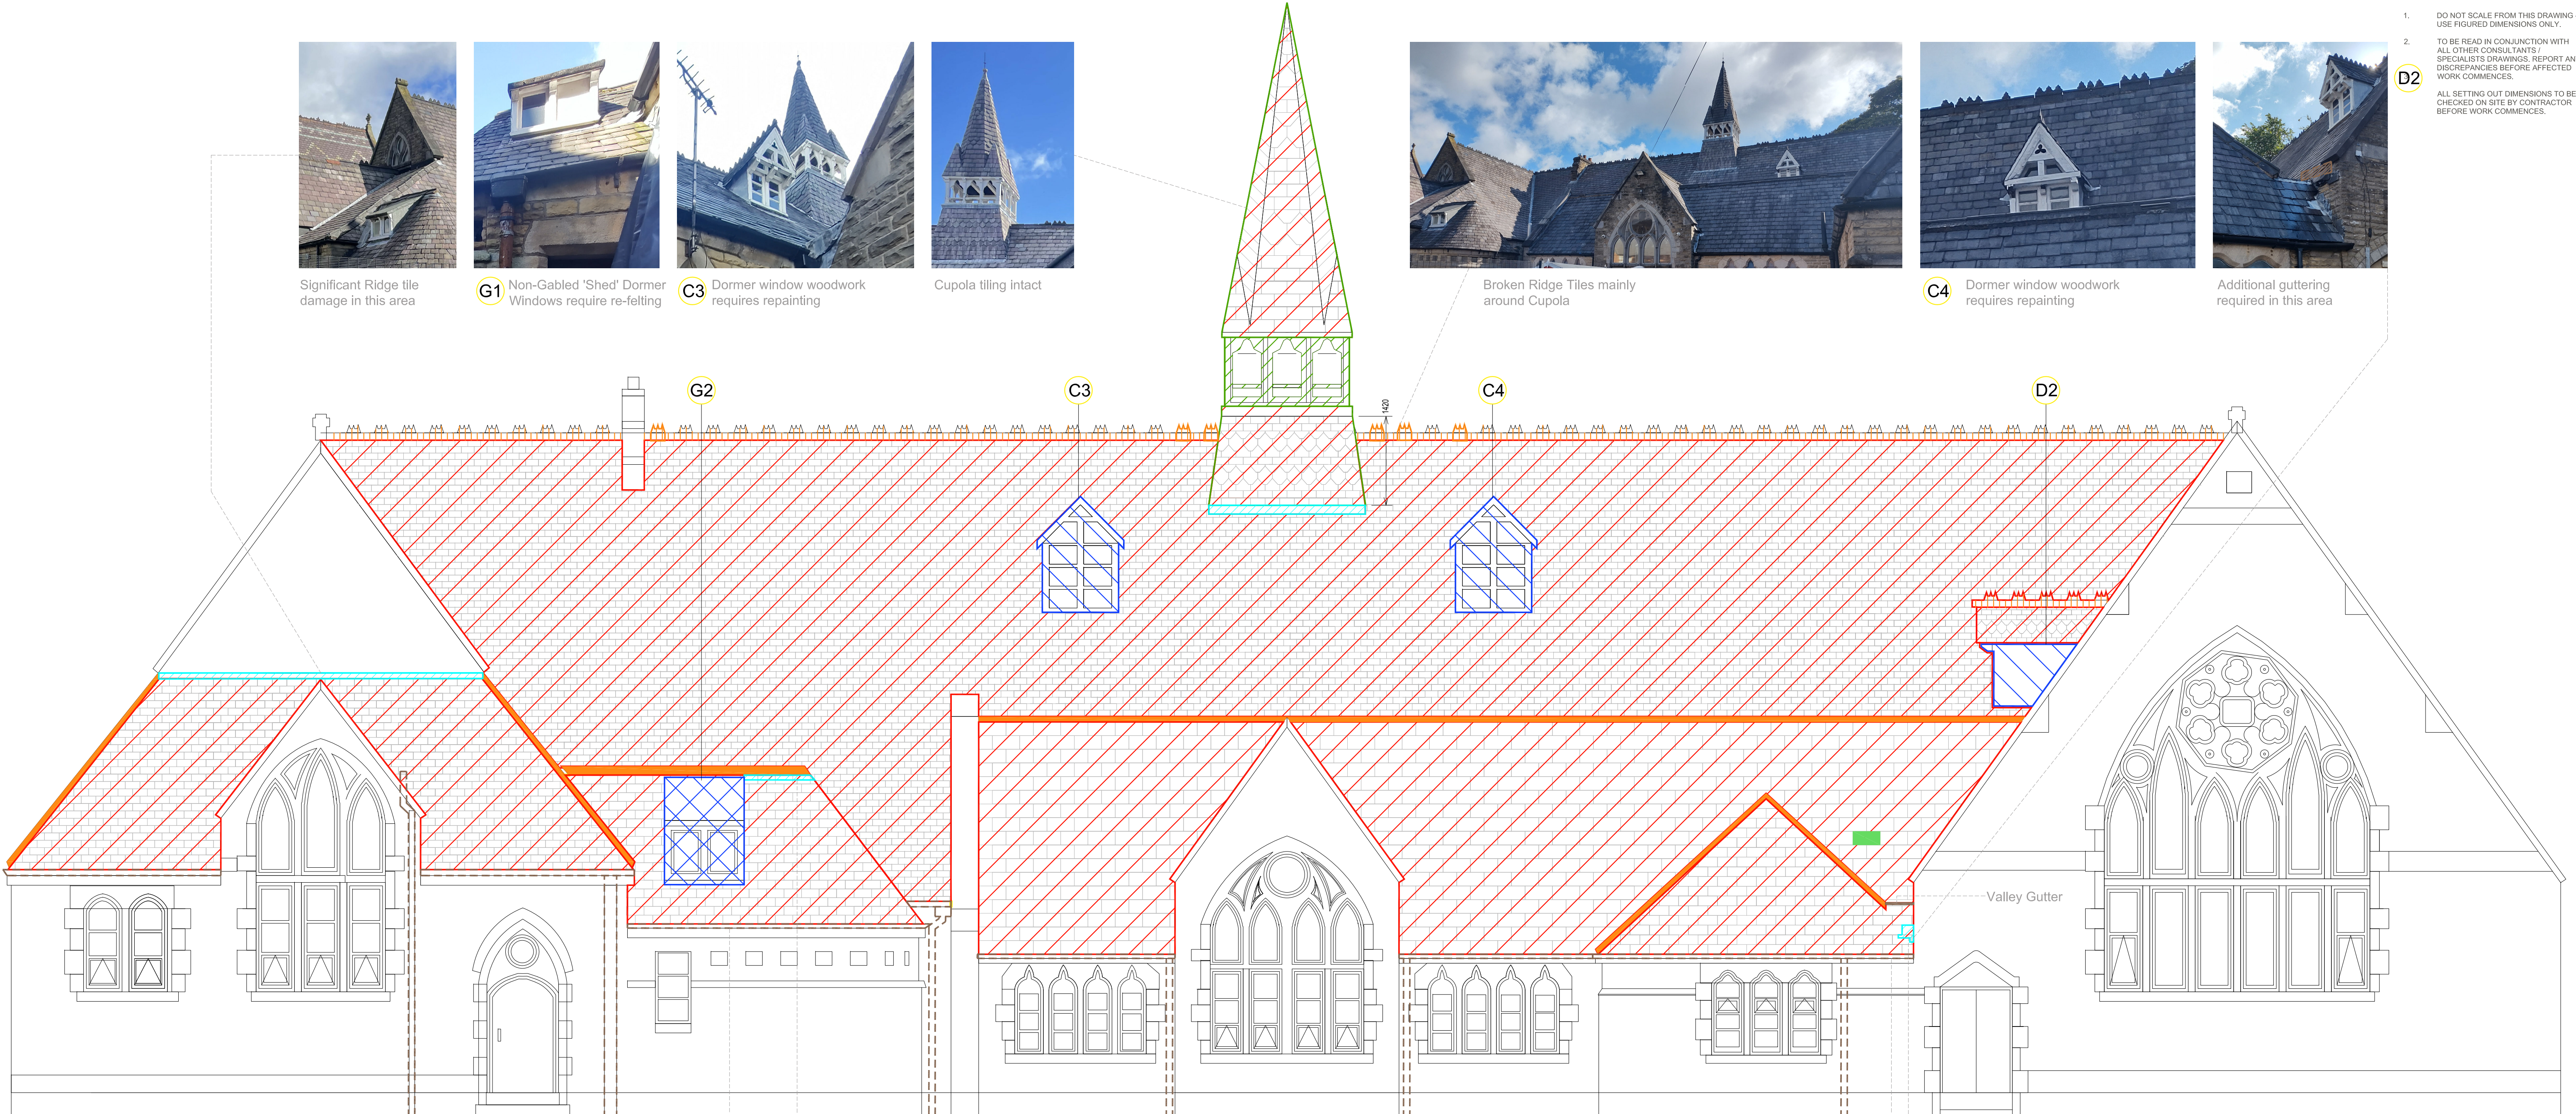
Elevation AA

Gutter on opposite side (under Dormer G1) sagging, downpipe rusted

Gutter Sagging

Missing tile covered with lead flashing; replace Tile.
