| PROJECT | SMP - St Mary's CE Primary School |
| TITLE | Elevation BB - Demolition & Repairs |
| NUMBER | SMP-SEV-XX-XX-DR-A-03011 |

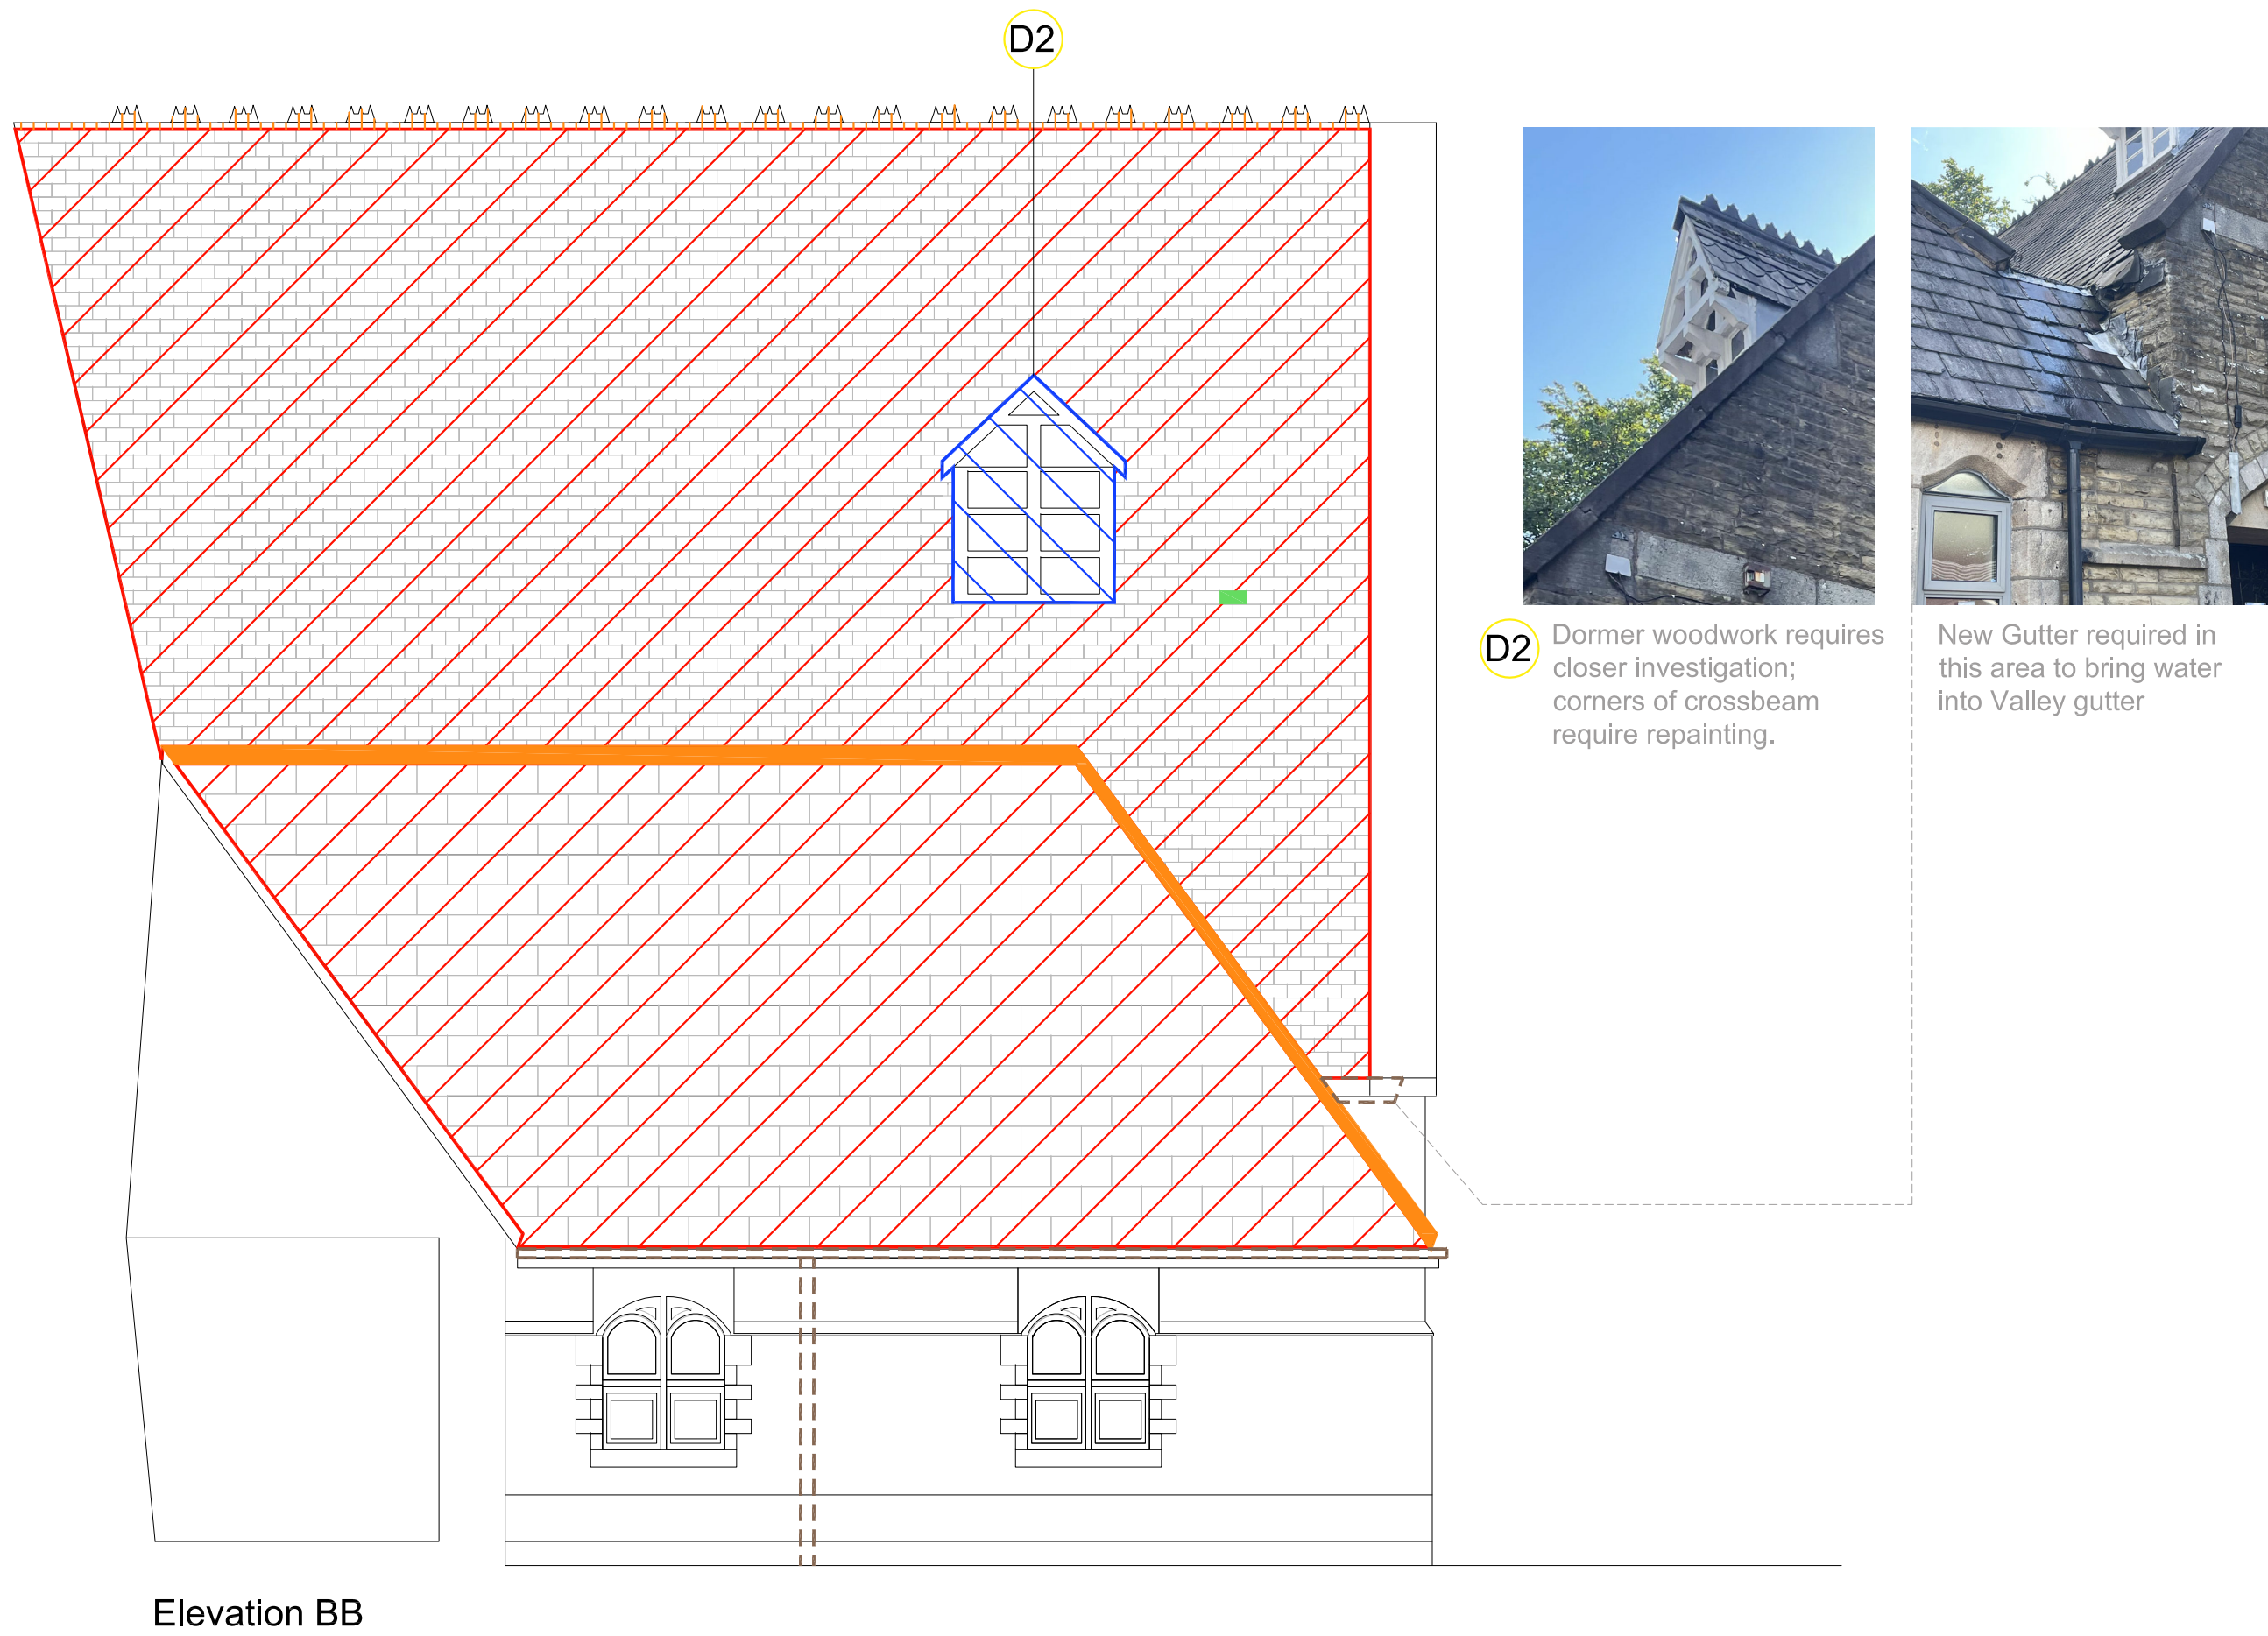
Elevation BB

D2 Dormer woodwork requires closer investigation; corners of crossbeam require repainting.

New Gutter required in this area to bring water into Valley gutter

- Roof Slate Restoration: 762sqm / 8220sqft  
Strip existing slate roof coverings and set aside salvaged slates for re-use. Strip existing battens, felt, lead-lined gutters and gutter structure then safely dispose of any defective material. Insulate, re-felt, batten, counter batten existing roof slope.  
As per detail A-A in drawing SMP-SEV-XX-XX-DR-A-03100 (Typical Roof Build-Up)

- Dormer Window: 09 no.  
Splice in new timbers where appropriate. Access to be provided for detailed inspection and methodology agreed. Carefully sand down and repaint in appropriate materials as per the specification. Roofing section per detail F-F in drawing SMP-SEV-XX-XX-DR-A-03105 (Typical Dormer Window)

- Cupola: 01 no.  
Splice in new timbers where appropriate. Access to be provided for detailed inspection and methodology agreed. Carefully sand down and repaint in appropriate materials as per the specification. Cupola roofing is as per the building's other slate roof eaves, but is at a steeper gradient.

- Rainwater Goods: 18 no.  
Down-pipe to be removed and replaced with cast-iron rainwater goods allowing for increased diameter (6 inch) to mitigate increased rainfall.  
Guttering per detail B-B in drawing SMP-SEV-XX-XX-DR-A-03100 (Typical External Gutter)

- Lead Flashing: 75 Lm  
Replace with new lead flashing where appropriate.  
Access to be provided for detailed inspection and methodology agreed.
- Ridge Tiles: 105 Lm  
Ridge tiles to be removed and set aside with salvaged tiles for re-use.  
Replace damaged tiles as per the existing style. Ridge ventilation provided with new linear vent.  
Ridge venting per detail F-F in drawing SMP-SEV-XX-XX-DR-A-03105 (Typical Dormer Window)

- Ridge Tiles: 50 Lm  
Ridge tiles to be removed and set aside with salvaged tiles for re-use.  
Replace damaged tiles like-for-like.
- Bat Slate: [Dashed Hatch Approx. Location, Solid Hatch Exact Location]  
Integrated Bat access slate: metal vent to allow access for bats into roof void, with sufficient gap cut into roof structure underneath. Fitted within a hole cut to slate which is placed over the vent to reduce visual impact. 1no. Bat Slate located in area of observed bat emergence (west wing of the building, facing north, adjacent to Dormer D2) and then 3no. supplementary 'enhancement slates' along remaining wings (north, east, south).
