21314

BRANCH ROAD FARM, BRANCH ROAD  
LITTLEBOROUGH – OL15 0AB

May 2021

# REPORT ON STRUCTURE

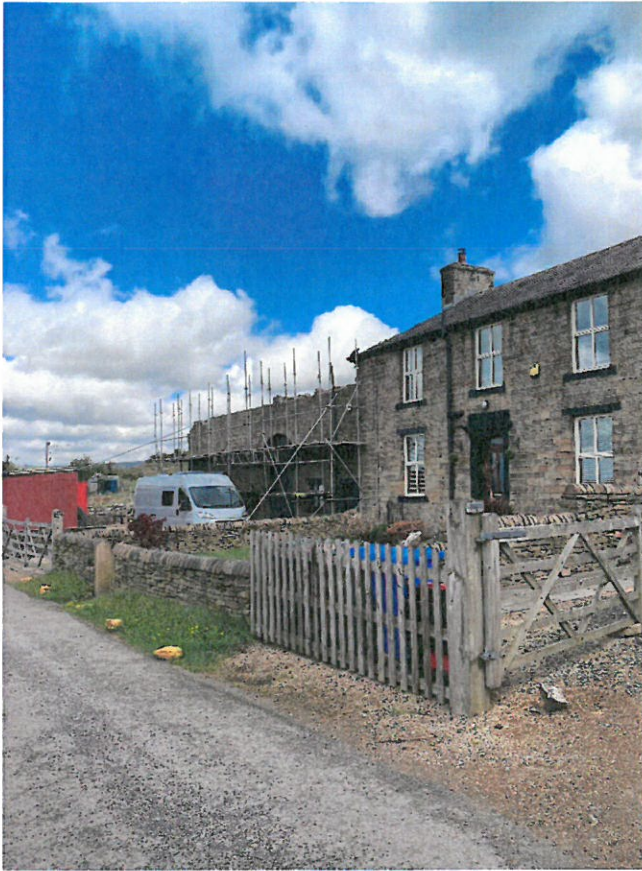
Photograph 1

- 1.01** We were requested by Mr Wildman to carry out a survey and to provide a report on the structure of the property known as The Barn, Branch Road Farm, Littleborough. See photograph 1.
- 1.02** The purpose of the report was to assess the structural suitability of the remaining structure for reinstatement and conversion to a domestic dwelling. The report is to be used to aid a planning application and to help identify to the Planning Officers, the intentions of Mr Wildman and his Design / Construction Team.
- 1.03** For the purposes of this report all references to left, right, front and rear should be taken as viewing the property from Branch Road.
- 1.04** This report has been carried out on a purely visual basis. We have not inspected parts of the property which are covered, unexposed or inaccessible and such parts are assumed to be in good repair and condition.

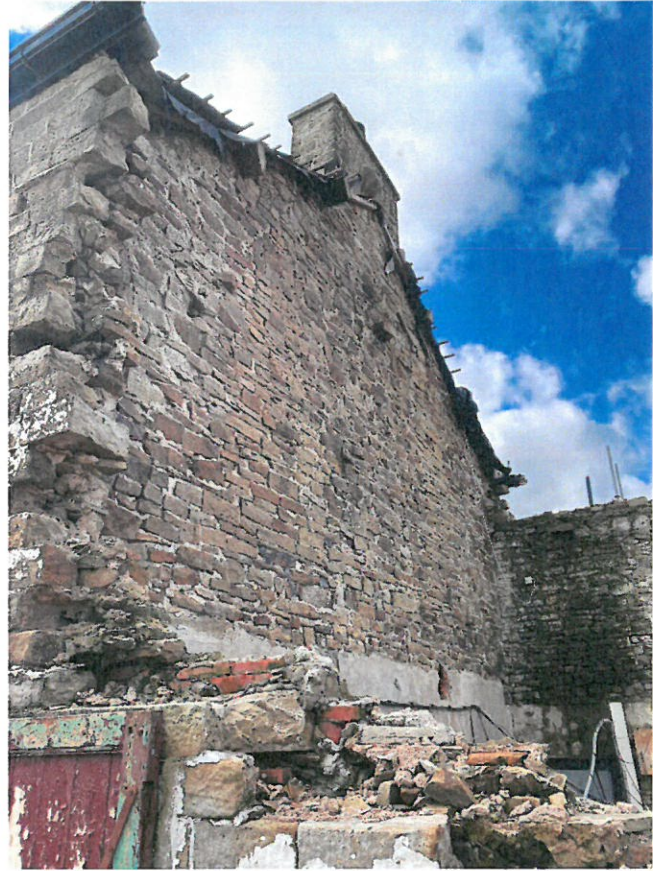
Photograph 2

The party wall, with the farmhouse, is to remain as a party wall in the new development. See photograph 2.

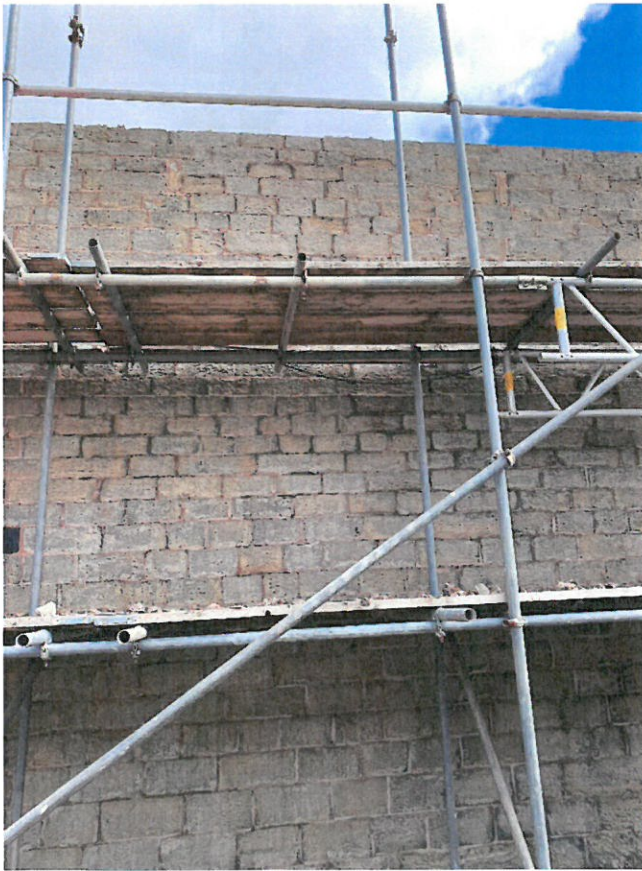
Photograph 3

**2.04** The remaining barn walls are faced with a coursed local stone with narrow beds joints. See photograph 3. The inner leaf is of random stone and there is a poor, loose rubble fill. See photograph 4.

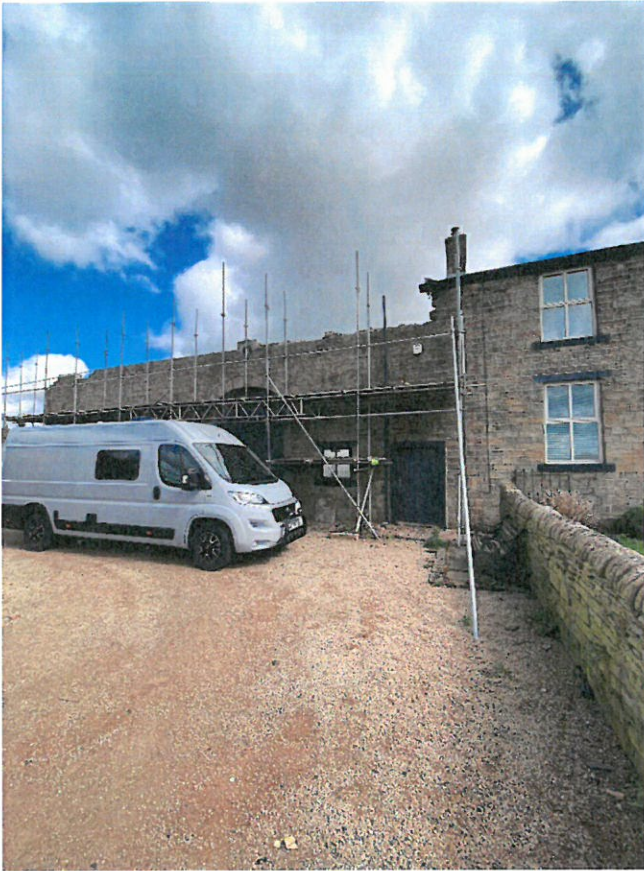
Photograph 5

**2.05** On the front elevation there is an existing large cart arch, two nominal window openings and a personnel door. See photograph 5.

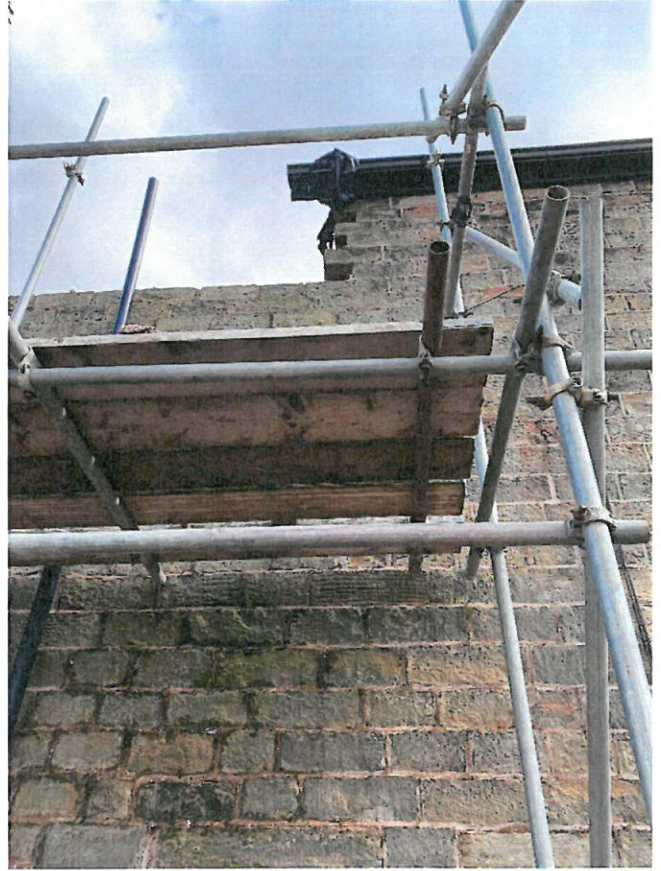
Photograph 6

**2.06** The existing front elevation is complete up to within a few stone courses below eaves level. See photograph 6.

The wall will be extended to eaves level, faced with the original coursed stone. The remaining partial elevations on the left and rear will be stabilised in a similar manner.

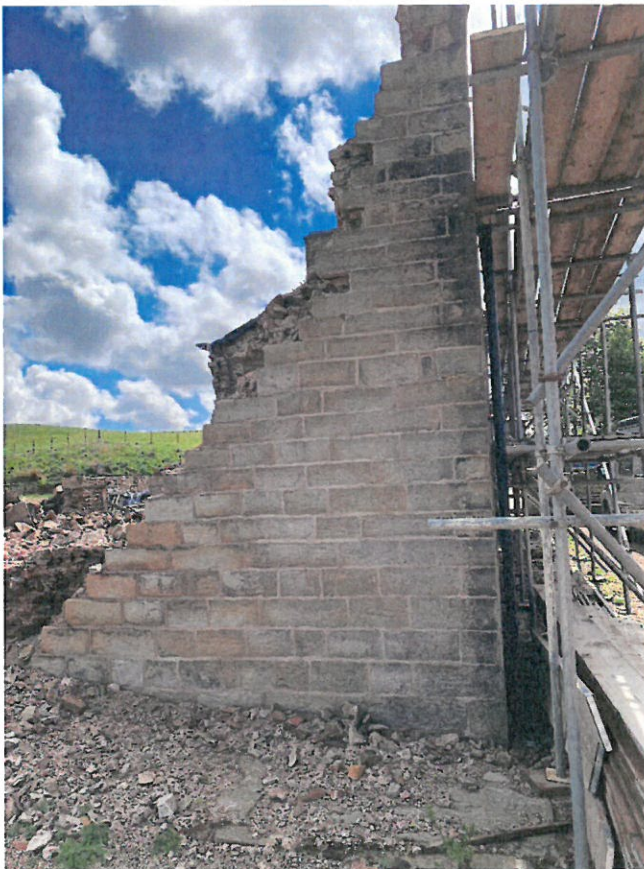
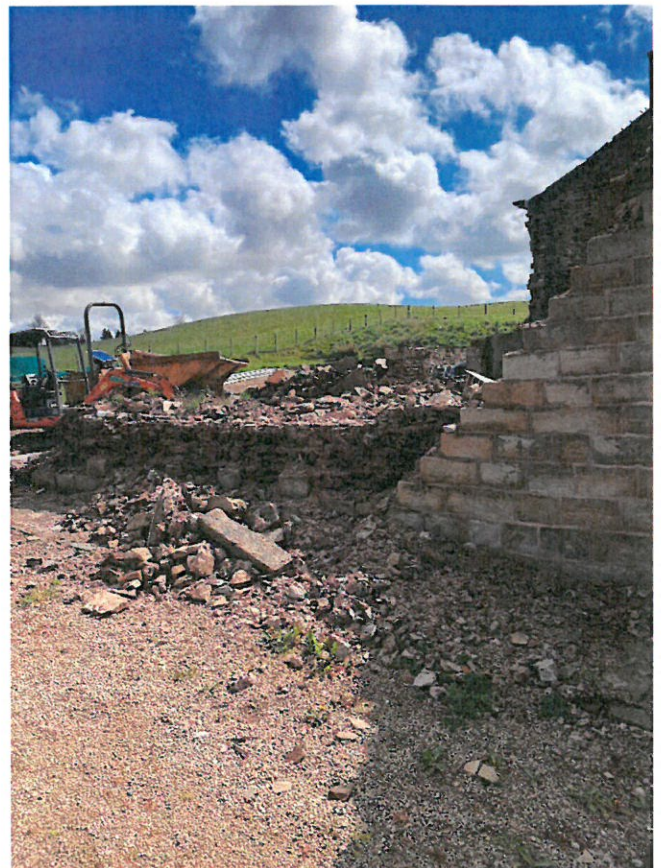
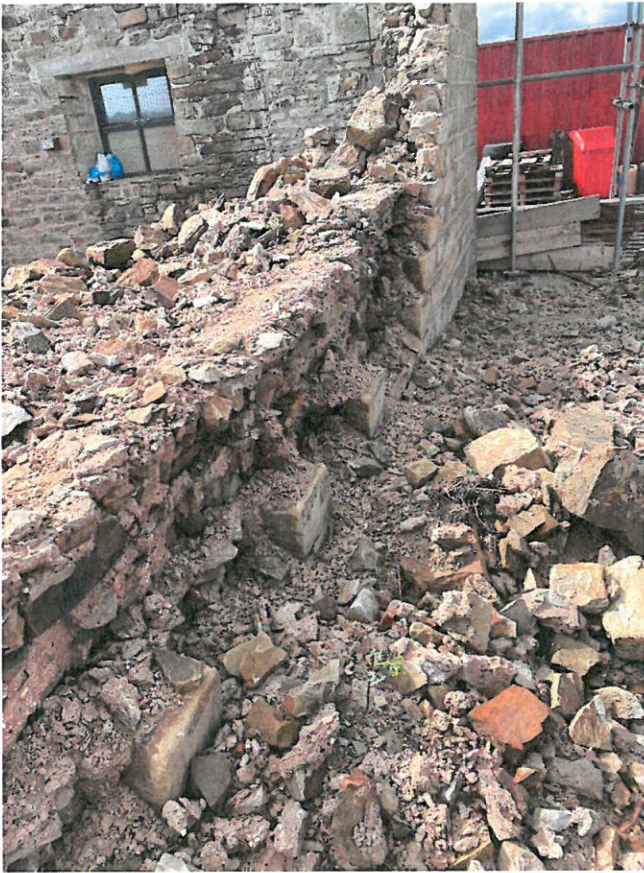
**2.07** The left-hand side and rear elevations became unstable during demolitions and now only remain in part. See photographs 7, 8 & 9 - side elevation and photographs 10, 11 & 12 - rear elevation.

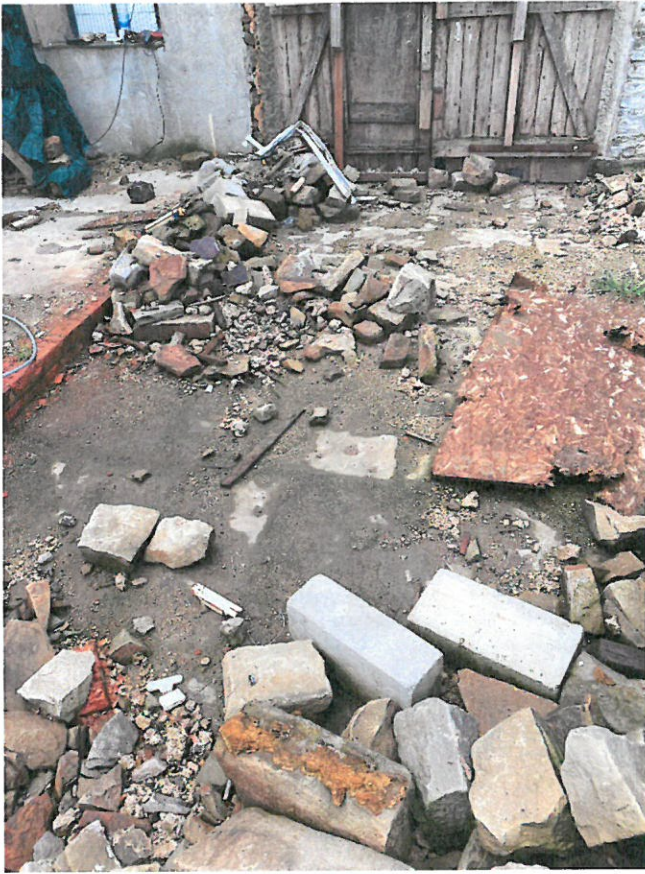
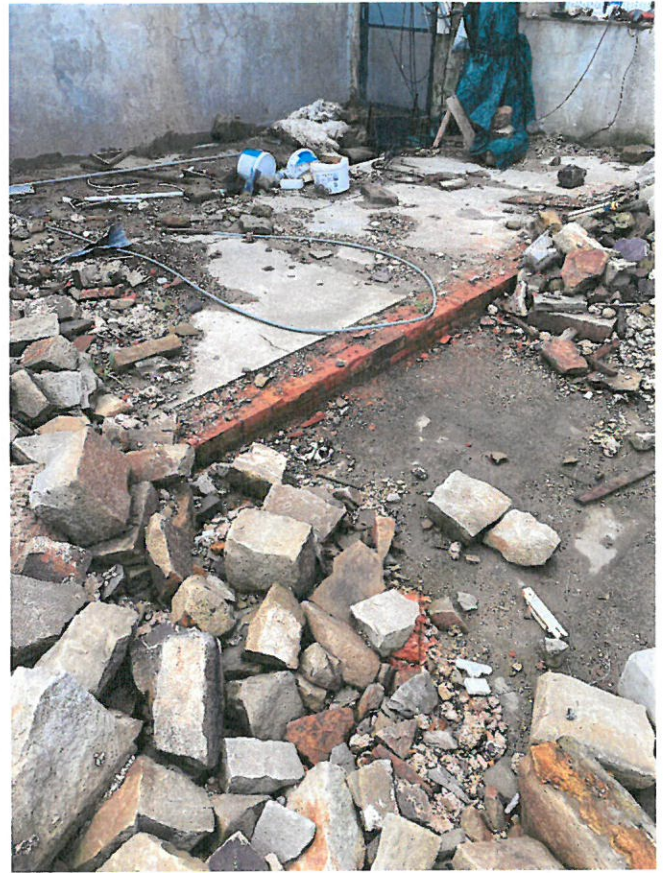
**2.10** The existing floor slab currently remains. This is a mixture of different surfaces set at varying levels. See photographs 13 & 14.

Prior to any further reconstruction, the existing floor slab will be removed and replaced with a new concrete slab / raft. A typical detail is shown in Appendix D.

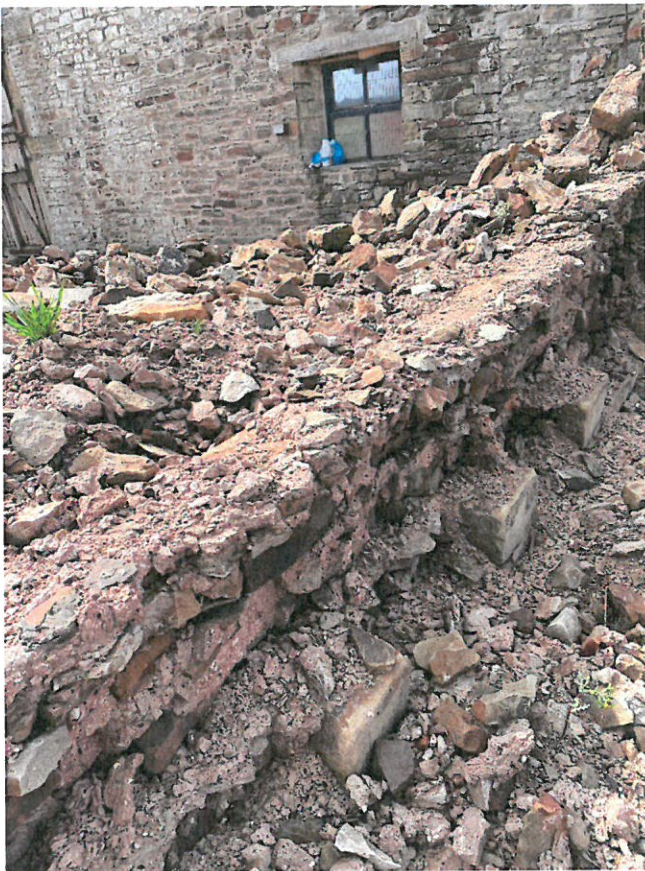
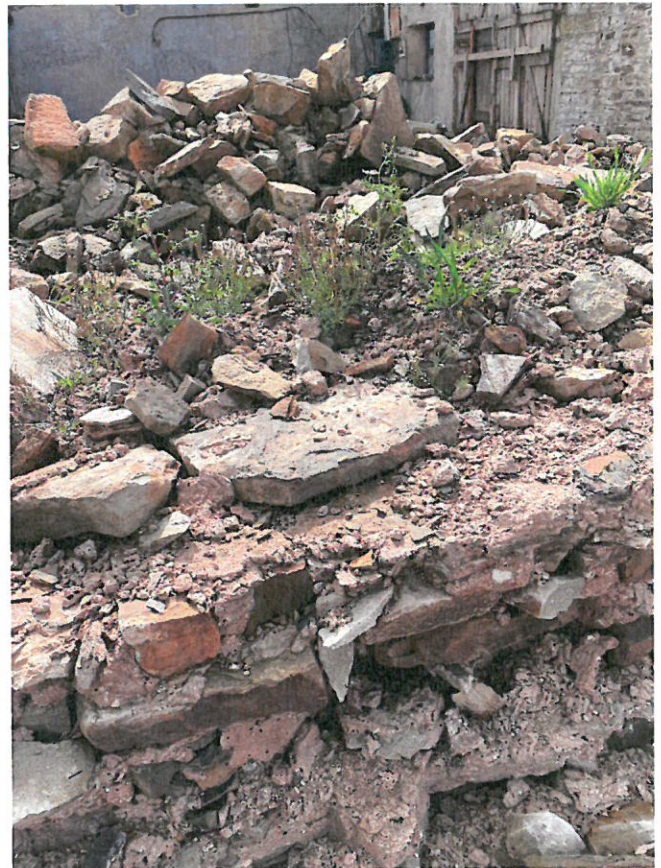
- 4.01** We believe the collapse of the left-hand side and the rear elevation was inevitable given the condition of the walls and the poor quality of the inner leaf matrix and the loose rubble fill. See photographs 15 & 16. The loss of lateral restraint due to the removal of the roof was also a contributing factor.

- 4.06** Given the nature of the remaining wall construction, it is in our opinion that the collapse was unfortunate but inevitable.

- 4.02** To this end, we have recommended action that will stabilise the remaining elements prior to any further work being undertaken.

The elevations to be rebuilt will be backed up with a blockwork inner leaf. This will need to step around areas of the external wall that remain standing.

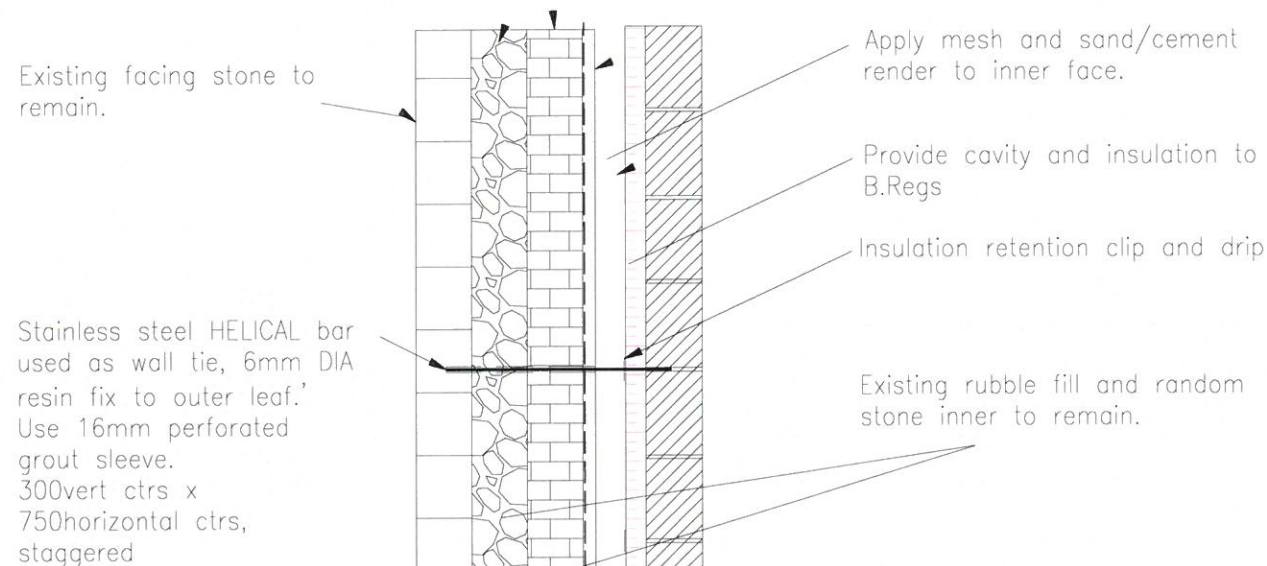
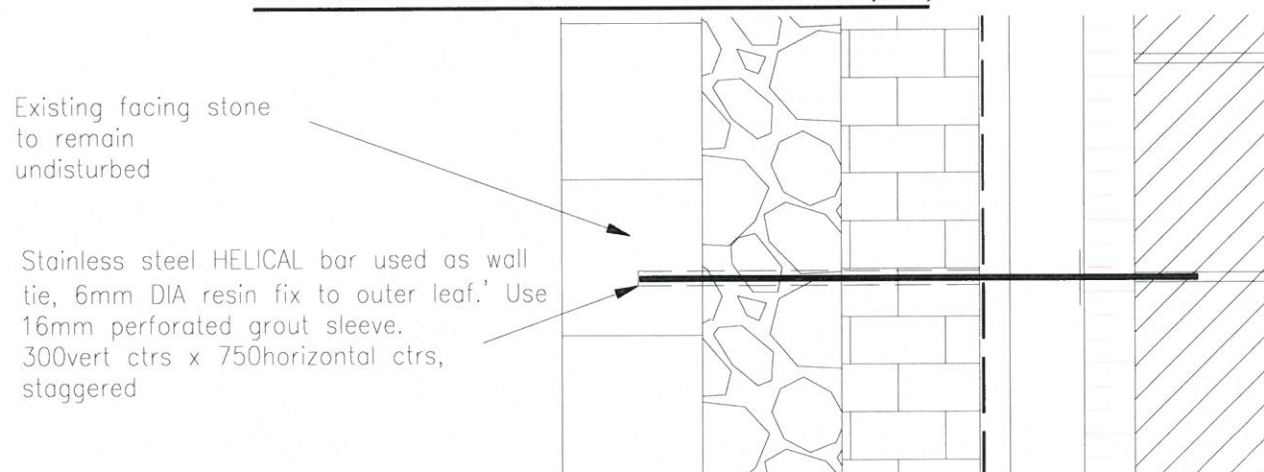
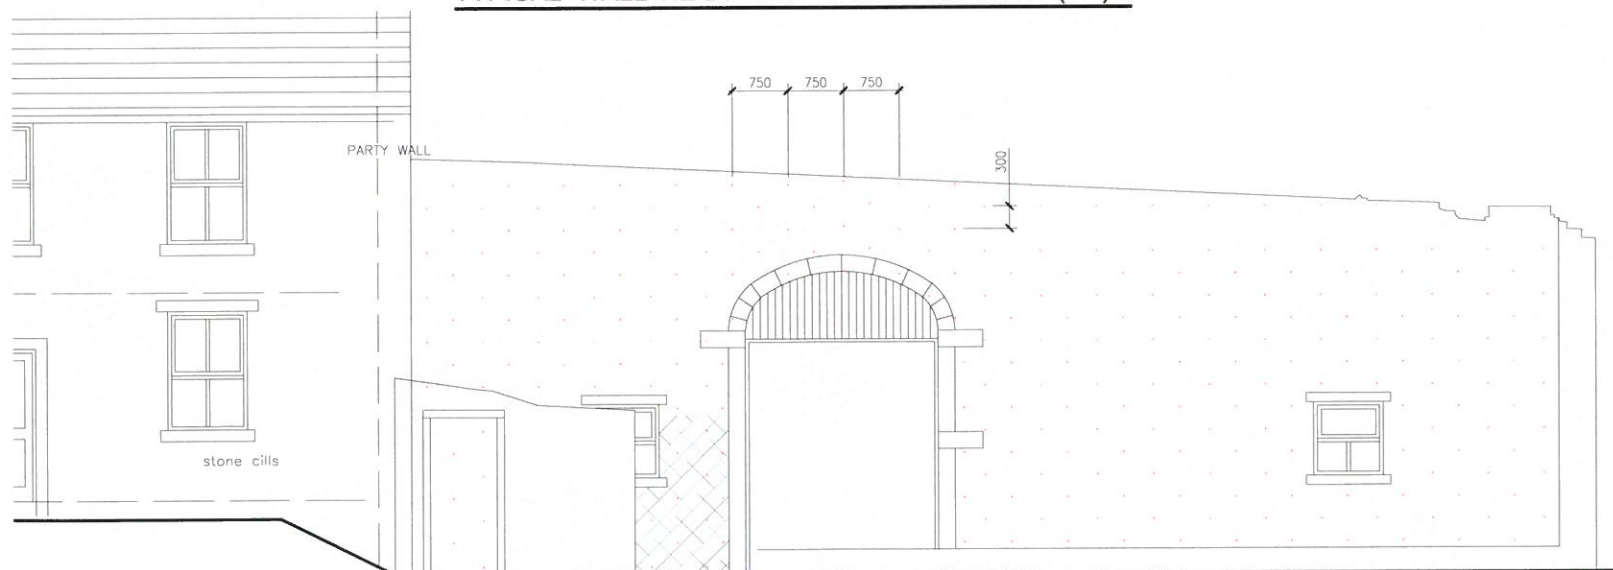
6. Where the existing random stone inner leaf and the rubble fill remains, this cannot be relied on to provide a suitable tie to the new proposed inner leaf. It is therefore intended that a stainless-steel bar is inserted through the wall, drilled from the inside, such that it is anchored into the outer stone face. This may be a resin fix or a mechanical fix. Drilling from the inside will ensure that this outer face remains visually undisturbed.

The bar may need to be purpose made to suit the wall thickness, the cavity width and the new inner leaf. The bar will have a clip on drip and will serve as a wall tie. These ties will be fixed at 300 centres vertically and 750mm horizontally in a staggered pattern. Elsewhere, the new wall construction comprising of an outer leaf of stone and a 140mm leaf blockwork (strength to be determined), will have traditional wall ties to suit the cavity width as dictated by BS5268. See HC 21314-(60)-03 & 04.
