This is an existing modern flush ply veneer faced door with applied mouldings.

Door GD10b.2 is to achieve FD30S fire rating.

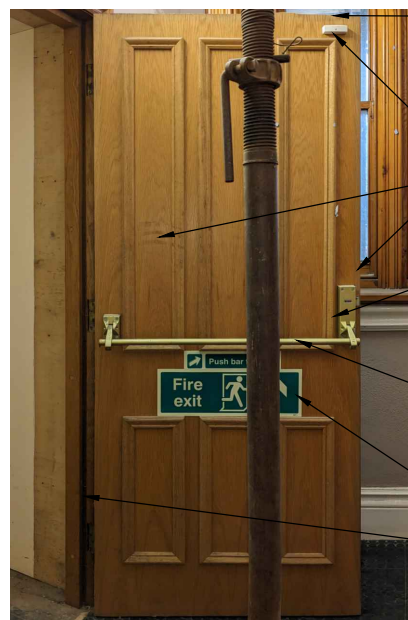
EXISTING VIEW OF DOOR FROM G10.a (STAIR) SIDE

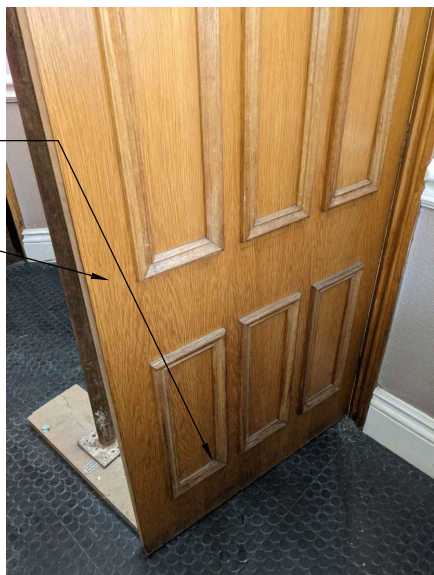
EXISTING VIEW OF DOOR FROM G10b (LOBBY) SIDE

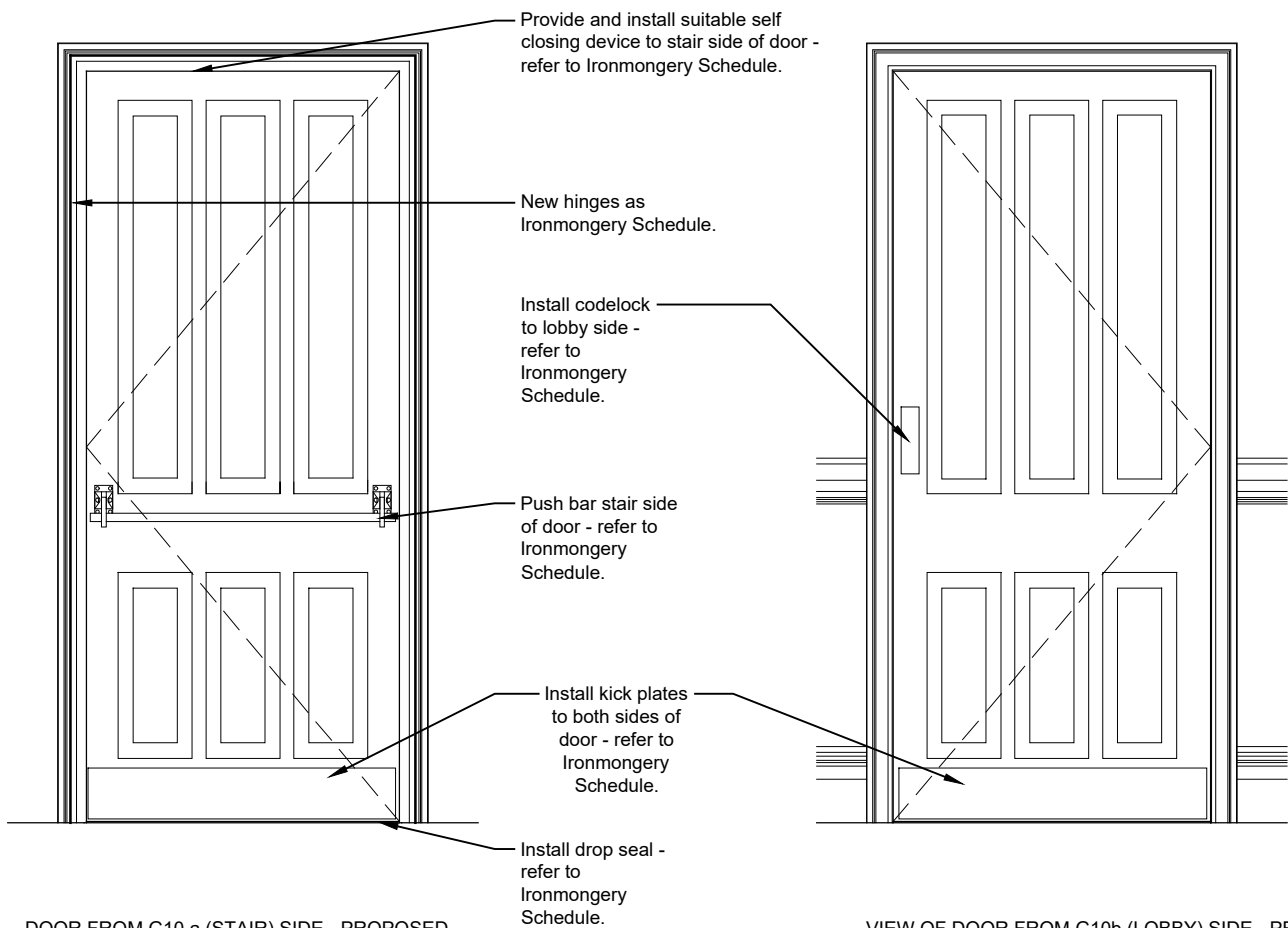
DOOR FROM G10.a (STAIR) SIDE - PROPOSED

VIEW OF DOOR FROM G10b (LOBBY) SIDE - PROPOSED

- 1. Indent repair to missing / damaged section of door**  
Remove minimum amount of existing timber to form an effective repair. Ensure an effective bond between the new and existing sections of timber. Work new material to line of existing and avoid unnecessary trimming of the original timber. Repairs to follow any existing deformations in the line of the doors. Piced-in repairs to be formed from wood, to match existing. The quality and grain must match the original. The moisture content must match the original. Screw / pin fix and glue to secure splice repairs. Screw / pin fixings to be countersunk and filled flush to match colour of timber indent. Where door is to be dismantled as part of the repair process, mark and record the constituent parts before dismantling. Store in a safe place and on dry bases. Protect from abrasion, damage and saturation.

- 2. Loose / delaminated veneer**  
Carefully pull back section of loose / delaminated veneer and work glue across rear with a hawksaw or piece of card. Clamp veneer in place making sure not to damage or indent outer face.

- 8. Infilling holes:**
  - 8.1** Where existing holes are small, fill with a high performance wood filler colour matched to the existing timber. Ensure filler is applied slightly proud of the existing surface and sanded back to a smooth seamless finish.

- 8.2** Where existing holes are medium / large, install timber pellet. Pellet to be secured in place with glue and formed from wood to match existing. Grain of pellet to be aligned with grain of existing timber. Pellet to be installed slightly proud of the existing surface and sanded back to a smooth seamless finish.

- 11. Existing Intumescent strips:**  
Carefully remove any existing intumescent / weather strips from the door leaf and frame along with all traces of adhesive. Where existing intumescent / weather strips have been rebated into the door frame, carry out an indent repair as per item 1.
