# Tree Report – 3 Bentgate Close - Milnrow - Rochdale - OL16 4NB

**Report brief** – To provide a report in support of a works to tree application at 3 Bentgate Close, Milnrow, Rochdale OL16 4NB. The report should make particular reference to not only the condition of the trees and the desired/required work, but the relationship of the trees and their proximity with associated buildings and structures.

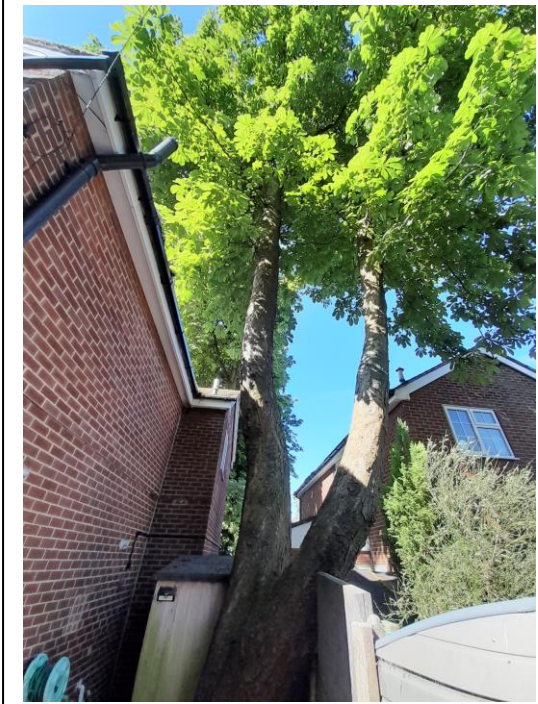
The main dwelling is situated within 1m of T3 which is a large and significant horse chestnut tree – it is beyond all doubt that significant damage must have been caused to the rooting zone of T3 during construction of the property in the 1970's and also inconceivable that such a building was consented believing that the long-term retention of T3 was feasible.

**Image 1** – Tree 3 – Horse Chestnut within 1m of property.

The retention of Trees 2 and 3 has now become unsustainable and I have recommended that they are removed and replaced. This has been outlined in the completed works to trees application.

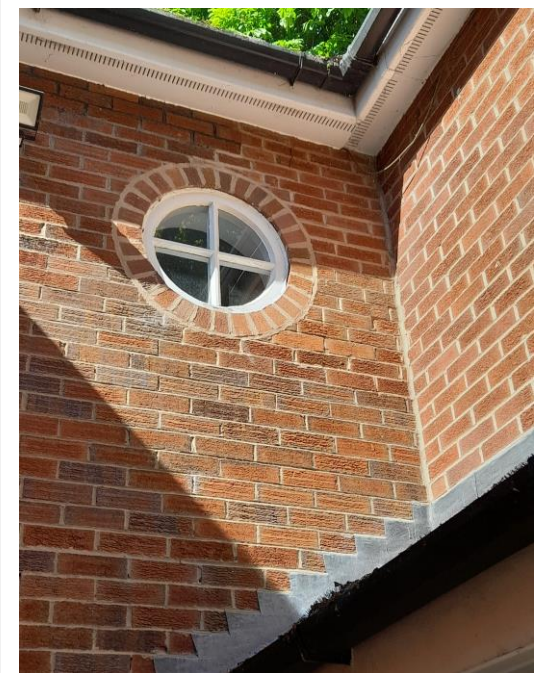
There is evidence of recent crack repairs to an invert corner nearest T3 and a step crack above and around the circular window.

**Image 2** – Recently pointed cracking along extension join and typical step crack above circle window.

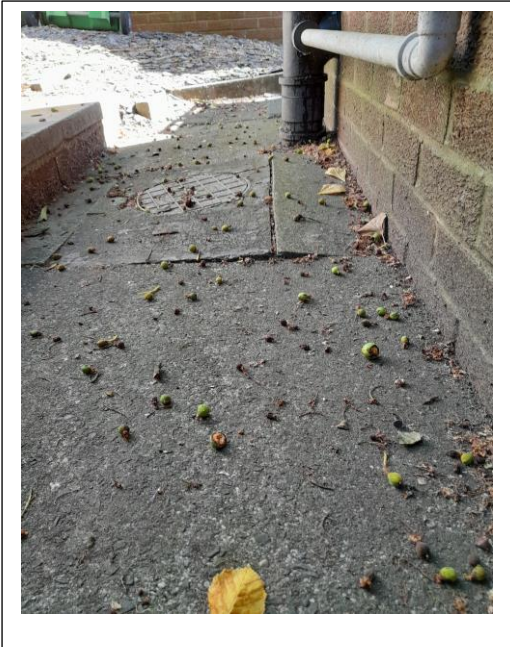
There is evidence of direct damage to hard standing near to the tree and also near to the drains and main structure. (T3)

**Image 3** – Damage to hardstanding by tree roots from T3

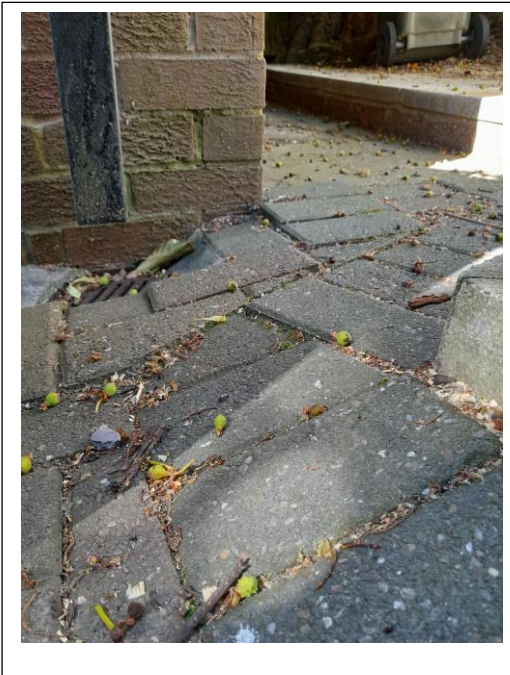
**Image 4** – Further damage to hardstanding by tree roots from T3

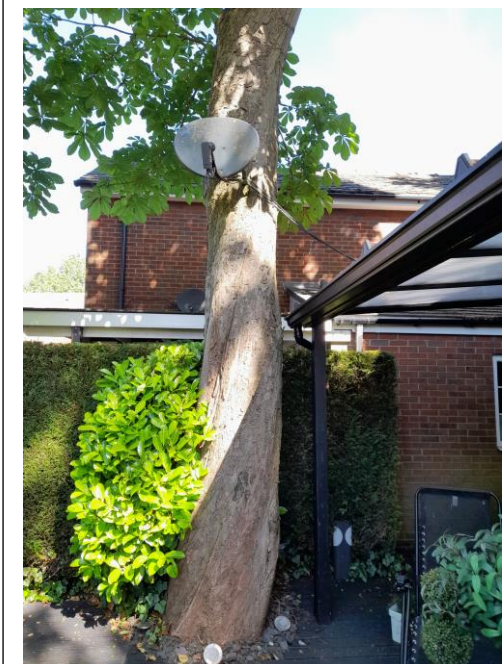
The lean to/portico is within 150mm of Tree 2 and the tree is 2.5m from the main dwelling (another significant horse chestnut tree)

When the tree moves in the wind it has been known to make contact with the portico.

**Image 5** – Tree 2 within 150mm of portico – note my client did not attach the satellite dish to this tree.

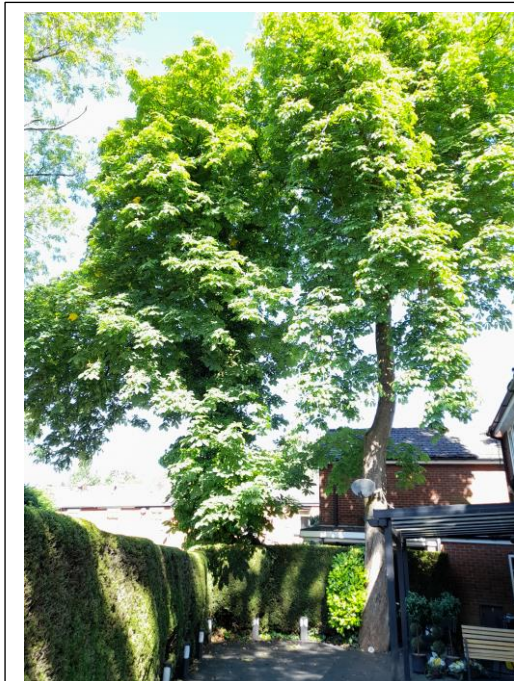
Tree 1 has low branches over the carriageway and an asymmetrical unbalanced crown.

**Image 6** – Tree 2 on left of image. T1 with unbalanced section of foliage over highway to left of image.

It is possible at this time to manage the issues caused by Trees 1, 4, 5 with pruning and as such a specification is submitted in a works to trees application.

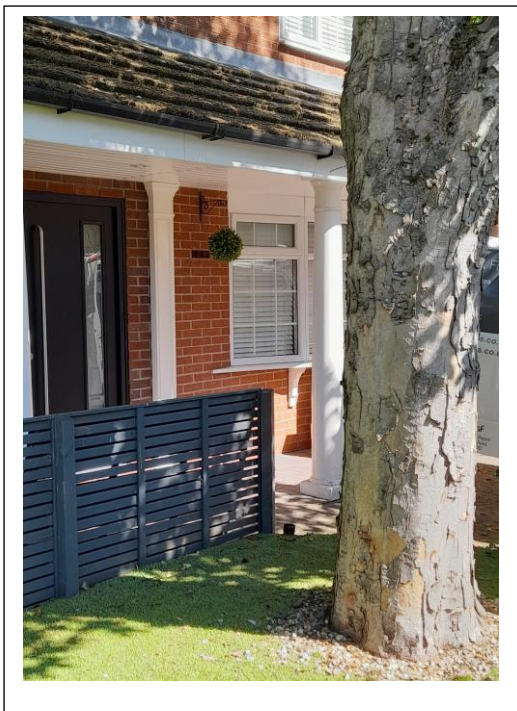
Another portico to the front of the property falls within 1m of Tree 5 and 2.5 m from the main dwelling.

**Image 7** – Tree 5 within 1m of portico and 2.5m of main dwelling.

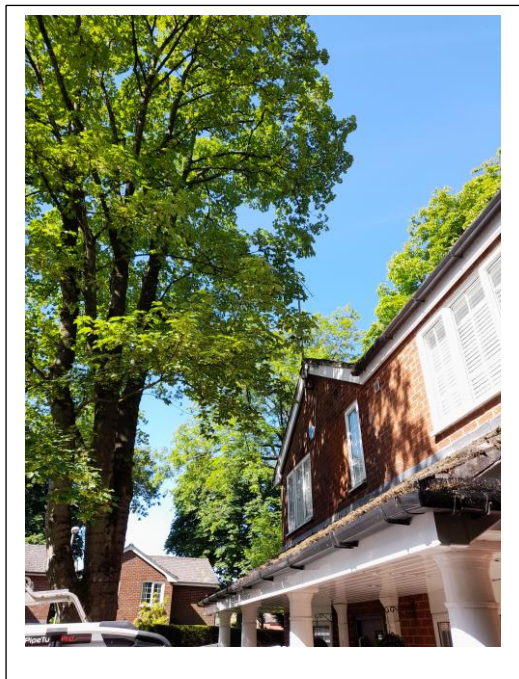
**Image 8** – Tree 5 showing growth onto roof of property.

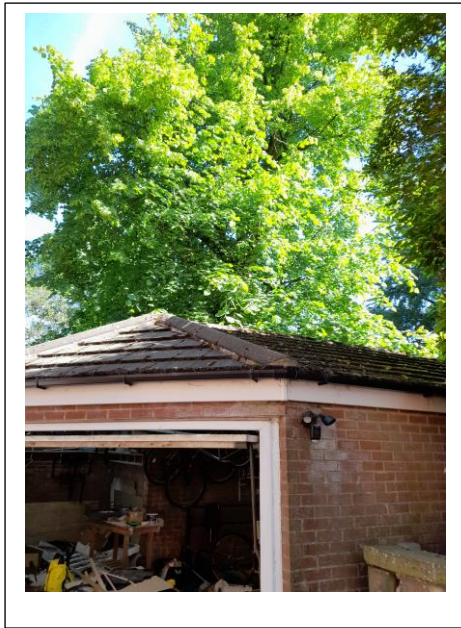
Tree 4 falls within 1m of the detached garage which it is also understood to have valid planning consent.

**Image 9** – Tree 4 Situated only 1m away from garage and showing the growth onto the roof.
