| PROJECT | SMP - St Mary's CE Primary School |
| TITLE | Elevation DD - Demolition & Repairs |
| NUMBER | SMP-SEV-XX-XX-DR-A-03013 |

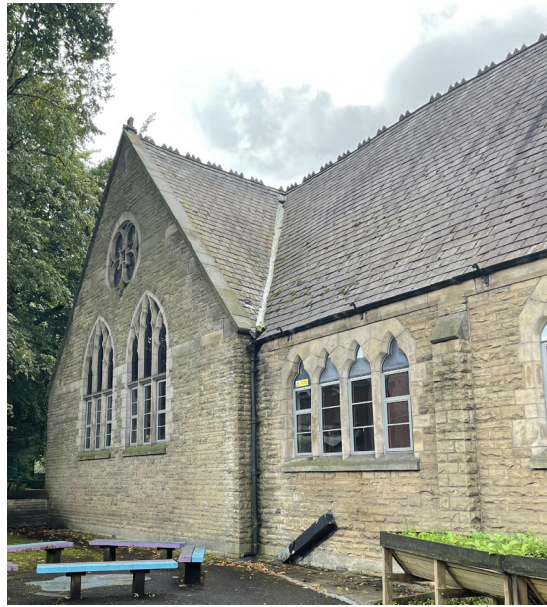
Multiple damaged Ridge Tiles

- Ridge Tiles: 50 Lm  
Ridge tiles to be removed and set aside with salvaged tiles for re-use.  
Replace damaged tiles like-for-like.

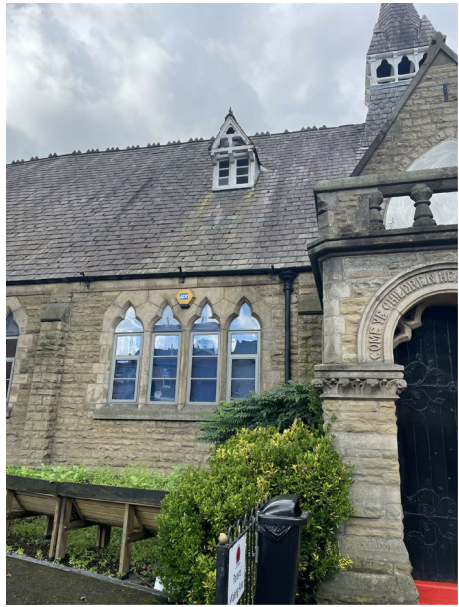
Ridge Tiles damaged near Cupola

Wooden structural arches between 2no. tiled sections

Significant Ridge tile damage in this area

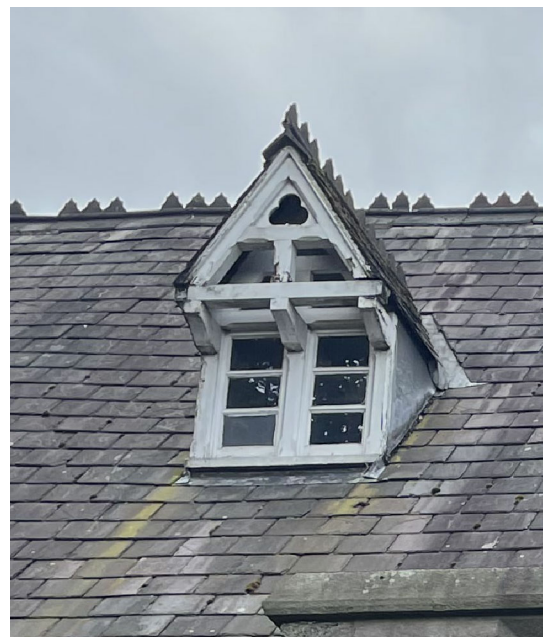
C3 Dormer wooden structure damaged; requires further inspection

- Dormer Window: 09 no.  
Splice in new timbers where appropriate. Access to be provided for detailed inspection and methodology agreed. Carefully sand down and repaint in appropriate materials as per the specification. Roofing section per detail F-F in drawing SMP-SEV-XX-XX-DR-A-03105 (Typical Dormer Window)

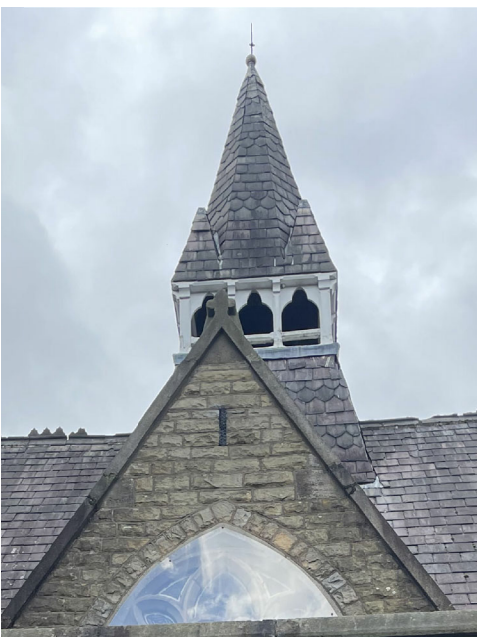
Cupola wooden structure undamaged; requires further inspection

- Cupola: 01 no.  
Splice in new timbers where appropriate. Access to be provided for detailed inspection and methodology agreed. Carefully sand down and repaint in appropriate materials as per the specification. Cupola roofing is as per the building's other slate roof eaves, but is at a steeper gradient.

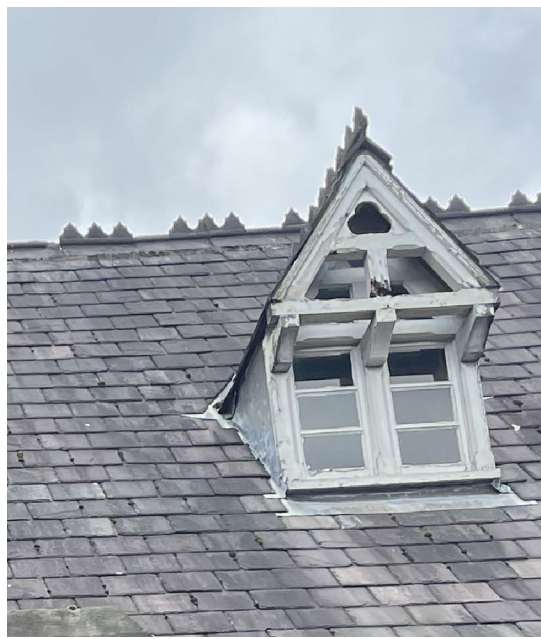
C4 Dormer wooden structure damaged; will require replacement sections
