RTH - DIA - ZZ- ZZ - DR- A - 3592

Rochdale Town Hall  
for Rochdale Development Agency

Clocktower Repairs  
Internal Elevation BB

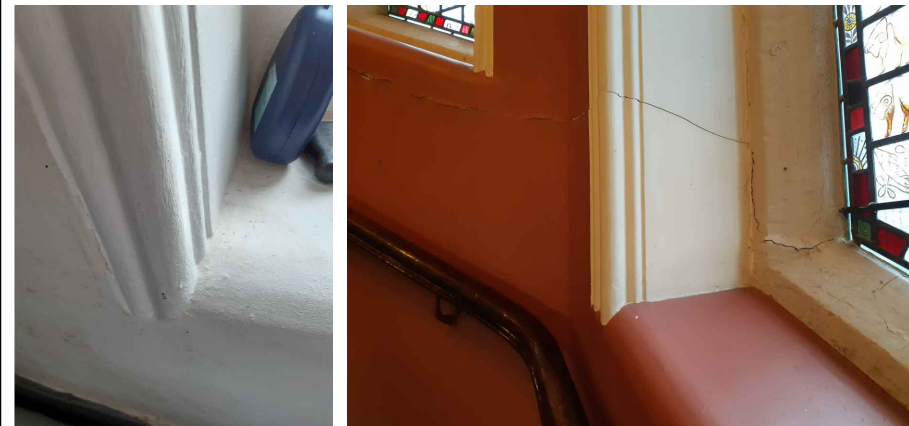
Where new filleted plaster cill is to be formed, replicate detailing of F3b/Stair 5 windows, as indicated in the images above.  
(NBS M20/685A - 4.5)

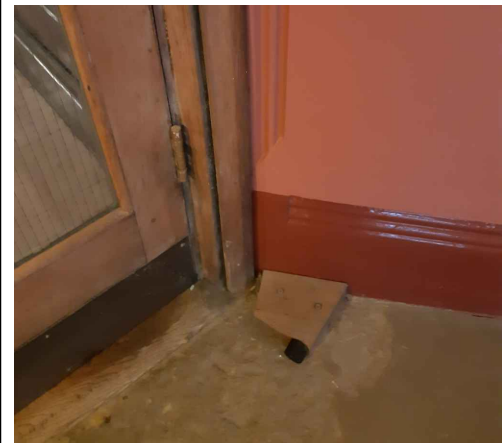
Where previously removed plastered skirting to be formed, replicate detailing of Stair 5 as indicated in the image above. Skirtings to finish at junction between plaster and stone floor. Typical detail found in Stair 5.  
**(M20/685A - 4.5)**

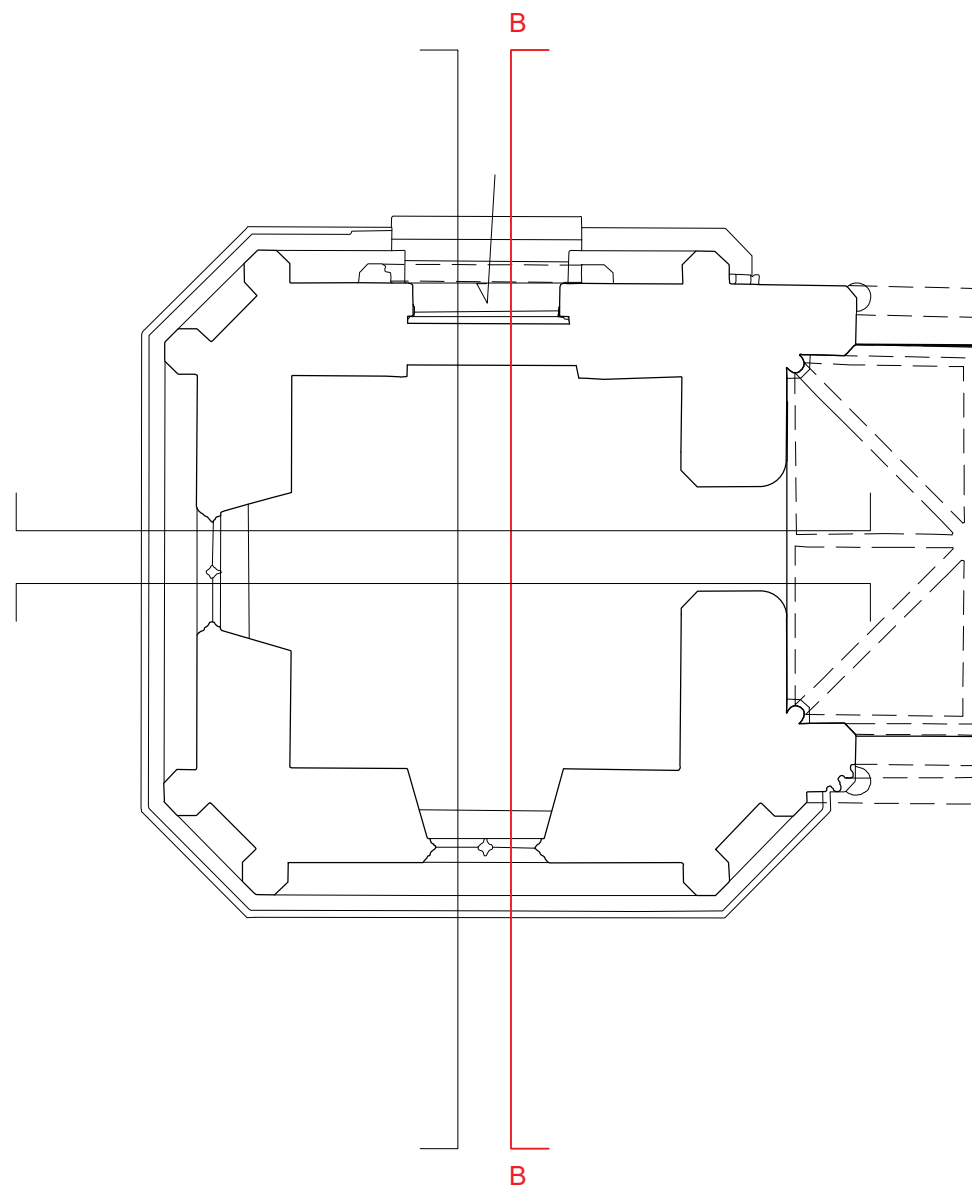
Remediation works to underlying masonry of recently removed RWP to be confirmed under a separate instruction.  
Reinstatement of lost area of plaster to masonry walls following completion of remediation works.  
**(M20/595)**

Area of damp plaster to be —  
removed prior to replastering.  
(M20/569)

Make good local plaster —  
damage caused by fixings  
where timber trim removed  
(M20/595)

Repair damaged sections of existing plaster cornice and reinstate missing sections to full perimeter of tower, except where this will clash with the proposed stair/landing.  
(M20/685A)

Area of damp plaster to be carefully removed prior to replastering.  
(M20/569)

Make good plaster and profile to underside of arch where removal of infill has left scarring.  
(M20/595)

Reinstate previously removed plastered skirting to full perimeter of tower, expect where this will clash with the proposed stair/landing.  
**(M20/685A)**

Historic plaster detailing of door surround to F3d side to be replicated to F4 side.

Reinstate previously removed coving to full perimeter of tower, except where this will clash with the proposed stair/landing.  
(M20/685A - 4.5)

Relieving arch to be replicated on room side to match existing profile surviving facing the window.  
(M20/685A)
