21314

BRANCH ROAD FARM, BRANCH ROAD  
LITTLEBOROUGH – OL15 0AB

Revised: 24<sup>th</sup> June 2022

# REPORT ON STRUCTURE

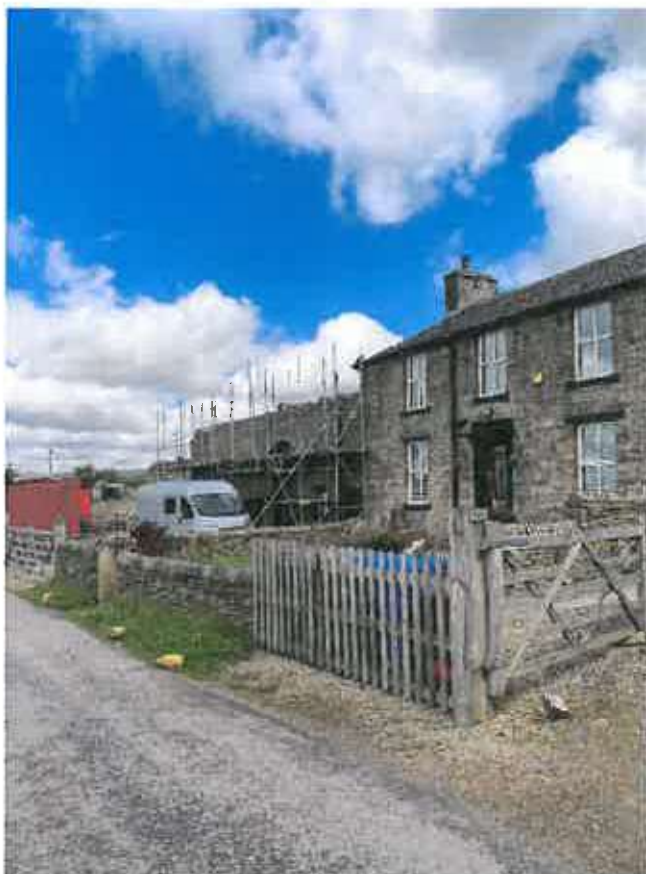
*Photograph 1*

- 1.01** We were requested by Mr Wildman to carry out a survey and to provide a report on the structure of the property known as The Barn, Branch Road Farm, Littleborough. See photograph 1.

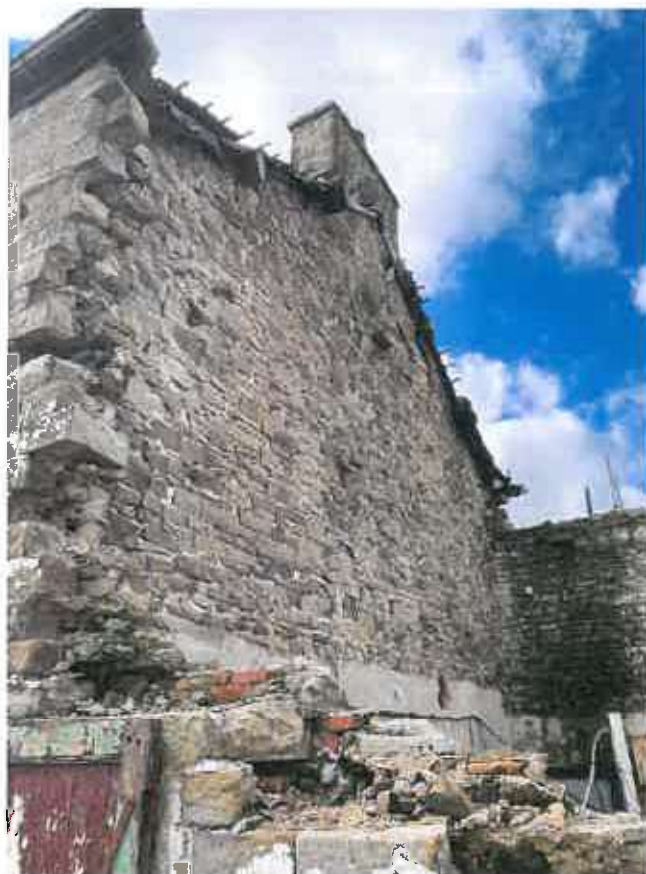
*Photograph 2*

The party wall, with the farmhouse, is to remain as a party wall in the new development. See photograph 2.

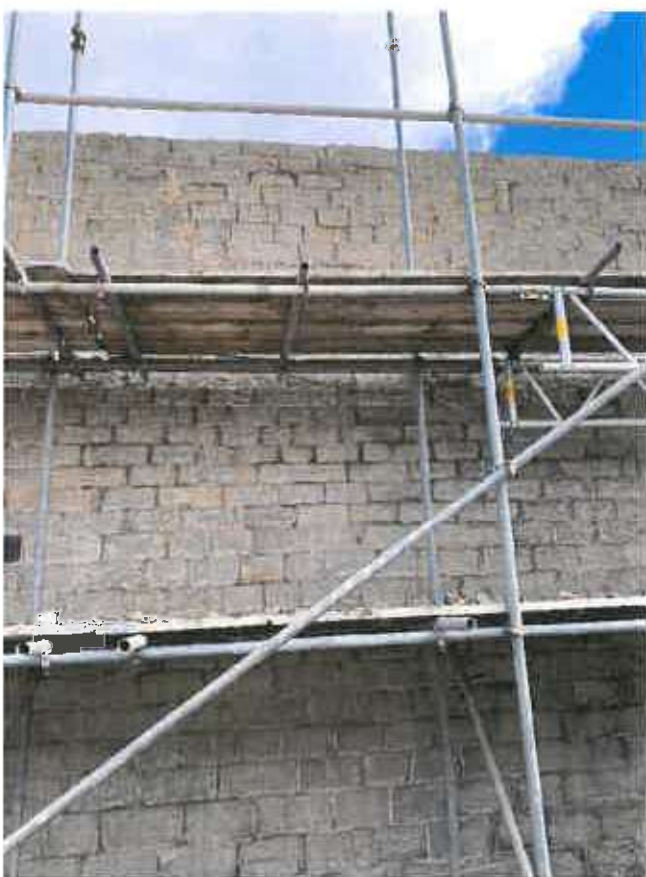
*Photograph 3*

**2.04** The remaining barn walls are faced with a coursed local stone with narrow beds joints. See photograph 3. The inner leaf is of random stone and there is a poor, loose rubble fill. See photograph 4.

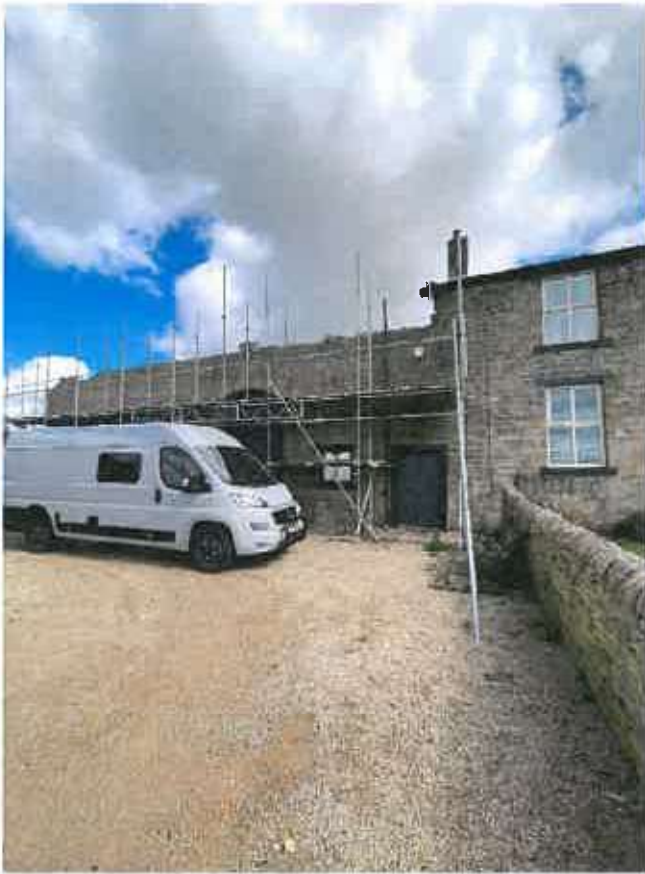
Photograph 5

**2.05** On the front elevation there is an existing large cart arch, two nominal window openings and a personnel door. See photograph 5.

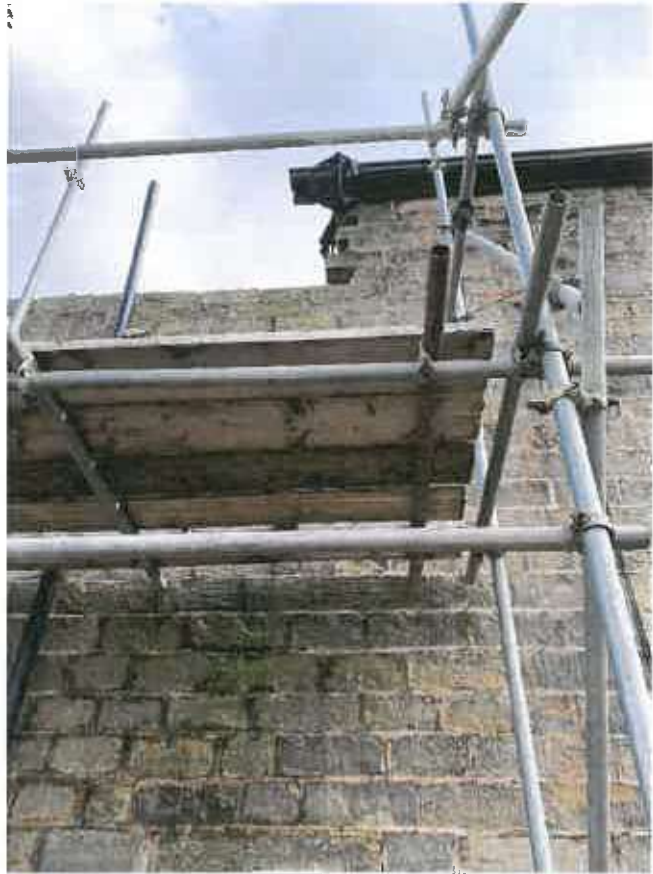
Photograph 6

**2.06** The existing front elevation is complete up to within a few stone courses below eaves level. See photograph 6.

The wall will be extended to eaves level, faced with the original coursed stone. The remaining partial elevations on the left and rear will be stabilised in a similar manner.

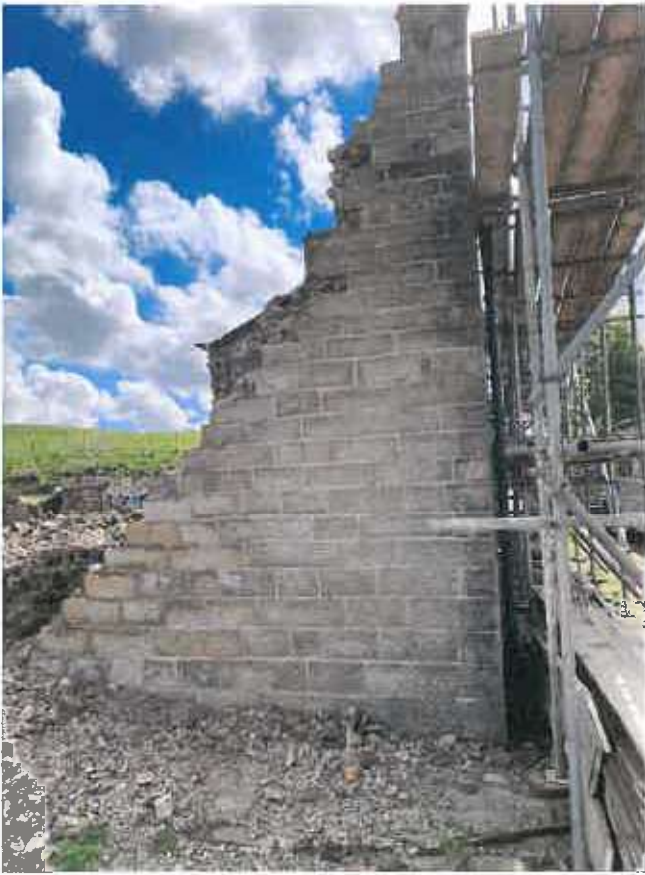
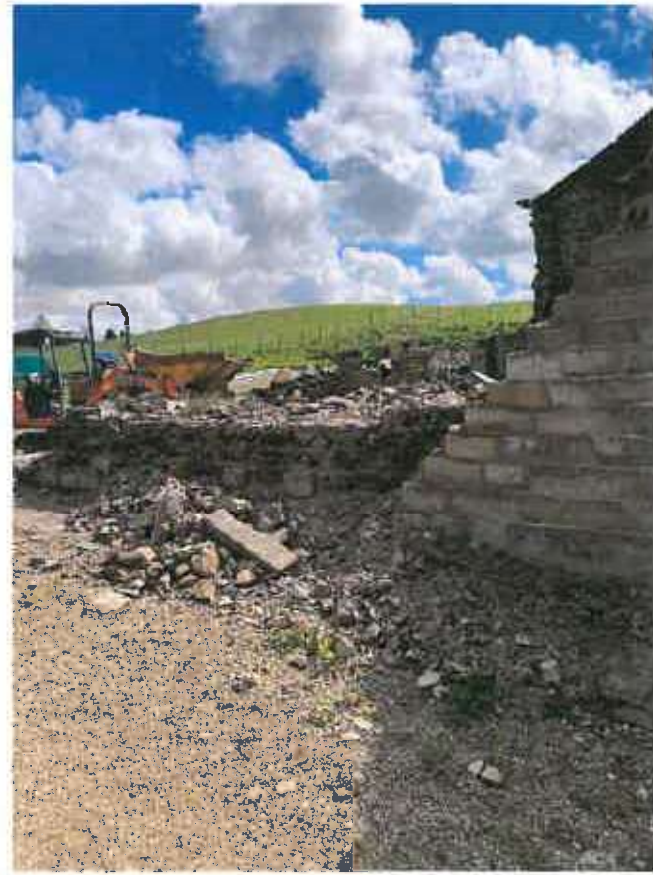
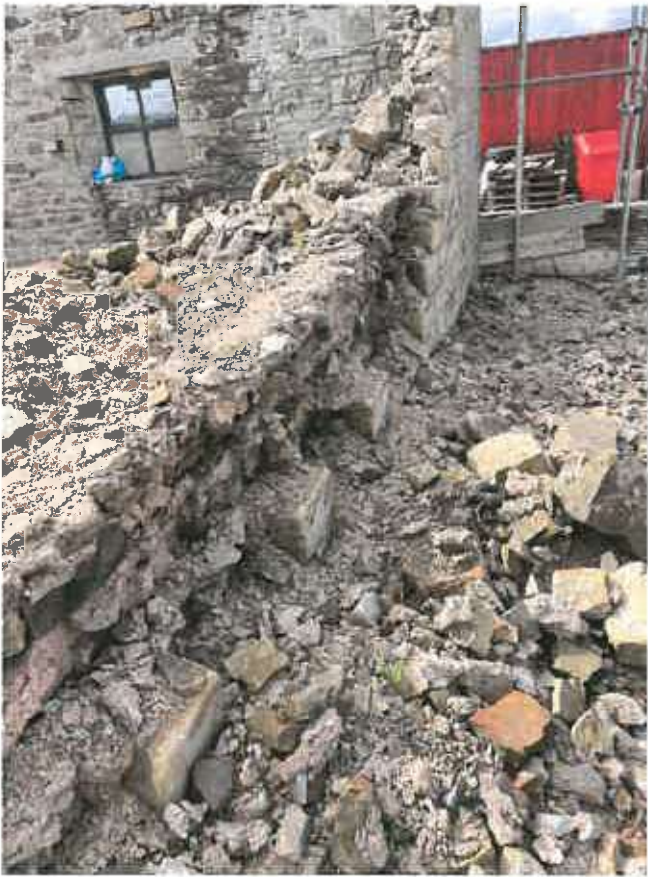
**2.07** The left-hand side and rear elevations became unstable during demolitions and now only remain in part. See photographs 7, 8 & 9 - side elevation and photographs 10, 11 & 12 – rear elevation.

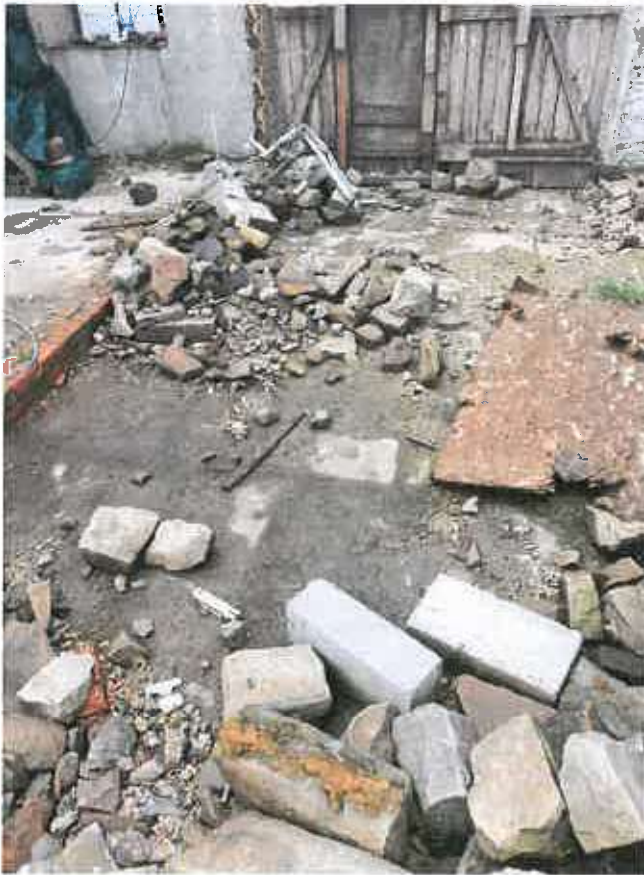
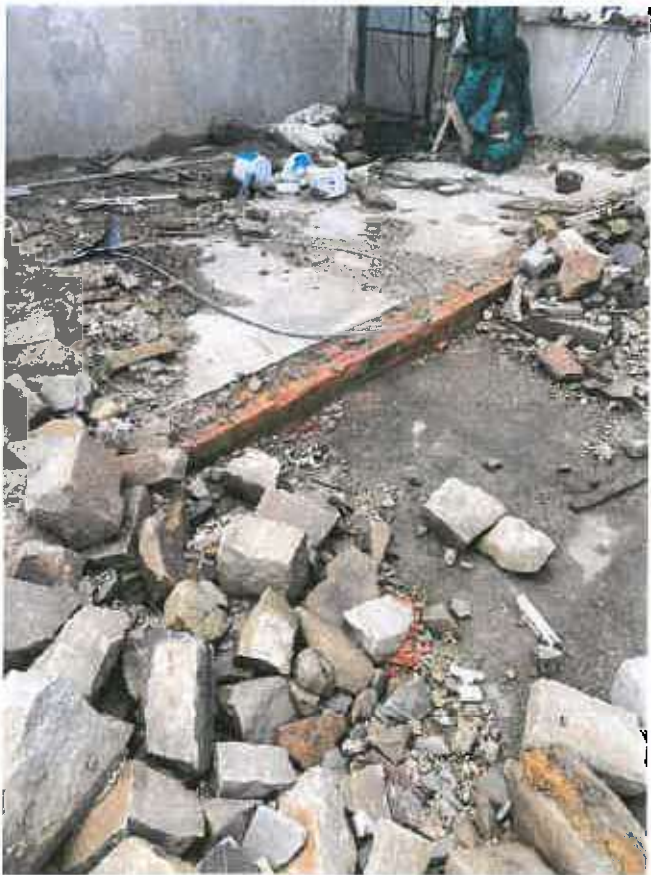
**2.10** The existing floor slab currently remains. This is a mixture of different surfaces set at varying levels. See photographs 13 & 14.

Prior to any further reconstruction, the existing floor slab will be removed and replaced with a new reinforced concrete raft. A typical detail is shown in Appendix D.

- 4.04** Once this debris is removed from the footprint, the floor slab will be carefully broken out and removed from site. A new insulated concrete raft with relevant thickenings will form the base / foundation for the inner leaf and any internal load bearing walls.

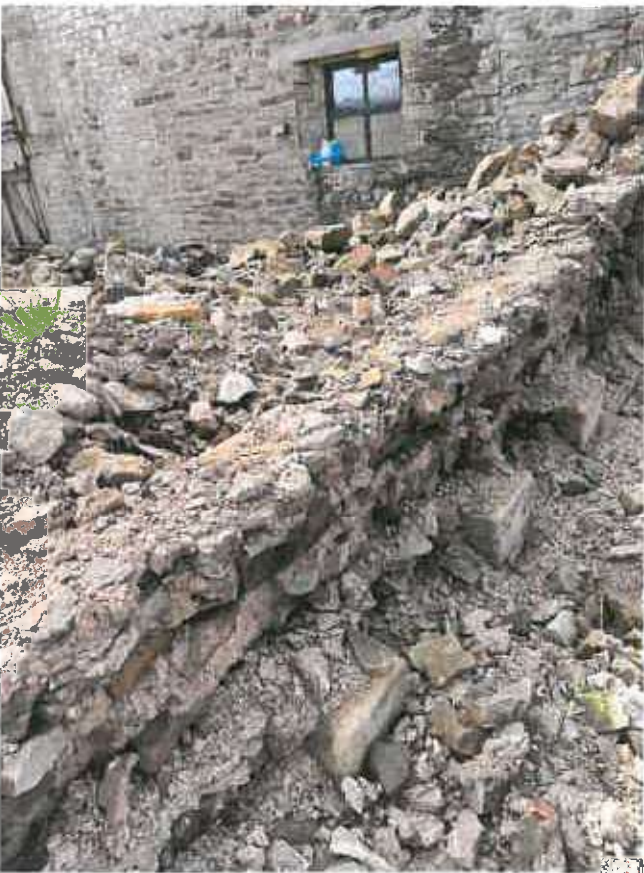
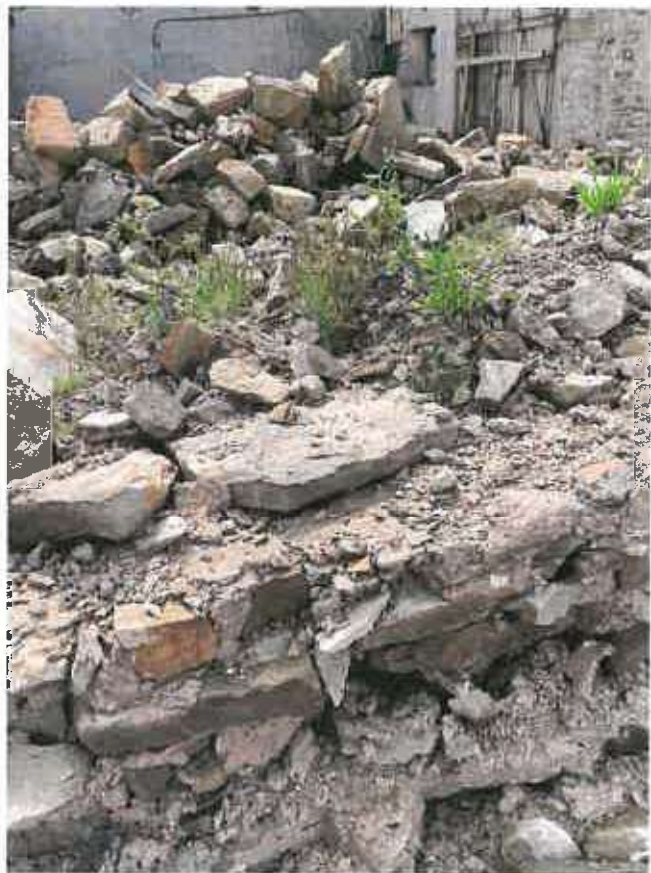
- 4.01** We believe the collapse of the left-hand side and the rear elevation was inevitable given the condition of the walls and the poor quality of the inner leaf matrix and the loose rubble fill. See photographs 15 & 16. The loss of lateral restraint due to the removal of the roof was also a contributing factor.

- 4.02** To this end, we have recommended action that will stabilise the remaining elements prior to any further work being undertaken.

The elevations to be rebuilt will be backed up with a blockwork inner leaf. This will need to step around areas of the external wall that remain standing.
