**Arboricultural Impact Assessment  
54 Norden Road  
Rochdale**

Report Reference: AIA-2157-1  
23 January 2025

Drawing Title:  
**Tree Impact Plan**

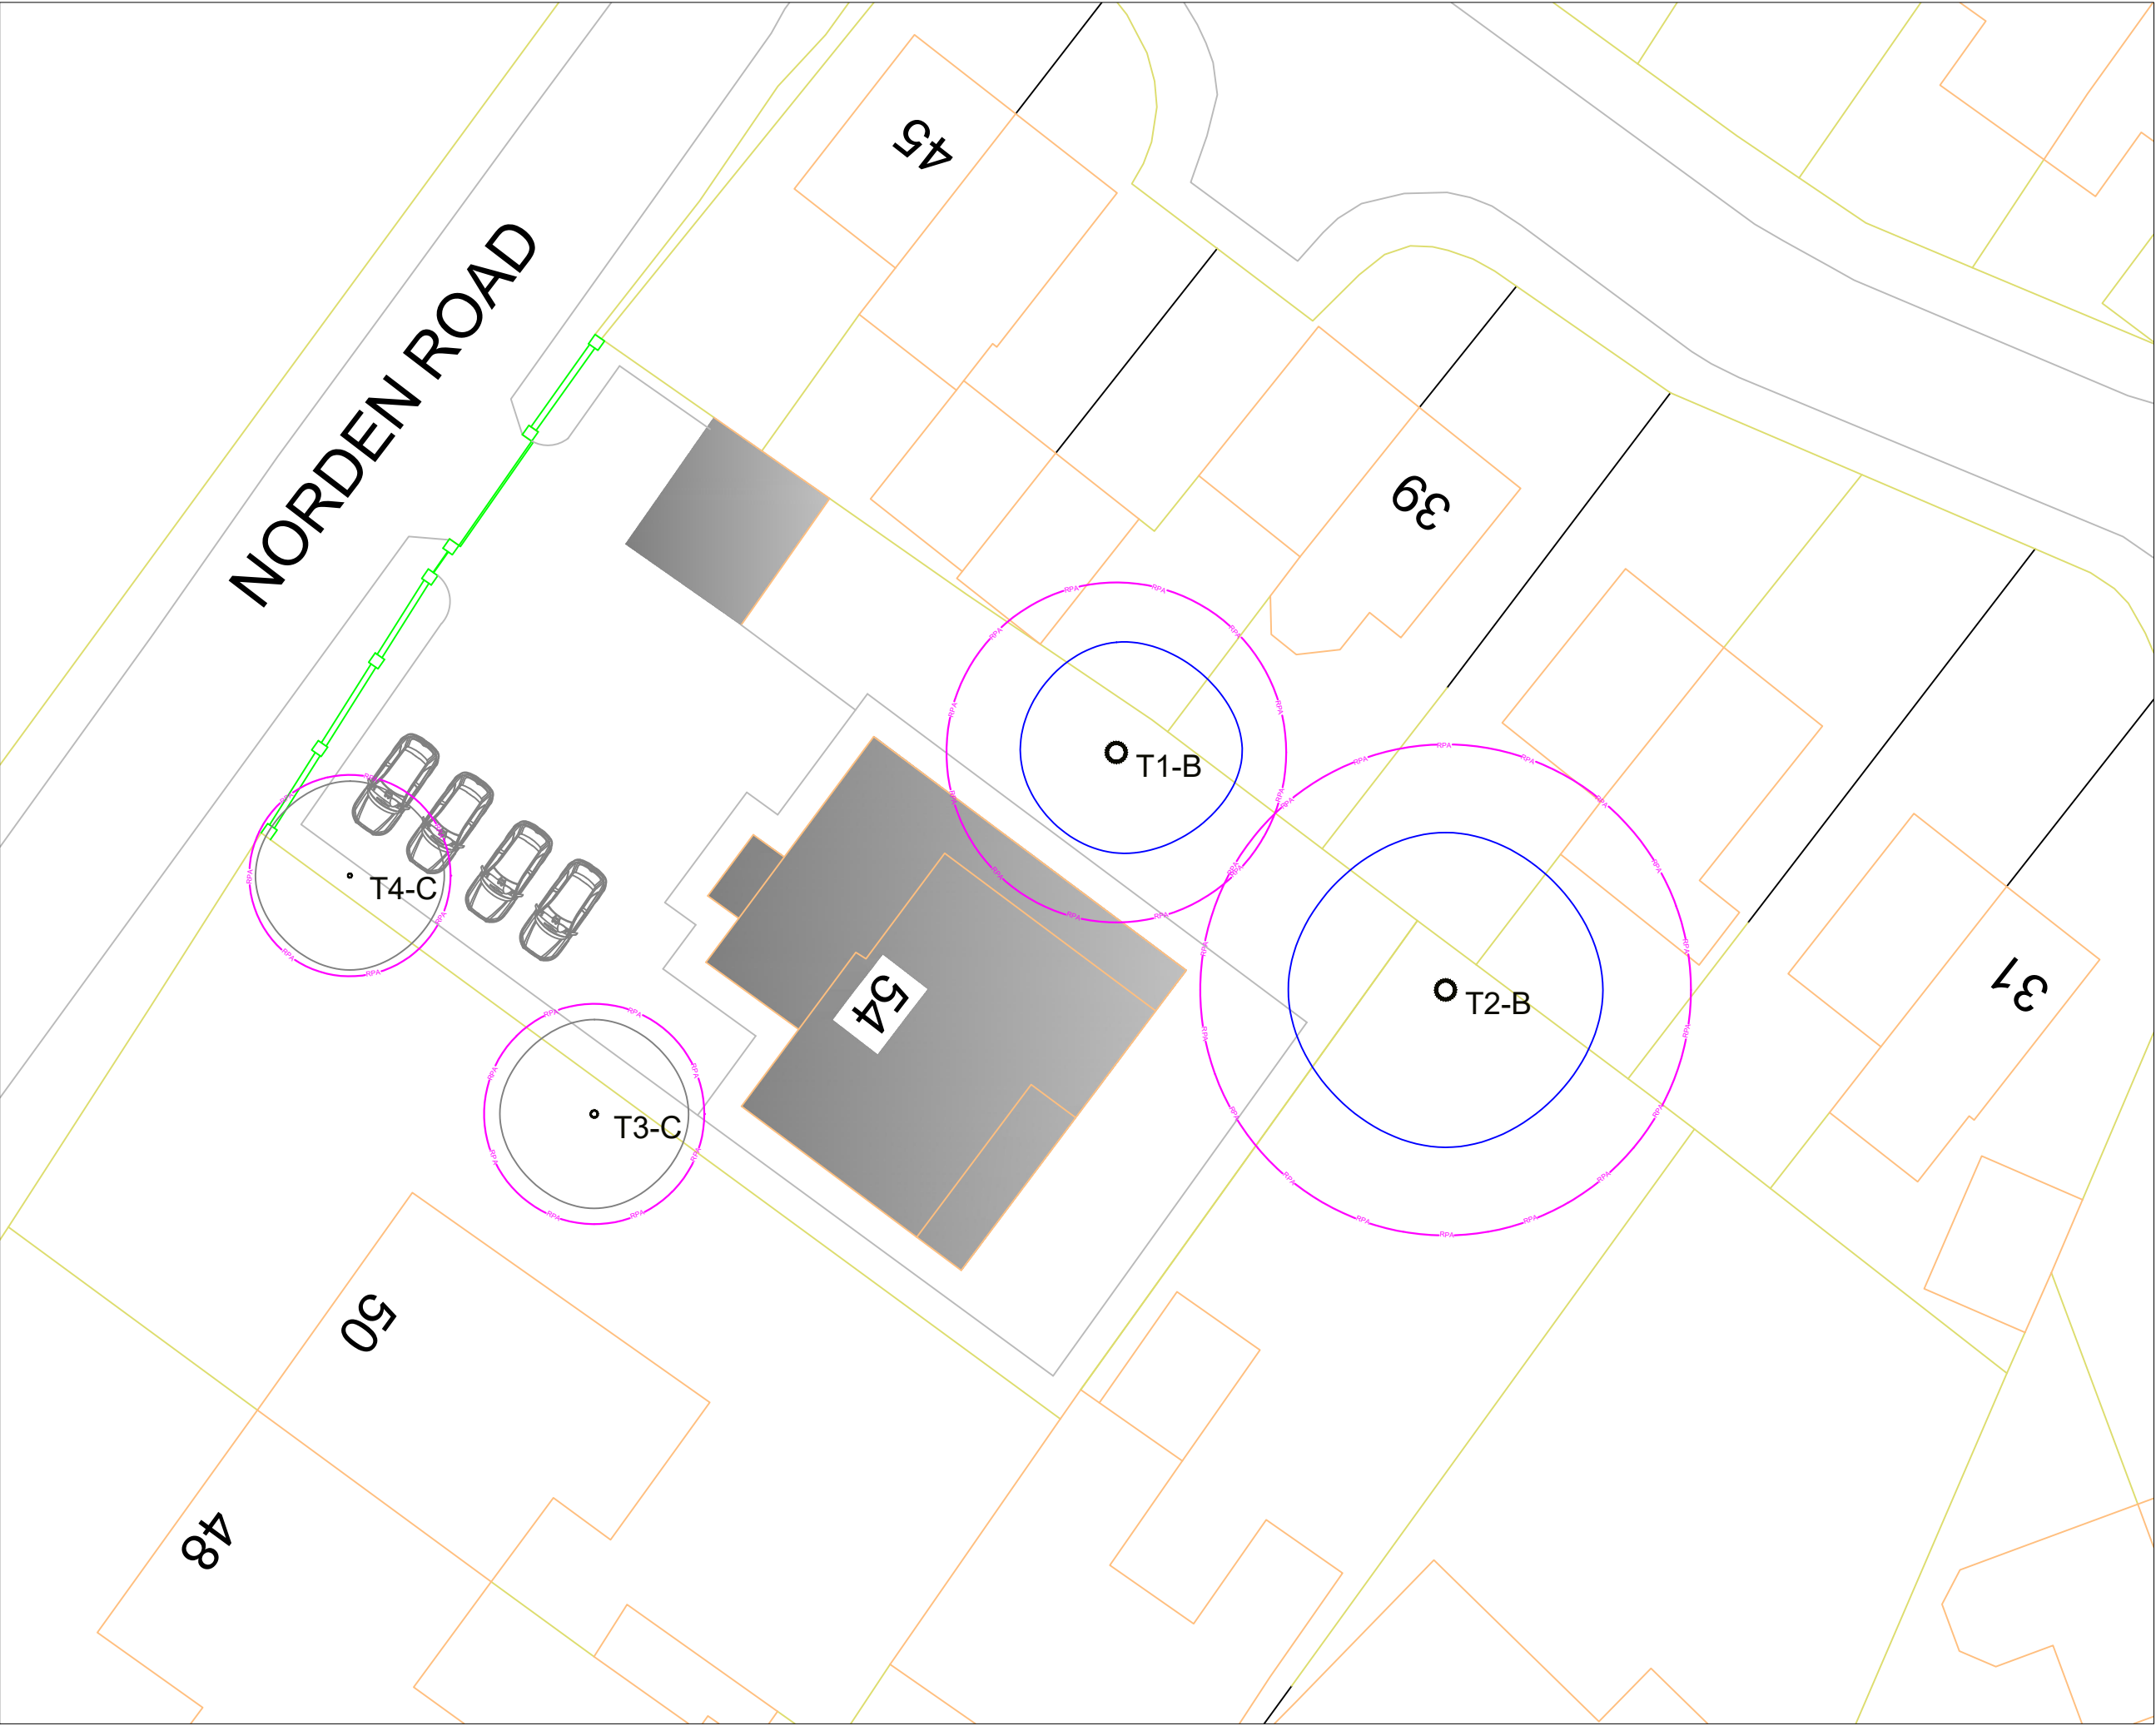
- 3.4.3 It will be noted that the footprint of the proposed dwelling involves a minor incursion within the RPA of Lime T1. The extent of encroachment will be approximately 1%, a proportion of which until recent construction activity was overlaid by hard surfacing where rooting volume is likely to have been impacted. Furthermore taking account of the strong growing condition of the specimen and the markedly improved growing conditions this tree will have derived from the removal of a neighbouring Ash the tree is likely to overcome the aforementioned construction activities. As such construction of the dwelling foundations is unlikely to have caused any demonstrable harm to the health and longer term viability of this tree.

- 3.5.1 The off-site Maple T3 was beginning to encroach upon the former dwelling and requires drawing back to facilitate scaffolding access on the new build. Drawing back of the crown by approximately 1.5m will provide adequate clearance.
- 3.5.2 With the exception of the off-site Maple T3 which will require periodic pruning to abate a nuisance retained trees can be expected to grow to their overall dimensions subject to remaining free of disease and the completion of routine maintenance. Such pruning works would be carried out in accordance with BS3998:2010 recommendations for tree work.
