### View from Stair M10

### Repair Notes & Specification

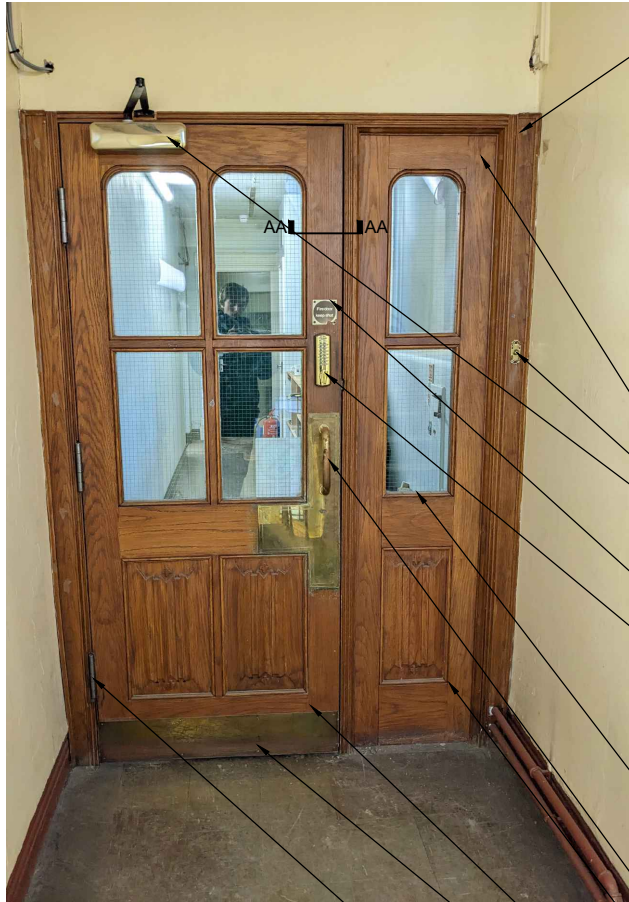
Note: Door to be upgraded and to achieve 30 minutes fire separation

Remove architrave and verify fire stopping and update to BS8214:2016 - Clean the joint between the architrave and the supporting wall by raking out the old mortar, if this reveals significant depth, the area if over 5mm wide should be packed with mineral wool to the depth of the hole and left 5mm shy of the architrave edge. This 5mm deep by 5mm wide rebate should be filled with intumescent mastic. If the raked out joint is under 5mm wide the joint should be capped off with a bead of intumescent at least 4 times the width of the joint in depth.

- Secure sidelight to the door frame and wall.

Remove door bell and make good.

Remove door closer, and make good door frame and leaf ready to receive new concealed closer.

Remove all signage and prepare the door to receive new.

Remove redundant combination lock, Install new mechanical code lock for door operation in existing location.

Door release to be interfaced with fire detection system and make door and frame good.

Unscrew beading and replace existing Georgian wired glass with new Promat Pyrosec 7 and trims as detail.

- Overhaul existing ironmongery as per item 6.1.

Clean timber door and frame to remove all dirt and grime and retreat with Osmo Oil.

- Fit new intumescent seals.

Fit new Slim-line mortised  
automatic drop seal by Lorient ref  
LAS8001 SI. Tolerance from base  
of door leaf to cill 3 -13mm.

3no. existing hinges to be  
replace with new modern fire  
rated hinges to EN1935.
