## GAS MEMBRANE VALIDATION

**Site: Boothroyden Road, Middleton**

Date: 27-09-2021

Project Number: 13-500

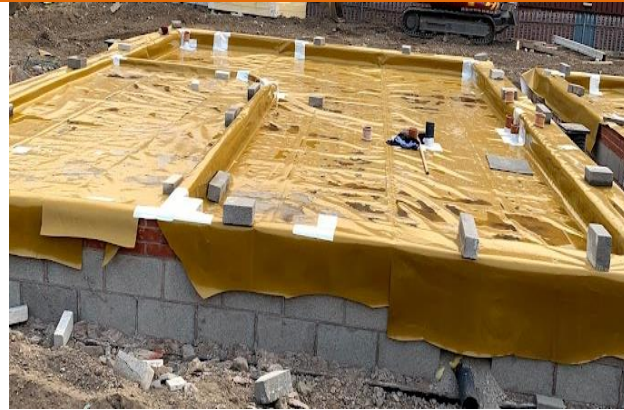
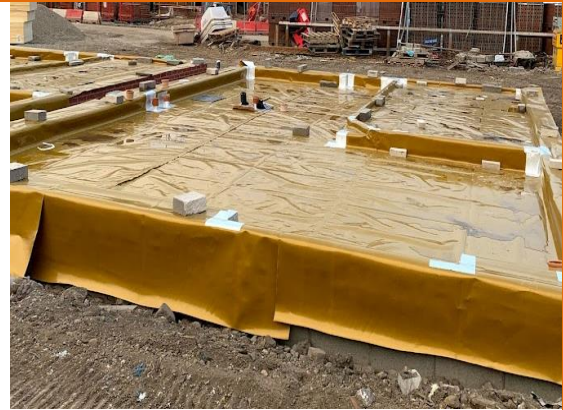
**Plot – 22**

**General Condition of Membrane-Good Condition**

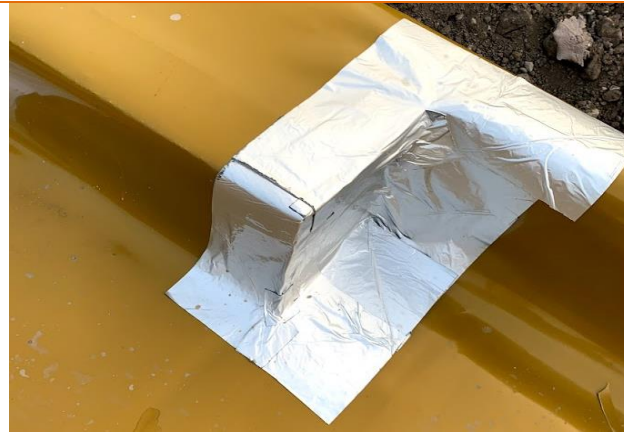
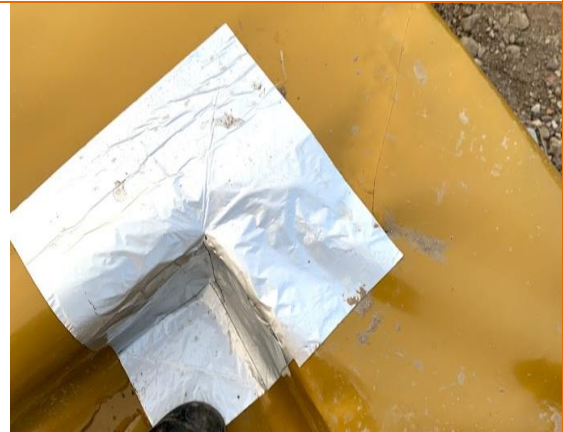
**Verification of Joints and Seals-Good Condition**

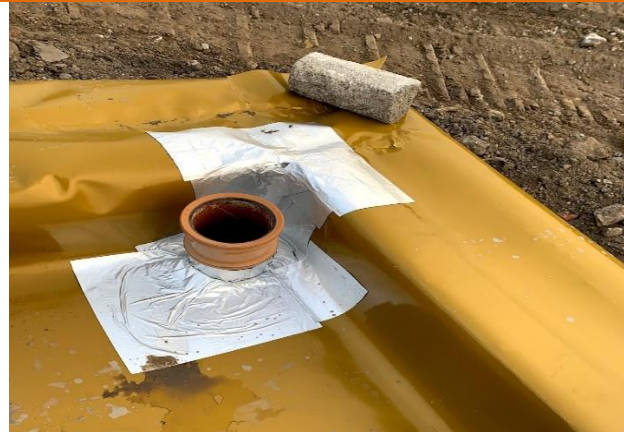
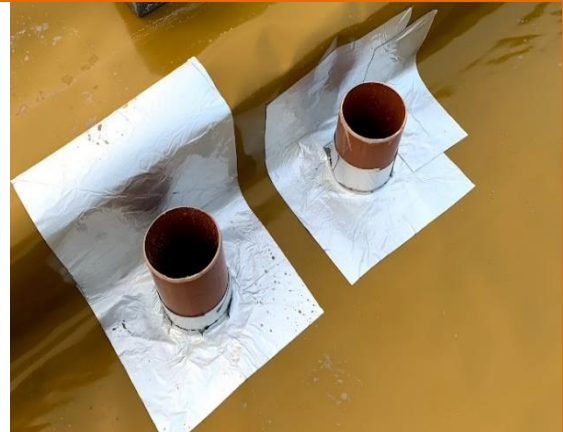
**Verification of Service Penetrations-Good Condition**

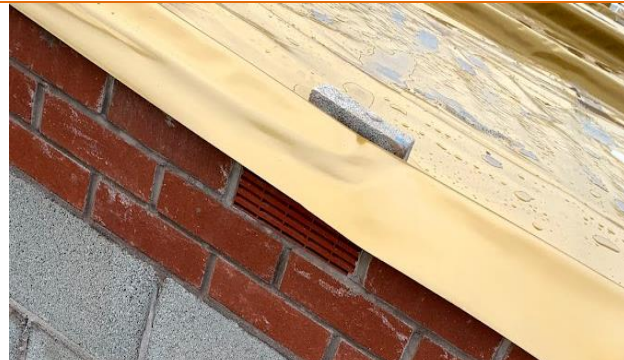
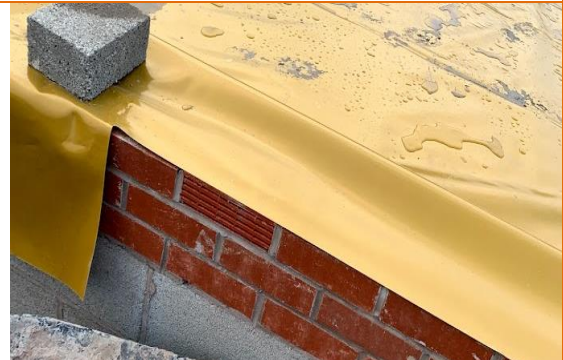
**Verification of Ventilation-Good Condition**

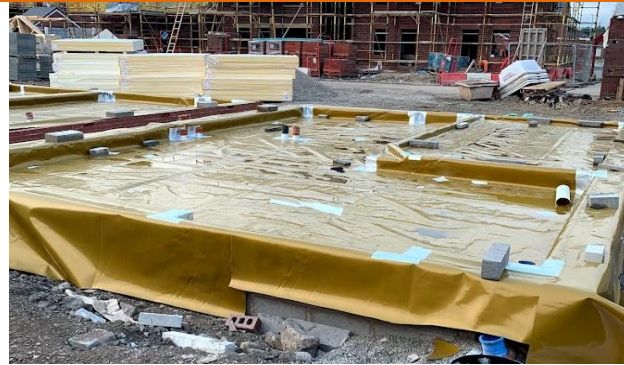
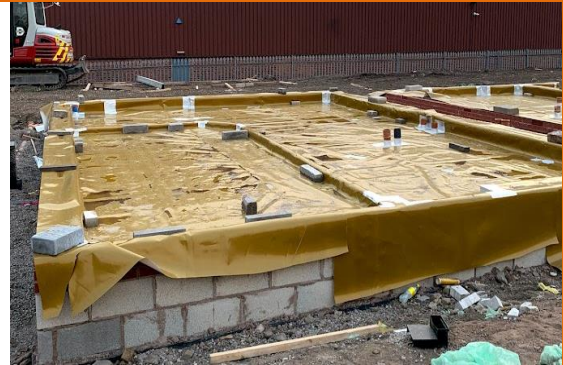
**Plot - 23**

**General Condition of Membrane-Good Condition**

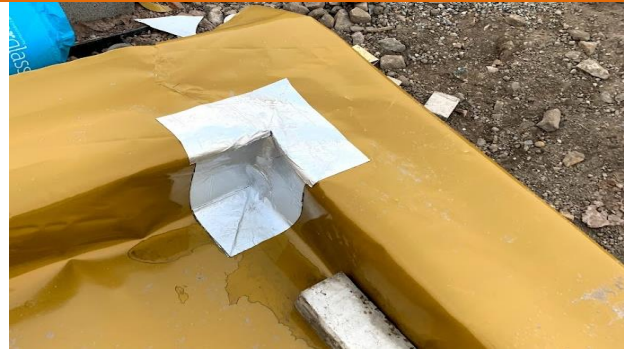
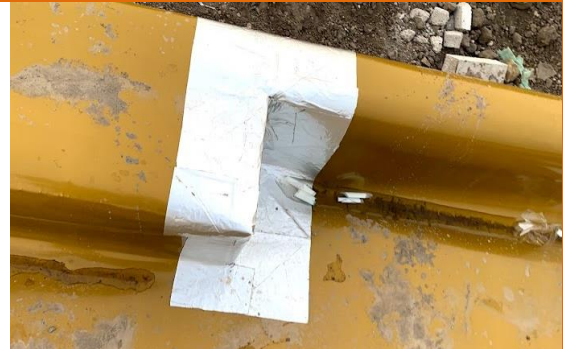
**Verification of Joints and Seals-Good Condition**

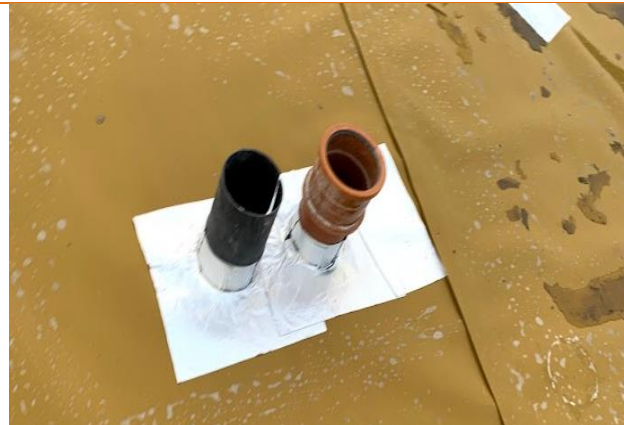
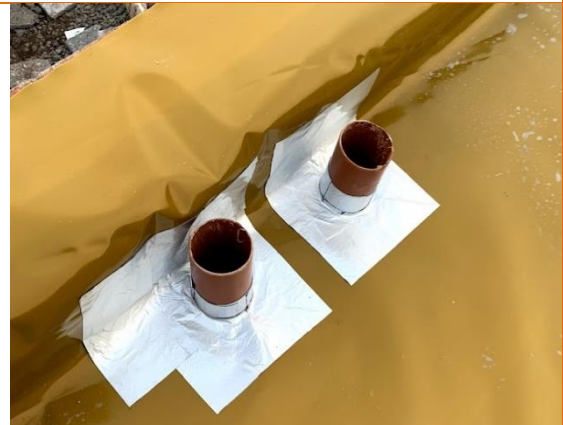
**Verification of Service Penetrations-Good Condition**

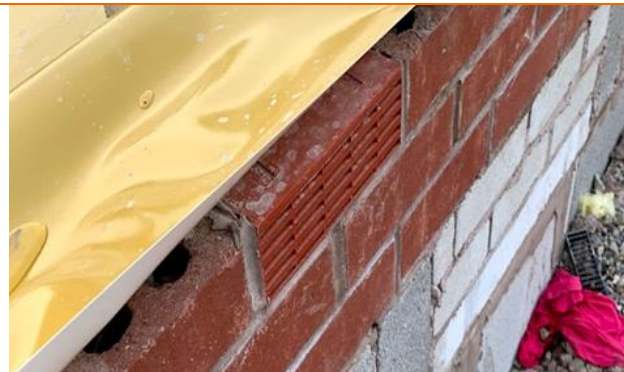
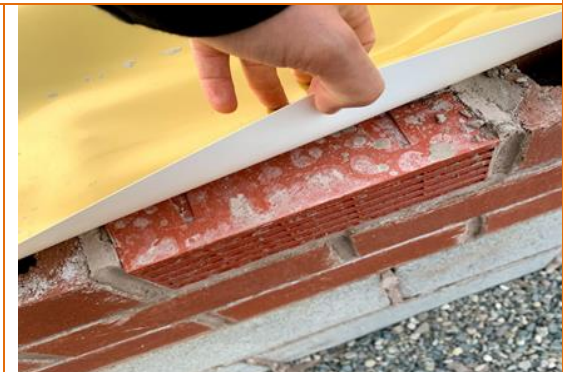
**Verification of Ventilation-Good Condition**

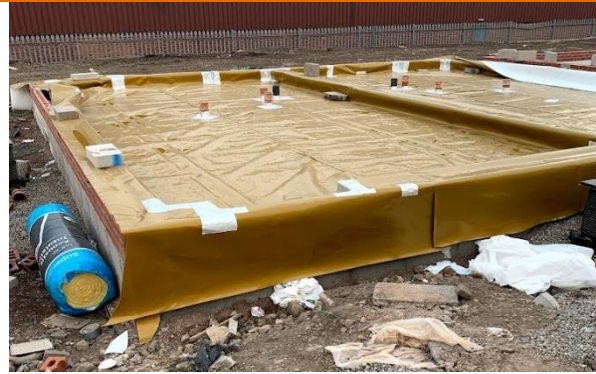
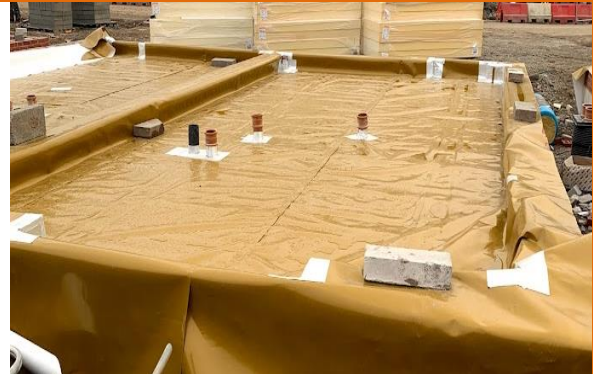
**Plot - 24**

**General Condition of Membrane-Good Condition**

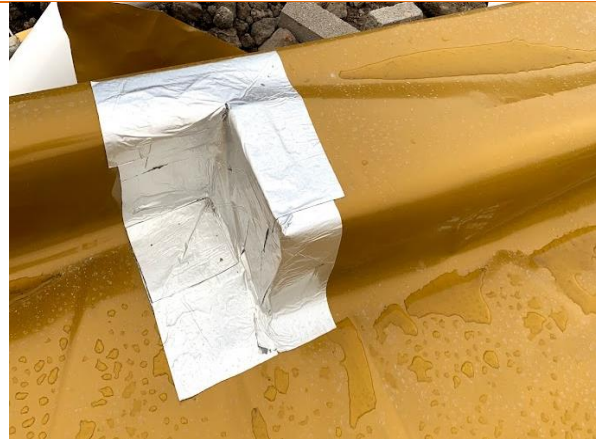
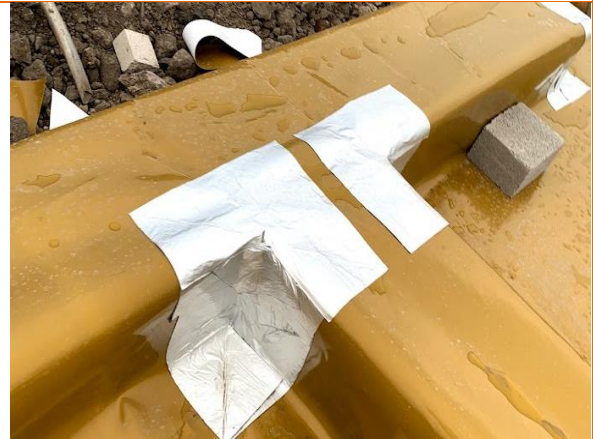
**Verification of Joints and Seals-Good Condition**

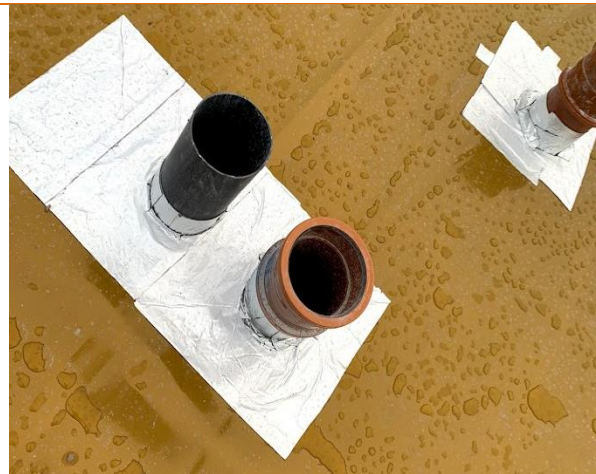
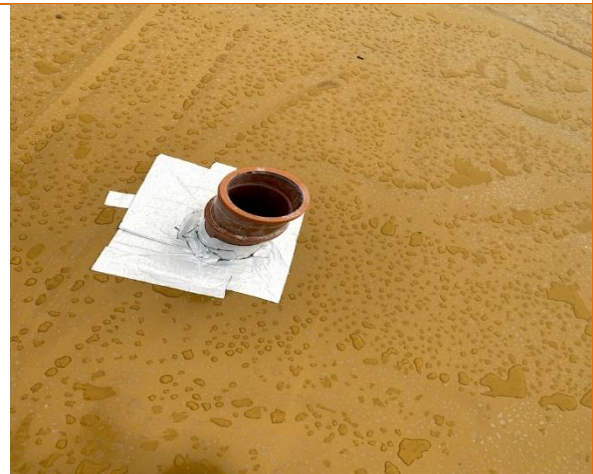
**Verification of Service Penetrations-Good Condition**

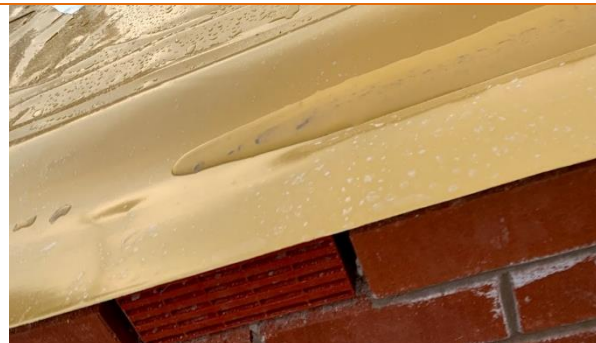
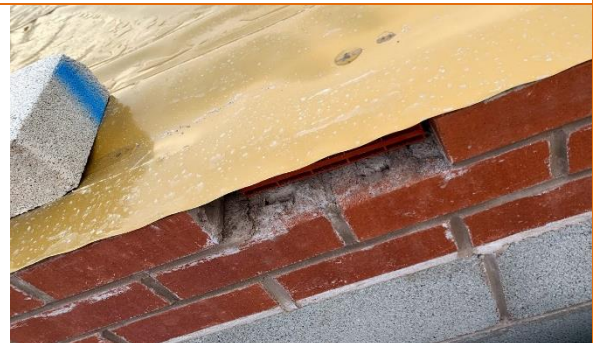
**Verification of Ventilation-Good Condition**

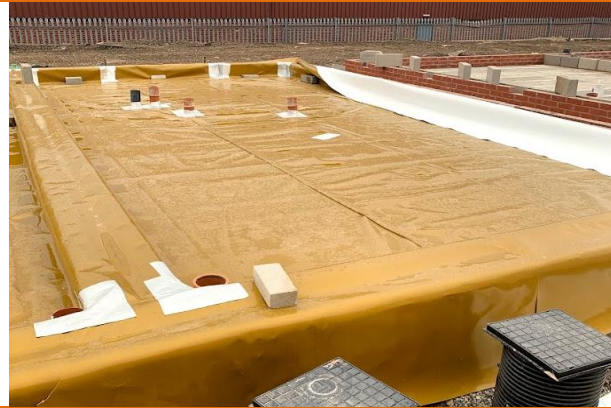
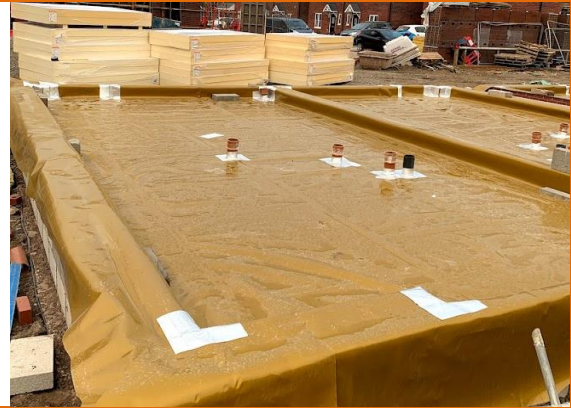
**Plot - 25**

**General Condition of Membrane-Good Condition**

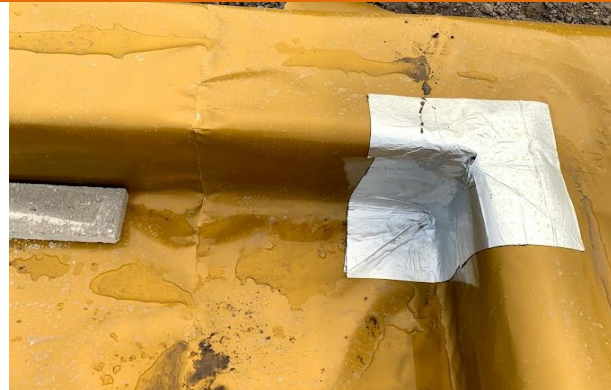
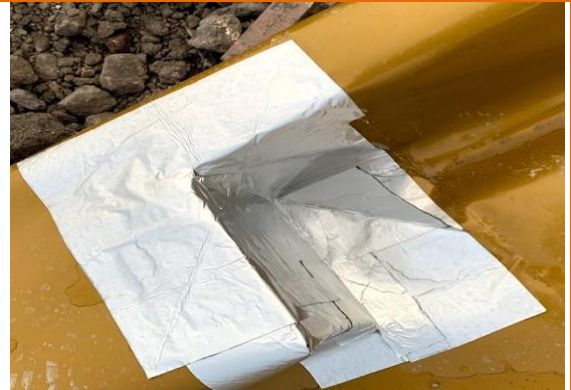
**Verification of Joints and Seals-Good Condition**

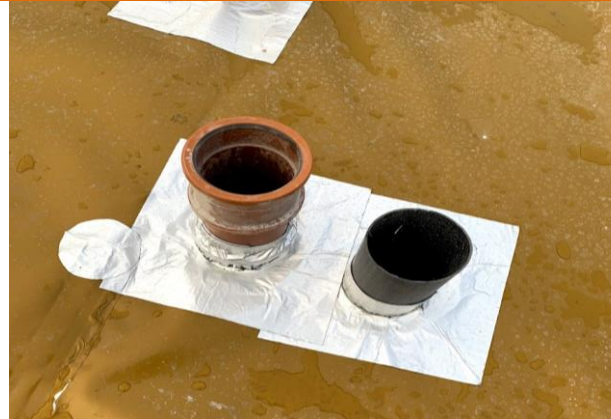
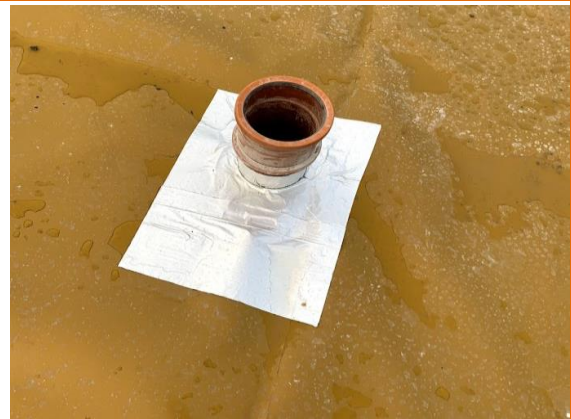
**Verification of Service Penetrations-Good Condition**

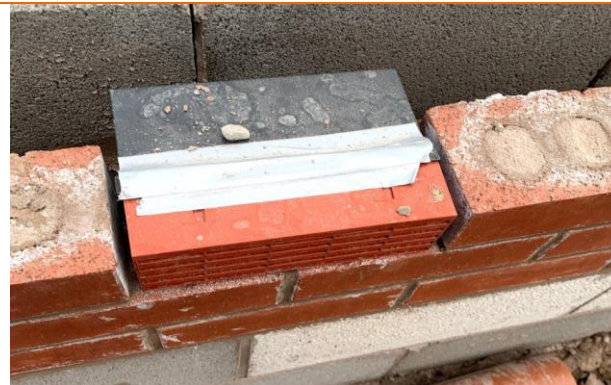
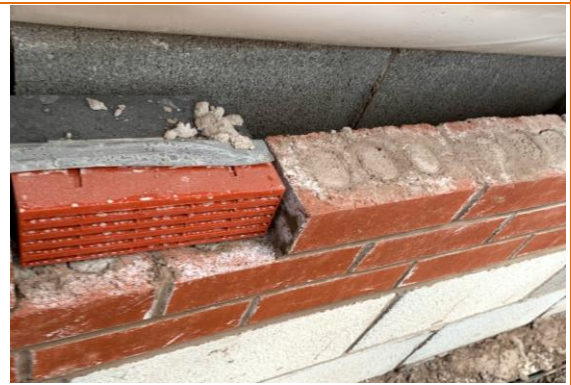
**Verification of Ventilation-Good Condition**
