**ENGINEERING REPORT 9179**

**ROBINSONS EQUESTRIAN CENTRE  
HARWOOD FIELD FARM  
CASTLE HILL ROAD  
BURY  
BL9 6UL**

**CLIENT: STEPHEN ROBINSON**

**24.11.2023 MP/CH**

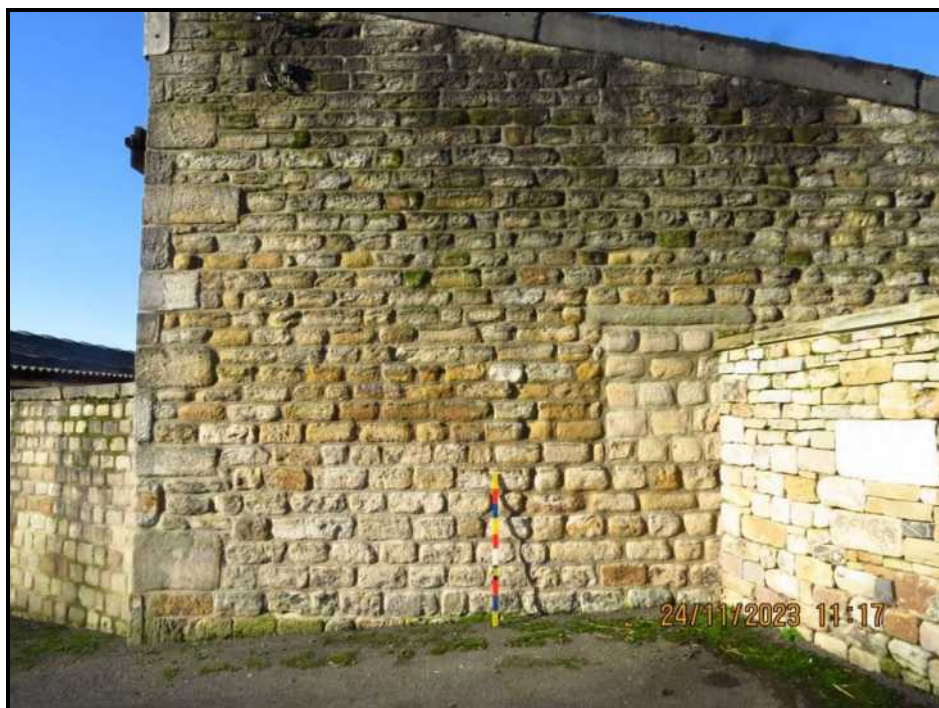
004 Chainage 0 – 5 metres

- 4.1 The Eastern elevation is half gabled constructed in a randomly coursed stonework, with larger stone sections to the quoins on the front and rear corners, completed with a mono pitched roof.
- 4.2 The Eastern half gable elevation is completed in well maintained coursed stonework with quoin returns on the front and rear wall returns. The wall extends for a length in the order of 9 metres wide, sloping from 5 metres high on the front (South Eastern corner) to 2.5 metres high on the rear North Eastern corner.
- 4.3 The existing ground level rises approximately 1 metre from front to rear. (Photographs 001, 002, 004, 005).

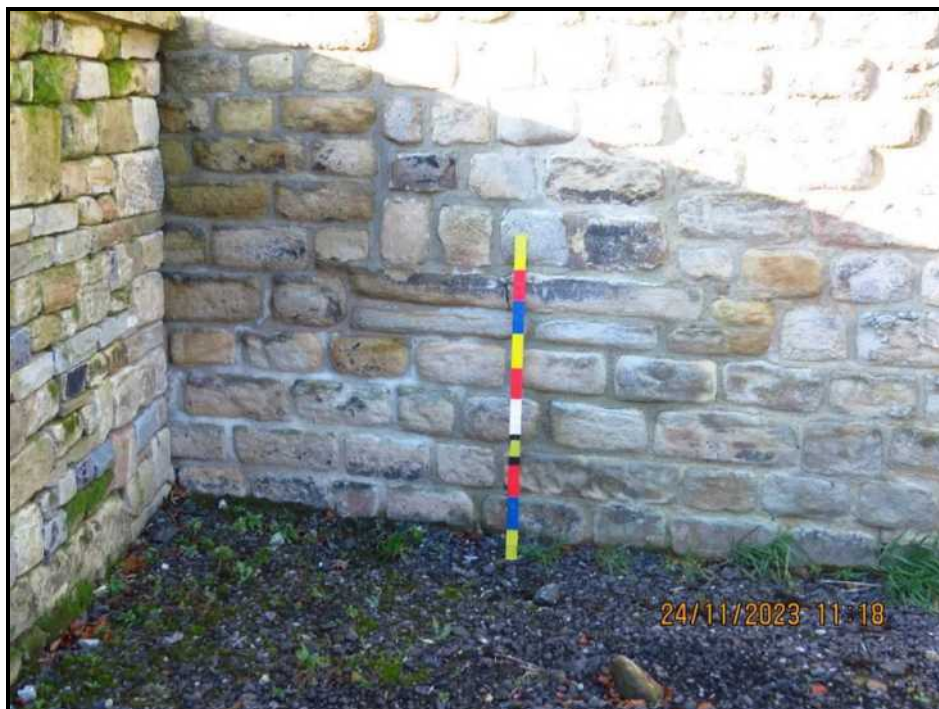
- 4.4 A 1.5 metre stone wall abuts the gable around chainage 5 metres with no evidence of any separation of movement between the two structures. (Photograph 006)
- 4.5 A former window opening has been infilled in matching stonework with the retention of the original stone lintel. The stonework and pointing are in very good condition.

006 No signs of separation between wall structures

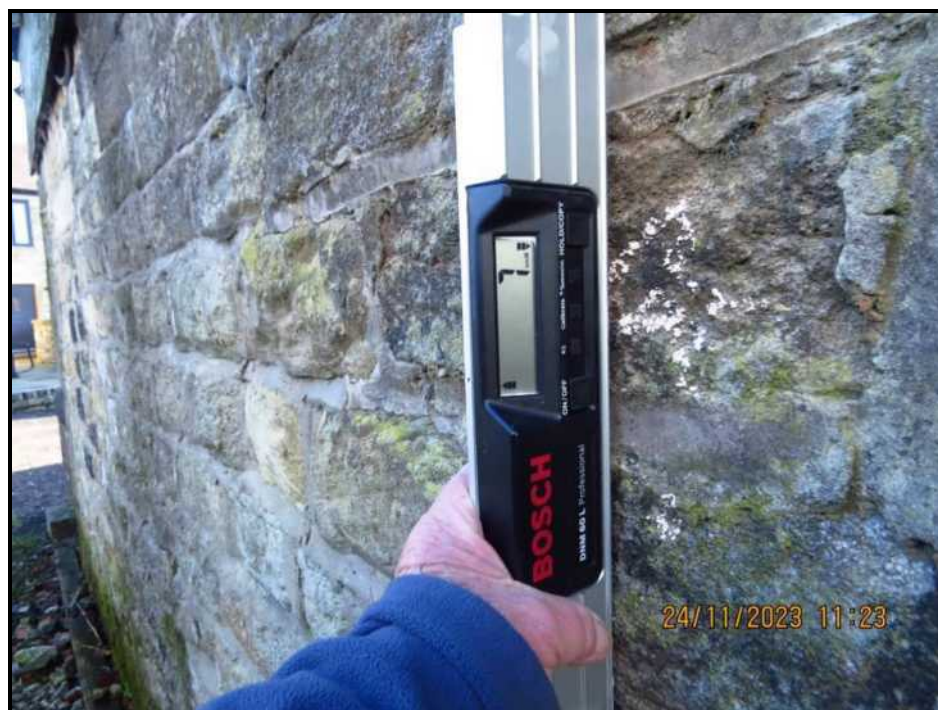
- 5.2 At chainage 0.5 metres the vertical alignment is in the order of 8mm per metre with a 7mm per metre at chainage 4 metres. (Photographs 010, 011).

011 Chainage 4 metres, 7mm per metre

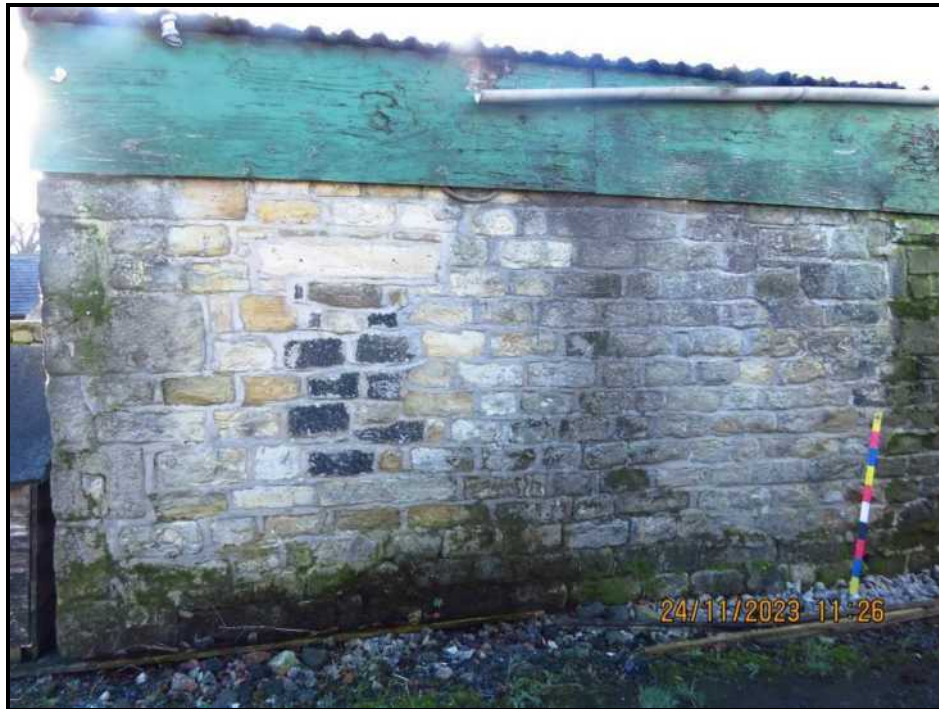
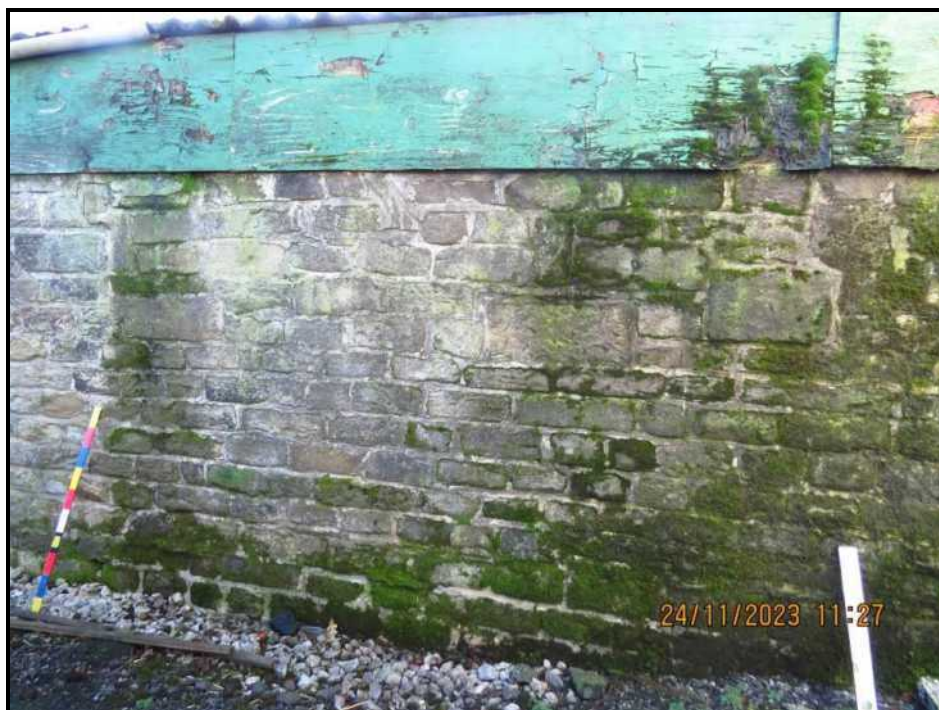
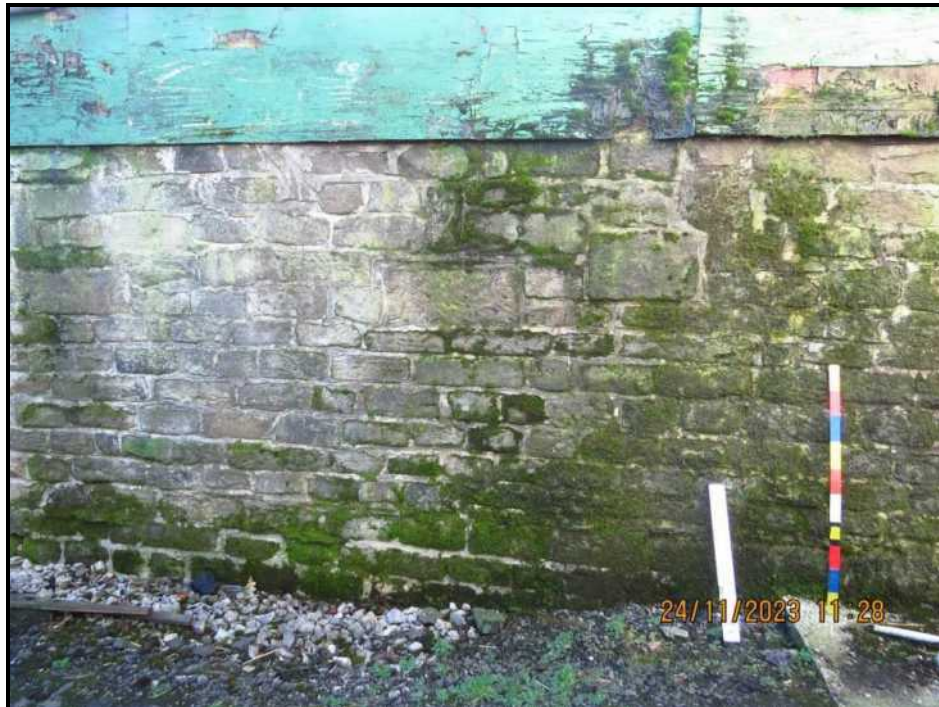
- 5.1 The North Eastern elevation extends for a length in the order of 15 metres in regular stone course of solid wall construction, a height in the order of 3 – 3.2 metres. (Photographs 012, 013, 014, 020).

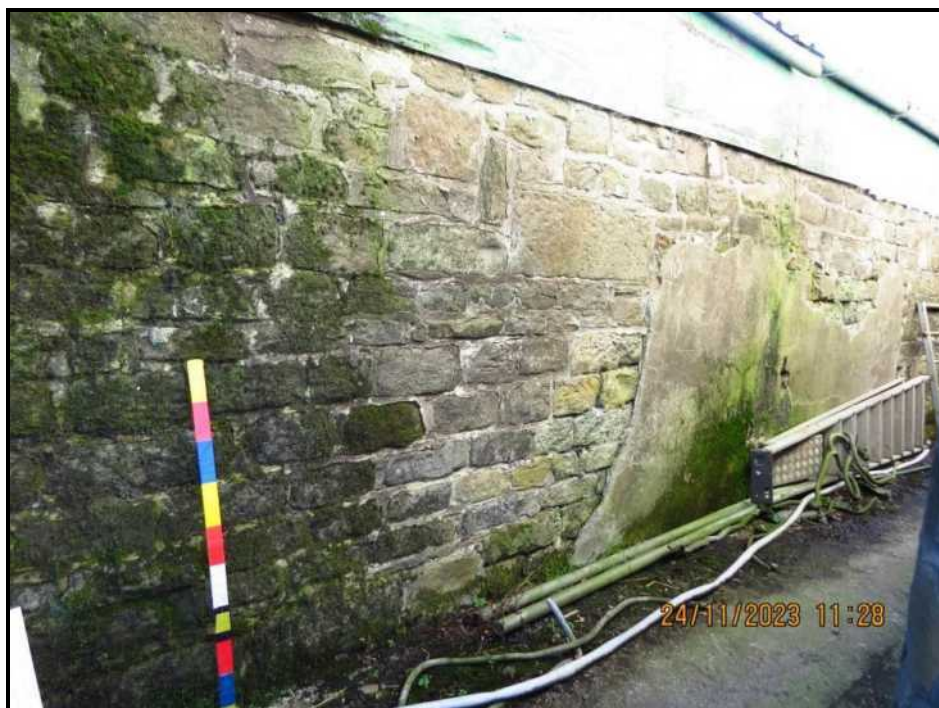
015 Chainage 8 – 12 metres

- 5.3 The vertical alignment at chainage 7 metres is good with irregularities in the order of 7mm per metre.
- 5.4 The rear wall terminates with a vertical joint between the North Eastern section and the North Western section. (Photographs 019, 020).
- 5.5 Between chainage 8 – 12 metres the wall is completed with a 25mm rendered panel extending for a height between 1 – 1.2 metres and the rendering is generally in a satisfactory sound condition with good vertical alignment. (Photographs 015, 017, 018).

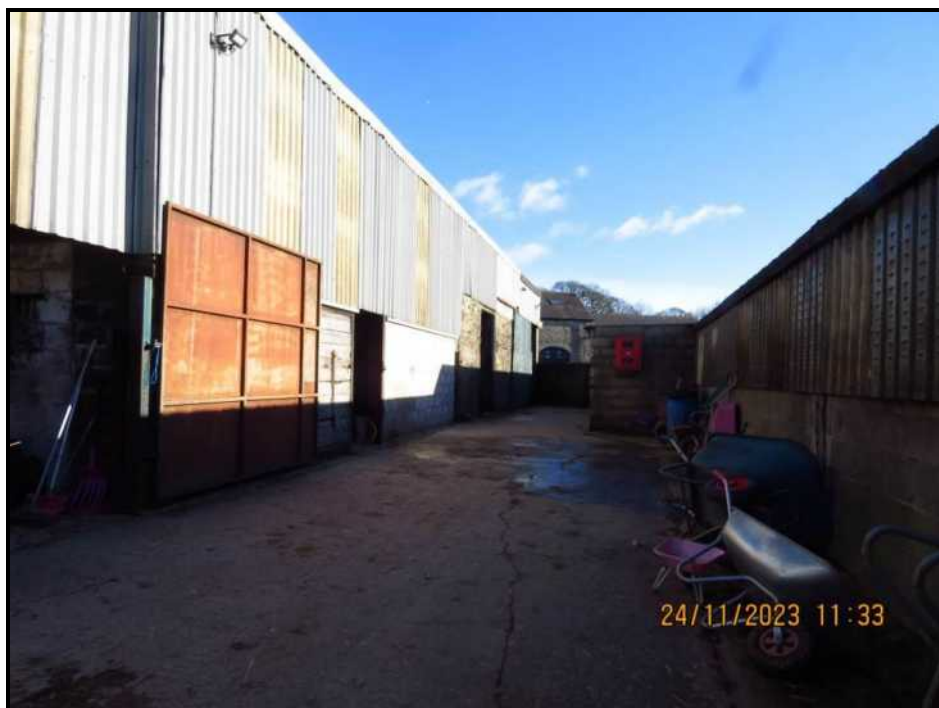
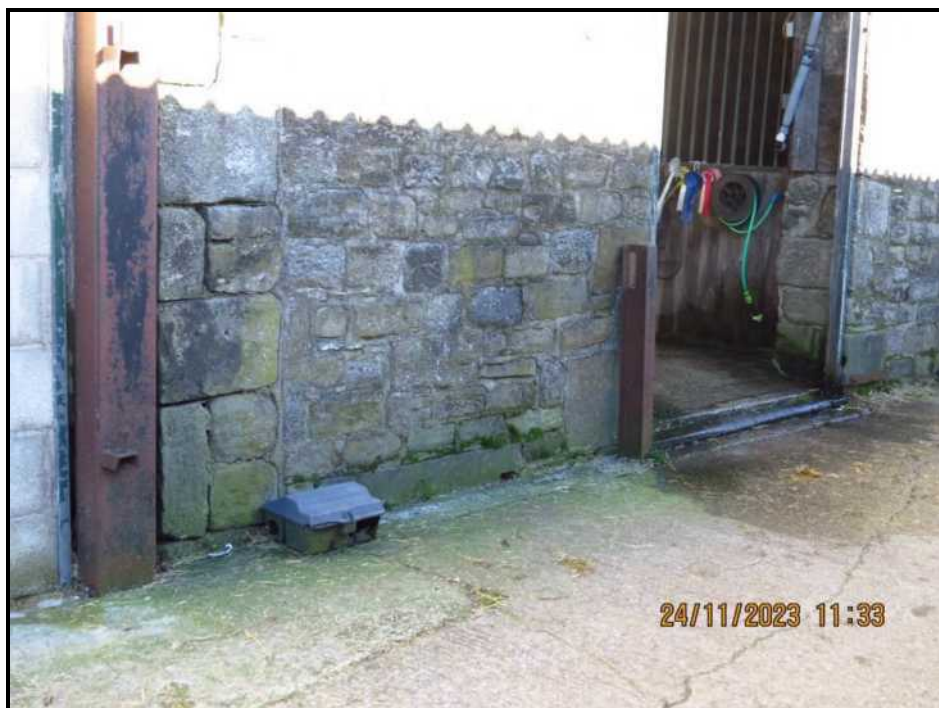
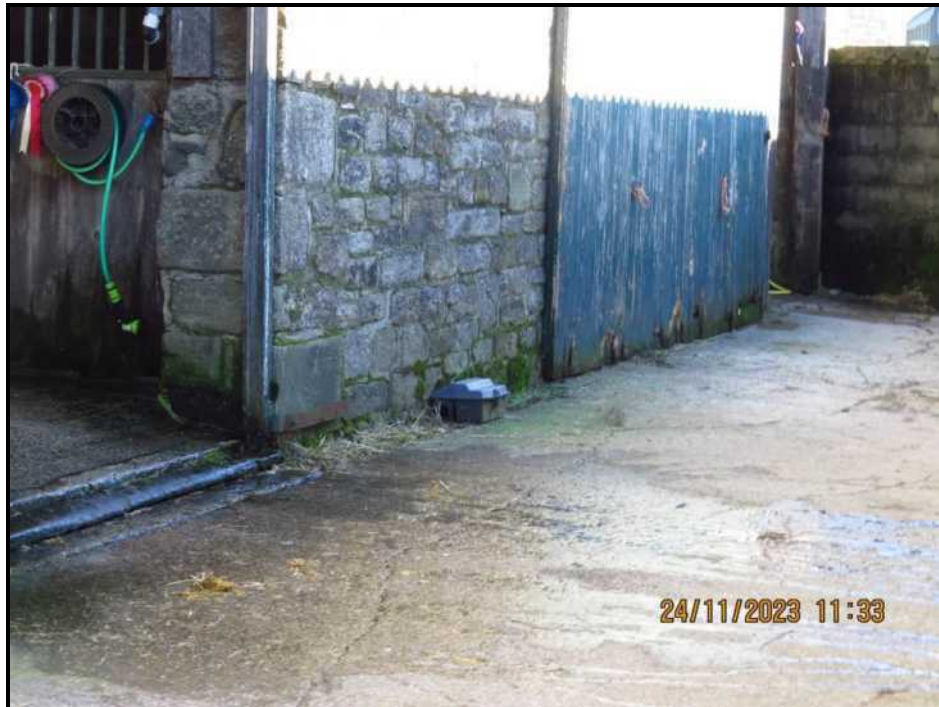
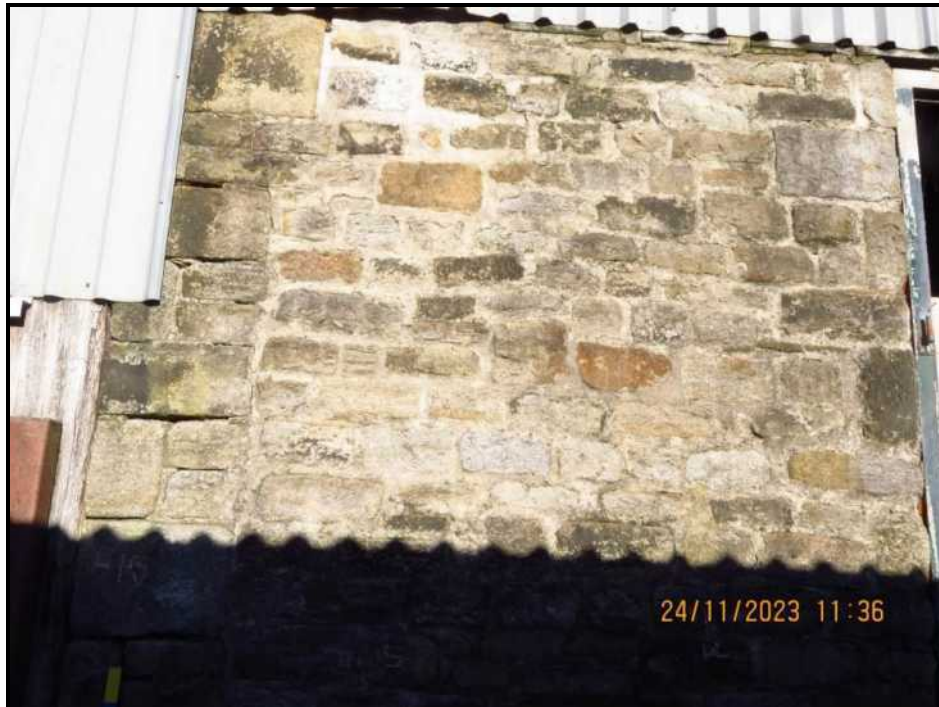
- 3.8 The vertical alignment to the right hand door reveal and the front elevation is good with irregularities less than 8mm per metre. (Photographs 029, 030).
- 3.9 The stonework and pointing on the end Western panel (10 – 15 metres) is good, isolated crazing is evident around the quoin details and some loss of pointing, but is not of any structural consequence with no evidence of any significant movement or rotation. (Photographs 023, 025, 026, 028).

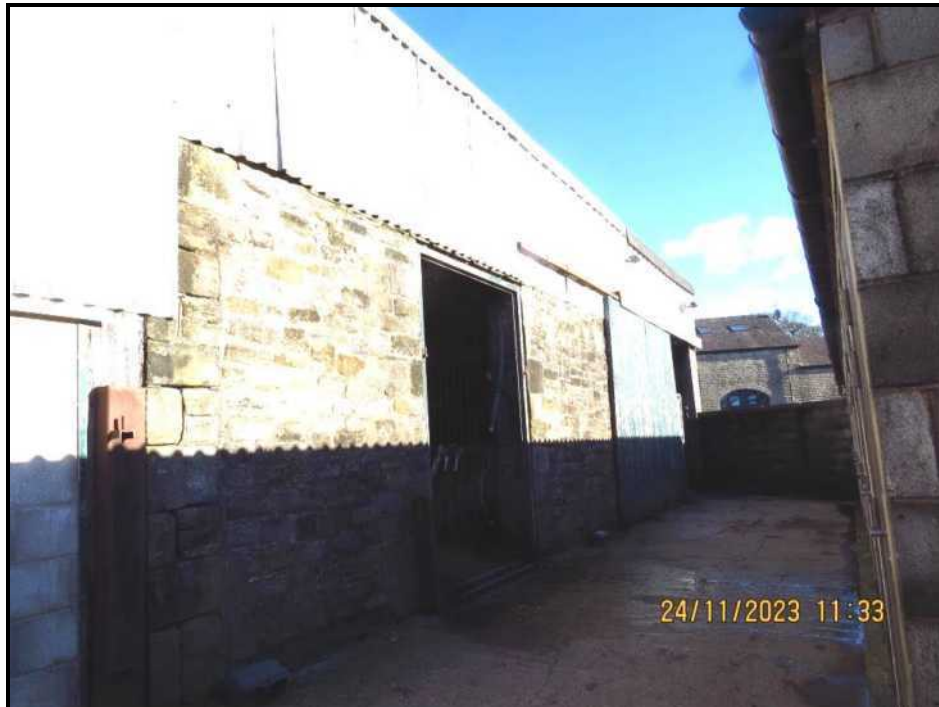
024 Front elevation

- 3.1 The front elevation extends for a width in the order of 16 metres completed in coursed natural stonework of solid wall construction with a struck pointing, incorporating larger stone quoins on the original corners of the barn (chainage 0 – chainage 16 metres).
- 3.2 The stone facing extends for the full height of the front elevation overlain at eaves level with a variable 2 – 3 metre deep profiled metal cladding from roof level.
- 3.3 The front elevation incorporates a large timber sliding door located between chainage 1.5 – 4 metres with a further doorway to the East (left) at chainage 10 – 12 metres. (Photograph 024)

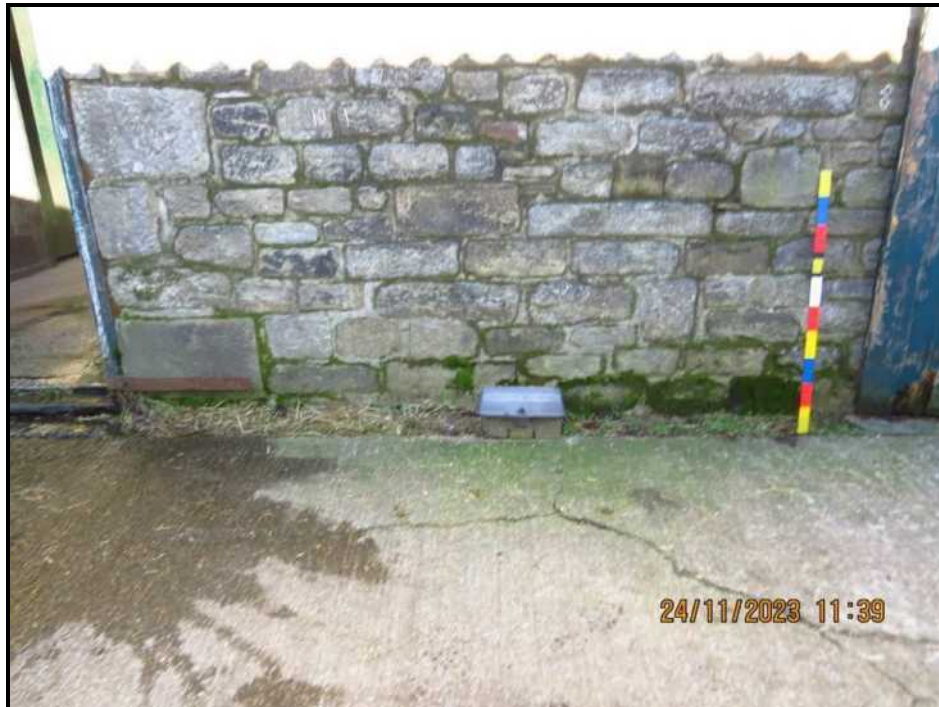
032 Plinth wall, chainage 10 – 7 metres

- 3.5 The vertical alignment of the right hand door reveal (chainage 1.5 metres) is satisfactory. (Photograph 038).
- 3.6 The sliding door covers the main wall section between chainage 4 – 5 metres but overall vertical profile on either side of the doorway is satisfactory with good vertical alignment and satisfactory horizontal coursing. (Photographs 036, 037).
- 3.7 The adjoining stone panel (chainage 8 – 10 metres) is well pointing with satisfactory vertical alignment. (Photographs 032, 033, 034, 035).

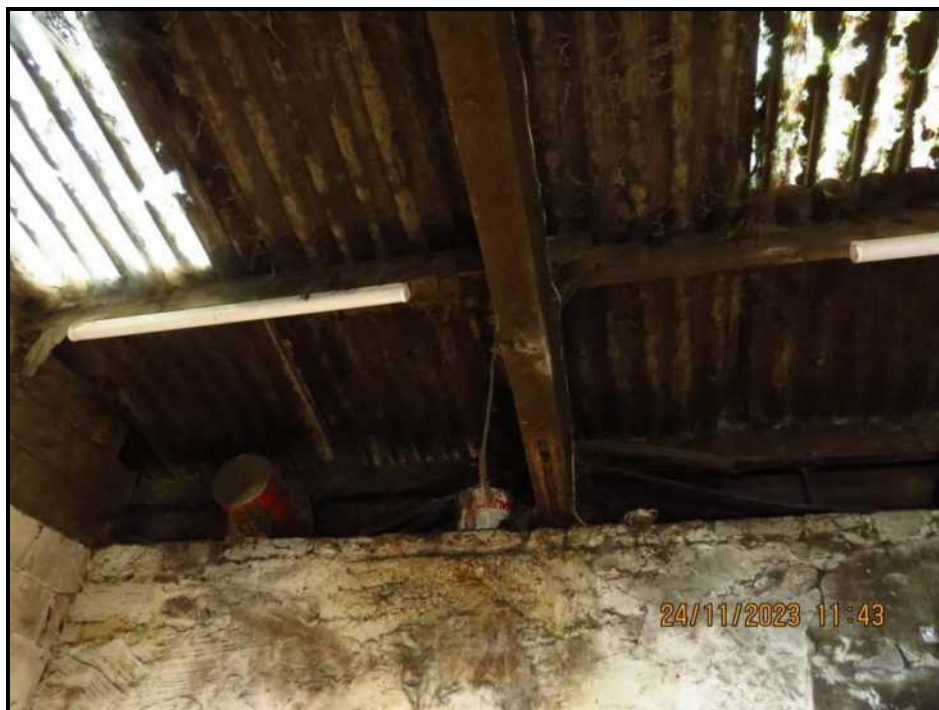
042 Rear wall rafter beam

- 7.2 Stable No. 1 is sub-divided into three stalls adjoining the internal cross wall and the inside face of the Western half gable wall is completed with a random render finish. The render finish follows a satisfactory vertical profile, the wall supporting 400mm x 150mm rafters at wall plate level spanning from the rear elevation to the front elevation. The Eastern gable wall supports the lateral purlins spanning from East to West. (Photographs 040, 041, 042).

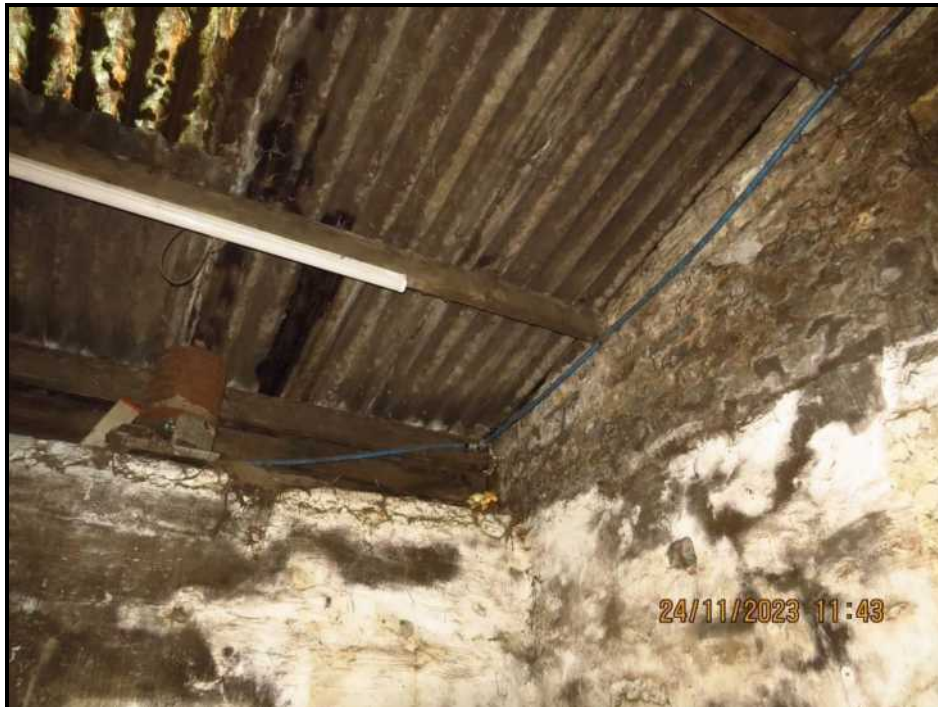
043 Roof, Northern corner

- 7.3 There are no signs of any separation where the rear wall adjoins the return half gable Eastern elevation. (Photographs 043, 044).

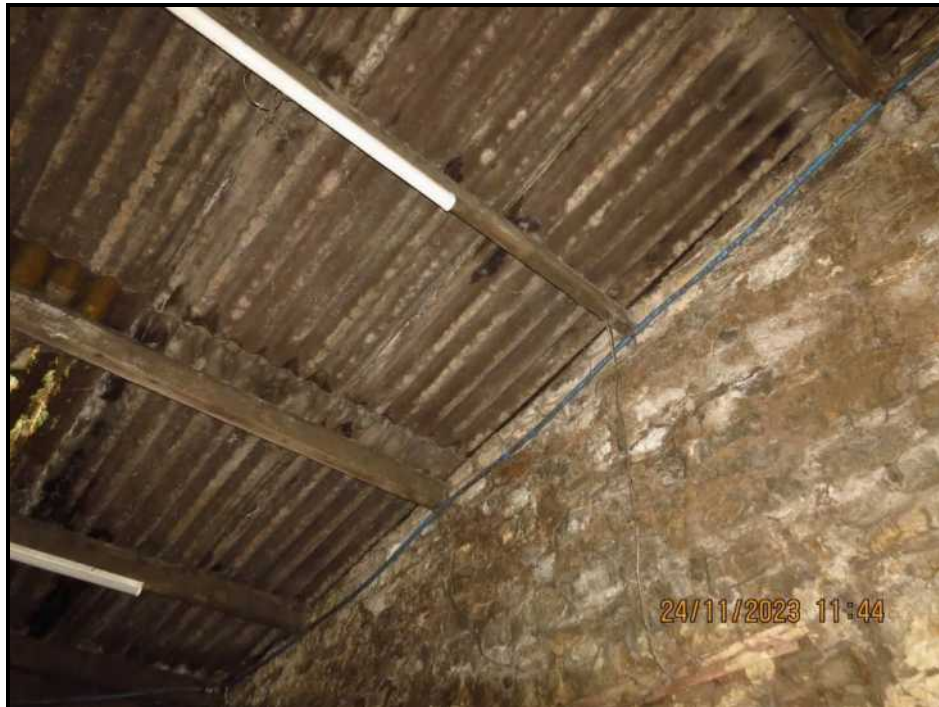
050 Eastern gable, roof support

- 7.5 There are no signs of any separation where the purlins seat into the gable wall. (Photographs 045, 047, 50, 051).

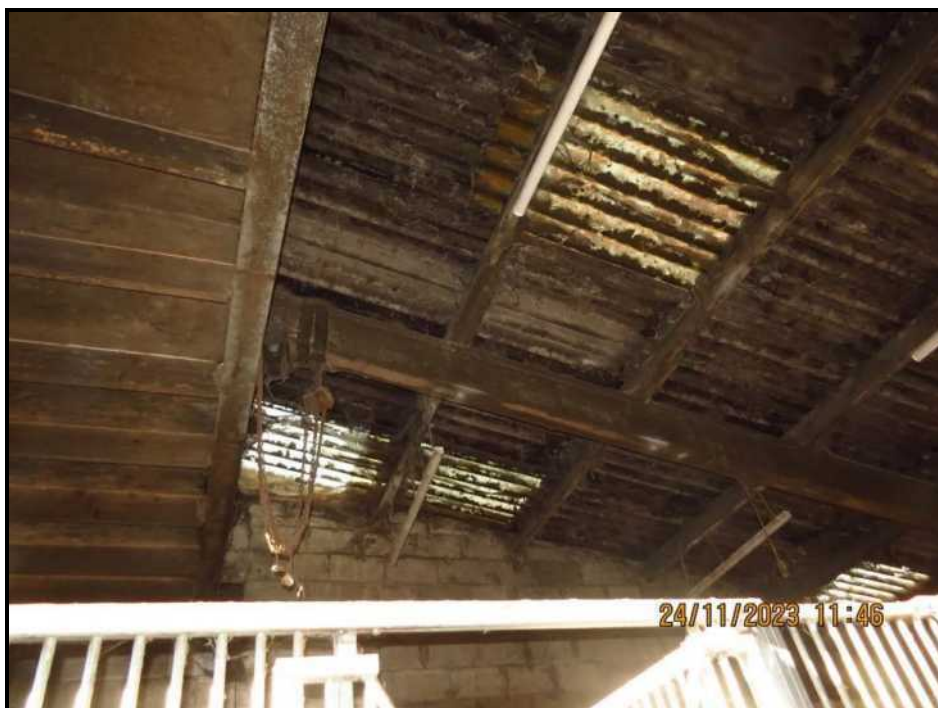
057 Internal cross wall to Stable No. 2

- 7.6 In the front stall the roof incorporates 300mm x 150mm joists spanning longitudinally onto a blockwork seating.
- 7.7 The vertical and horizontal alignment of the internal cross wall is good and the blockwork and pointing in very good condition.
- 7.8 Parallel to the front wall there are suspended beams supporting a timber platform between the gable and the internal cross wall. (Photographs 056, 057, 058).

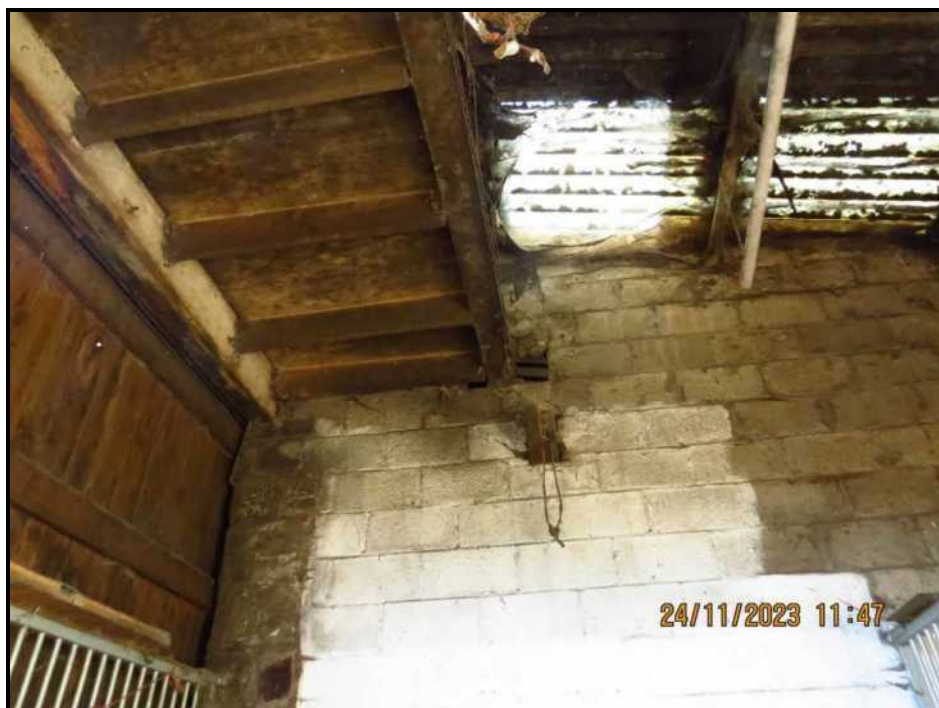
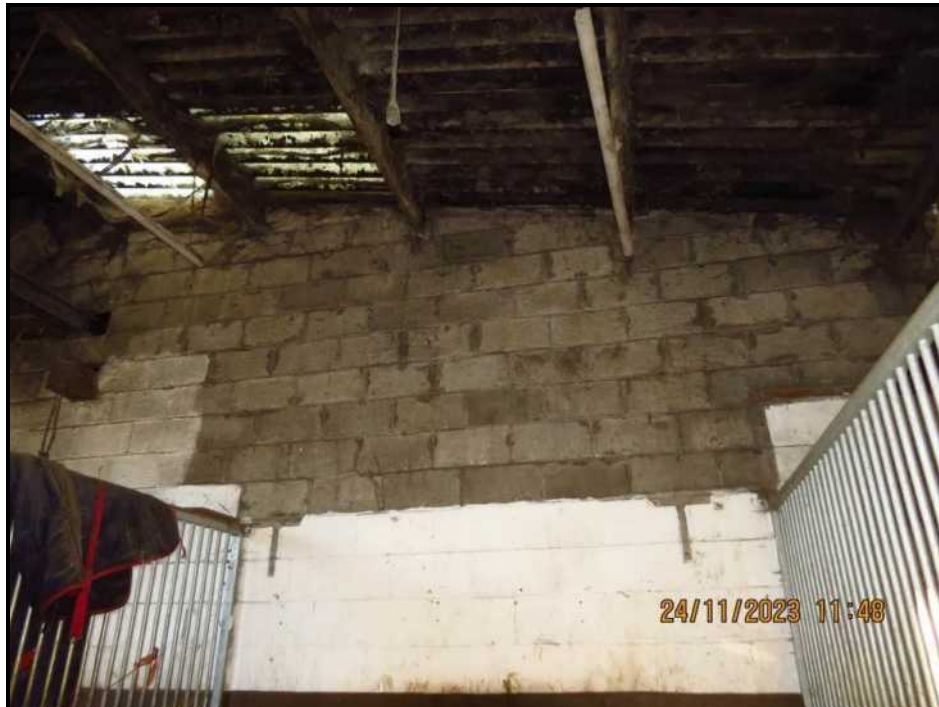
- 7.9 The internal party wall between stables 1 and 2 is completed in well maintained blockwork following a satisfactory line and level, with no evidence of any lateral movement where the purlins and rafters seat on the internal walls. (Photographs 061, 062, 065, 066).

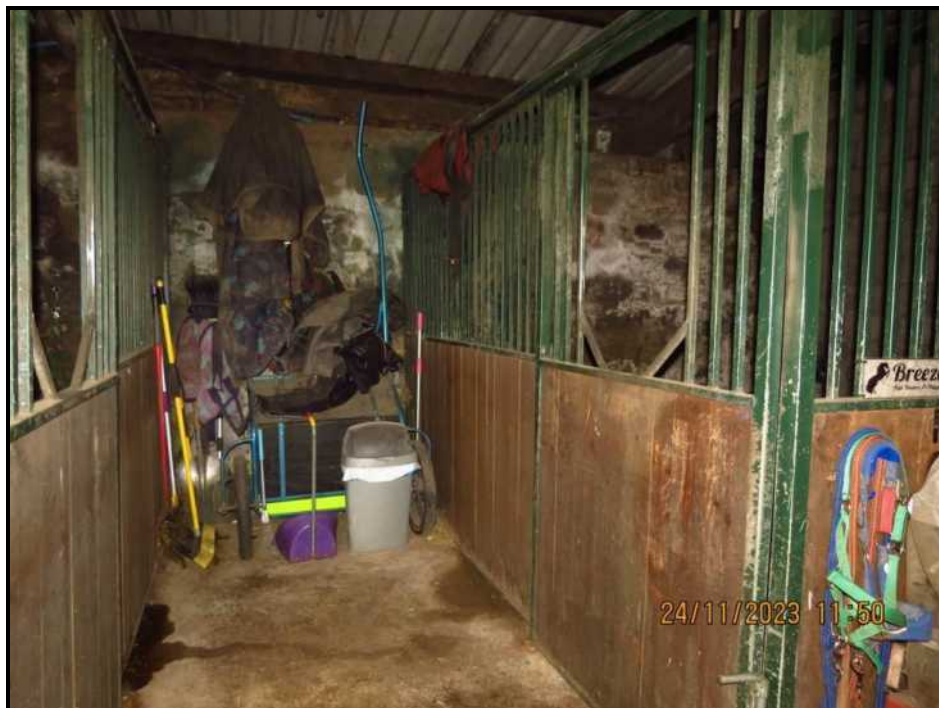
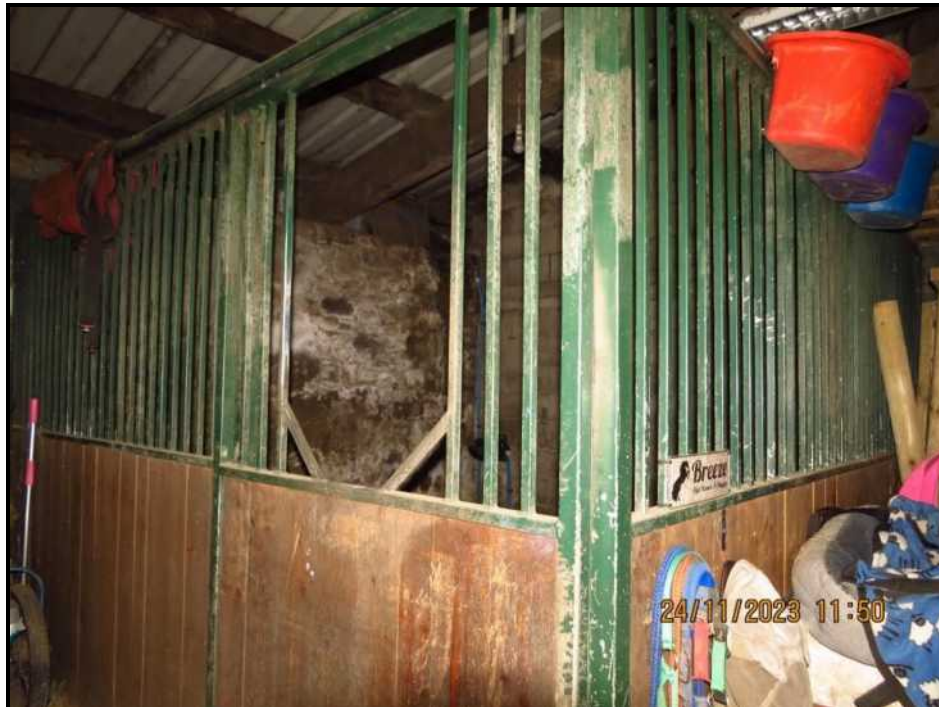
- 7.10 Stable No. 2 incorporates two Tack Rooms with limited access to the rear walls. (Photographs 070, 071).
- 7.11 The rear wall of the original building is finished with a weathered and stained render finish, with a reasonable vertical alignment, with the internal party wall completed in satisfactory blockwork.
- 7.12 There are no signs of any separation where the blockwork cross wall adjoins the original rear and front elevations. (Photographs 072, 073, 074).

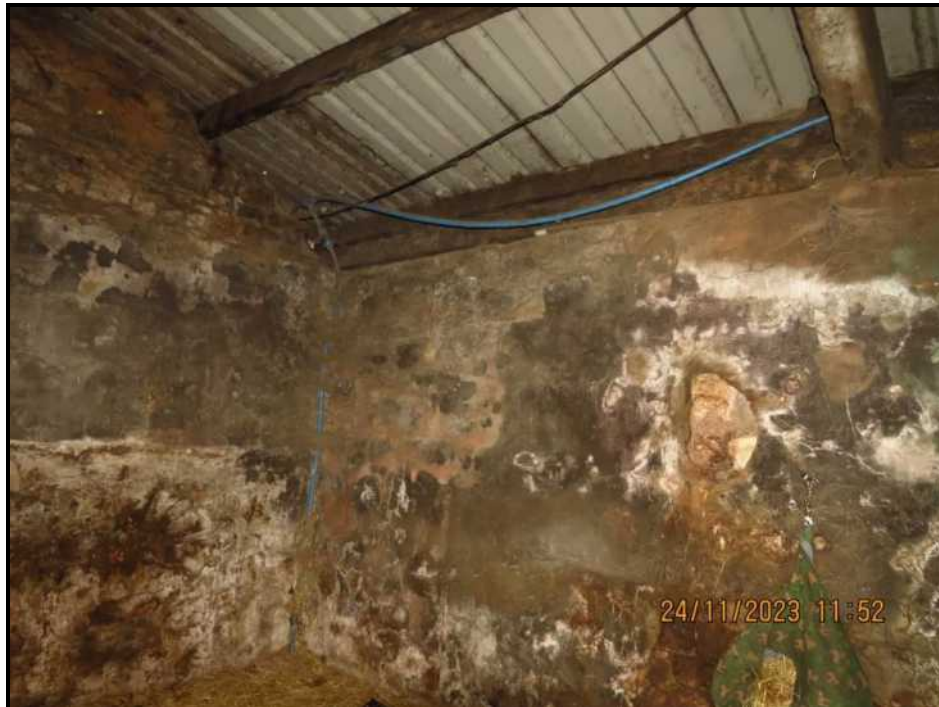
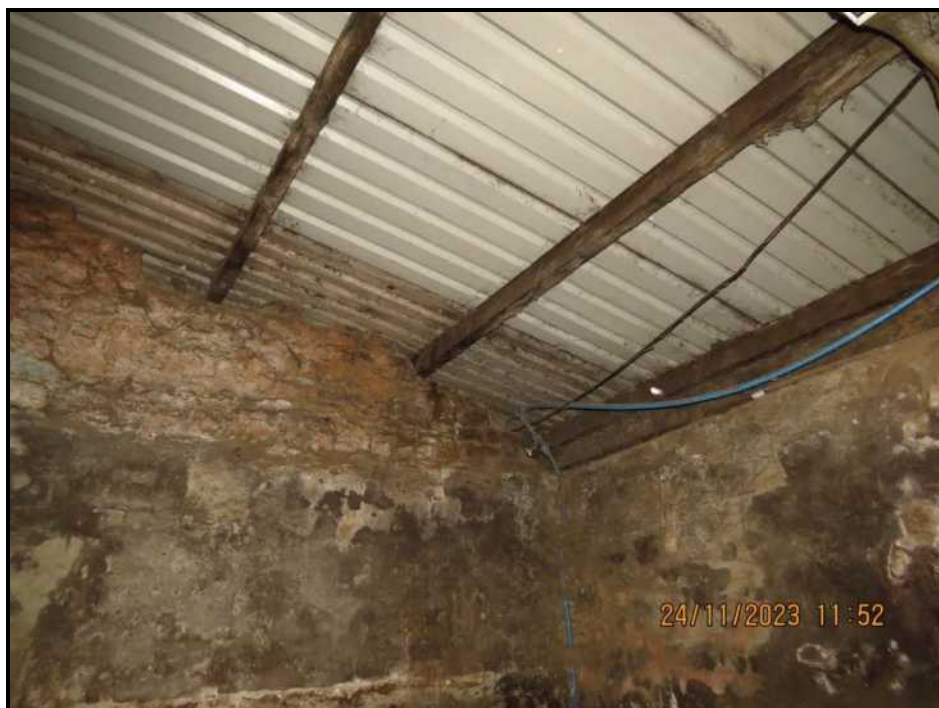
- 7.13 In the North Western corner the rendering to the rear wall shows evidence of weathering and deterioration but there are no signs of any separation or rotation of the purlin seatings onto the internal cross wall (proposed external wall). (Photographs 075, 076).
- 7.14 The blockwork party wall is completed with well maintained blockwork and pointing with good horizontal and vertical alignment to the wall supports, the structural purlin seatings onto the main roof rafters. There are no signs of any separation where the party wall adjoins the front masonry. (Photographs 083, 084).

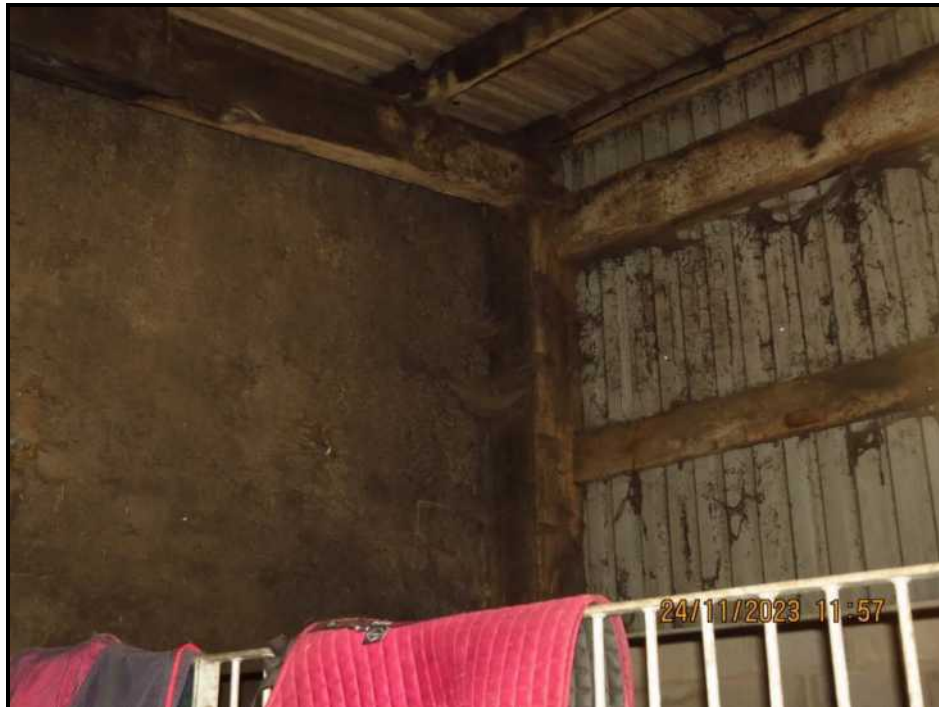
093 'Outside' of Western wall

- 6.1 The North Western half gabled wall currently acts as an internal party wall between stable units 1 and 2 to the East, and stable units 5 to 4 in the Western section (to be demolished).
- 6.2 The inspection of the Western outside face of the proposed gable elevation is limited with the existing usage (limited access).
- 6.3 The stone wall is completed with a flat cement render supporting the lateral purlin members, spanning from East to West towards the front elevation. (Photographs 093, 094 and photograph 090 towards the rear elevation).
