## Phase 1 GeoEnvironmental Desk Study

Buckley Road

Rochdale

**Report No. A5784/24/FDS**

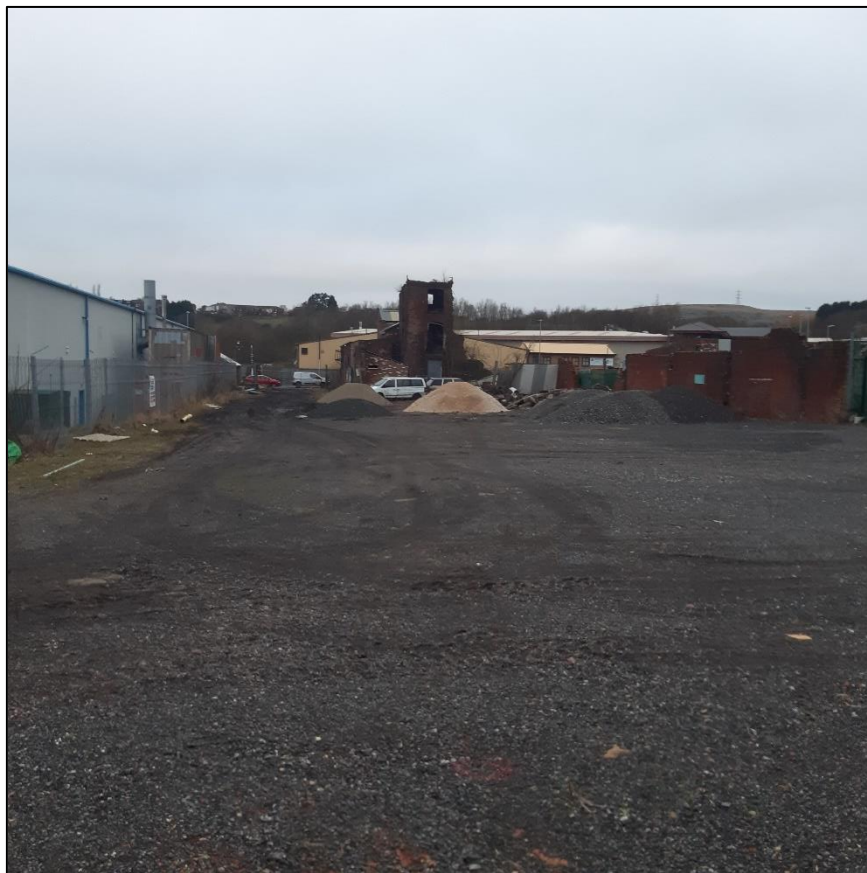
**Figure 3: Site Photograph**

- 2.2 A site walkover was conducted on the 12<sup>th</sup> January 2024 from which the following descriptions have been taken.
- 2.3 The site is an irregular shaped parcel of land with which comprises of hardstanding (100%) related to a disused former mill and approximately 0.27 hectares in size.

- 2.4 The topography of the site is generally flat having been built up with hardcore and slopes at the eastern and southeastern corner towards the stream and pond located adjacent to the site.

- 2.5 The site is currently unoccupied former industrial land with small stockpiles of demolition rubble and hardcore.
- 2.6 The site is bounded by metal palisade fencing on the east and south sides and by a brick wall and palisade fencing along the northern boundary, the west of the site has a metal gate from which access for a vehicle off Buckley Road is provided.

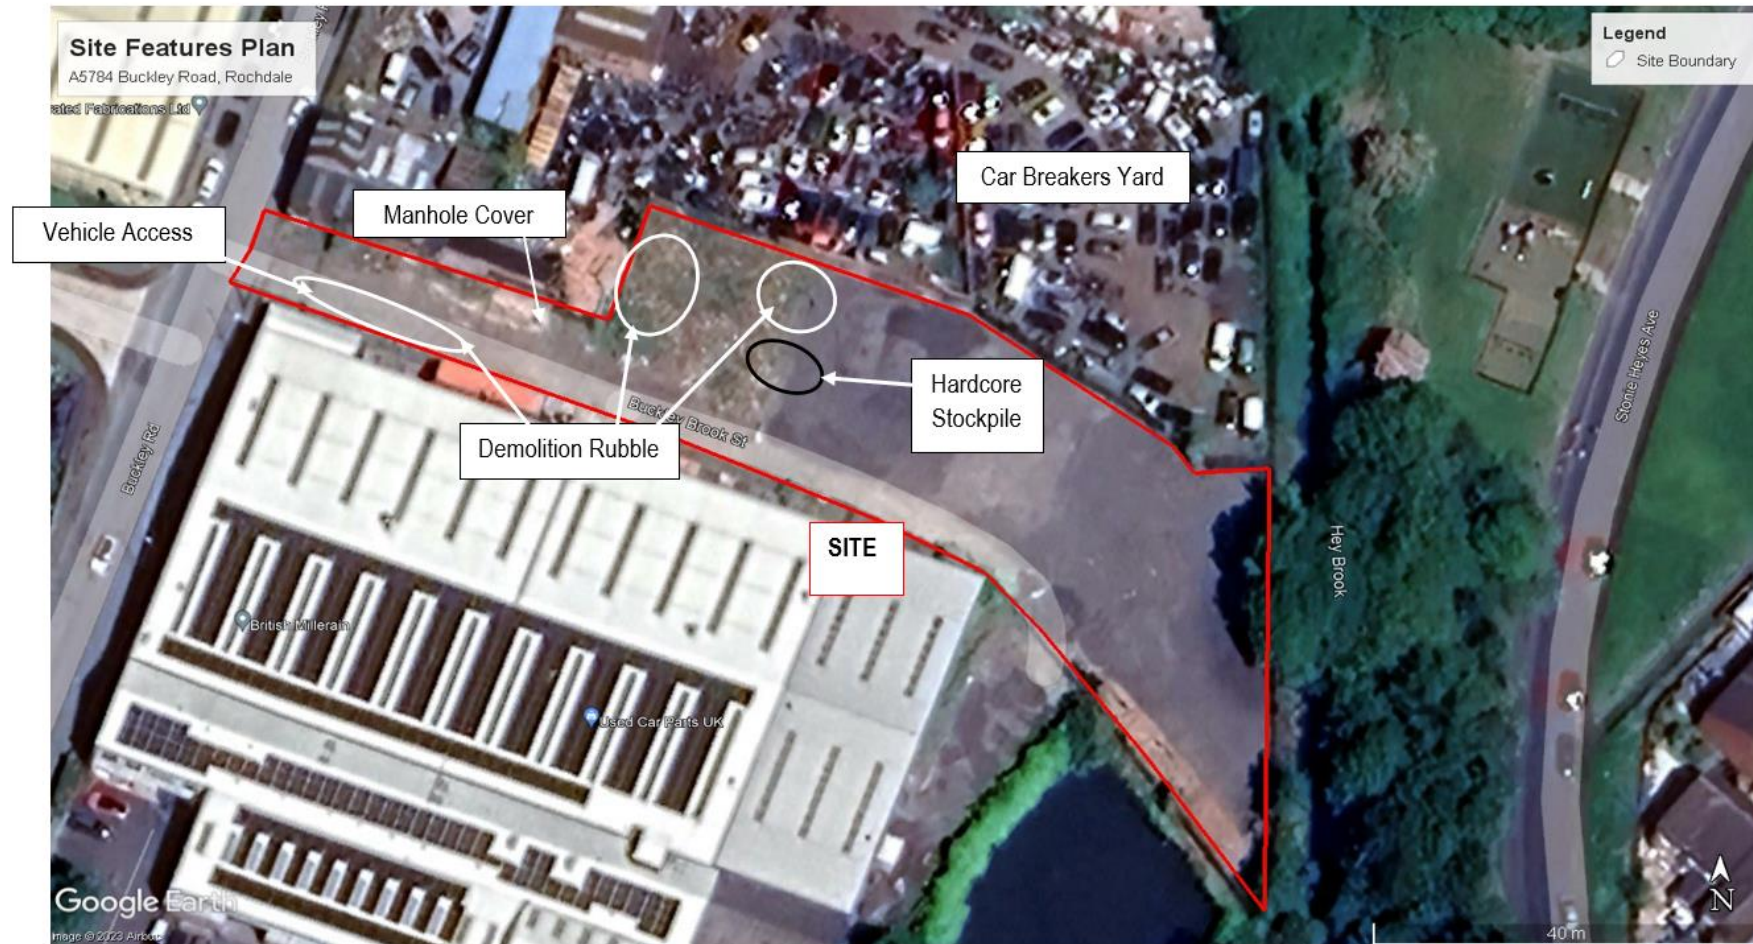
**Figure 9: Site Features**

- 5.10 A site features plan is presented as Figure 9 overleaf.

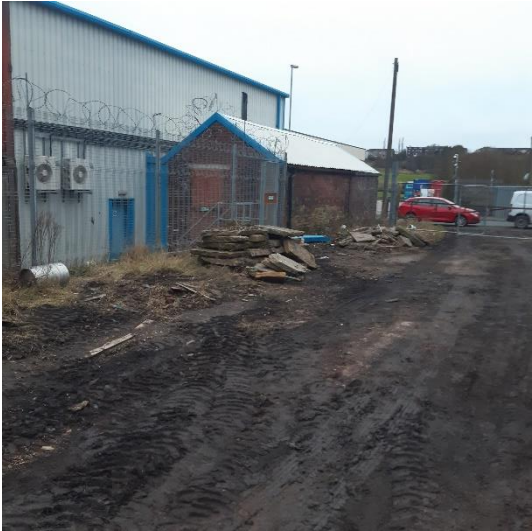
| <p><b>Plate 1</b> Viewing entrance to the site and adjacent substation</p> | <p><b>Plate 2</b> View of northwestern boundary of previous mill wall</p> |

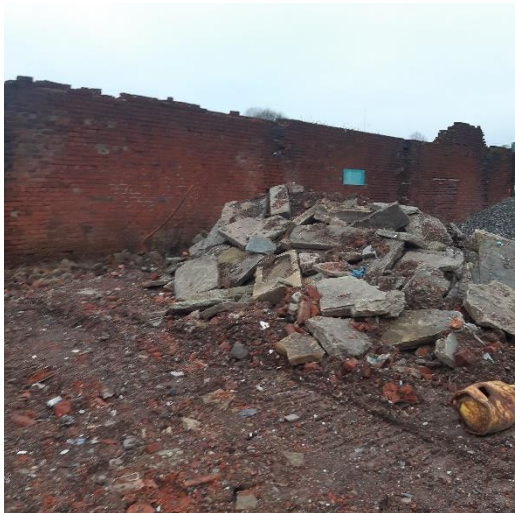
| <p><b>Plate 3</b> View facing north of boundary wall of previous mill and rubble stockpile.</p> | <p><b>Plate 4</b> Viewing north showing green palisade fence of northern boundary and adjacent car breakers yard.</p> |

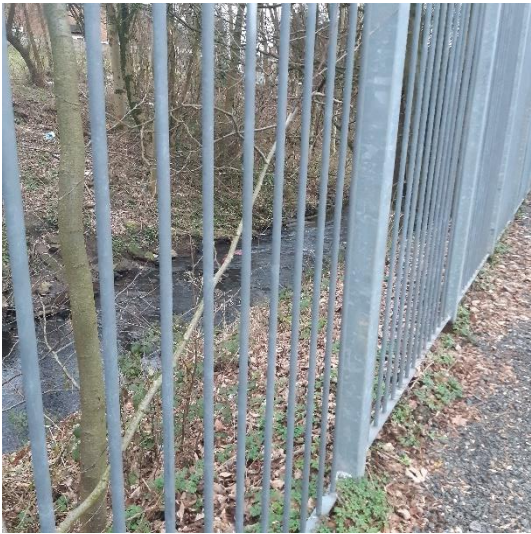
| <p><b>Plate 5 Looking east showing palisade fencing and Hey Brook at rear of the site.</b></p> | <p><b>Plate 6 Looking at the southeastern corner of the site and offsite pond with down from built up hardcore.</b></p> |

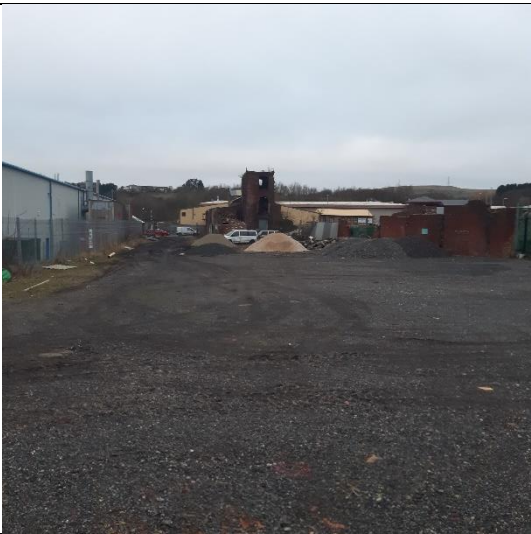
| <p><b>Plate 7 Viewing West showing majority of the site covered with hardcore and stockpiles of hardcore.</b></p> | <p><b>Plate 8 Viewing southwest showing stockpile of hardcore.</b></p> |
