Week 6– W/E 20.09.2024 – Stonework dismantling and window repairs

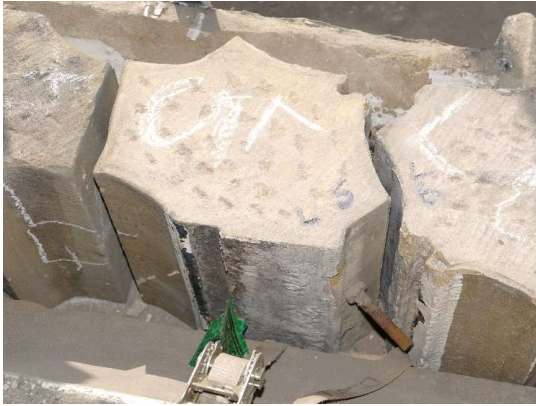
Assessment of stone repairs

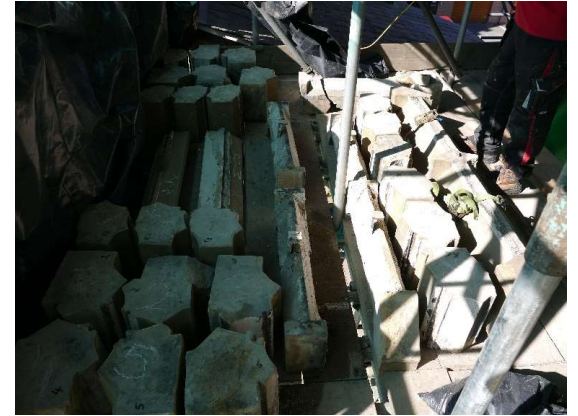
Stonework fully inspected and laid out for re-installation

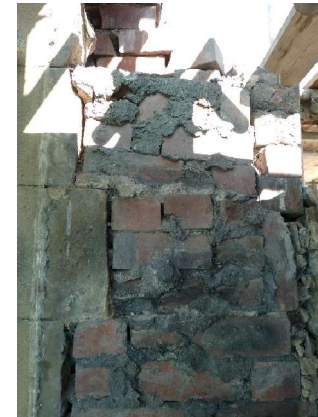
Condition of gable brickwork assessed
