LAND AT GREENBOOTH ROAD  
NORDEN  
ROCHDALE

GEOENVIRONMENTAL RISK  
ASSESSMENT & REMEDIATION  
STRATEGY

**Job Number:** LKC 20 1618

**Date:** September 2020

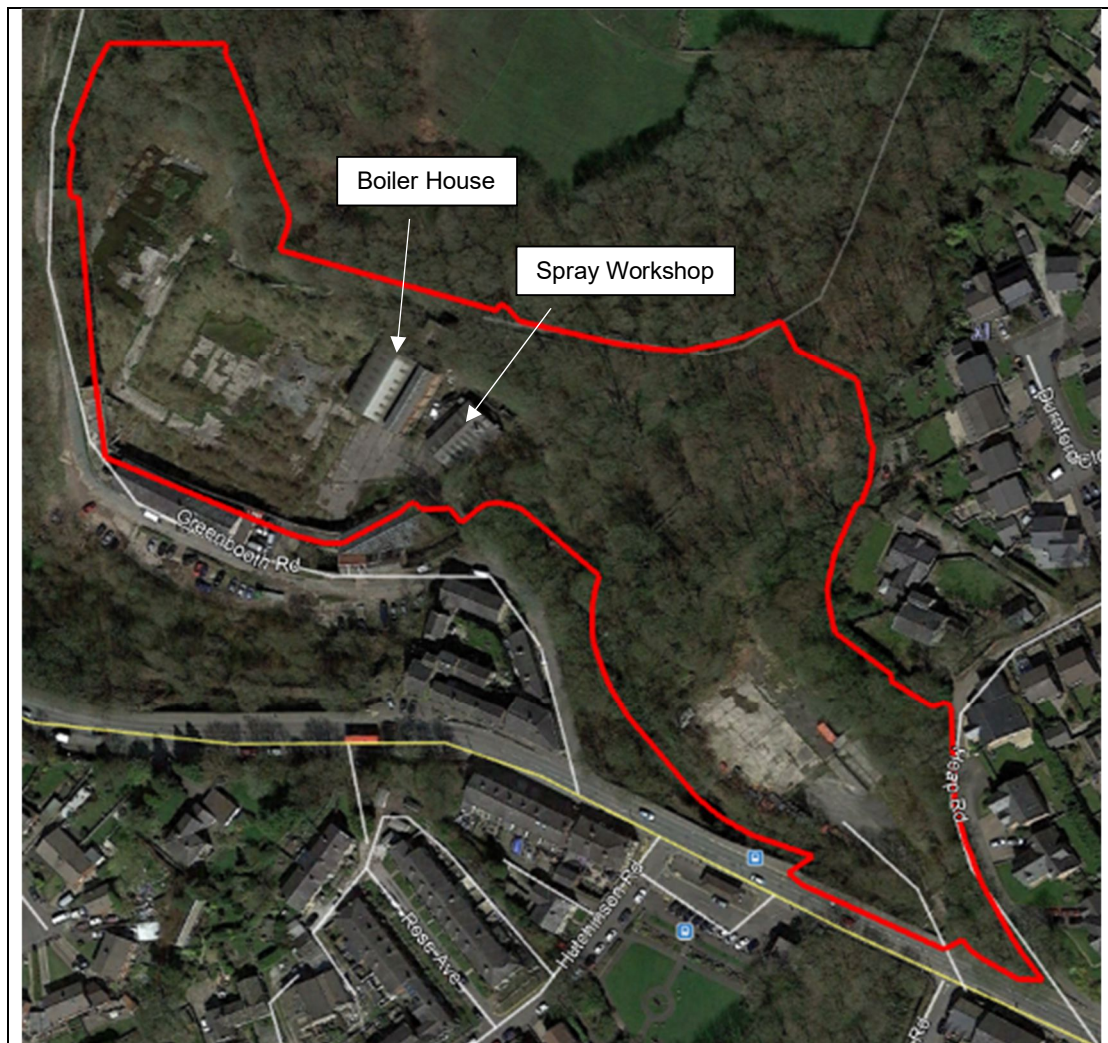
Plate 2-3: Extract from Google Earth Imagery 2018 © Google 2020.

2018 photography shows the former boiler house and former spraying workshop buildings only extant on Tack Lea Works and all buildings removed from the Shepherd Mill site.

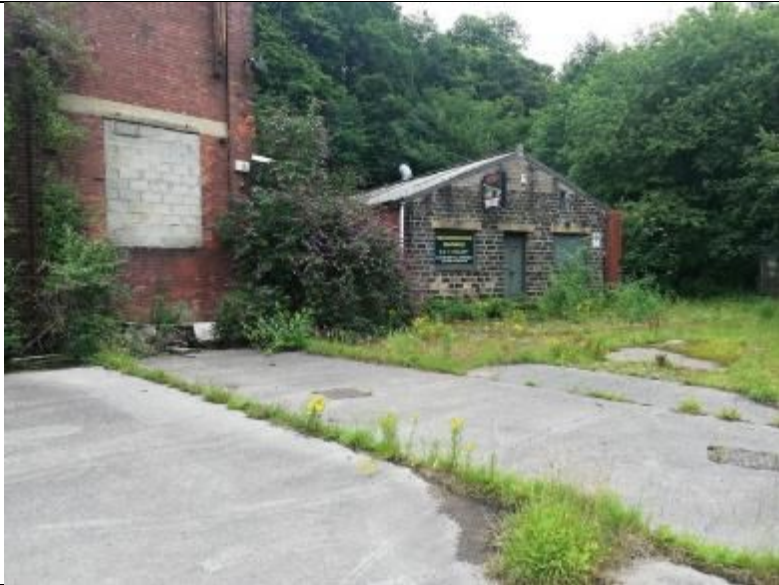
| | <p>Former boiler house and garage remain extant.</p> |

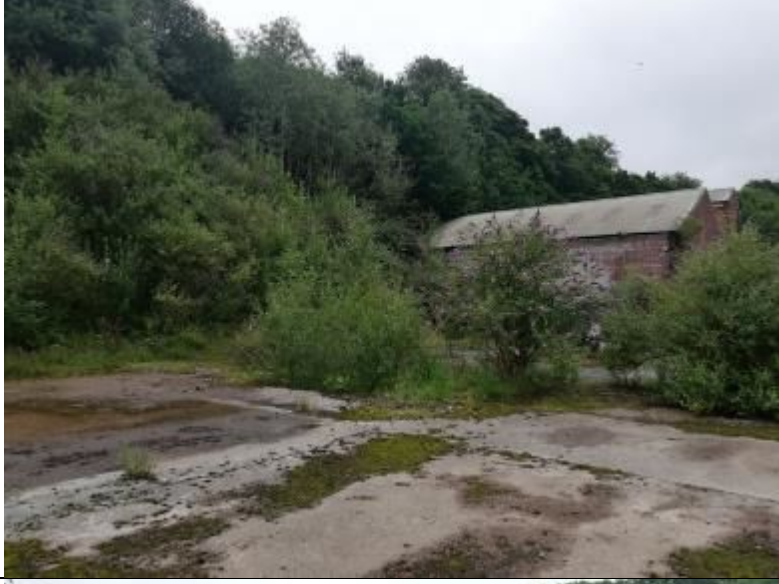
| | <p>Remnant hardstanding in former Tack Lea works building. Boiler house visible. Compare to Encia photograph 1.</p> |

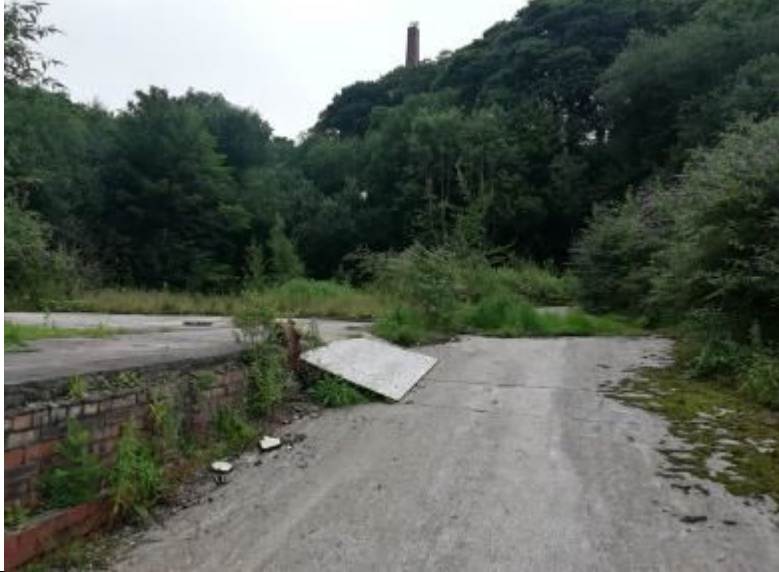
| | <p>Cleared former dye works building area. Compare to Encia Photograph 3.</p> |

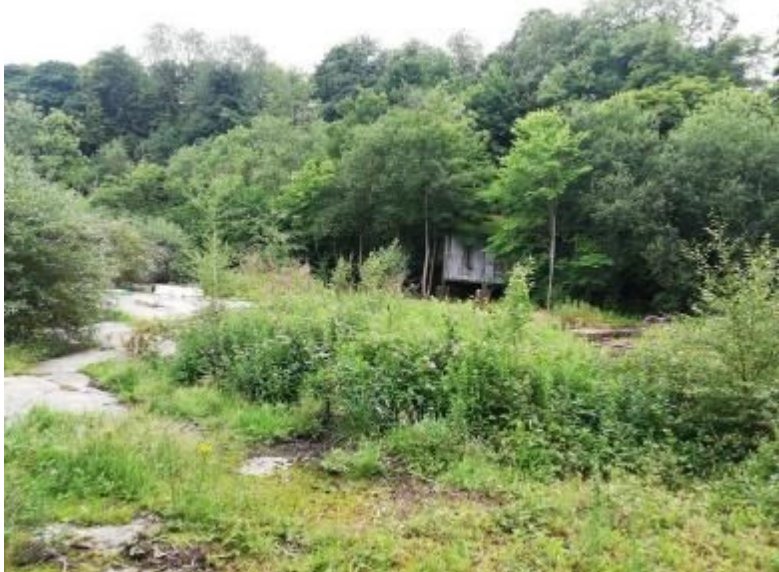
| | <p>Former dyeworks looking towards Naden Brook (see visible building across the watercourse). Hardstanding and scrub vegetation.</p> |

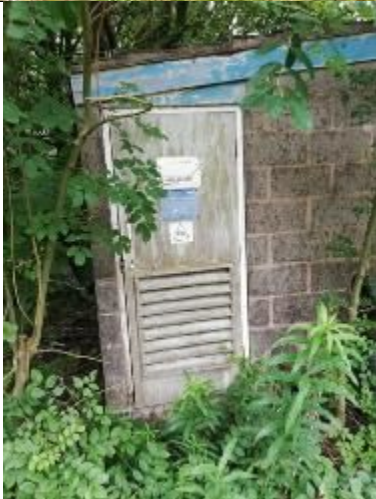
| | <p>Substation to east of garage.</p> |

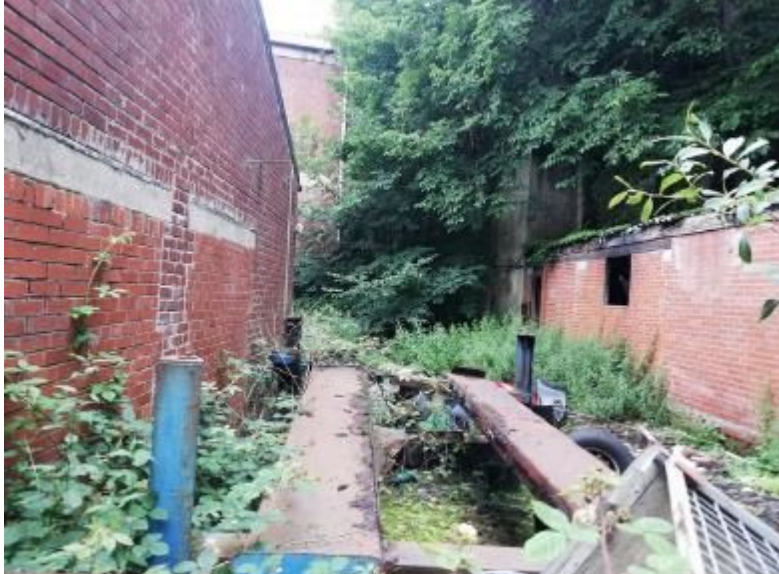
| | <p>View to north of garage. Brick building is adjoined to coal bunker at the upper level and has suspected asbestos cement roof.</p> |

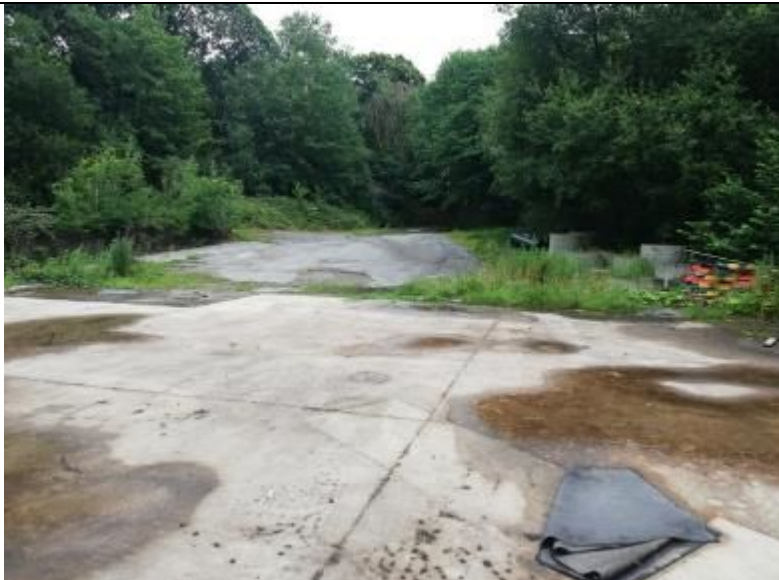
| | <p>Hardstanding present on Shepherd Mill.</p> |

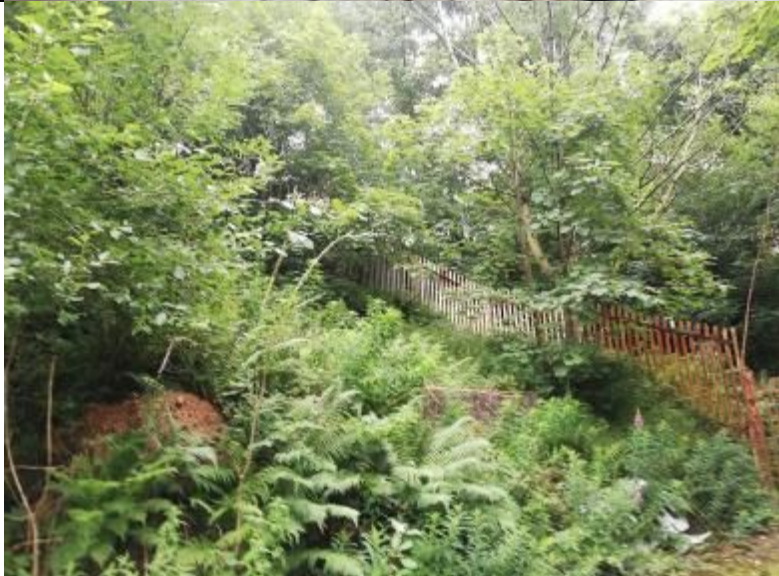
| | <p>Steep slope and vegetation to the north eastern boundary of Shepherd Mill. Compare to Encia photograph 15.</p> |
