**REPORT ON COAL MINING INVESTIGATIVE WORKS**  
**UNDERTAKEN ON LAND OFF**  
**SMITHY BRIDGE ROAD, LITTLEBOROUGH OL16 2RY**

**Q316 SFK (TLC1004) rep CH LKConsult 011018 (Rev G)  
October 2019**

***Report on Coal Mining Investigative Works undertaken on Land off Smithy Bridge Road,  
Littleborough OL16 2RY.***

**Report Number** : TLC1004 **Report Status** : Final

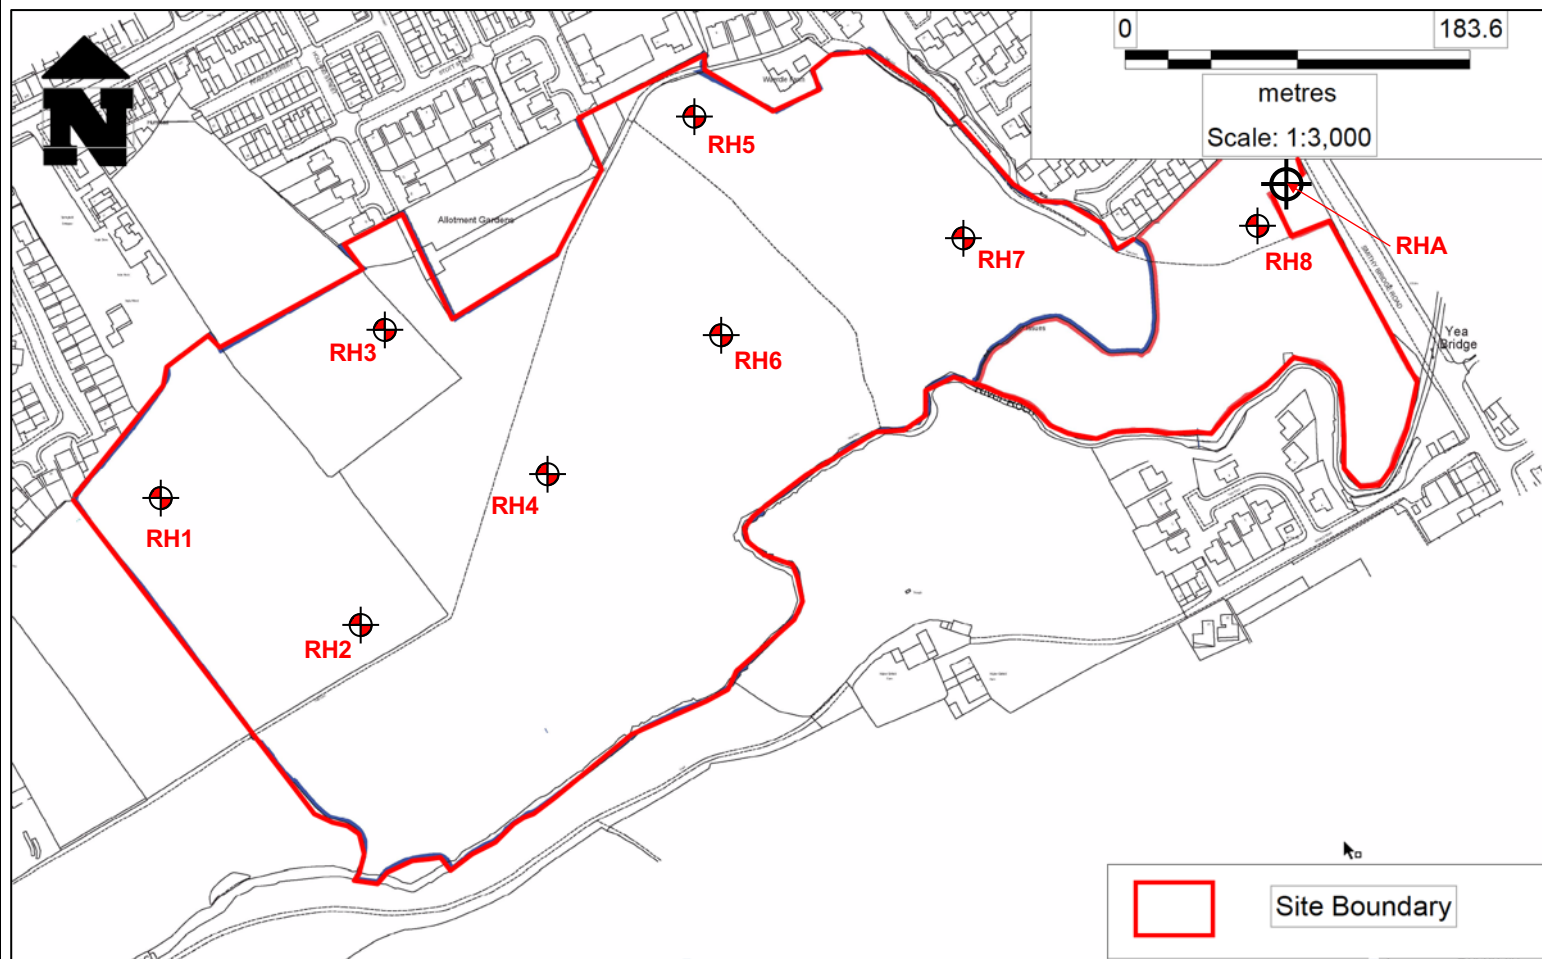
**Drawing No.: TLC1004/04**

**Mine Shaft Ref: 392415-005 (no treatment records). Investigated by trial trenching and rotary drilling.**

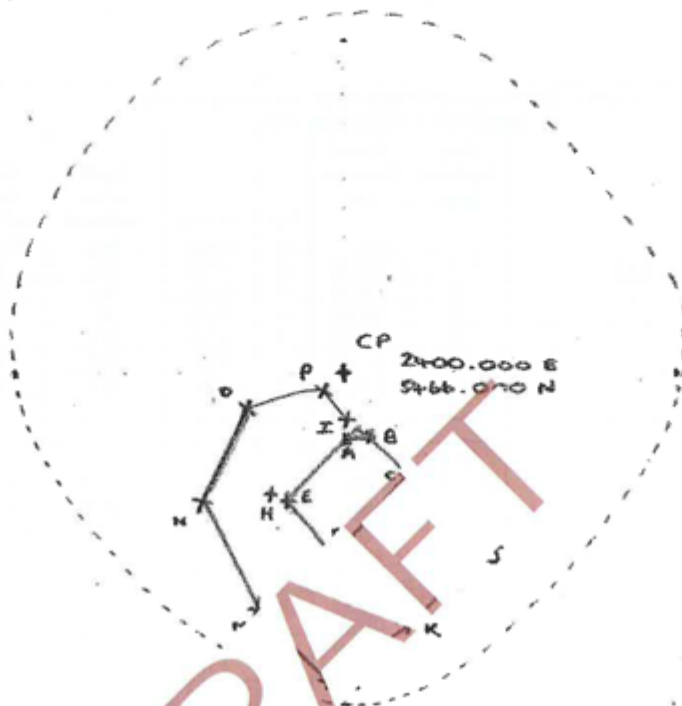
Drawing No.: TLC1004/05

- 3.5.4 Geotechnics exposed what they thought to be the concrete cap covering mine shaft and its position was surveyed by them. Drawing No. TLC1004/05 in Appendix A, which is reproduced from the Geotechnics report, displays the extent of shaft cap and also indicates the presence of a large sandstone block on top of the concrete. The coordinates of the edges of the concrete cap and sandstone block are also given on this drawing.

# EXISTING MINE SHAFT SURVEY. 4/3/2013
