# TREE SURVEY & REPORT

# **TREE SURVEY / SCHEDULE AND REPORT**

Location: 21 Botesworth Green, Milnrow OL16 3PJ

Order: Land off Charles Lane Milnrow, Sycamore T5 TPO 137

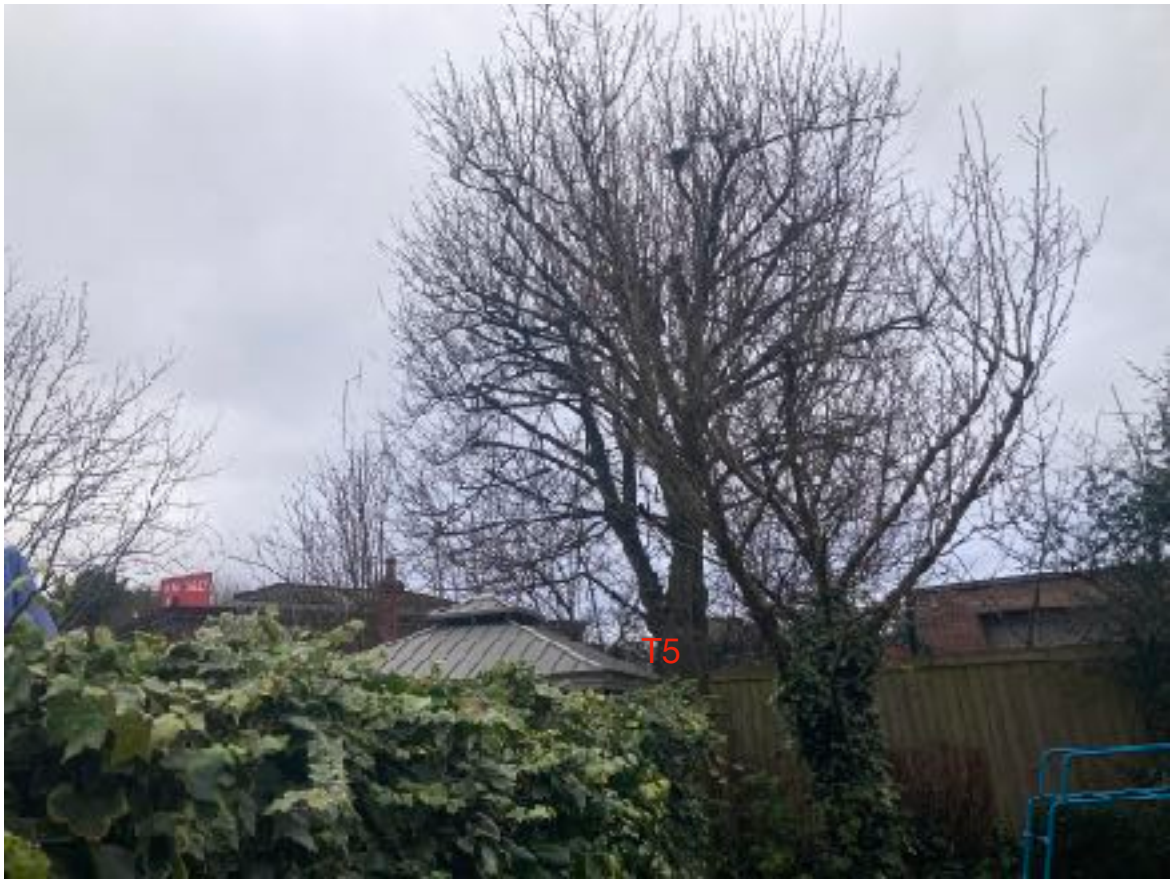
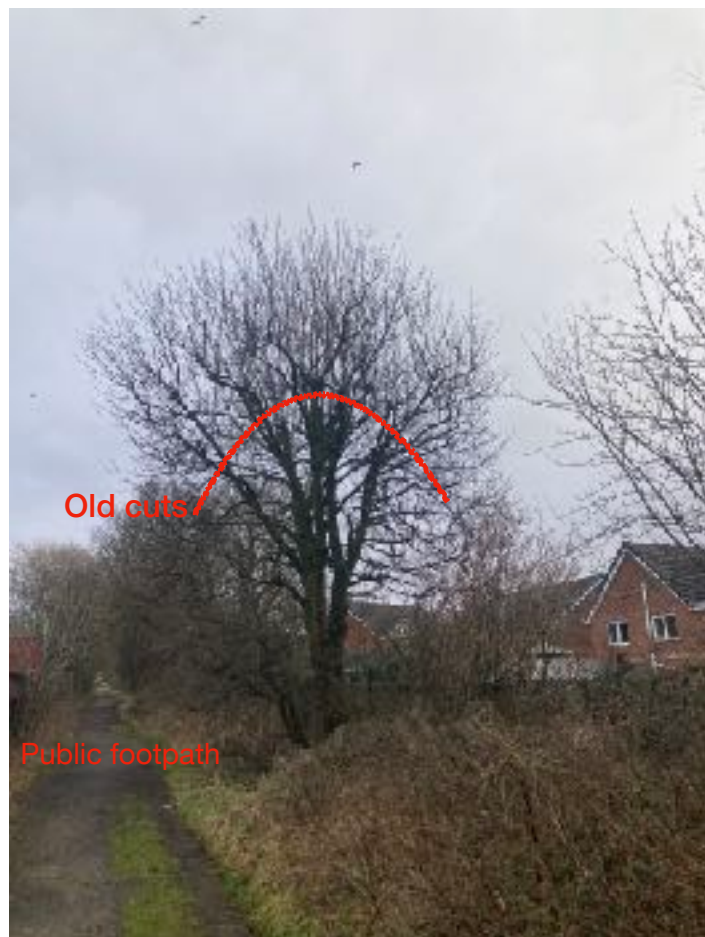
The tree is a mature 3 stemmed Sycamore in good health. However a significant fault on the main scaffold limb facing 21 Botesworth Green needs to be mentioned. The included bark union of the 3 main stems shows signs of weakness and risk of failure. Typically the debris and ingress of rainfall to the included bark union can be seen by the damp and moss growth on the limb.

Remove the tree by section down, and replant with 2 x Heavy Standard native trees more suitable in height and shape. This option takes away the risk and the shading, plus eliminates the continuing application process and work load on the Local authority.

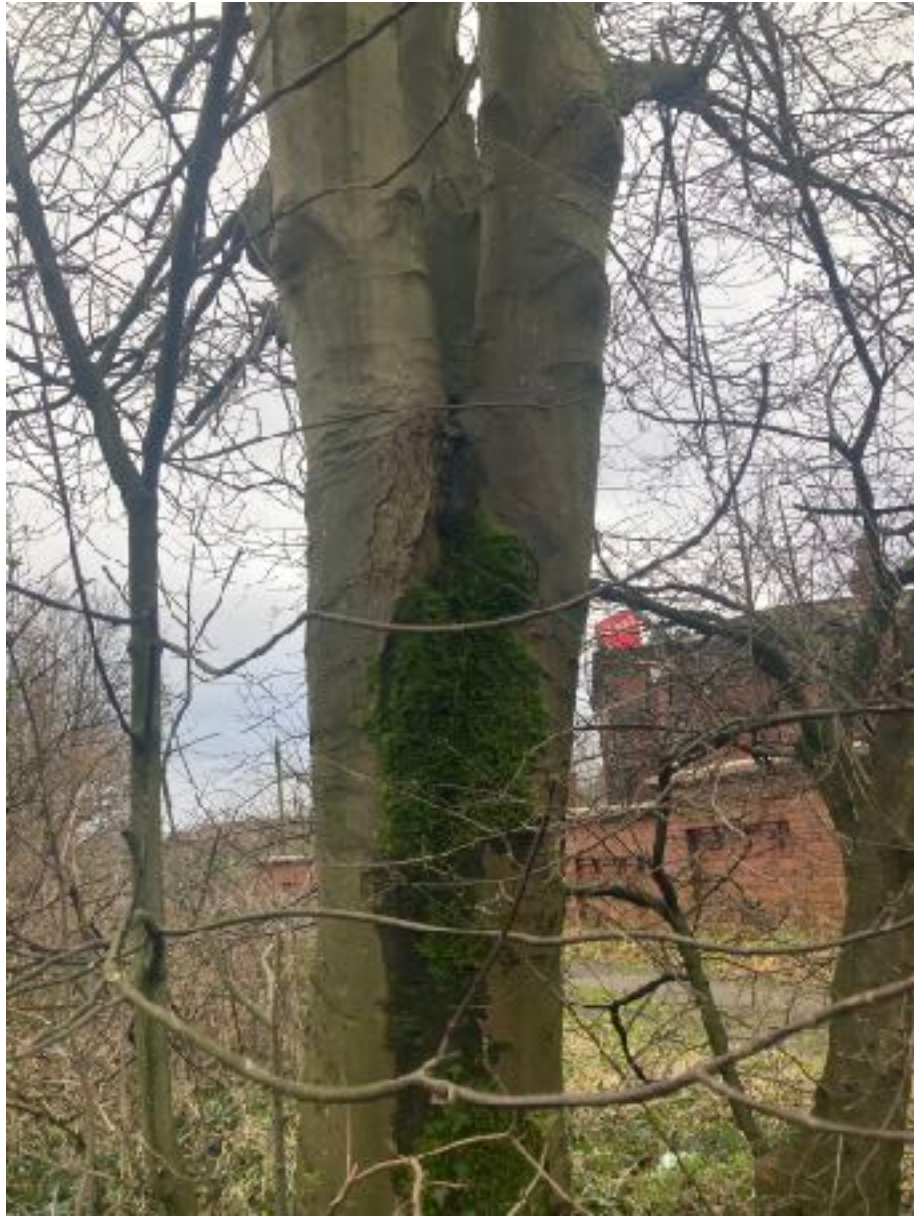
A hazard and risk of a scaffold limb failure due to an unstable included bark union must be addressed. It is negligent to do nothing in particular as the tree is next to residential properties and a public footpath. There are a number of options that can be taken:

T5 Showing included bark union

The recommendation is for option 3 above. The mentioned works in the tree schedule be maintained through good practice and any surgery completed to BS3998, 2010.
