Week 7– W/E 27.09.2024 – Stonework repairs, copings, brickwork raking out and re-pointing

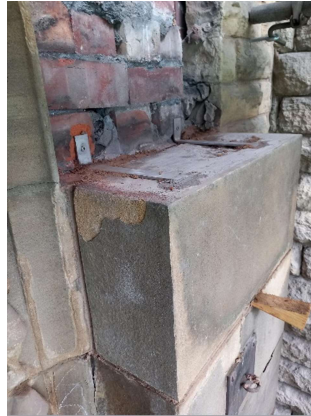
Dismantled entrance gable buttress being re-built and tied in for future stability..

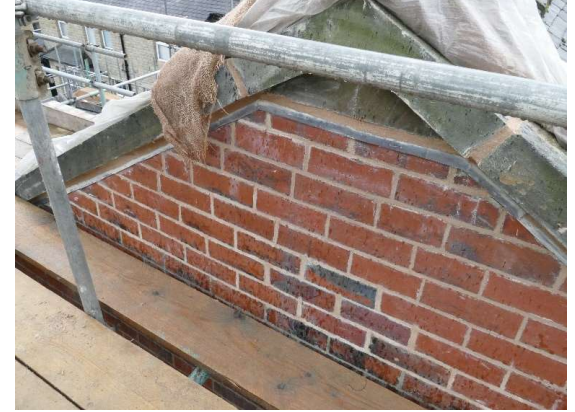
Completed coping, flashing detail and pointing to the meeting room roof.

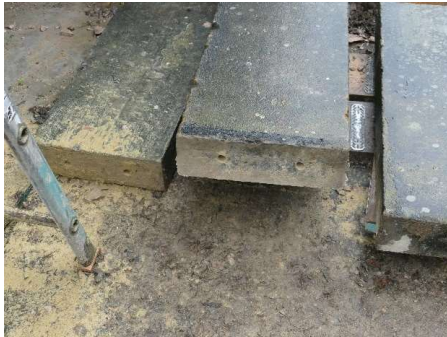
Copings to the flat roof parapet prepared and drilled to receive locating dowels.

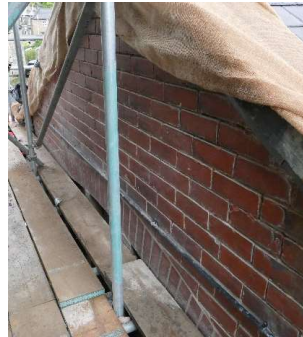
Reading room gable raked out ready for re-pointing.
