Validation Report  
Land off Don Street, Middleton

Reference: 14-554-R8-3  
Date: February 2025

# REMEDIATION AND ENABLING WORKS VALIDATION

Land off Don Street  
Middleton  
Greater Manchester  
M24 2DB

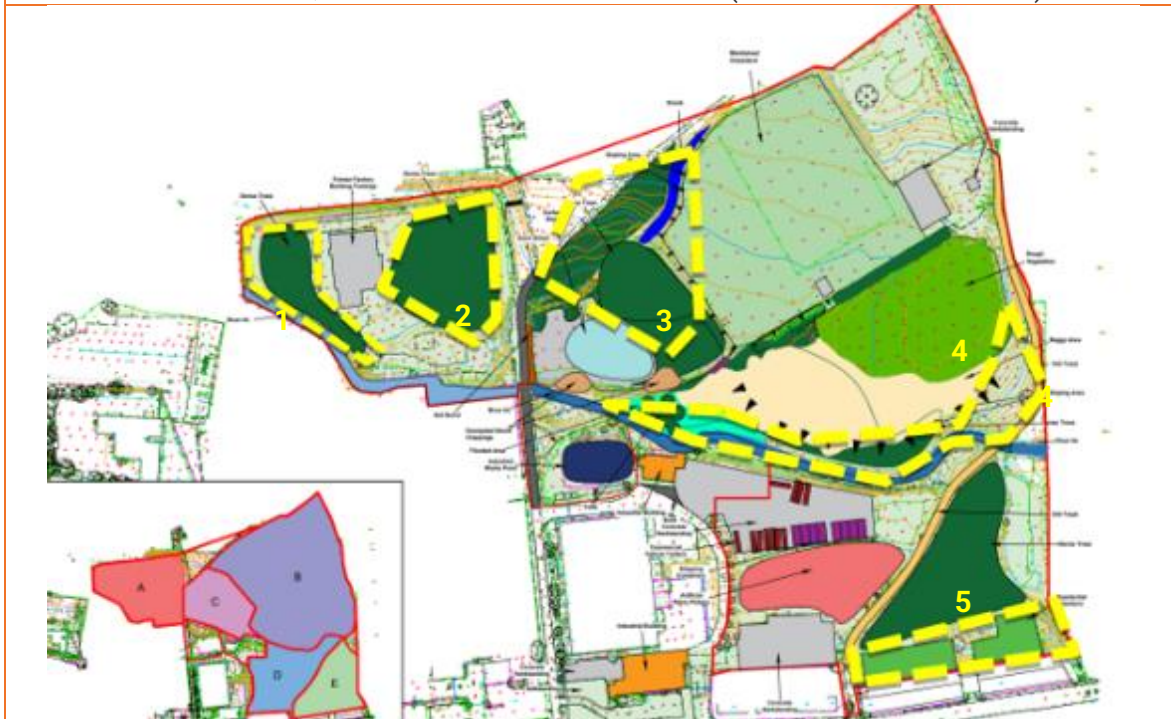
FIGURE 4.1 – AREAS REQUIRING FURTHER INVESTIGATION (YELLOW DASHED AREAS)

| Within Areas 1-4, as shown on Figure 4.1 overleaf, multiple phases of supplementary trial pitting were undertaken on the 8 <sup>th</sup> and 9 <sup>th</sup> of February 2022, 8 <sup>th</sup> of March 2022 and 10 <sup>th</sup> May 2022 to record ground conditions and obtain geotechnical and geochemical samples. Additional investigation of potential peat deposits in Area 3 (Phase 2A) were undertaken within these phases of supplementary trial pitting. The further investigation did not identify any true peat deposits, only very soft to soft clays with a shear strength value (Cu) of less than 30 kN/m <sup>2</sup> , the material is not suitable for vibro stone columns and requires removal with granular replacement during remedial works in this area. |

Granular replacement of soft organic clays in Area 3 (Phase 2A) was completed in January and February 2023.

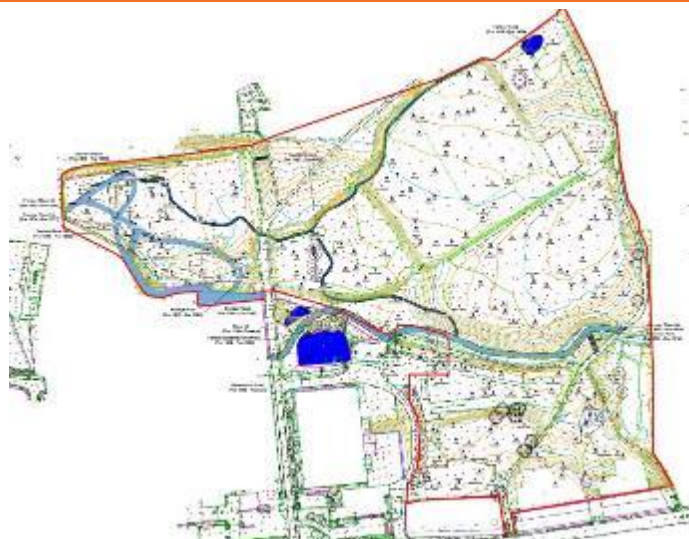
FIGURE 4.4 LOCATION OF IDENTIFIED INFILLED PONDS, STREAMS AND RIVERS

The location of known historic infilled ponds, streams and rivers are identified within the E3P Historical Features Plan (Drawing 14-554-003) in Appendix III and in Figure 4.4 below.

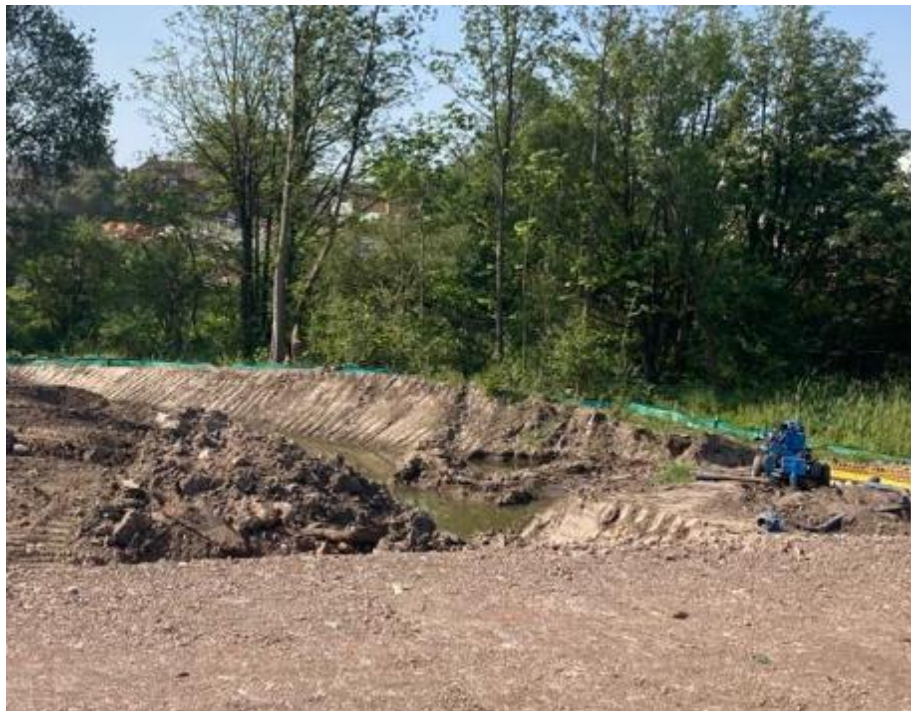
PLATE 6 SILT BUSTER AND FENCING ON SITE DURING EXCAVATION AND DEWATERING

In line with the dewatering plan, silt busters were present on site throughout the works for use in excavations below the water table. Additionally, silt fencing was erected along the boundary of the River Irk during active works and routinely inspected and replaced as necessary.

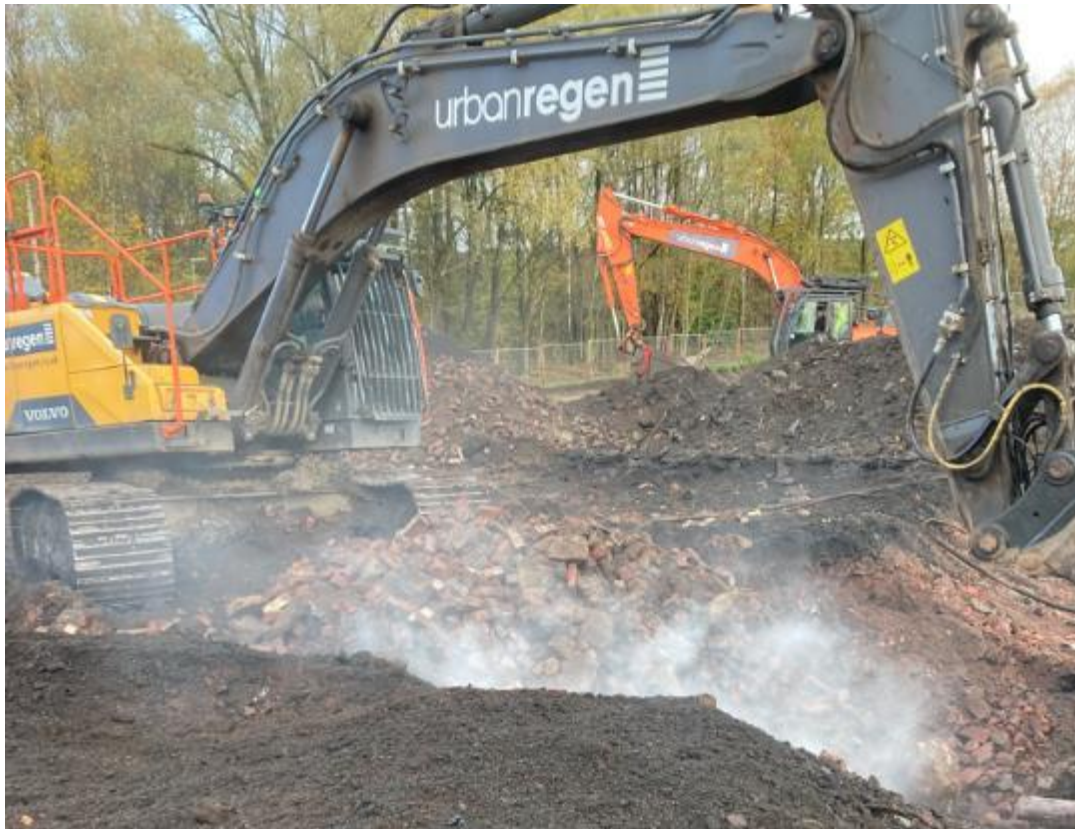
PLATE 11      REMOVAL OF SLAB AND SHALLOW OBSTRUCTIONS WITHIN PHASE 1

Within Phase 1 and Phase 3 concrete slabs and asphalt hardstanding were present and required removal. E3P observed the hardstanding being broken out and inspected soils beneath the slabs. No visual or olfactory evidence was identified directly underlying the historic slabs in Phase 1 or Phase 3. The hardcore arisings from historic slab removal were crushed and screened on site for re-use within the development upfill and temporary works mats.

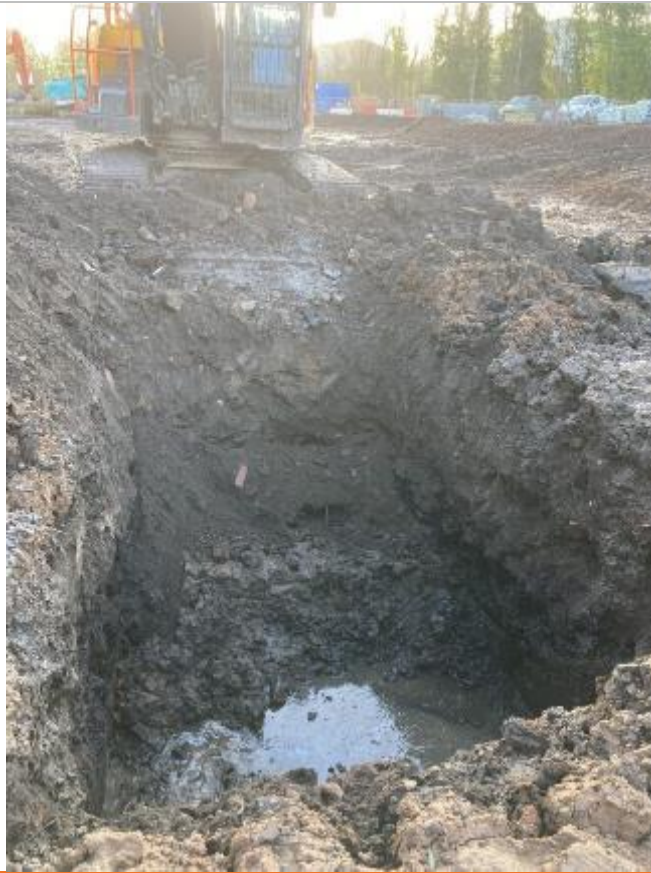
PLATE 39 TANK VALIDATION IN PHASE 2A

Along the boundary of Don Street within Parcel C a previously unidentified tank was uncovered during the turnover works, denoted on the sample location plan in Appendix III. The tank was removed, and chemical samples were obtained from the sides and base of the excavation to determine whether any leaching had occurred into the surrounding soils. During the excavation no visual or olfactory contamination was noted. Results from the chemical analysis did not exceed remediation thresholds and therefore soils were used in the upfill of Phase 2A.

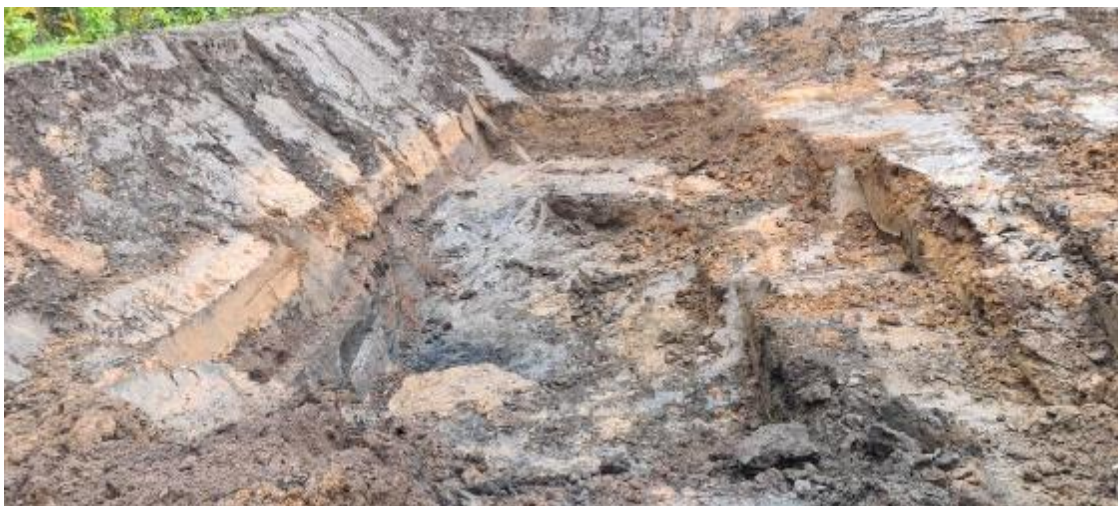
**PLATE 42** DELINEATION, EXCAVATION AND TREATMENT OF INFILLED HISTORICAL PONDS AND STREAMS

Within Phase 1 a former stream and historical River Irk layout is present through much of the south and west of the parcel. E3P maintained part time supervision during turnover in this parcel, no soft alluvial deposits or geotechnically unsuitable material resembling historic river or stream deposits was noted, as such, it is assumed this was grubbed out prior to the construction of the former Rex Mill. No further works were required in this area.
