# Drainage Report

**Morris Construction Ltd**  
**Moorgate Far East Farm**  
**Burnedge**  
**Rochdale**  
**OL16 4QL**

## Moorgate Farm - CCTV Survey Report : 10/10/23

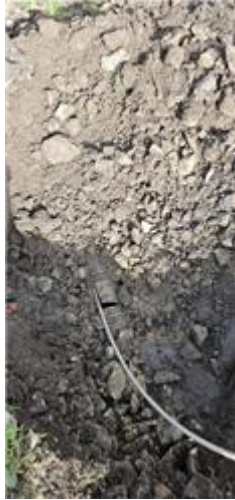
| Pos | Video Ref | Code | Description | Image |
|---|---|---|---|---|
| 00.00m | | OF | Start node type, outfall EXCO | <p>Image Provided - Ref: 0_0</p> |

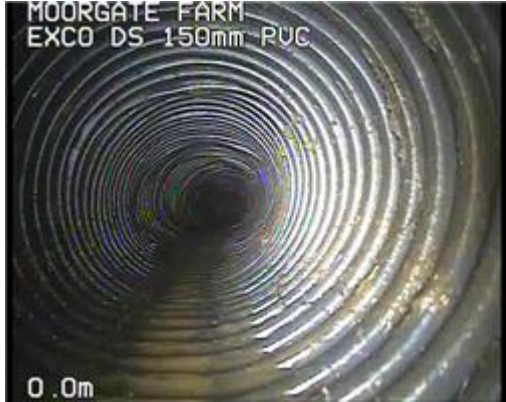
| Pos | Video Ref | Code | Description | Image |
|---|---|---|---|---|
| 00.00m | 0:00:00 | WL | Water level: 5% Height/Diameter | <p>Image Provided - Ref: 0_1</p> |

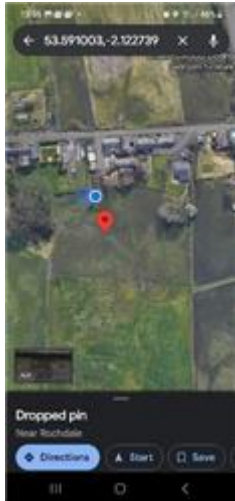
| Pos | Video Ref | Code | Description | Image |
|---|---|---|---|---|
| 00.00m | 0:06:44 | REM | General remark<br>Blue pin denotes EXCO location | <p>Image Provided - Ref: 0_4</p> |

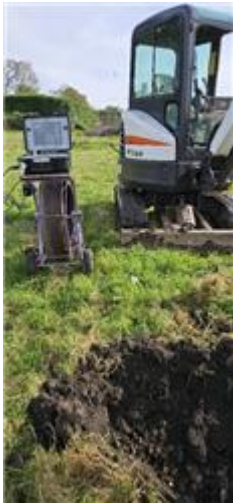
| Pos | Video Ref | Code | Description | Image |
|---|---|---|---|---|
| 50.00m | 0:00:00 | REM | General remark<br>Photo shows location for EXCO2 to take place | Image Provided - Ref: 0_2<br> |

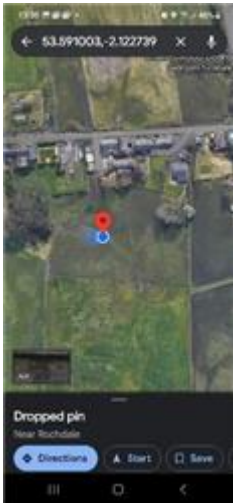
| Pos | Video Ref | Code | Description | Image |
|---|---|---|---|---|
| 50.00m | 0:00:00 | REM | General remark<br>CO ORDS EXCO2 | Image Provided - Ref: 0_3<br> |

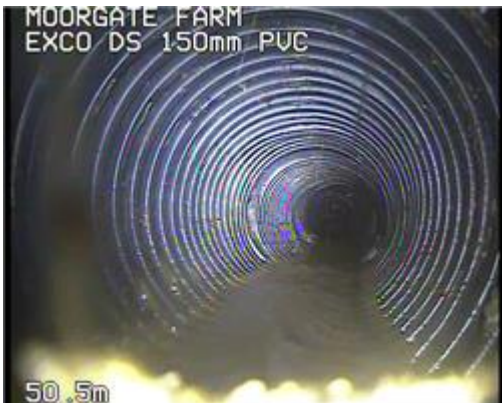
| Pos | Video Ref | Code | Description | Image |
|---|---|---|---|---|
| 50.50m | | OFF | Finish node type, outfall<br>EXCO2 | Image Provided - Ref: 0_9999<br> |

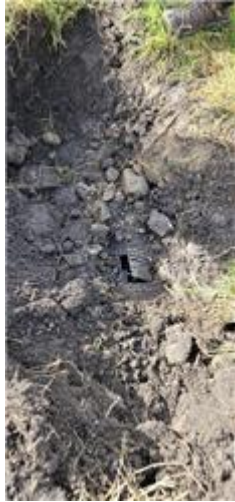
| Pos | Video Ref | Code | Description | Image |
|---|---|---|---|---|
| 00.00m | | OF | Start node type, outfall EXCO2 | <p>Image Provided - Ref: 1_0</p> |

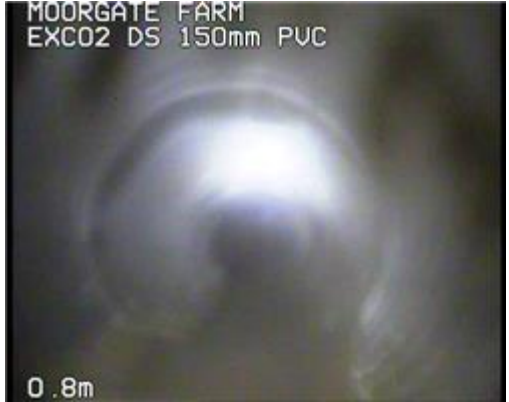
| Pos | Video Ref | Code | Description | Image |
|---|---|---|---|---|
| 00.00m | 0:00:00 | WL | Water level: 5% Height/Diameter | <p>Image Provided - Ref: 1_1</p> |

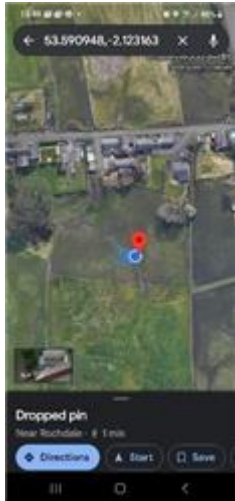
| Pos | Video Ref | Code | Description | Image |
|---|---|---|---|---|
| 23.20m | 0:01:20 | REM | General remark CO ORDS BRF | <p>Image Provided - Ref: 1_2</p> |

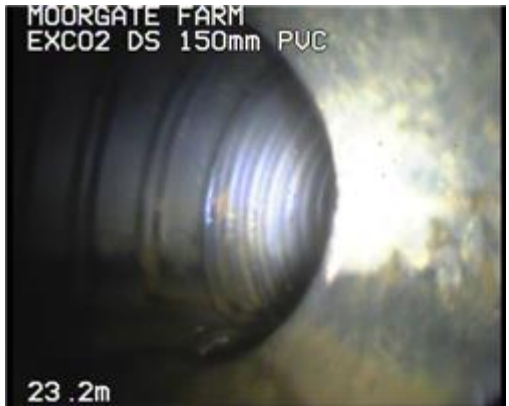
| Pos | Video Ref | Code | Description | Image |
|---|---|---|---|---|
| 23.20m | | BRF | Finish node type, major connection without manhole<br>Branch Soak | <p>Image Provided - Ref: 1_9999</p> |

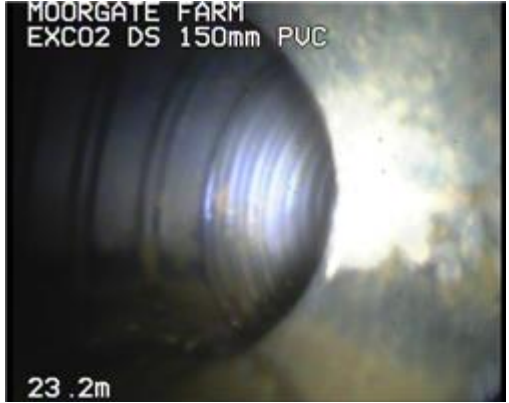
| Pos | Video Ref | Code | Description | Image |
|---|---|---|---|---|
| 23.20m | 0:00:00 | WL | Water level: 5% Height/Diameter | <p>Image Provided - Ref: 2_1</p> |

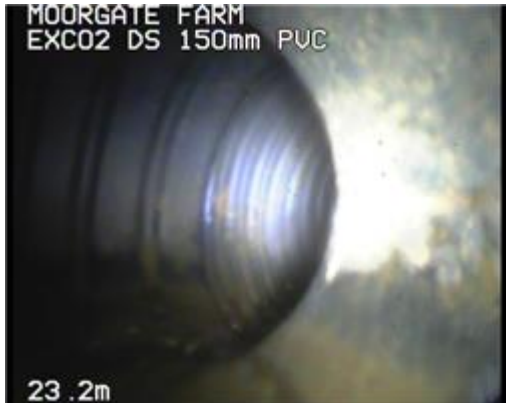
| Pos | Video Ref | Code | Description | Image |
|---|---|---|---|---|
| 23.20m | 0:01:30 | REM | General remark<br>Start from Branch @ 23.3m | <p>Image Provided - Ref: 2_2</p> |

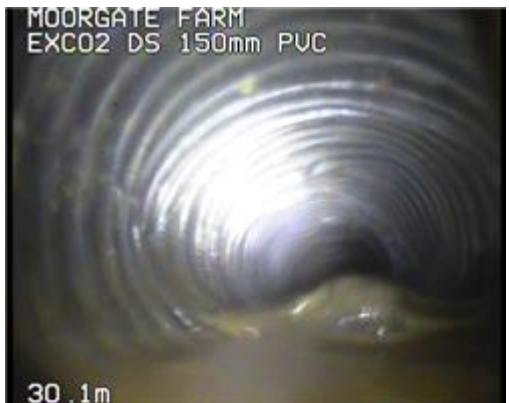
| <b>Section: 3</b><br><br><b>From: BRF</b><br><b>To: Crushed</b> | Pipe deformed - Unable to pass | <b>DRB Grade: A</b><br><b>Pipe Size: 150</b><br><b>Material: Polyvinyl Chloride</b><br><b>Use: Surface Water</b> |

| Pos | Video Ref | Code | Description | Image |
|---|---|---|---|---|
| 30.10m | | SA | Survey abandoned<br>Pipe deformed - Unable to pass | <p>Image Provided - Ref: 2_9999</p> |
