# Heritage Statement

## Silverhill Farm, Rochdale

July 2022

### SILVERHILL FARM AND BARN ROCHDALE

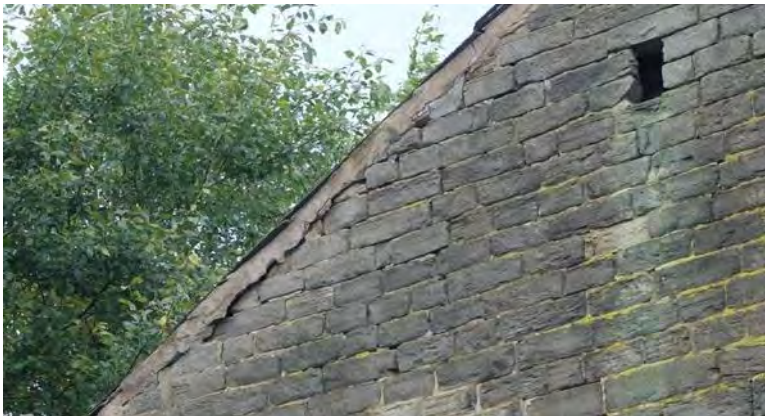
At the verges the slates extend over the face of the stonework the infill verge detail is untidy and has been done using a hard cementitious mortar. This has become loose in places and will require complete renewal.

Photo. Loose cement verge pointing

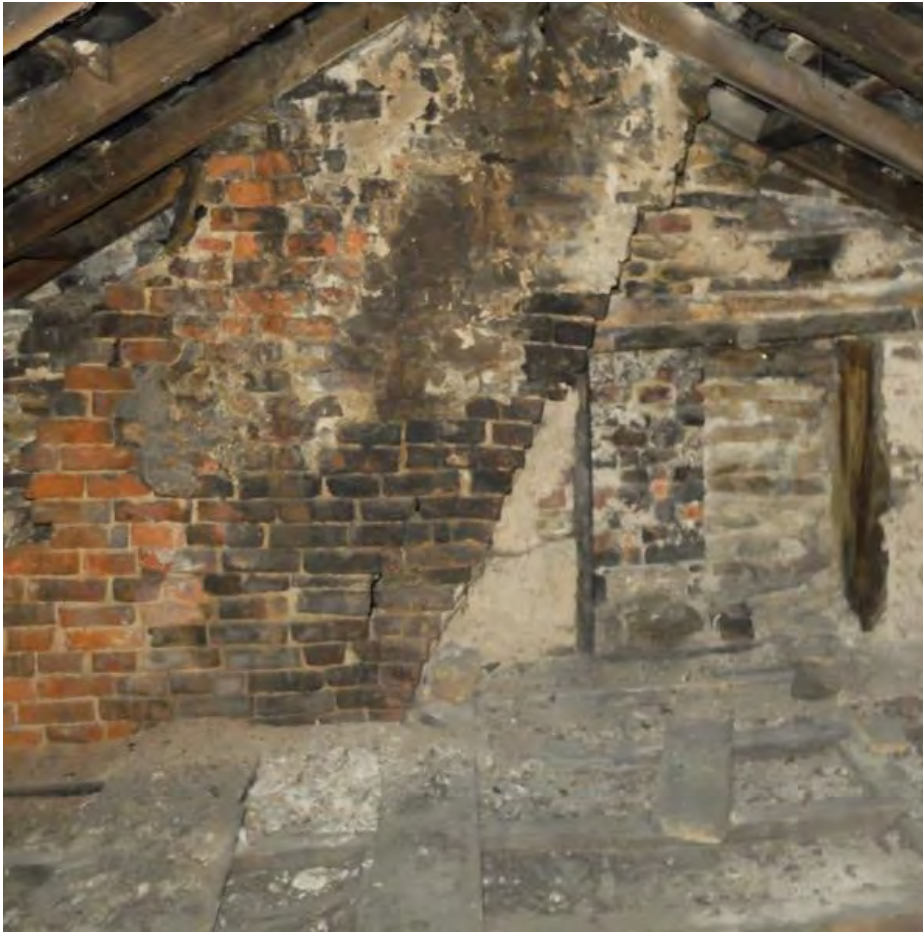
There is concern regarding the stability of the left-hand chimney within the external gable wall and further support is required.

Photo. Crack at base of chimney the angle of build is too steep and urgent support is required, Roof space R1

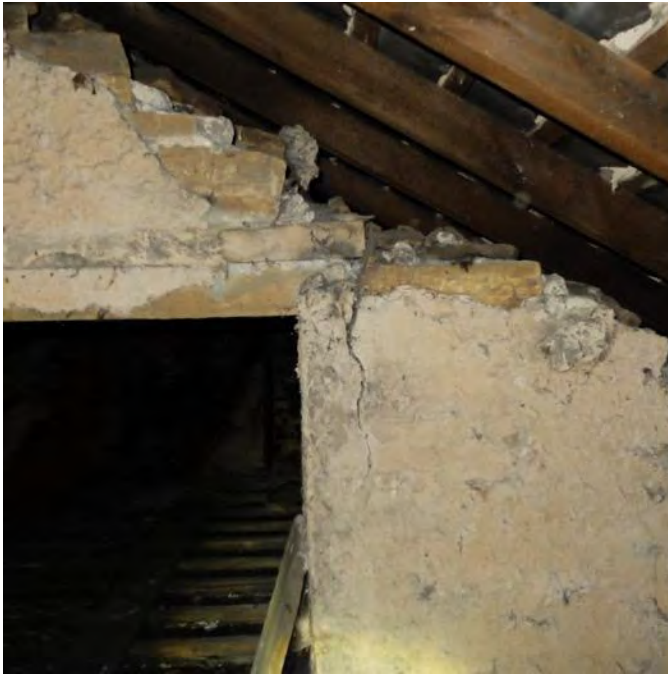
There is cracking around the lintel above the doorway which provides access into the middle roof area and some rebuilding works are required to make this secure.

Photo. Crack around lintel to opening between roof spaces R1 and R2

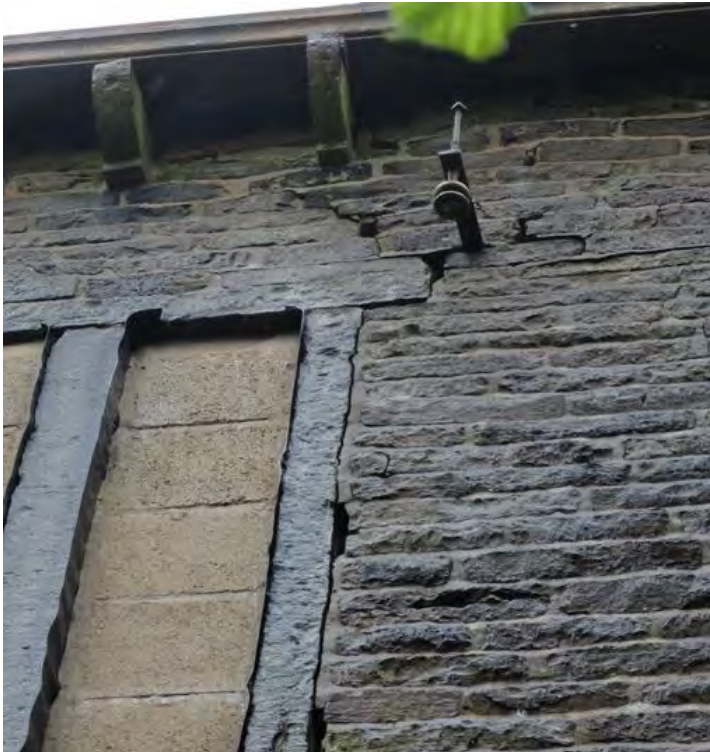
There is a diagonal crack within the mortar joints of stonework which extends from the top of the first floor left hand window down to the living room window below.

Photo. Crack from roof along vertical stone reveal to window.

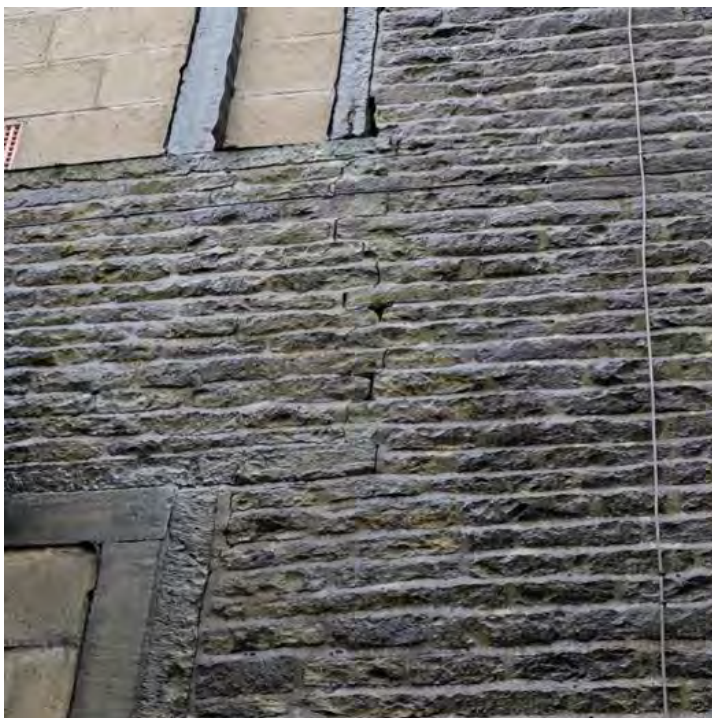
Photo. Crack extends from first floor to ground floor window.

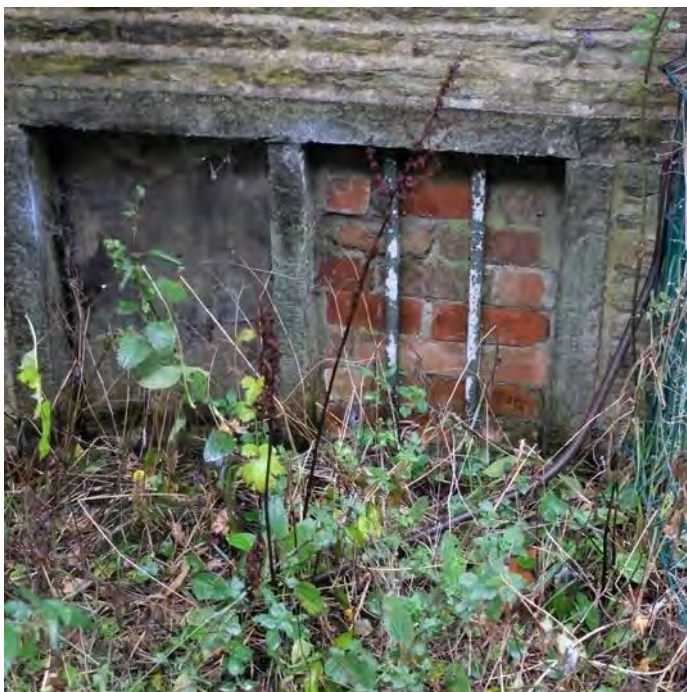
At basement level there are metal bars within the window openings between the stone head and cill and this may have caused rusting and damage to the stone. Further investigation is required.

Photo. Bars to basement window concern regarding corrosion

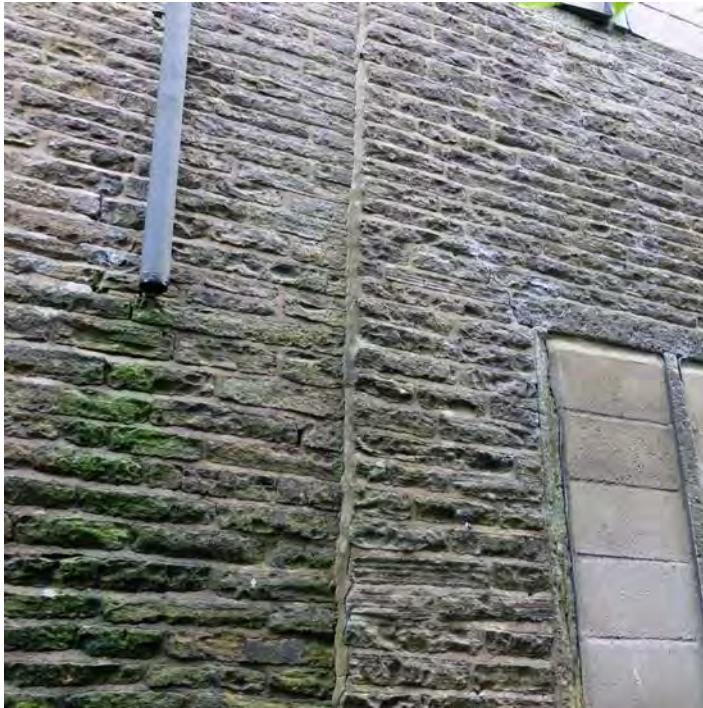
Along the vertical joint between the existing building and the extension there is bowing to the extension wall which now projects out at the centre.

Photo. Outward bowing to extension wall at chamber level.

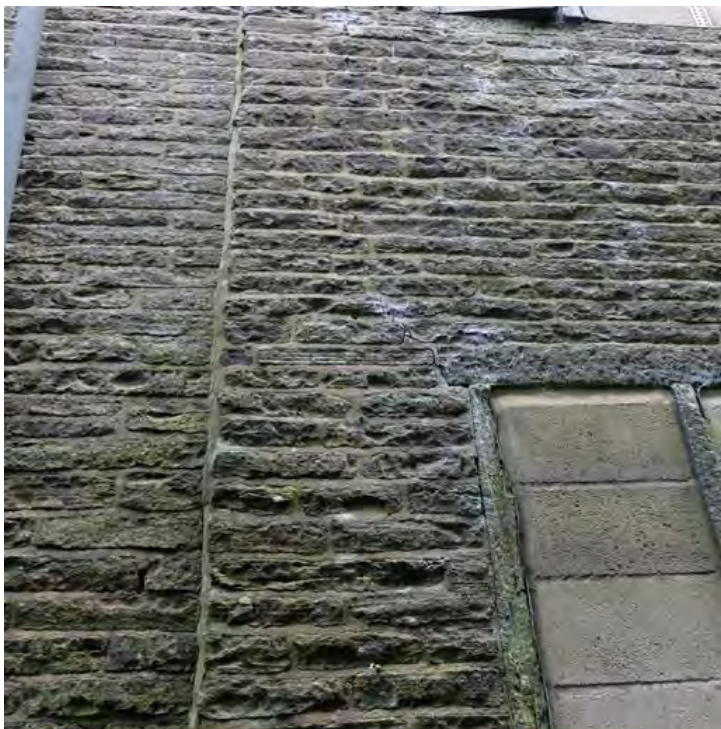
There is diagonal cracking from the top left corner of the ground floor extension window which travels upwards.

Photo. Diagonal crack above ground floor window to extension

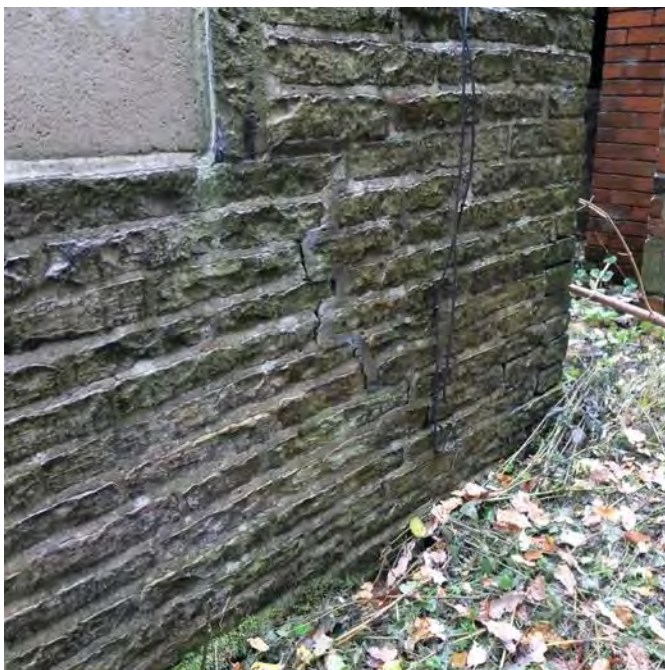
Photo. Diagonal cracking towards front right corner

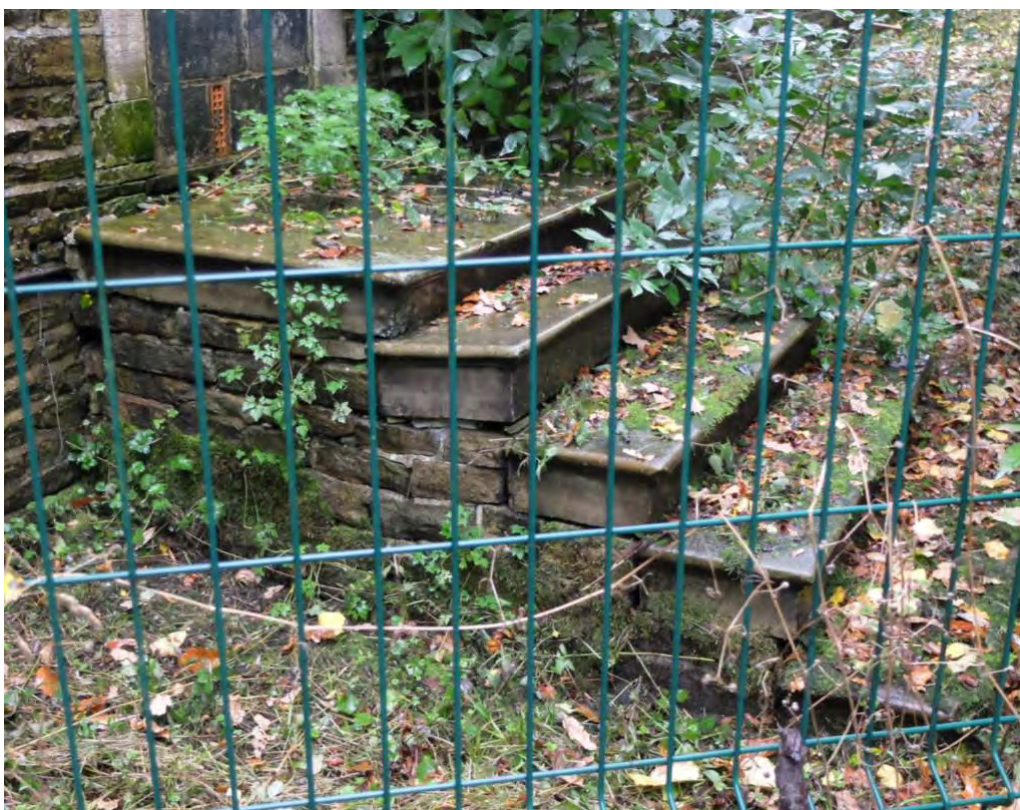
The ashlar stone steps to the front door have moved and will require repair and rebedding.

Photo. Stone steps to front door require repair.

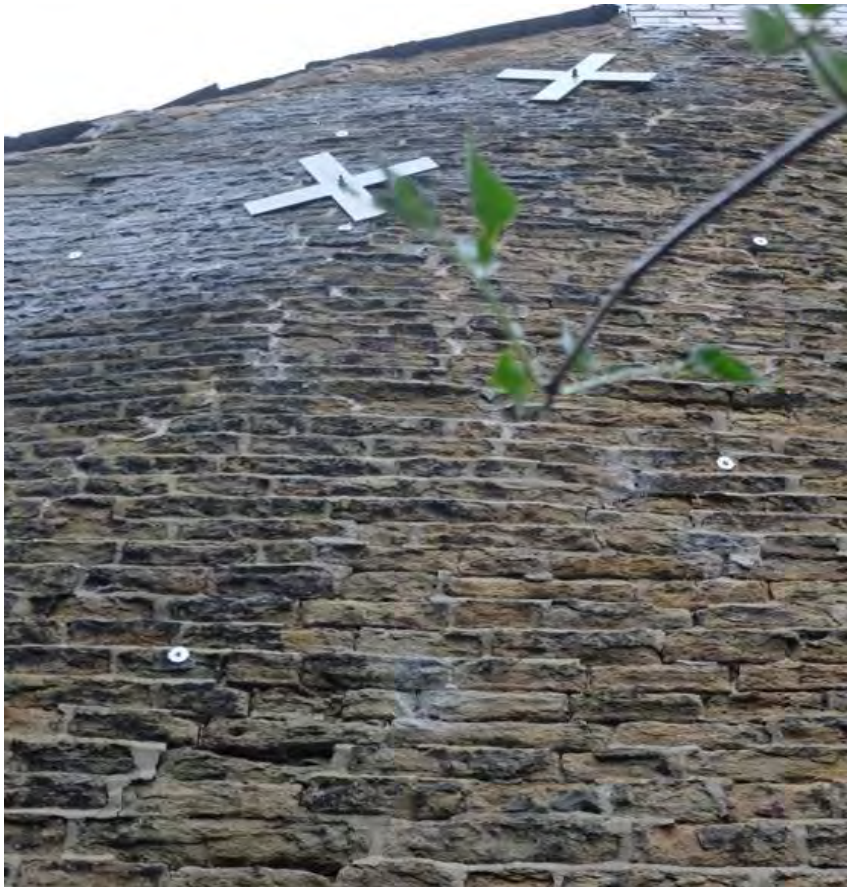
There is a large area of bowing to the gable which extends from the front top corner down to the first floor, floor level and then backup to the underside of the chimney. This is indicative of movement of the outer leaf of stone and may have been caused initially by sulphate attack within the chimney stack which will have caused the volume expansion of the mortar. Horizontal cross ties have been added in the past to try and restrain this movement however rebuilding of the outer leaf is required which would have to incorporate some horizontal ties to tie the two leaves of masonry together.

Photo. Bowed section of gable around flue to chimney.

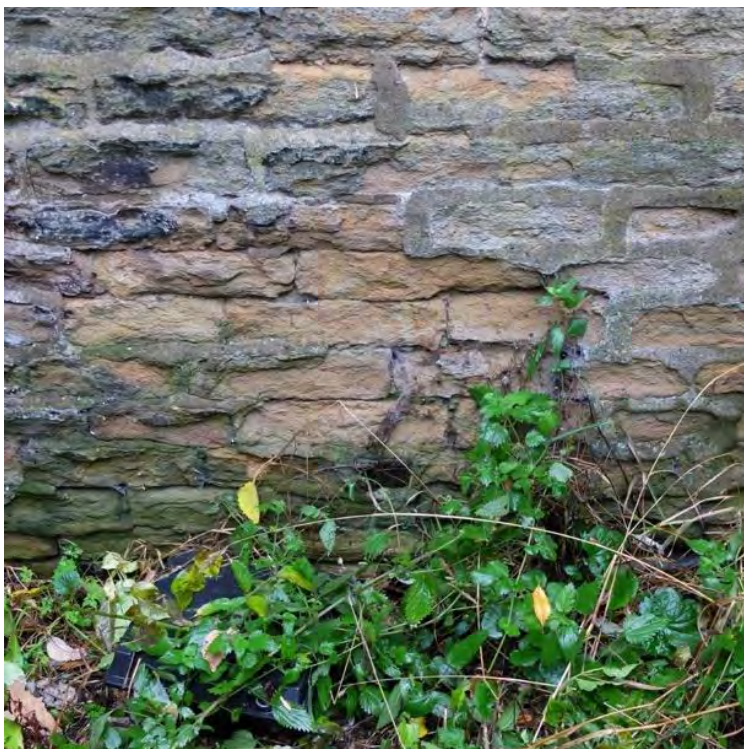
At low level the stonework to the back of the chimney flue is very badly corroded which is indicative of sulphate attack. Some of the stones are corroded to the extent where they will require replacement and cannot be dressed back cosmetically.

Photo. Corroded and frost damaged stone beyond repair.

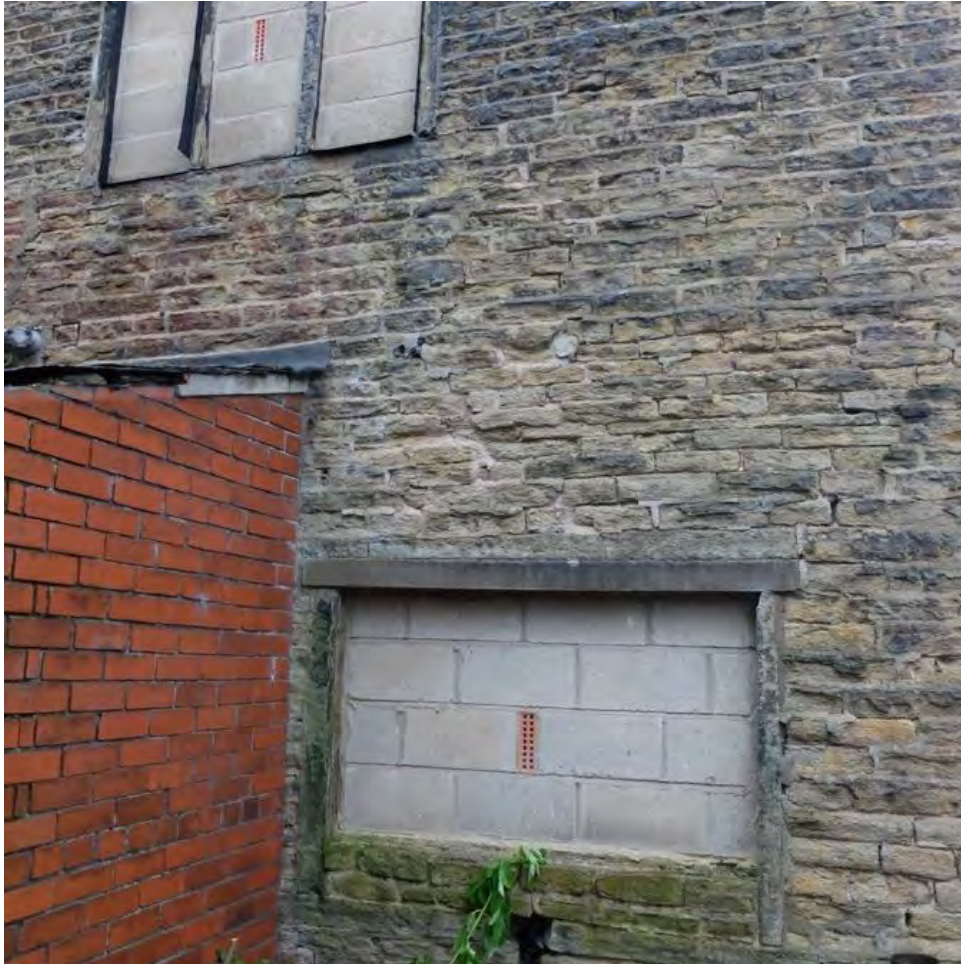
Photo. Cracking between ground and first floor windows.

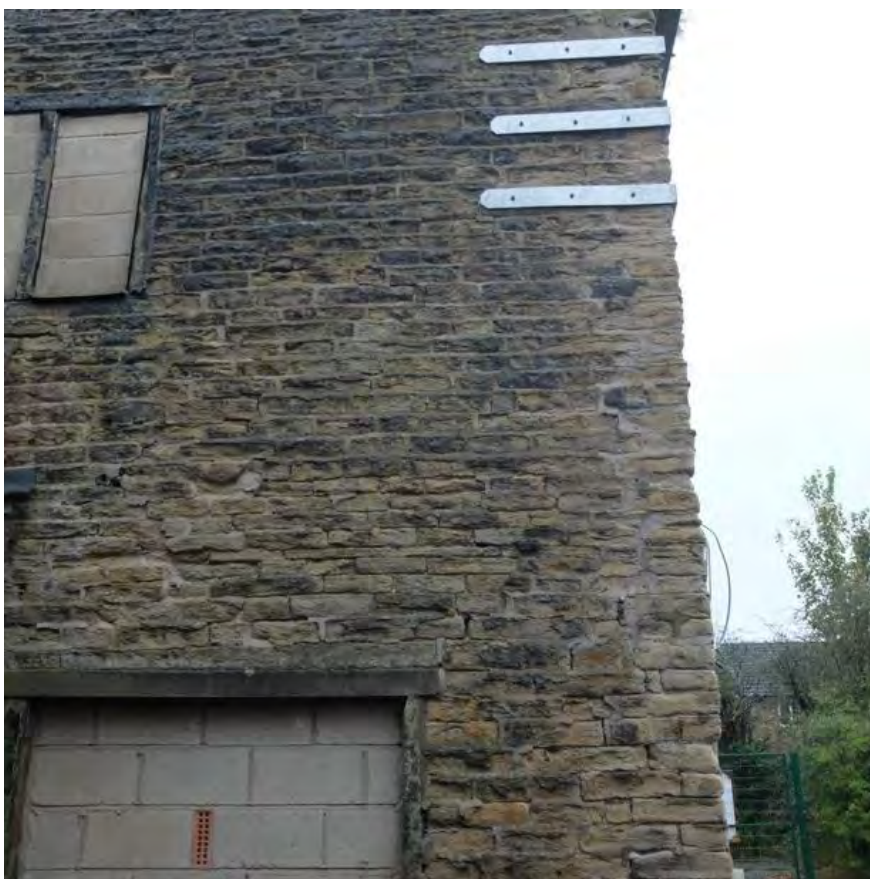
Photo. Frost damaged and eroded stone.

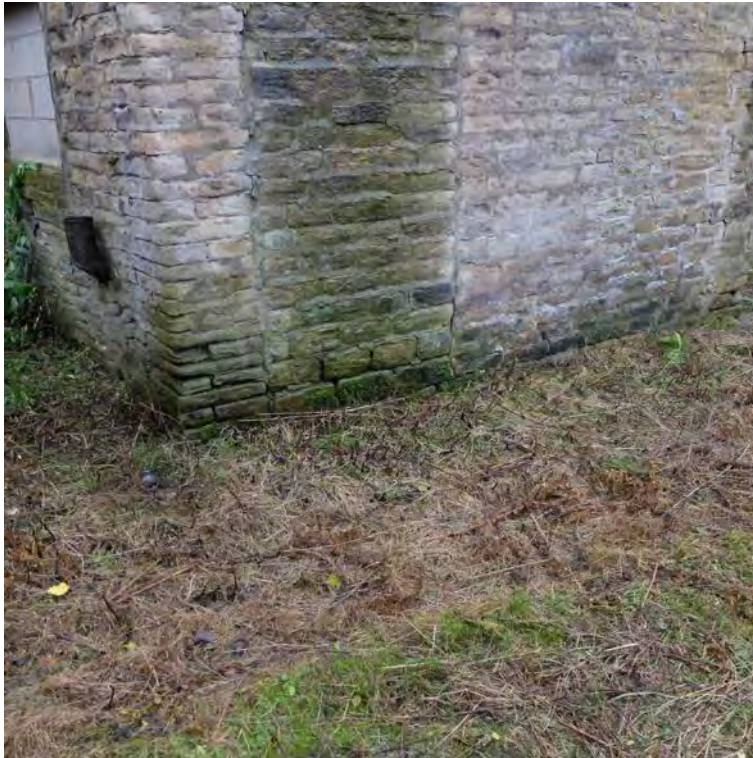
A crack is evident along the vertical joint which has been formed by the blocking up of the door towards the right (east) corner. There is a further blocked up window at first floor level.

Photo. Crack along vertical joints between wall and infill.

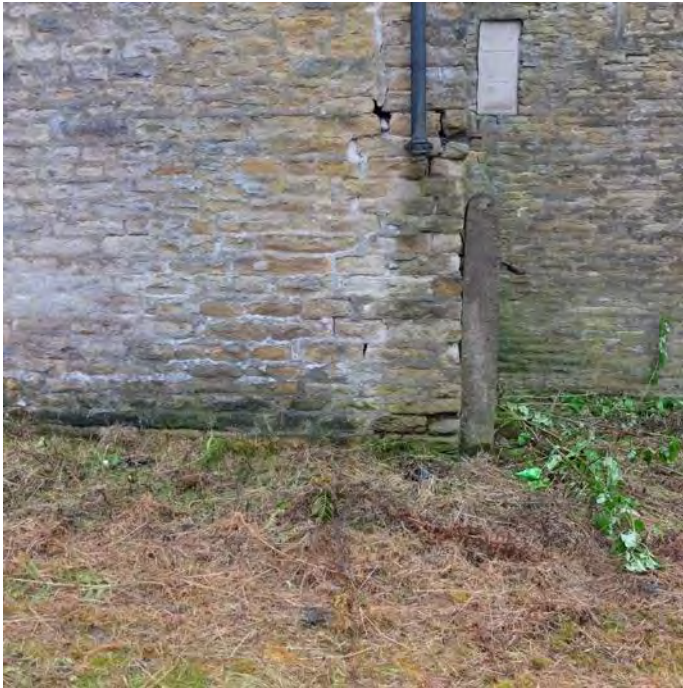
Photo. Eroded stonework to corner in location of downspout, foundation investigation required

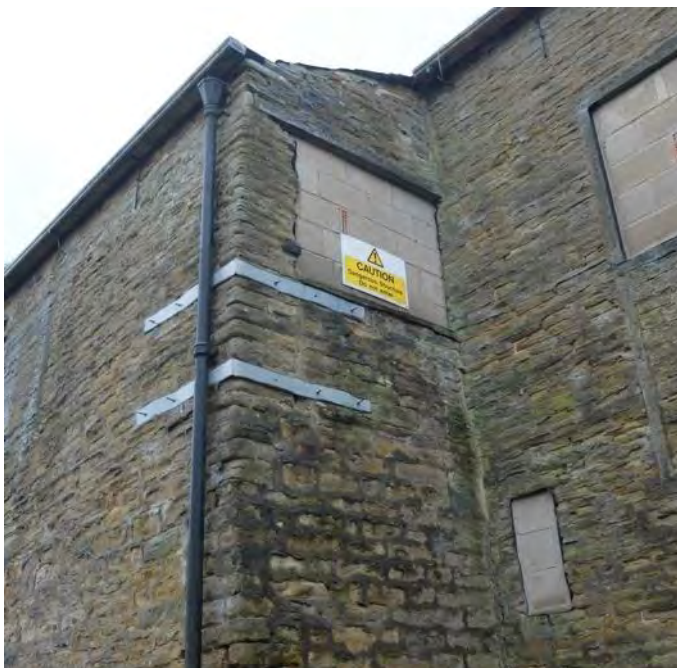
Photo. Outward bowing of wall caused by position of window opening.

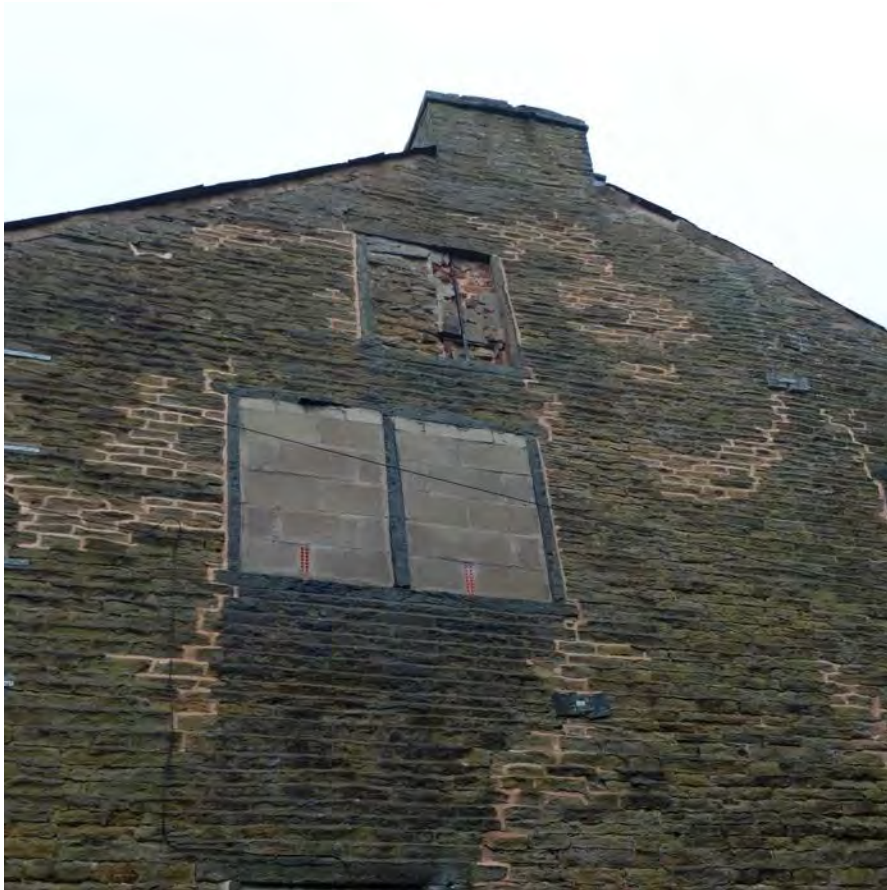
The mortar used for the repair is the wrong colour and appears to not contain sufficient aggregate to prevent future shrinkage and failure. With stonework of this type, it is necessary to use larger particles of aggregate which prevent excessive shrinkage in-service.

Photo. Previous repairs and bowing of masonry below chimney

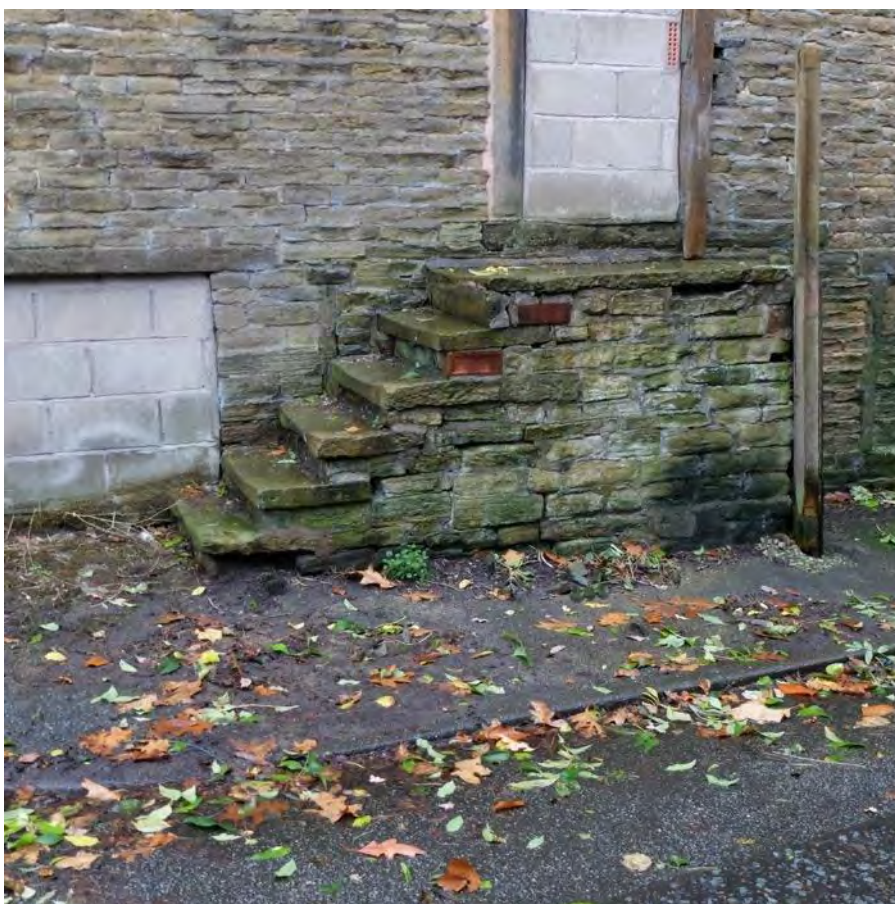
The stone steps to the side door are badly corroded and will require some rebuilding.

Photo. Later stone steps to gable door will require rebuilding

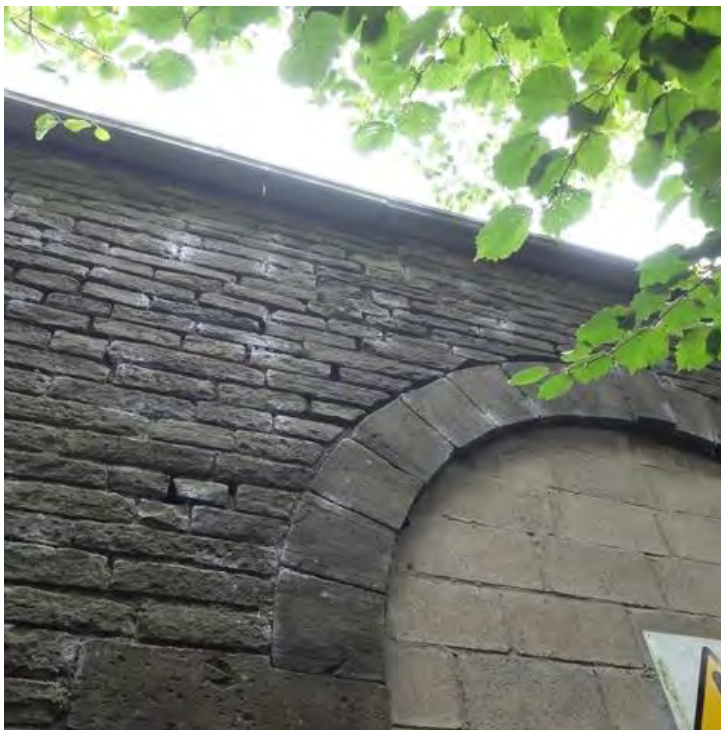
There are areas on the front elevation where leaks from the gutters have promoted the washing out of mortar from the walling stones.

Photo. Mortar was away by leaks

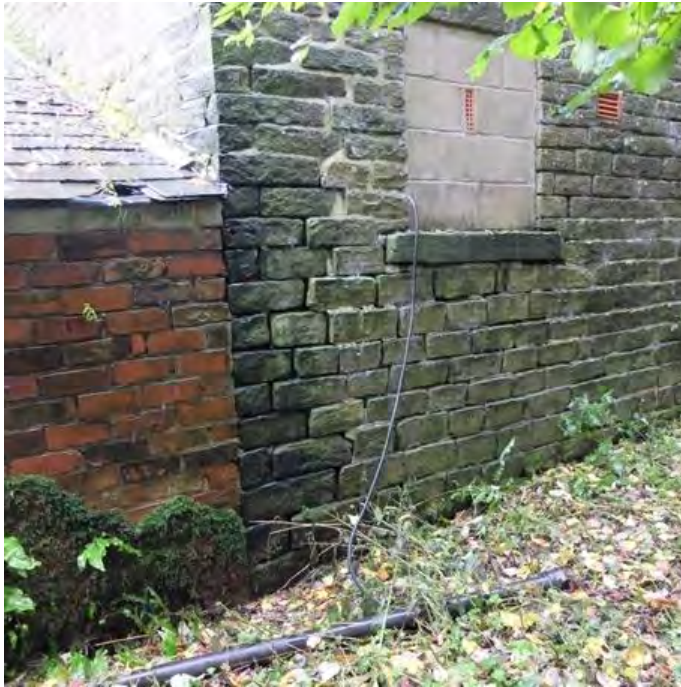
There is some loose stone located to the front left corner at low level.

Photo. Loose brickwork at ground level

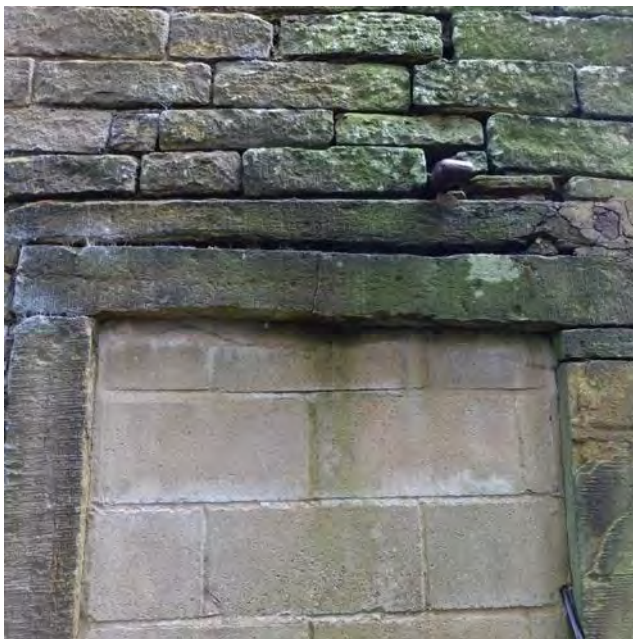
The stone lintel above the window is cracked and there is loose stone above.

Photo. Crack to lintel and movement of masonry above

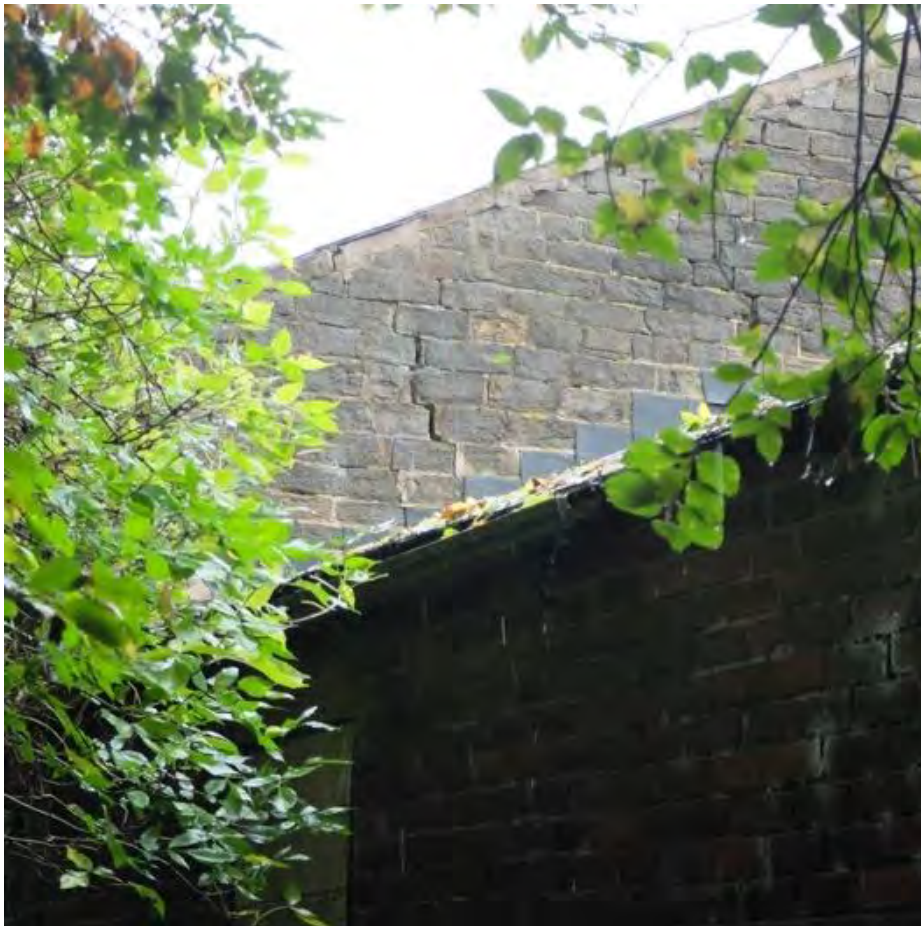
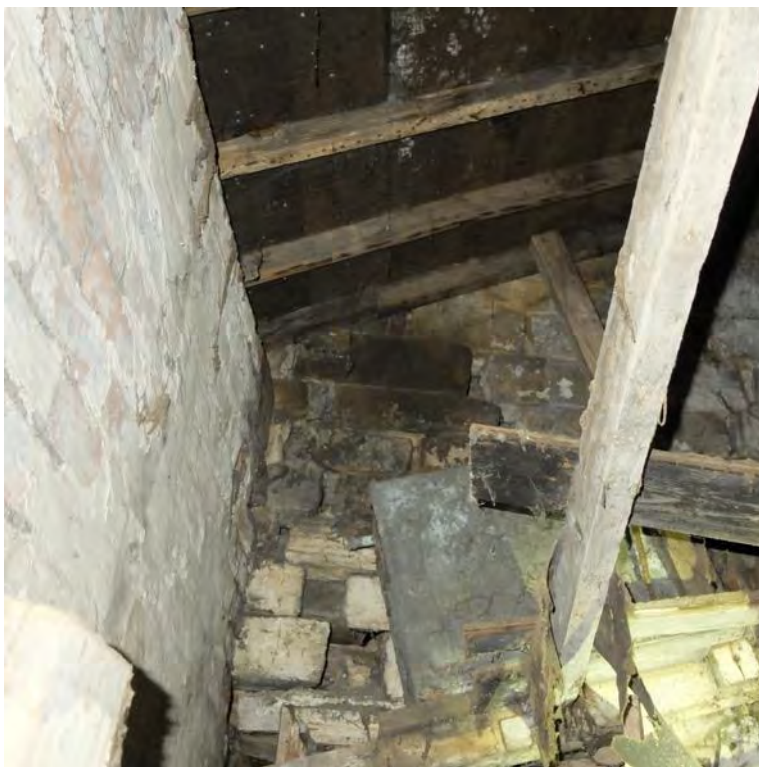
Along the front section of the gable there is an opening into the barn. This opening coincides with the opening in the front elevation the barn meaning there is only a very small pillar of stone which supports the corner of the barn. There is considerable outward movement in this area and this movement appears to extend up to roof level. The gap which has opened is approximately 50 to 75 mm in places and urgent support and restraint is required in this location.

Photo. Movement extents up to roof level

Photo. Movement above doorway which extends up to roof (photo above)

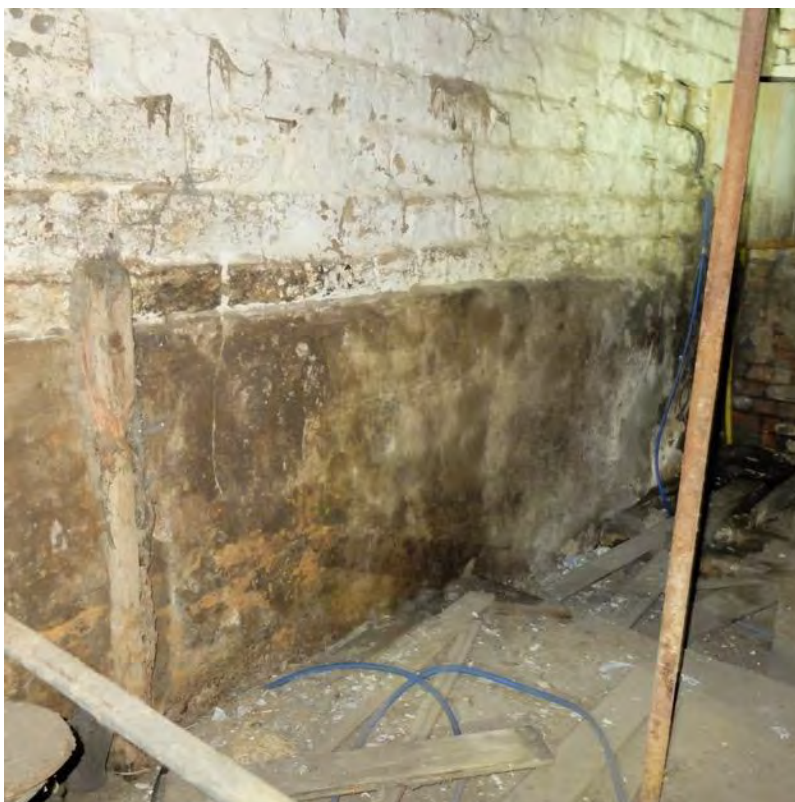
At low level when viewed from the cowshed the wall has been tanked using a hard cementitious render system to support framing activities. When the cowshed is removed, and the full gable is exposed the cementitious render will be difficult to remove without causing serious damage to the face of the stones at low level.

Photo. Tanking to external barn wall will be difficult to remove.

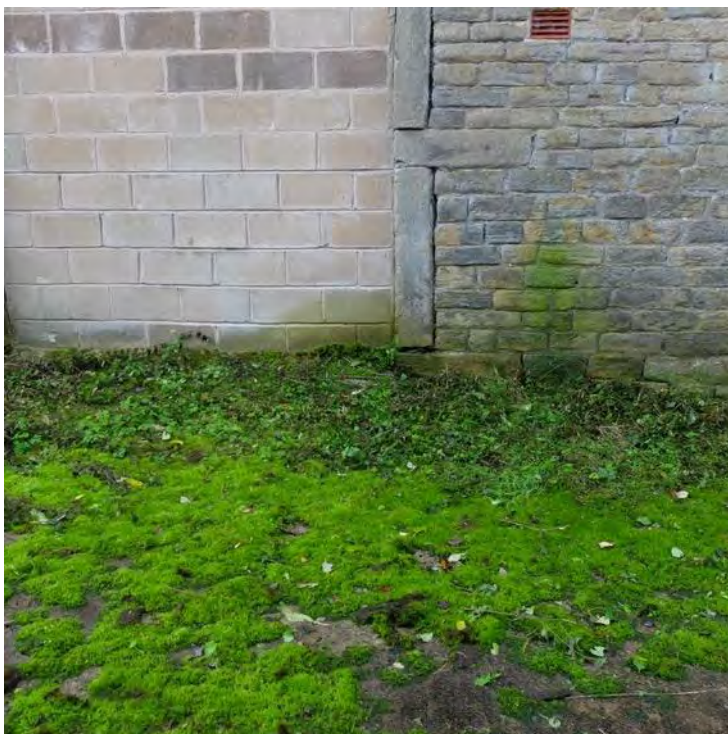
The stone reveals at low level which form the threshing door appear to have been repacked at the base. It is possible that the action of the large doors has caused these to become loose and these have had to be repacked. It is considered that these will need removal and re-bedding incorporating horizontal tie system with the masonry walls.

Photo. Repacking of threshing door reveals

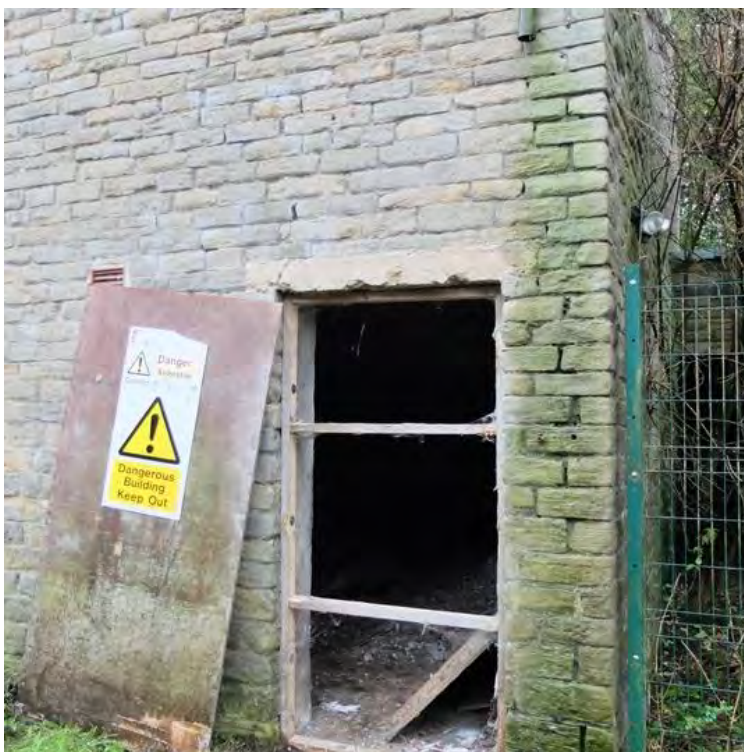
The stone lintel over the door opening has been bashed and damaged by years of carrying items into the barn.

Photo. Damaged stone lintel above door

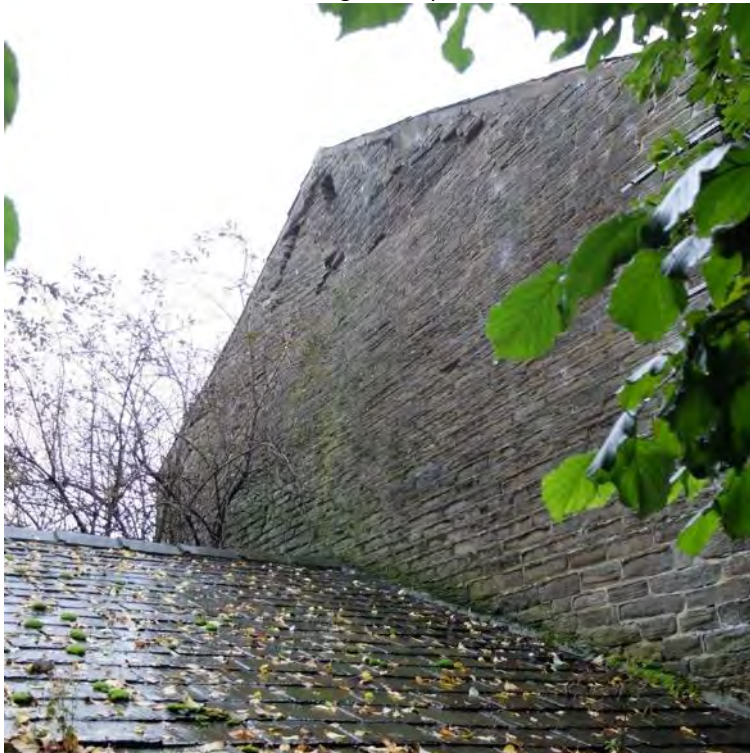
At high level a section of the inner leaf has collapsed, and the outer leaf has bellied inward as a result. This is currently very dangerous as it is possible that this outer leaf could collapse inwards at any time. It is considered it is only the roof loads transferred onto the walls via the purlins is providing lateral restraint to the wall and holding this in position.

Photo. Inward bulge to high level gable

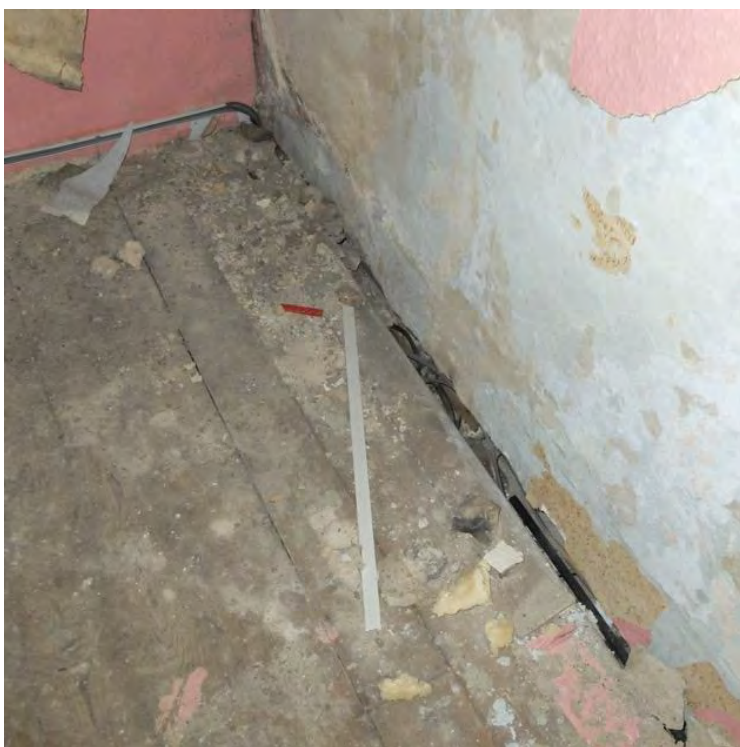
Photo. Gap between floor and wall indicates movement. Room F.07

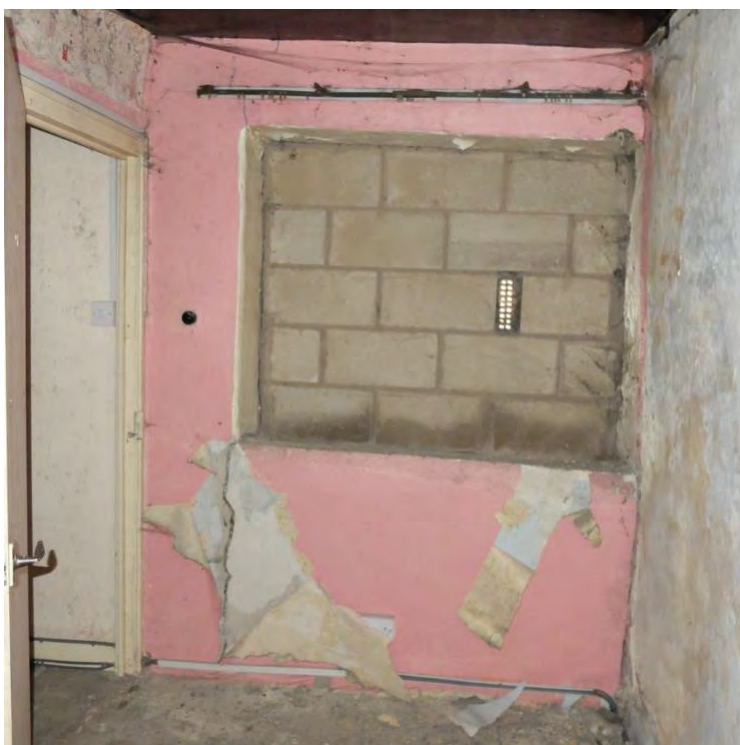
Photo. Cracking to below window west wall of outrigger Room F.07

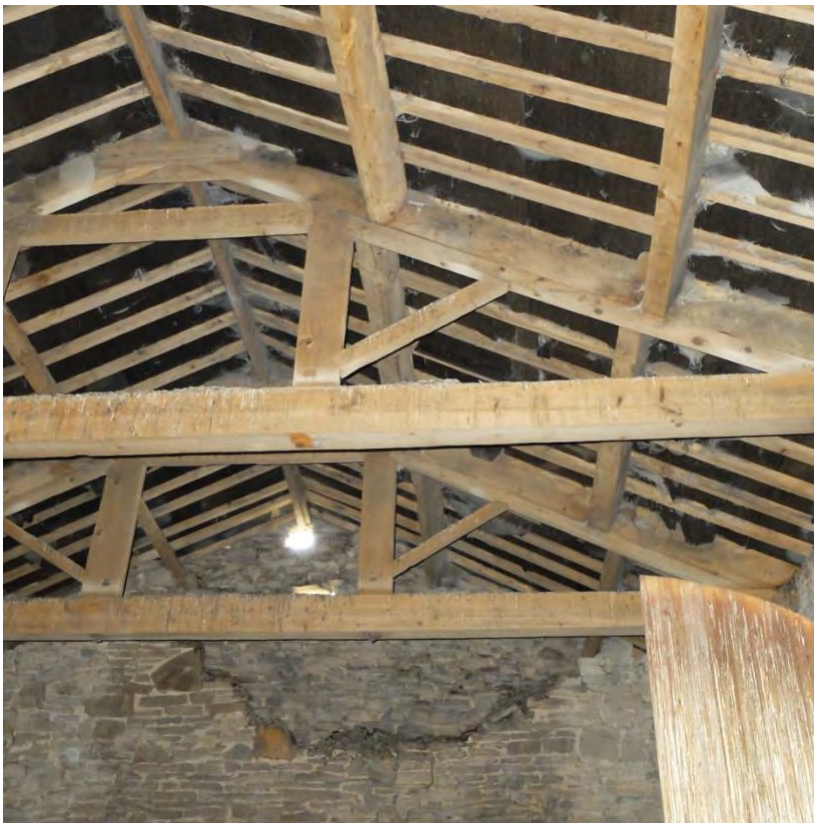
Photo. Collapse of inner leaf to gable.

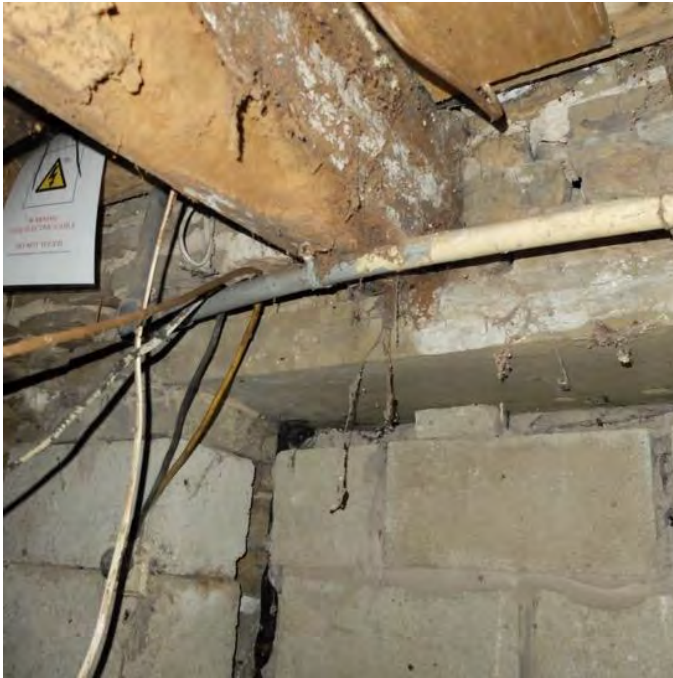
Photo. Decay to timber beam Room B1

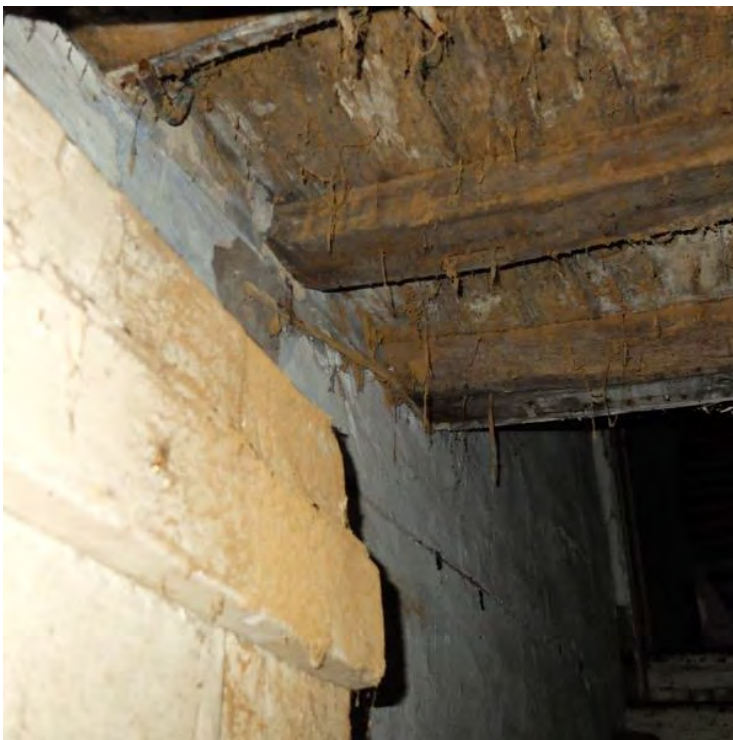
Photo. Decay to joists and boards which support York stone floor above, Room B1

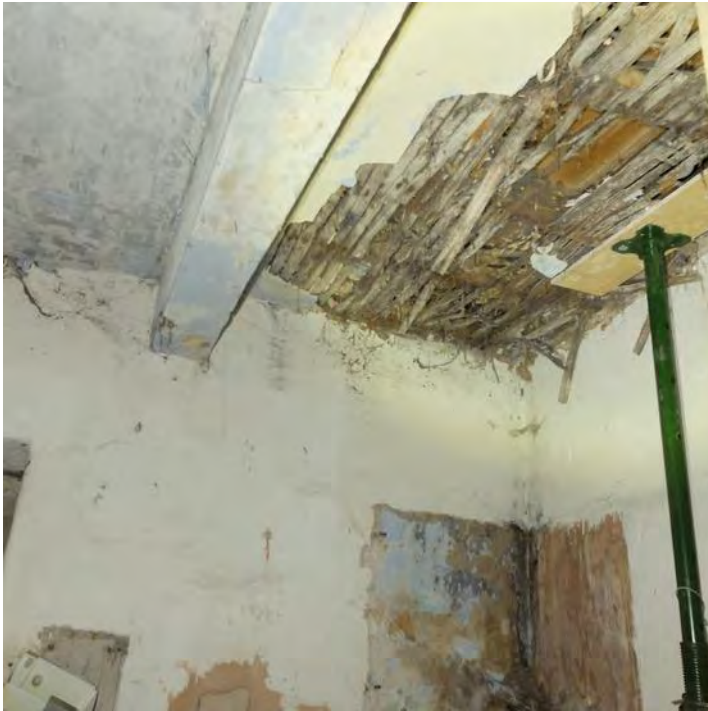
Some sections of the lath and plaster ceilings have collapsed which is due to water ingress.

Photo. Example of damage to lath and plaster ceilings and downstand timber beam
